# Unisense Apparels Ltd.

Beraider Chala, Sreepur, Gazipur  
(24.2000004, 90.420685)

15<sup>th</sup> May 2017

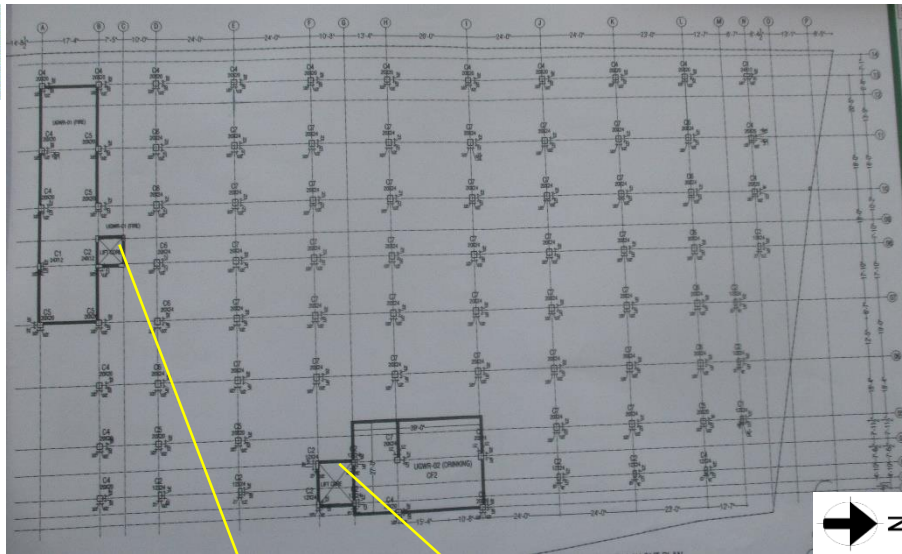
column layout.

Column size and nos. of rebar & rebars dia are not fully match with column schedule. Building engineer is required confirm the dia, size & nos. of rebar on each column.

| Item No. | Observation | Recommended Action Plan | Recommended Timeline |
|---|---|---|---|
| 1 | (Production Building)<br>Discrepancies between drawings and on site condition | Engage a qualified engineer for producing correct “as-built” drawings which reflect the actual site condition with complete structural and architectural information. | 6-weeks |

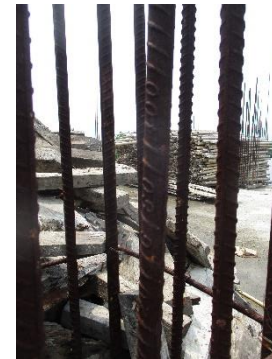
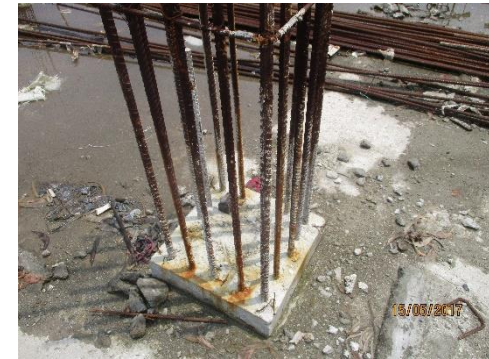
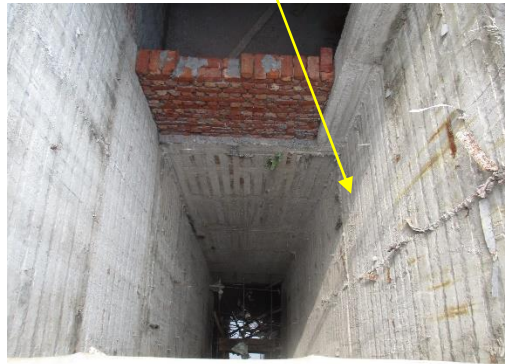
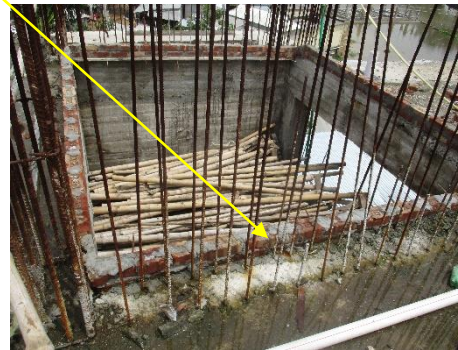
Shear walls are not shown in structural drawings which are exists on both lift core.

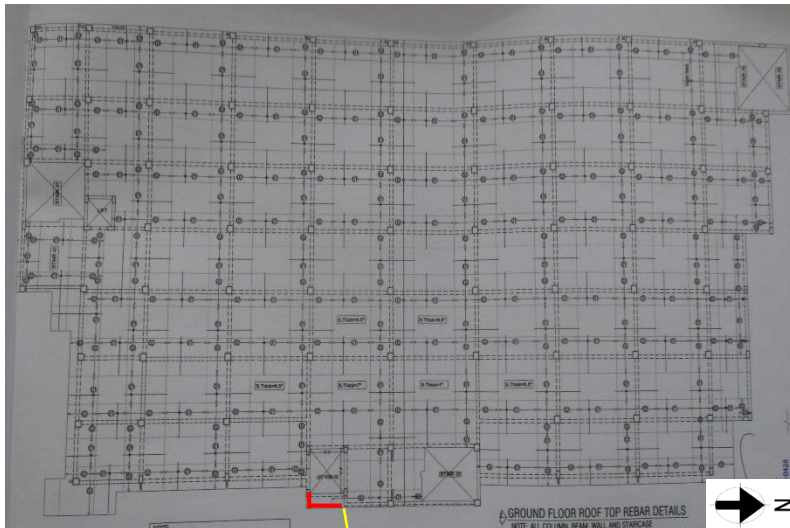
Beam Layout

Minor mismatch in beam layout. Mismatch shown in red on beam layout.

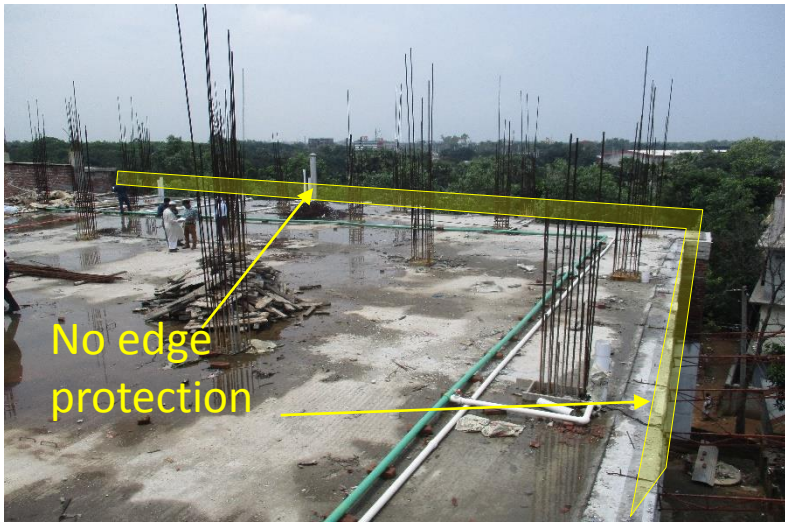
Factory building

Falling hazards due to unprotected edge of under construction building. All exposed reinforcement must have adequate protection from the elements. Currently the exposed reinforcement is prone to corrosion.

| Item No. | Observation | Recommended Action Plan | Recommended Timeline |
|---|---|---|---|
| 2 | (Production Building)<br>Falling hazards on the roof and protect reinforcement from corrosion | Secure constructed area around the perimeter wall to exclude any possible falling hazard. | Immediate - Now |
| 3 | (Production Building)<br>Falling hazards on the roof and protect reinforcement from corrosion | All exposed reinforcement is to be protected from corrosion which may cause degradation of the concrete. | 6-weeks |

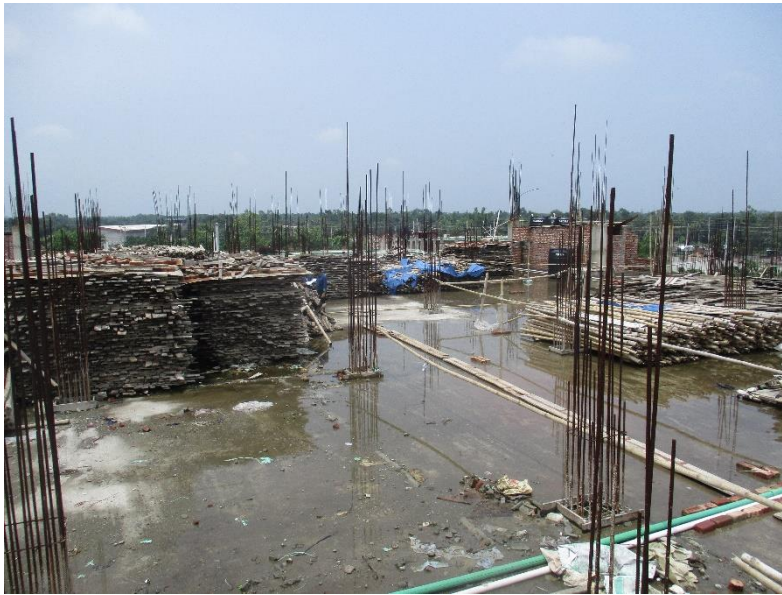
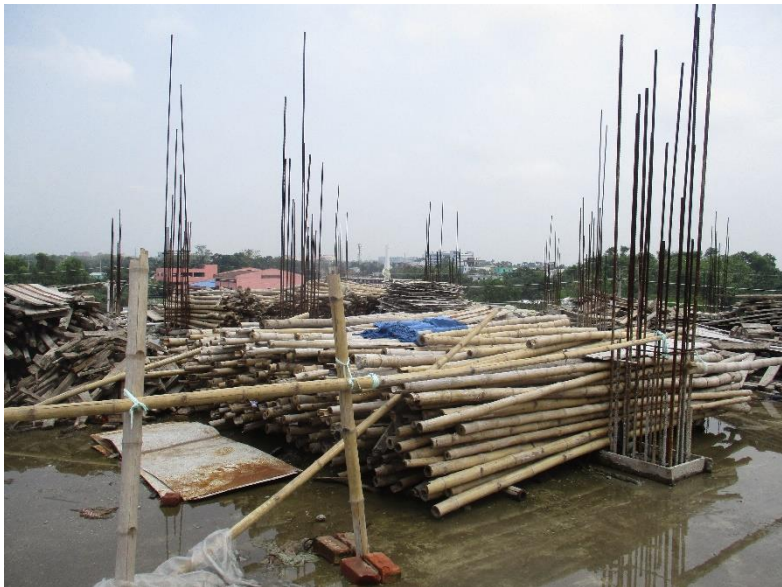
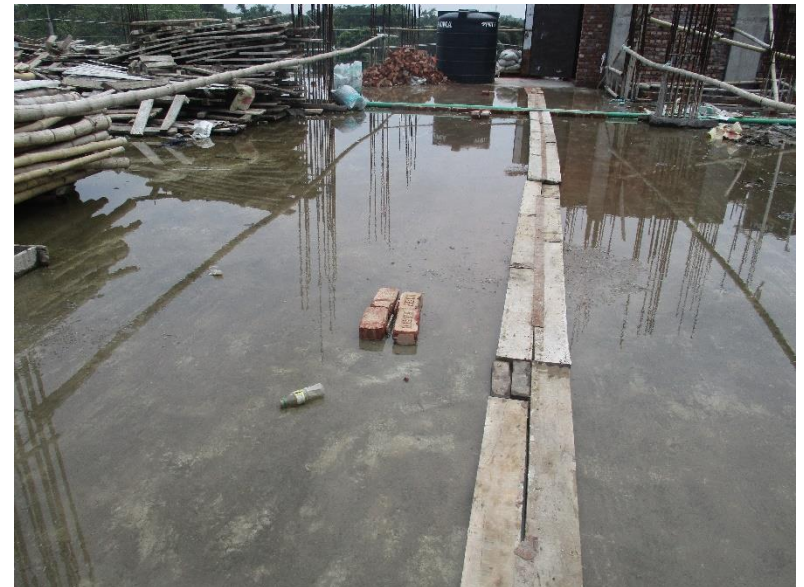
Water ponding found at current roof of the factory building. Also stacking of construction materials found almost every where at roof.

| Item No. | Observation | Recommended Action Plan | Recommended Timeline |
|---|---|---|---|
| 4 | (Production Building)<br>Water ponding and stacking of construction material on roof | For both durability and serviceability, waterproofing on the roof slab is recommended. Moreover the roof slab drainage system should be investigated. | 6-weeks |
| 5 | (Production Building)<br>Water ponding and stacking of construction material on roof | Remove construction materials from roof top. | 6-weeks |

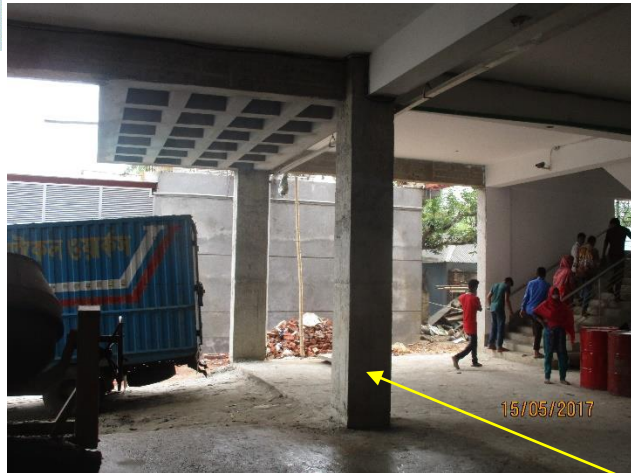
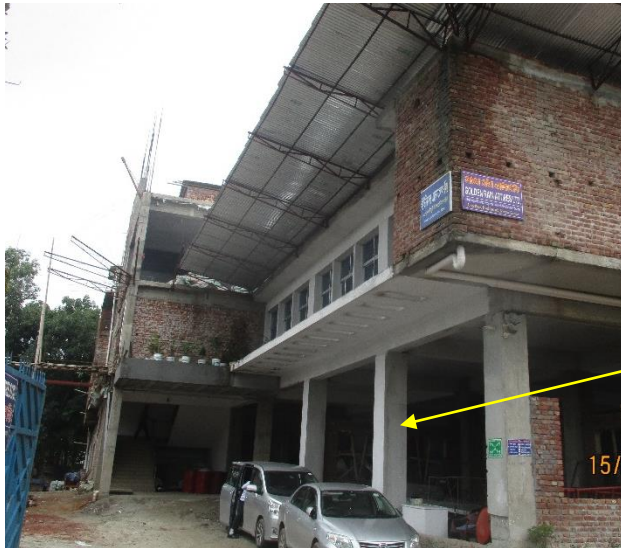
Impact protection not provided to columns at loading – unloading area. Columns are susceptible to impact loading from vehicles.

| Item No. | Observation | Recommended Action Plan | Recommended Timeline |
|---|---|---|---|
| 6 | (Production Building)<br>Columns susceptible to vehicle impact | Install a barrier to prevent vehicle impact in column. | 6-weeks |
