# Divine Garments Limited

Koyerpara, Chowgacha, Jessore.  
(23.255206, 89.039256)  
11<sup>th</sup> May, 2017

# Observations

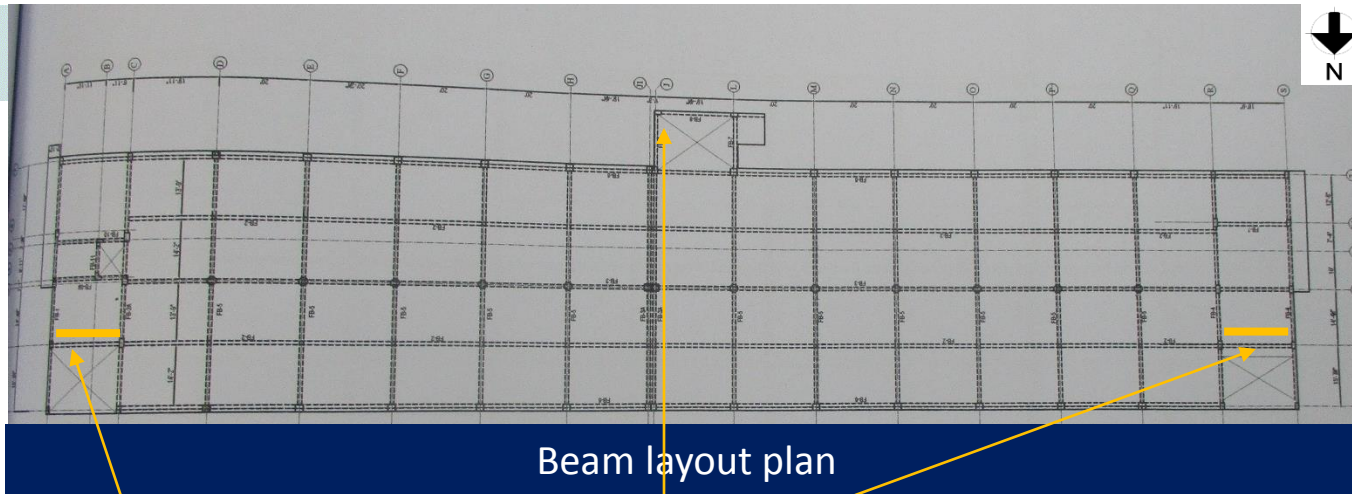
Beam layout plan

# Inconsistency in beam layout of Garments Building

| Item No. | Observation | Recommended Action Plan | Recommended Timeline |
|---|---|---|---|
| 1 | Inconsistency in beam layout of Garments Building | Factory engineer is required to survey the structure and update the drawings where necessary. | 6-weeks |

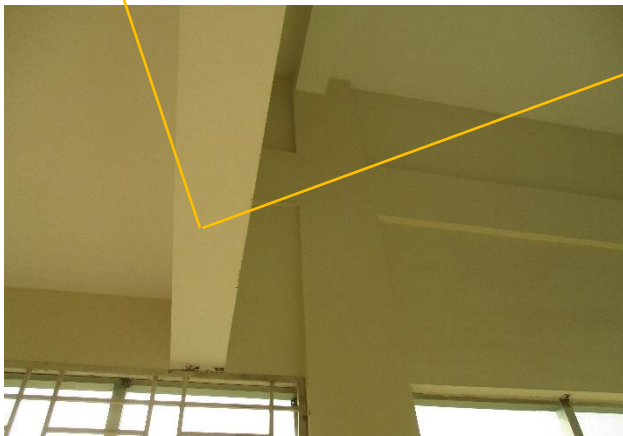
Beam shifted from drawings in yellow marked area.

Inconsistency observed between provided drawing and site observation. Factory engineer is required to survey the structure and update as built drawing..

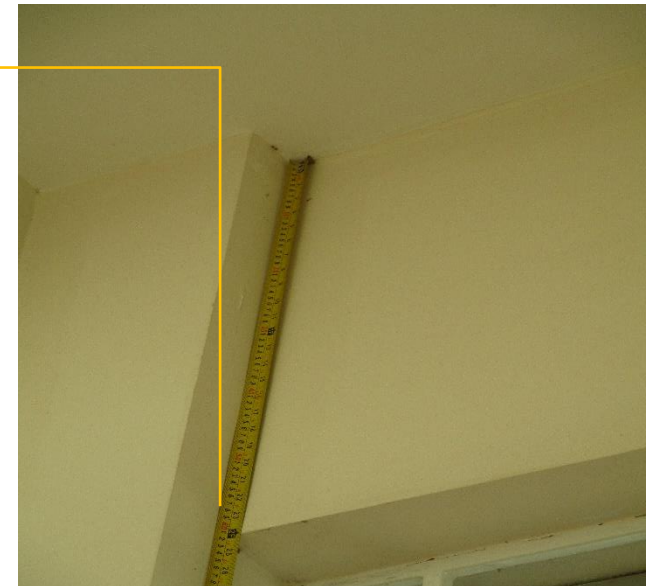
Several beam sizes doesn't match with provided drawings.

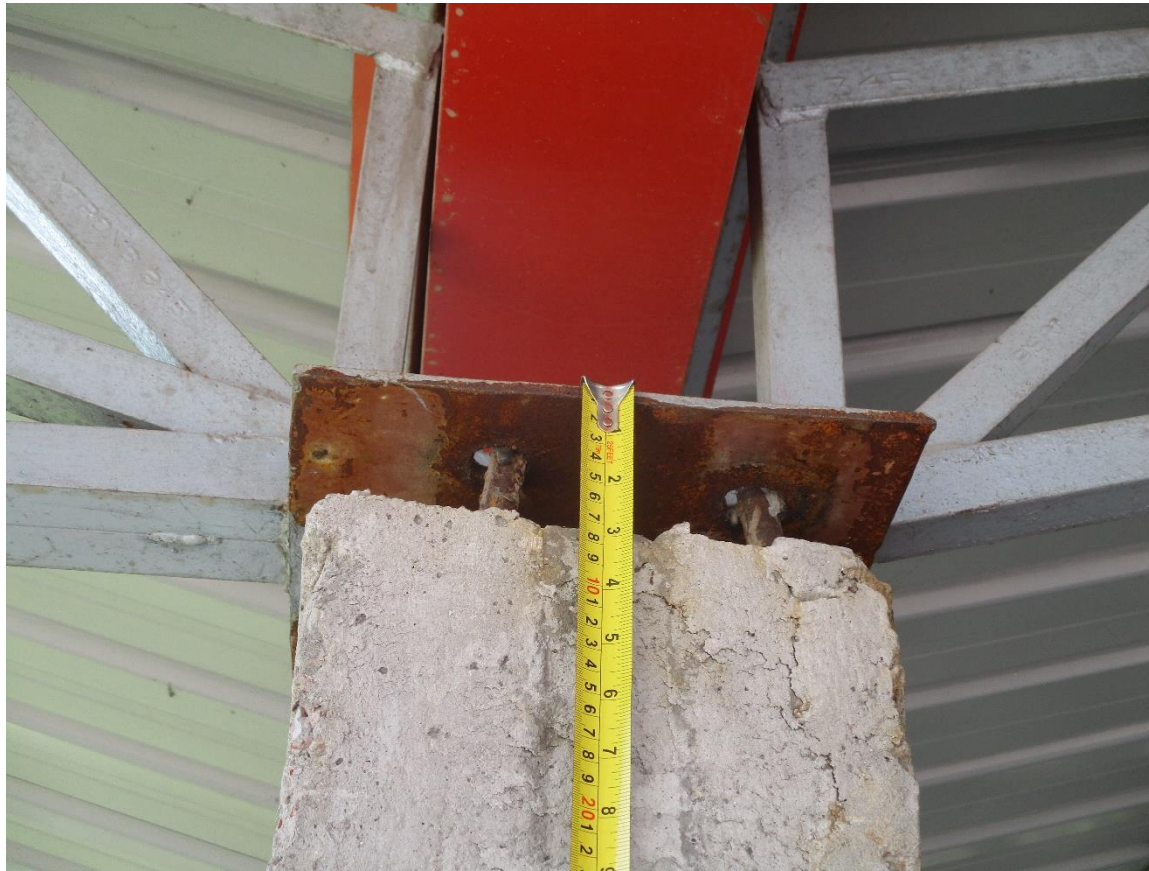
**Significant gap between steel baseplate and  
RCC column of cycle shed**

Significant gap observed between steel baseplate and RCC column. Which is required to be remediated.

| Item No. | Observation | Recommended Action Plan | Recommended Timeline |
|---|---|---|---|
| 2 | Significant gap between steel baseplate and RCC column of cycle shed | Carryout suitable remedial works as per suggestion of factory engineer. | 6-weeks |

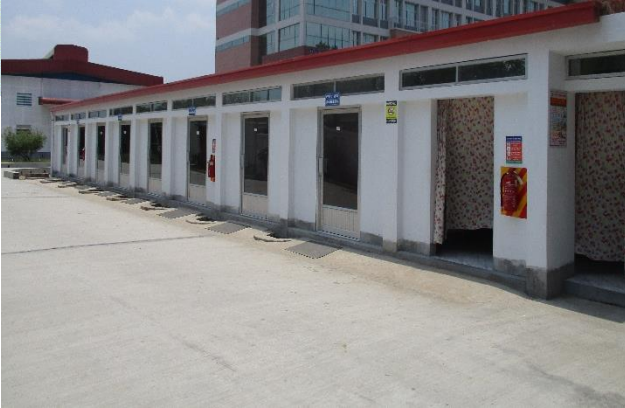
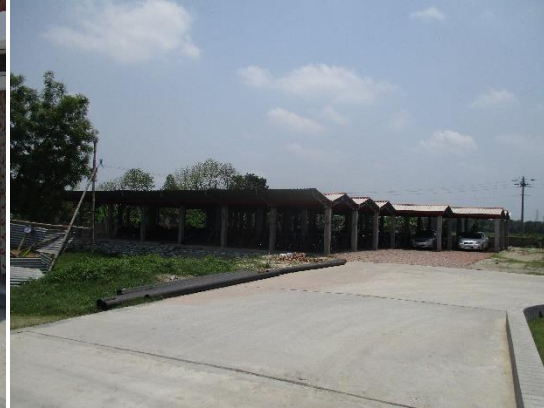
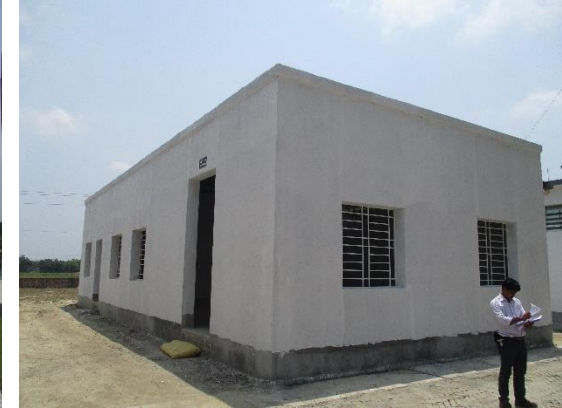
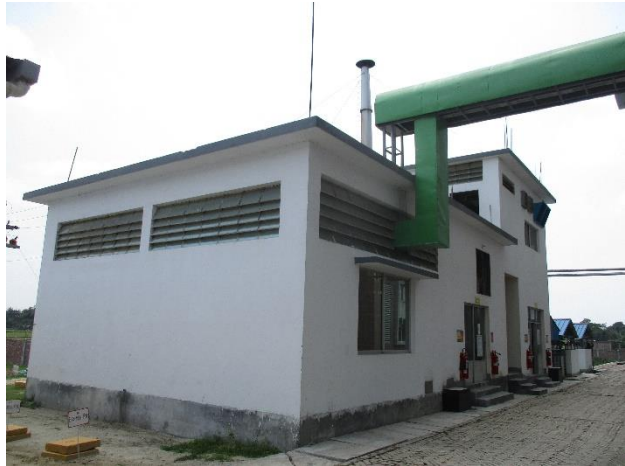
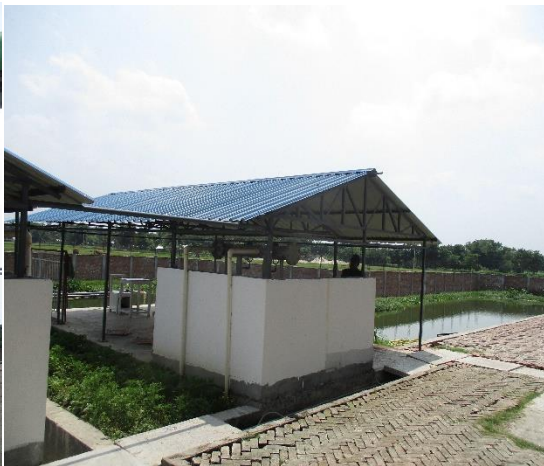
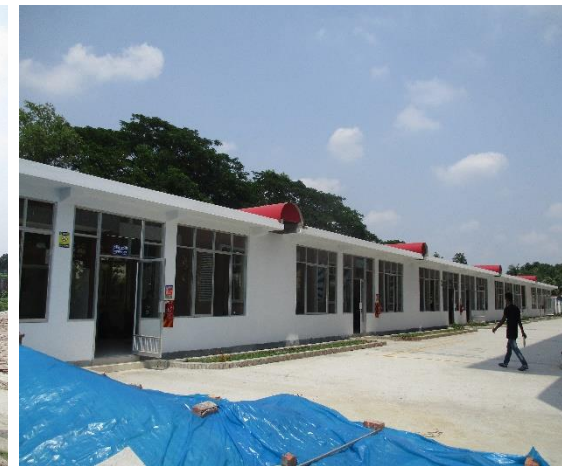
**Drawings for the ancillaries weren't available.**

No as built drawings were available on site. Factory engineer is required to produce as built drawings for ancillary structures.

| Item No. | Observation | Recommended Action Plan | Recommended Timeline |
|---|---|---|---|
| 3 | Drawings for the ancillaries weren't available | Produce as built drawings for all ancillary structures. | 6-months |

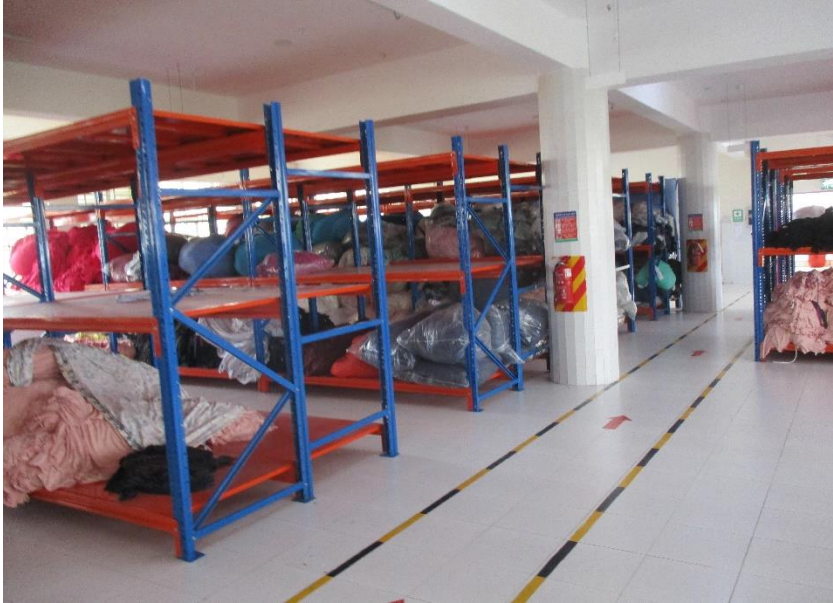
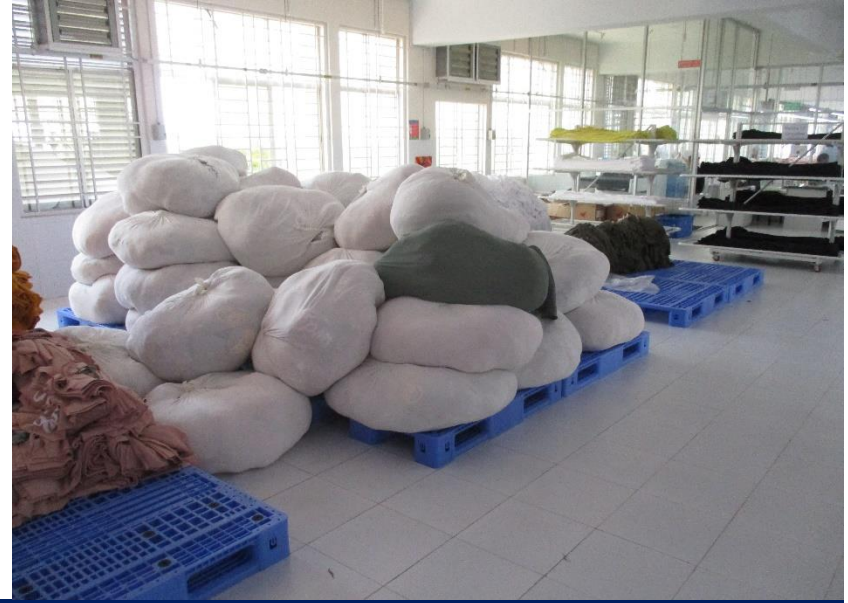
# Implement floor load management program

No load management programs were visible. Factory is required to implement load management program as per its floor loading capacity and Follow the load plans for all floors of the buildings and make sure that the workers understand the loading requirements.

| Item No. | Observation | Recommended Action Plan | Recommended Timeline |
|---|---|---|---|
| 4 | Implement floor loading management program | Factory is required to implement load management program as per its floor loading capacity. | 6-weeks |
| 5 | Implement floor loading management program | Follow the load plans for all floors of the buildings and make sure that the workers understand the loading requirements. | 6-months |

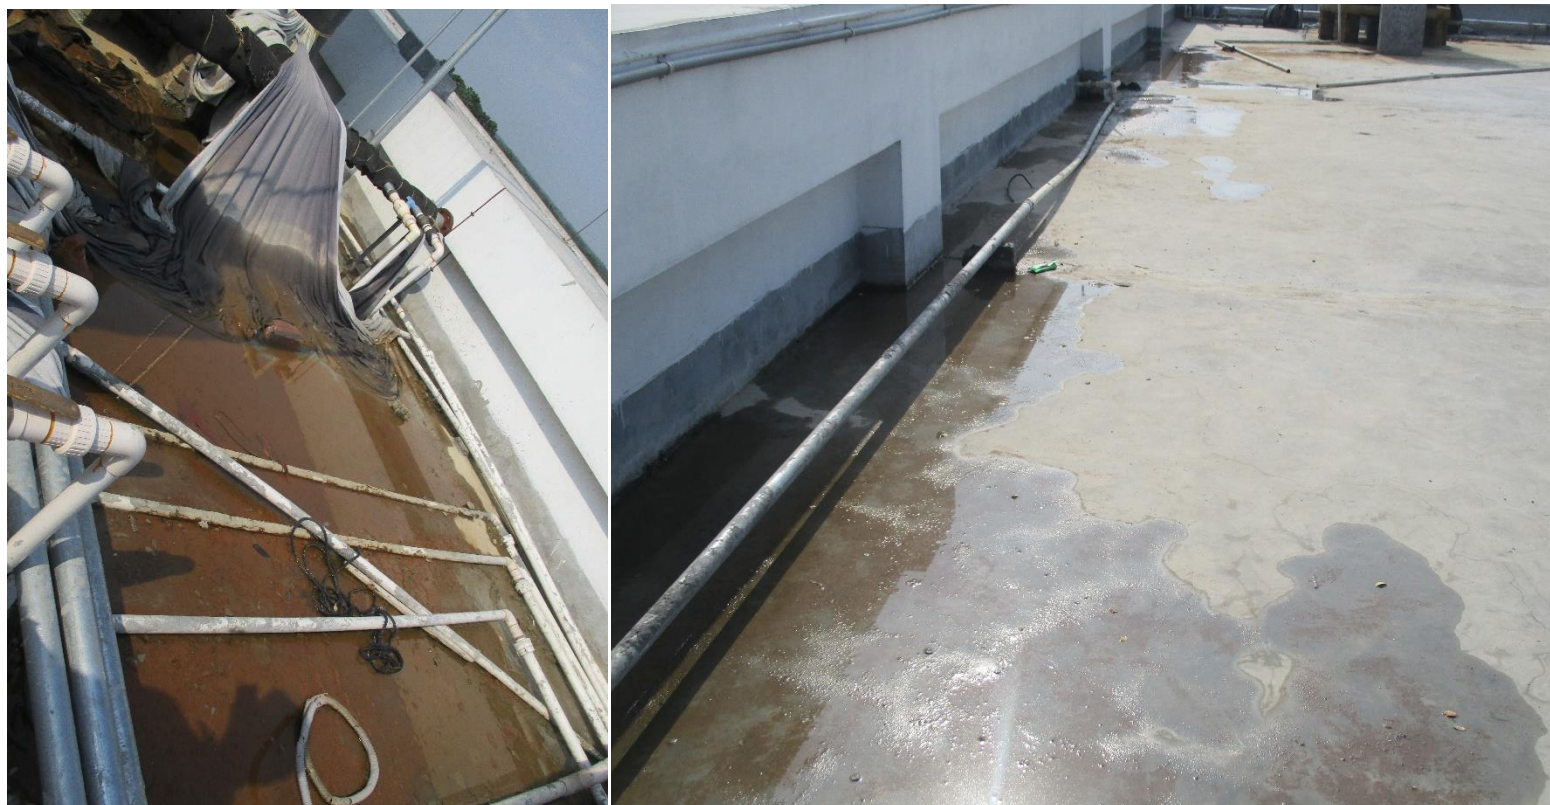
# Poor water drainage system at roof of garments building

Poor water drainage system observed at roof of garments building.

| Item No. | Observation | Recommended Action Plan | Recommended Timeline |
|---|---|---|---|
| 6 | Poor water drainage system at roof of garments building | Improve roof drainage system of garments building | 6-months |
