FIRE SAFETY INSPECTION REPORT

**APPAREL 21 LTD. NEUE UNIT LITHE
GROUP
SHIRIR CHALA, BAGHER BAZER GAZIPUR SHADAR,
GAZIPUR**

May 5, 2014

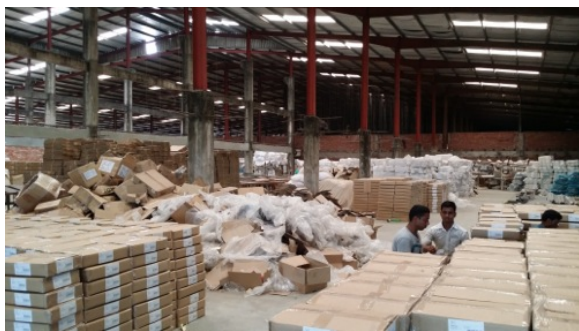
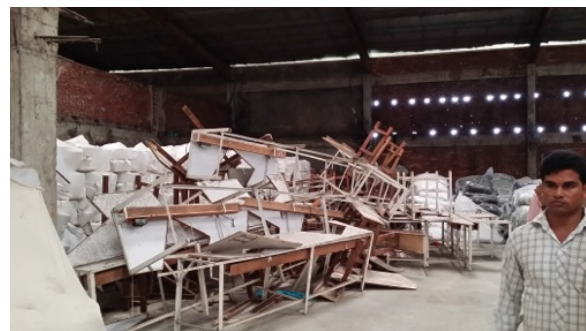
No.	Category	Finding	Recommendation	Remediation Timeframe
F-1	Fire Rated Construction	<p>Areas used for combustible storage are not separated by fire-rated construction.</p> <p>Storage was located in various areas throughout the west wing ground floor. The various storage areas were scattered, around the floor with no dedicated storage rooms or areas.</p>	<p>Provide dedicated storage rooms separated by minimum 1-hr fire-rated construction.</p> <p>Where separate storage rooms are not feasible, provide defined storage areas and limit the storage arrangement as follows:</p> <ul style="list-style-type: none"> - Maximum height of 2.4m and maximum area of 23m² - If sprinkler protected: maximum height of 3.66m and maximum area of 93m² <p>Separate areas of unenclosed combustible storage by a minimum clear distance of 3m.</p>	Within 3 months

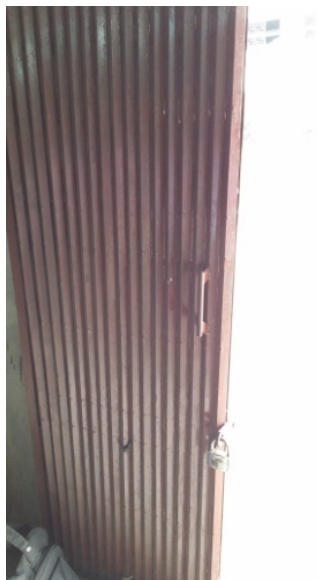
F-2	Egress	Egress doors / gates with locking features are provided at building exits, exit stairs, along egress routes, and exit discharge. This was reflected throughout the building on all floors.	Remove locking features from all egress doors / gates. If locks are required for security reasons, utilize special door locking features complying with NFPA 101.	Immediate
-----	--------	--	--	-----------

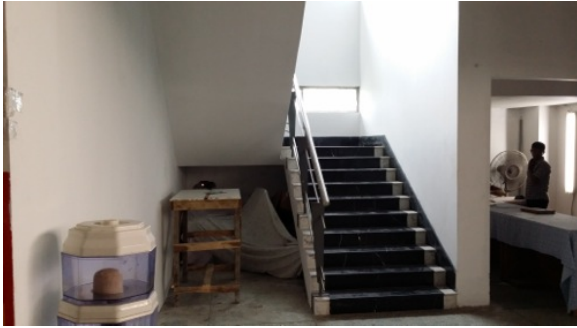
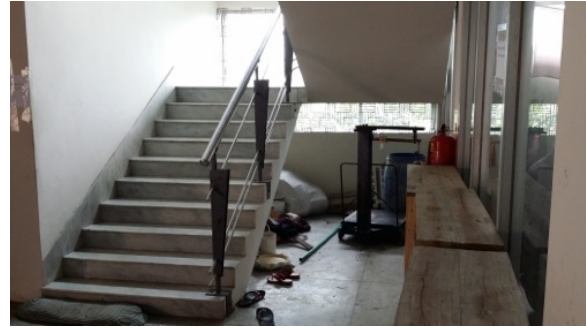
F-3	Egress	Storage areas / electrical boxes were located in all exit stairwells on the ground floor, underneath the stairs.	Remove all storage from exit stairs and egress paths.	Immediate
-----	--------	--	---	-----------

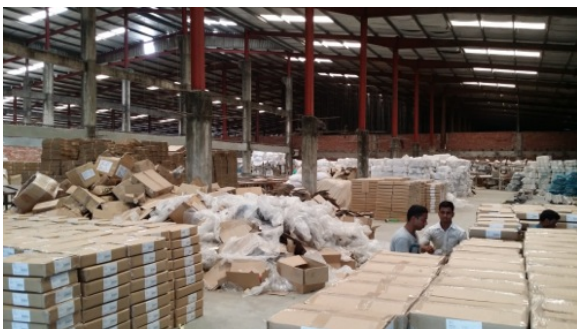
F-4 Egress

Storage was located in various areas throughout the west wing ground floor. The various storage areas were scattered, around the floor with no dedicated egress path.

Keep egress paths and stairs clear of storage.

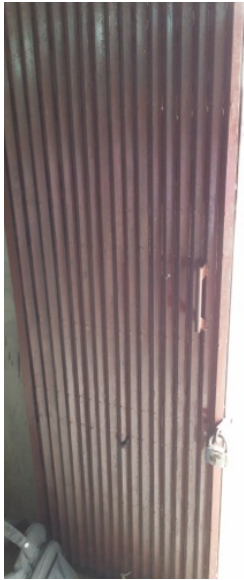
F-5	Egress	Collapsible gates / sliding doors are provided at building exits, exit stairs, along egress routes, and exit discharge. This was reflected throughout the building on all floors.	<p>Replace all gates / sliding doors along the means of egress with side-hinged, swinging egress doors.</p> <p>If locks are required for security reasons, utilize special door locking features complying with NFPA 101.</p>	Within 1 month
-----	--------	---	---	----------------

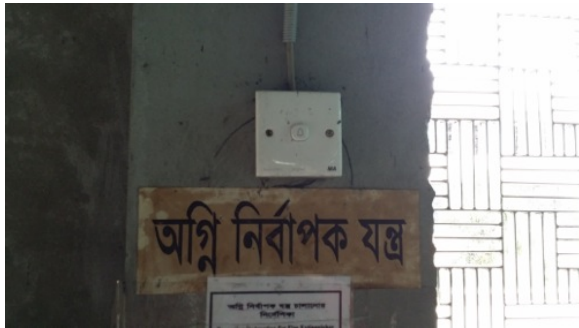
F-6	Fire Protection	The fire alarm system is antiquated, not a listed system, and does not provide alarm and notification features consistent with acceptable standards.	Replace the fire alarm system with a new, listed addressable fire alarm system in accordance with NFPA 72.	Design within 4 months, install within 9 months
-----	-----------------	--	--	---

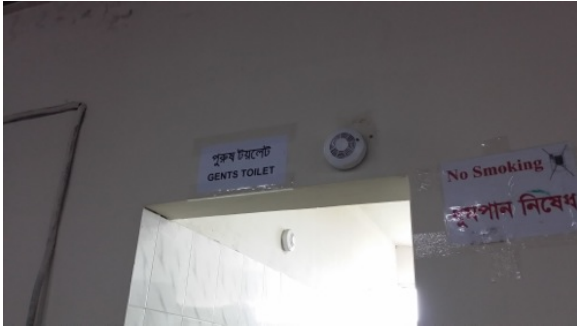
F-7	Fire Protection	Inspection, testing, and maintenance for the fire alarm system was not in accordance with NFPA 72.	Inspect, test and maintain the fire alarm system, and keep written records on-site, in accordance with NFPA 72.	Within 3 months
F-8	Fire Protection	The building is equipped with single-station smoke alarms. Smoke alarm activation sounds only a local alarm and does not provide automatic fire alarm notification of occupants.	Replace the single-station smoke alarms. Provide automatic smoke detection throughout the building in accordance with NFPA 72.	Within 6 months
