# Jay Jay Mills(Bangladesh). Pvt. Ltd.

1<sup>st</sup> July 2014

# Observations

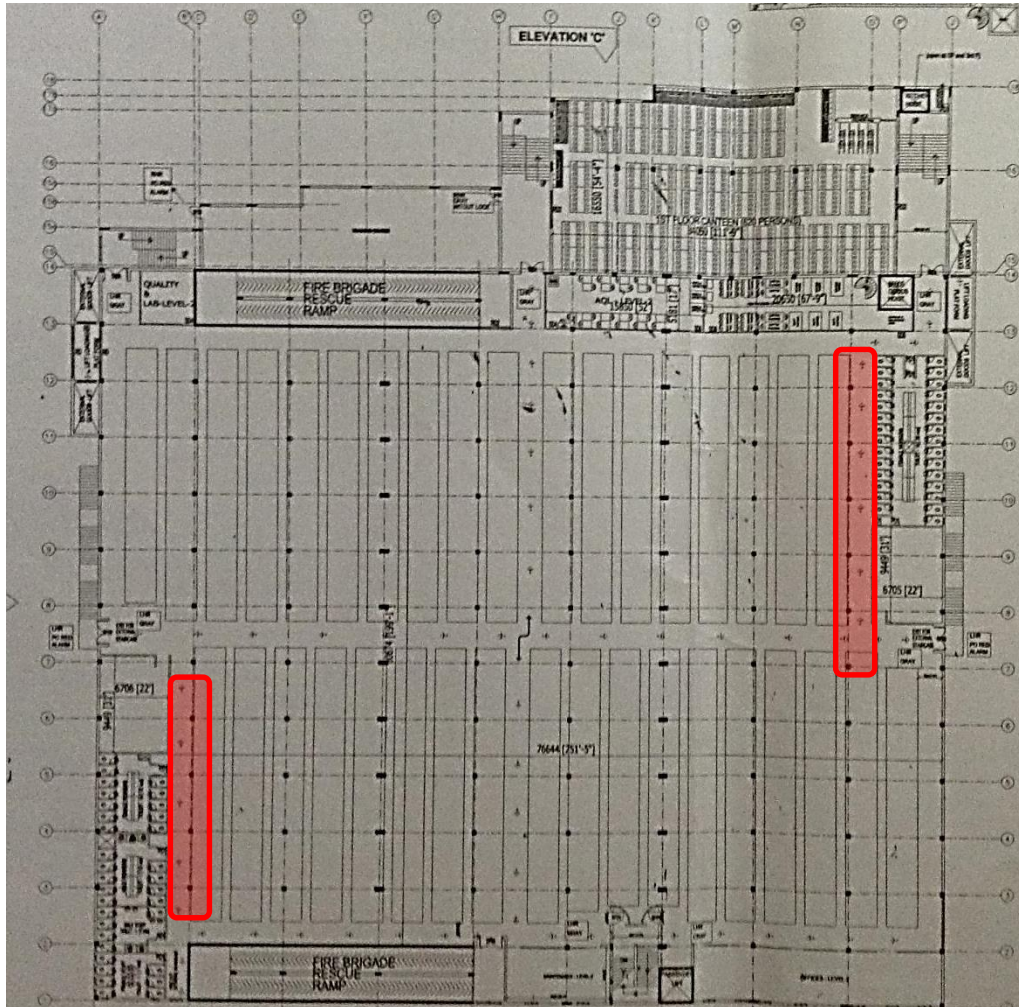
Typical Floor plan

**Columns, which support toilet area floor build-up loads, appear to be stressed in excess of normal design limits**

Highly stressed column locations – in the area of toilets

| Item No. | Observation | Recommended Action Plan | Recommended Timeline |
|---|---|---|---|
| 1 | Columns, which support toilet area floor build-up loads, appear to be stressed (at ground floor level) in excess of normal design limits. | Factory Engineer to review design, loads and column stresses in area identified above. | 6-weeks |
| 2 | Columns, which support toilet area floor build-up loads, appear to be stressed (at ground floor level) in excess of normal design limits. | Verify insitu concrete strengths (using min. 4 no. 100mm dia. Cores) and existing reinforcement for all columns in the highlighted area. | 6-weeks |

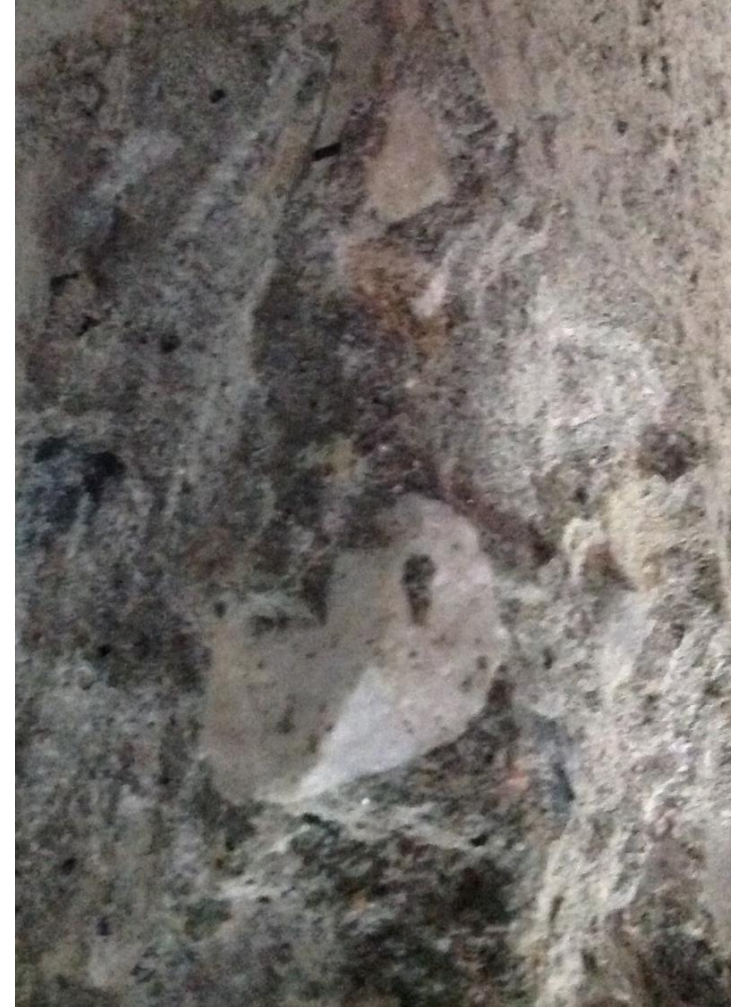
Stone aggregate observed in columns

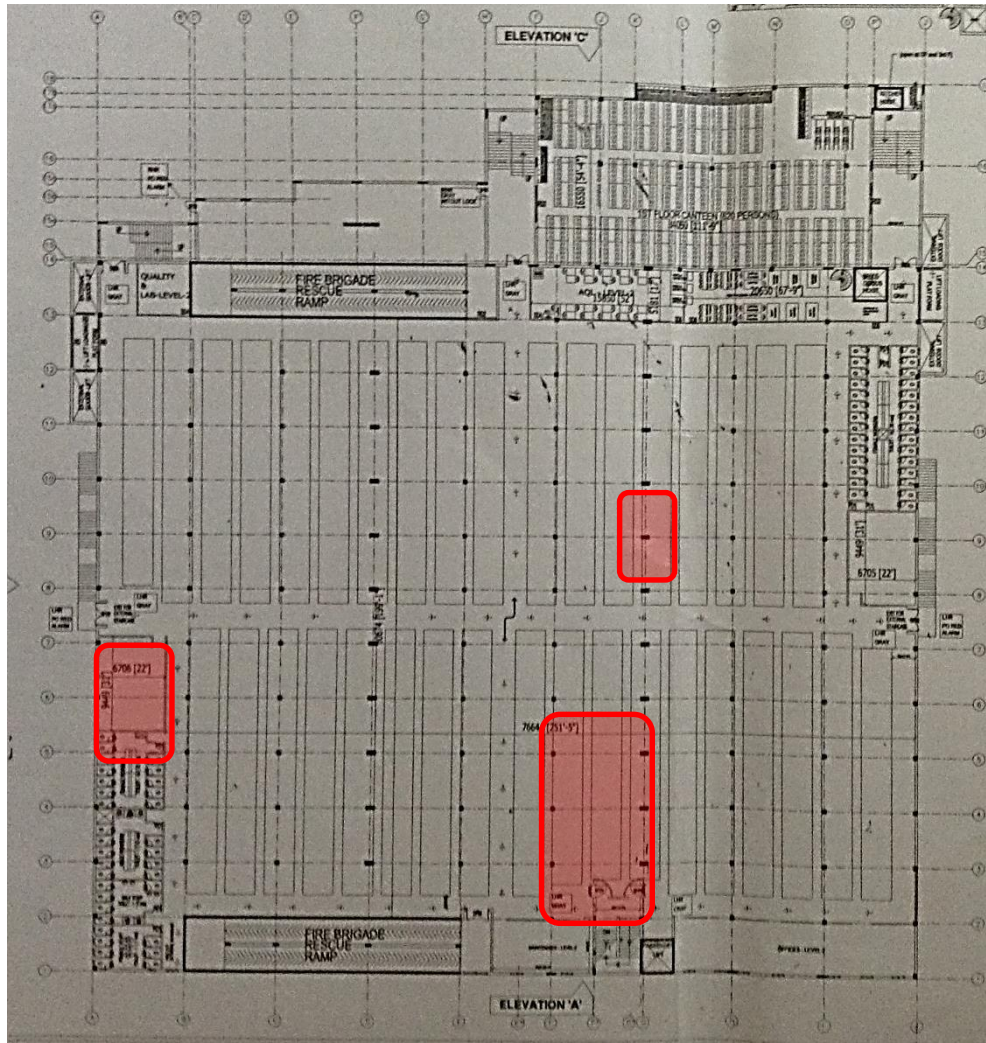
Typical floor plan

Unmanaged storage

| Item No. | Observation | Recommended Action Plan | Recommended Timeline |
|---|---|---|---|
| 5 | Management of floor loads | Produce and actively manage a loading plan for all floor plates within the factory giving consideration to floor capacity and column capacity. (Refer to Item 1) | 6-weeks |
| 6 | Management of floor loads | Implement floor loading plans on an on-going basis. | 6-months |

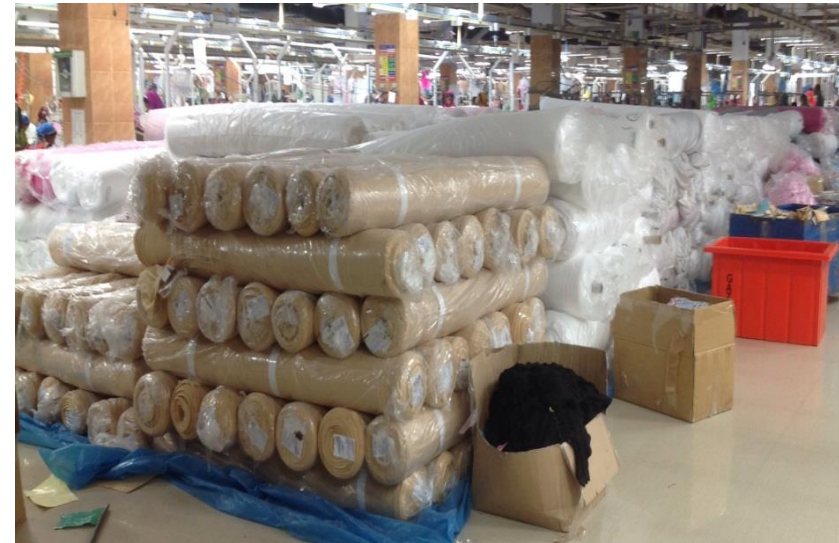
Area of material storage on 1<sup>st</sup> floor

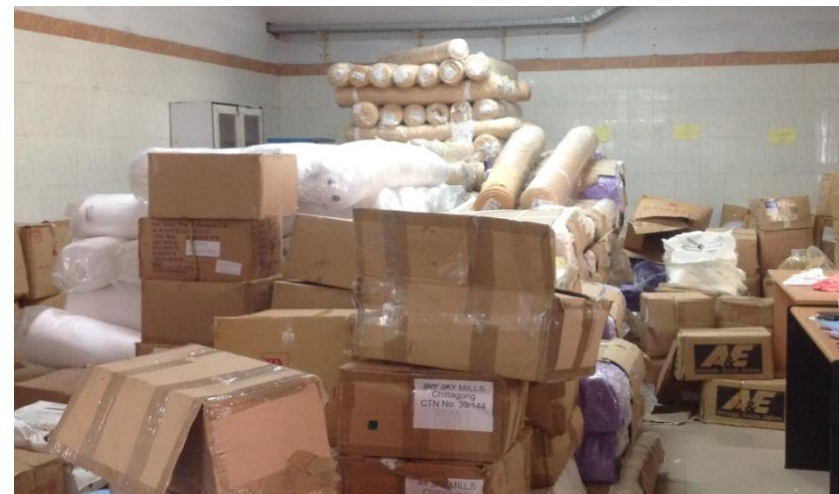
Unmanaged storage

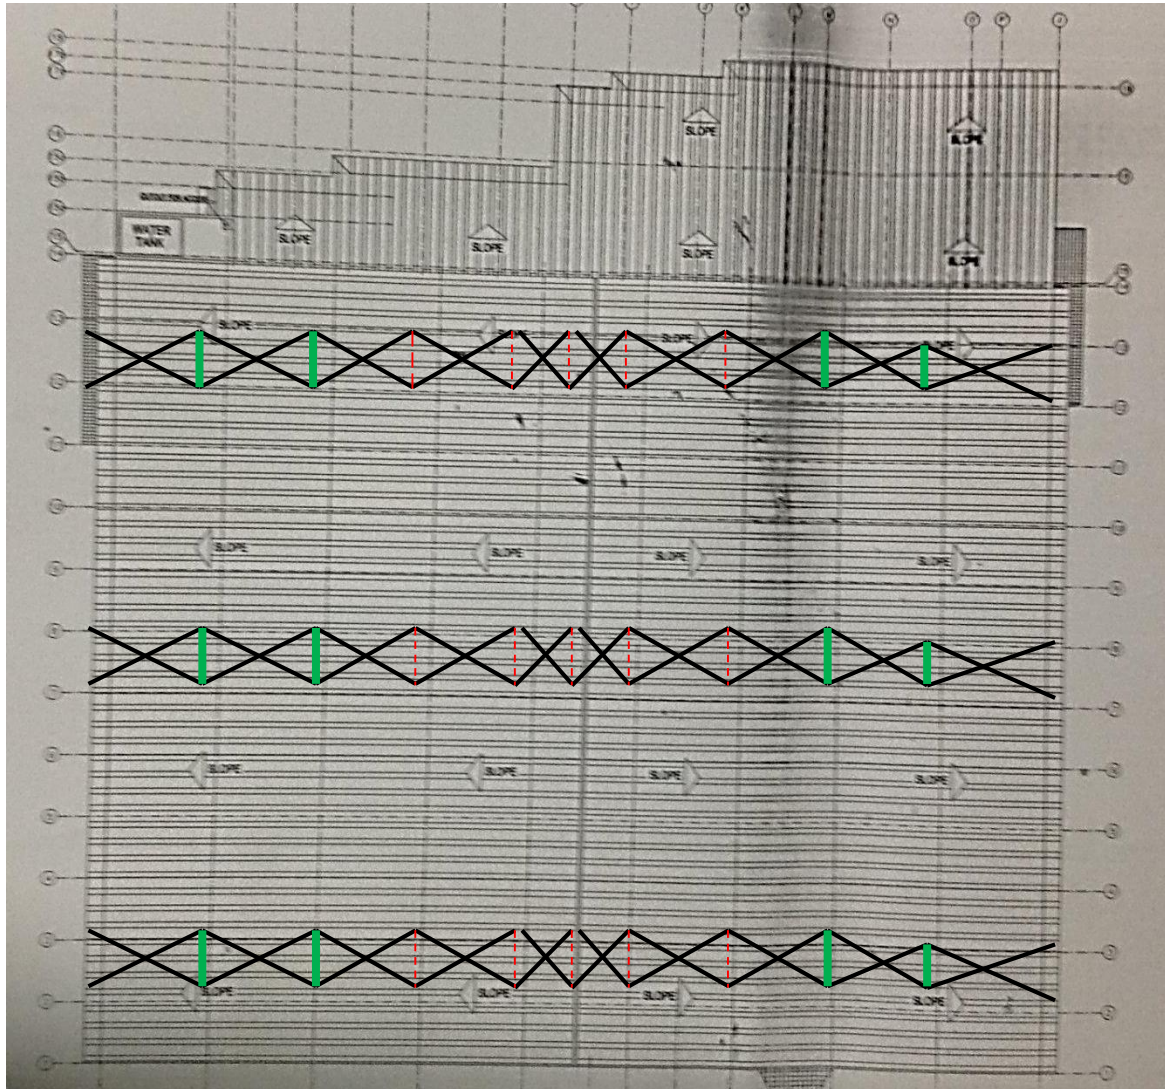
Production Building - Roof Plan

## Missing Compression Struts to Roof Bracing System

- Missing Compression Strut
- Existing Tension only member
- Existing Compression Strut

| Item No. | Observation | Recommended Action Plan | Recommended Timeline |
|---|---|---|---|
| 7 | Compression struts missing from roof bracing system | Building Engineer to assess roof bracing system for lateral wind loading as per BNBC. Particular consideration should be given to missing compression struts in braced bays | 6-months |
| 8 | Compression struts missing from roof bracing system | Building Engineer to design and detail structural upgrading works, as necessary. | 6-months |

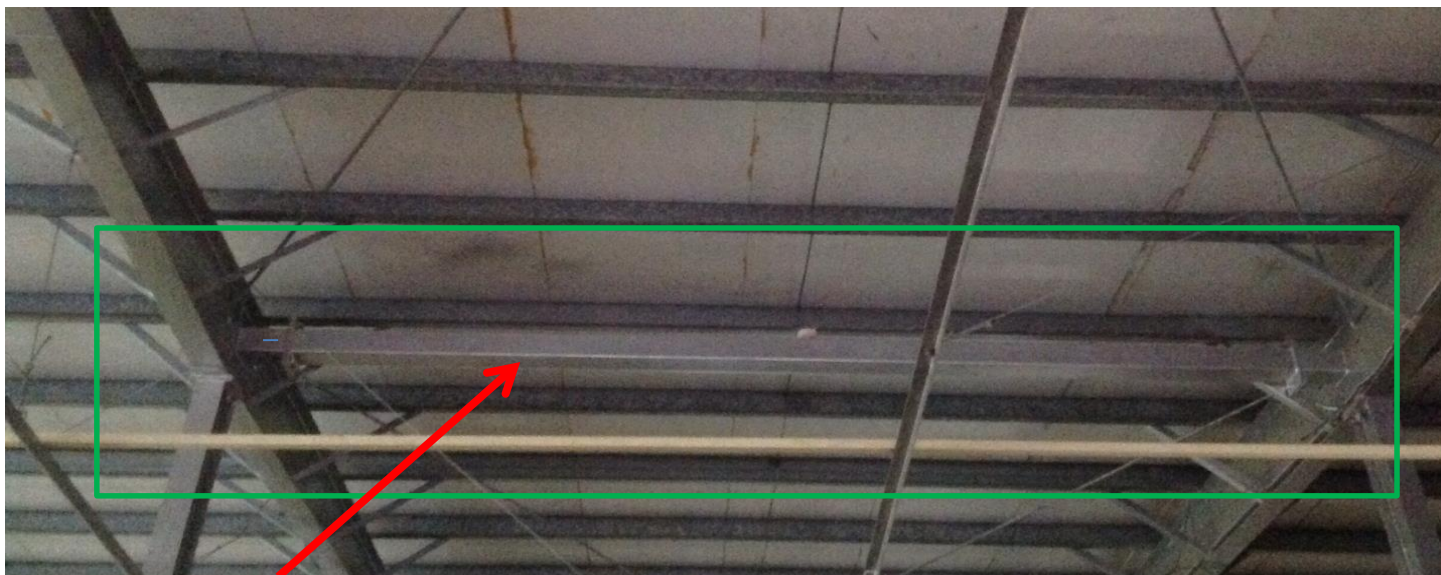
Compression strut in roof bracing

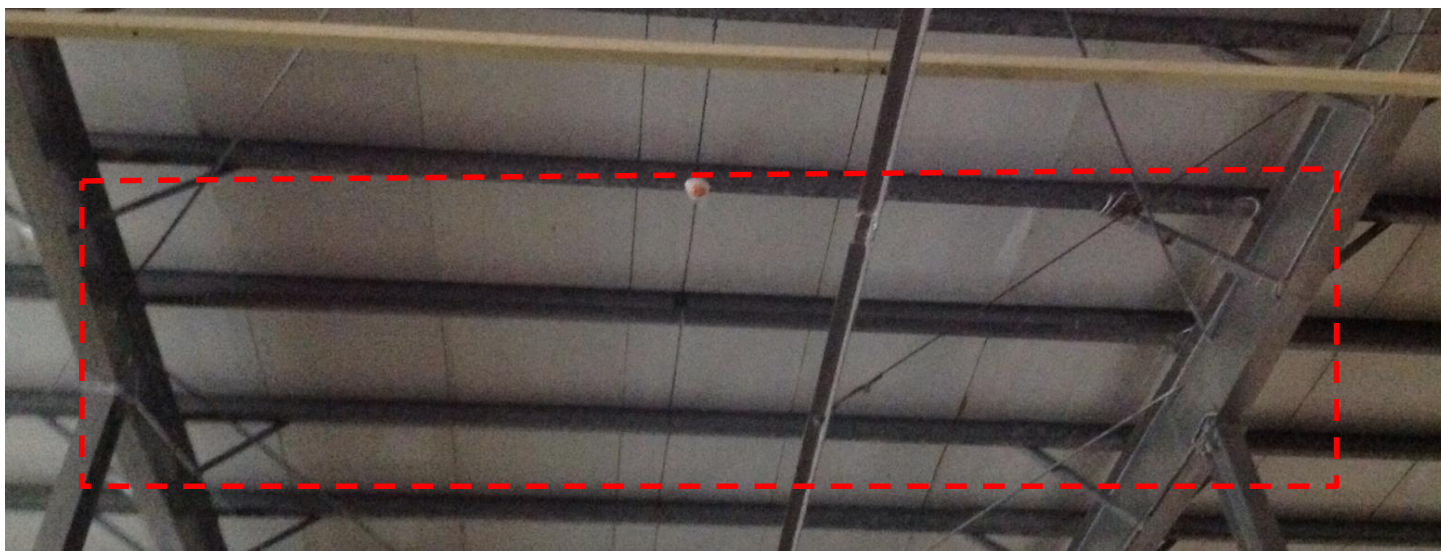
Compression Strut missing from roof bracing

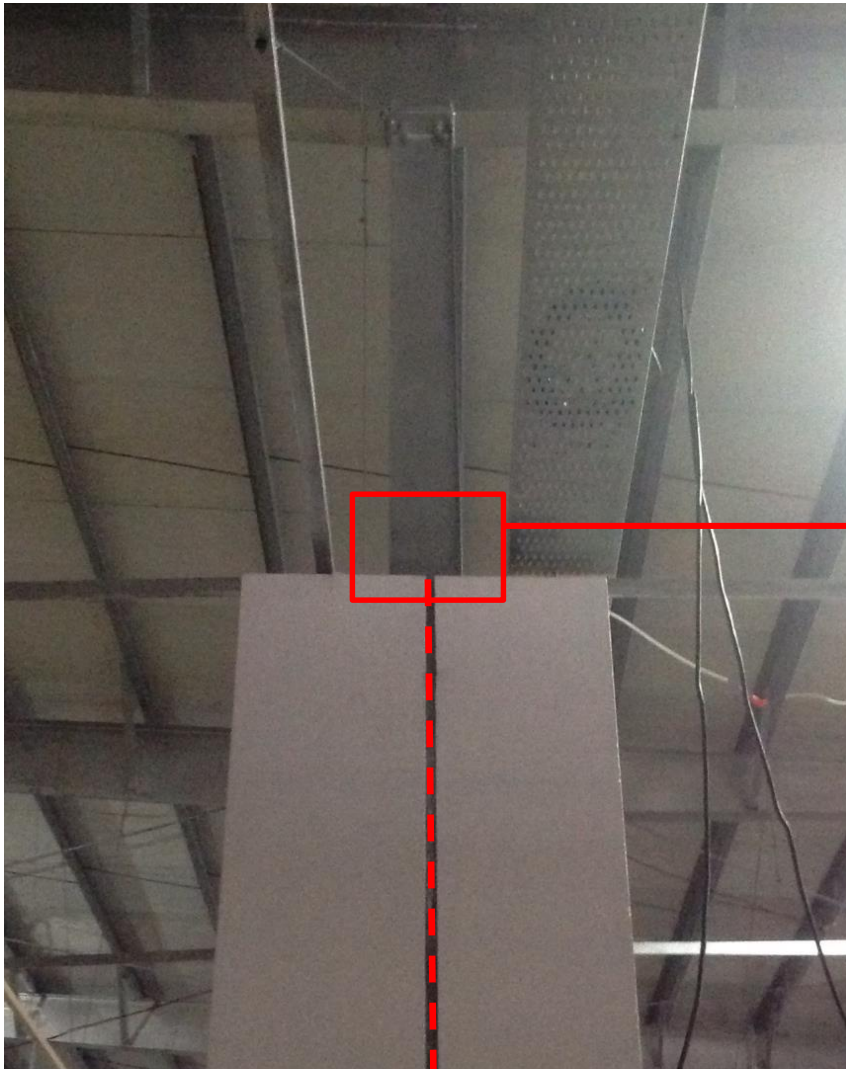
Roof Support centred on movement joint

Double columns - movement joint

| Item No. | Observation | Recommended Action Plan | Recommended Timeline |
|---|---|---|---|
| 9 | Roof Support Baseplate anchored both sides of Movement joint | Building Engineer to monitor baseplate connections across movement joints given consideration to spalling of concrete around anchors. | 6-months |

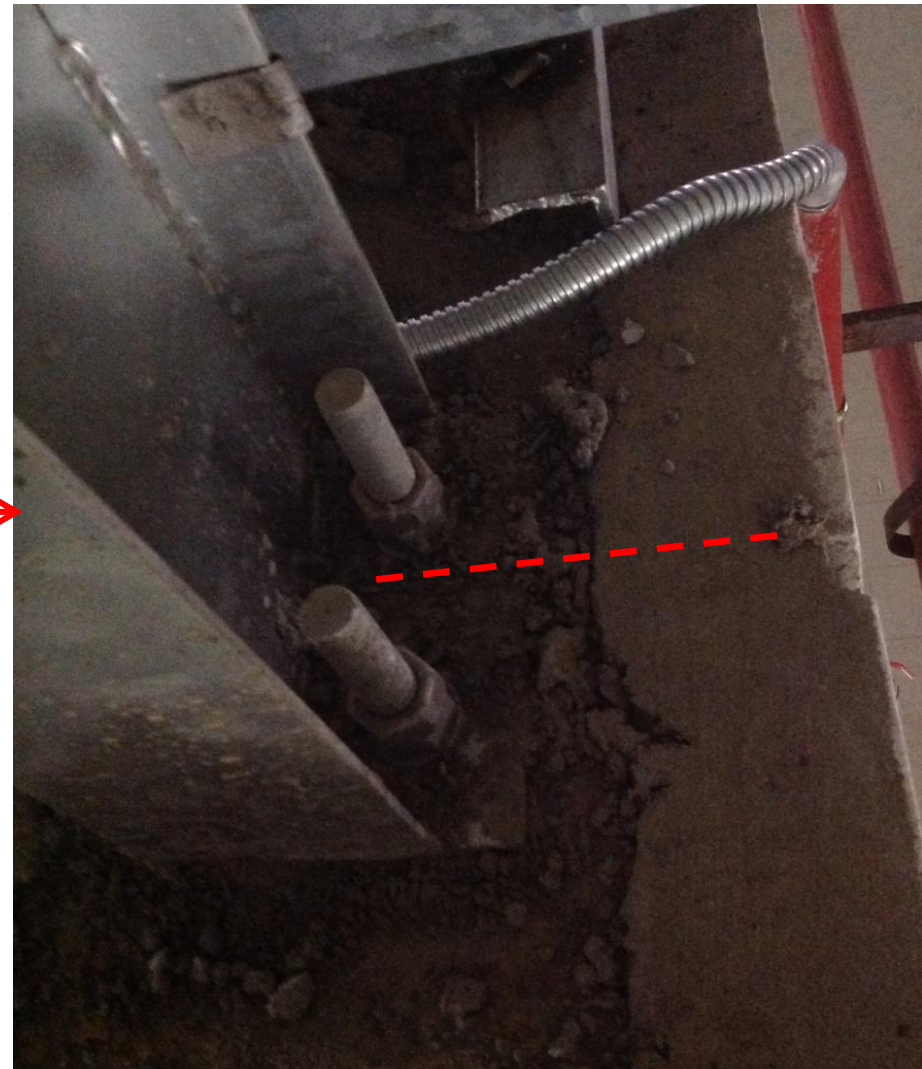
Baseplate anchored both sides of movement joint
