Body Fashion (PVT) Ltd.

Naogor kadda, Konabari, Gazipur, Dhaka.
(23.991440N, 90.356099E)

15 June 2014

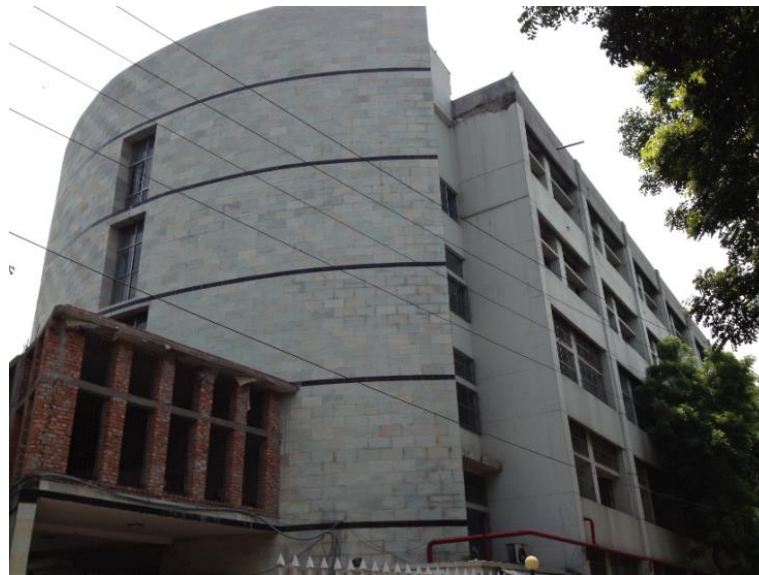
High column stress levels

Columns appear to be stressed to levels that require immediate action

Item No.	Observation	Recommended Action Plan	Recommended Timeline
1	Highly-stressed columns at ground floor level	The replacement of the steel roof structure with a concrete slab is to be put on hold, pending the outcome of the Detail Engineering Assessment.	Immediate - Now
2	Highly-stressed columns at ground floor level	Building Engineer to review design, loads and column stresses.	Immediate - Now
3	Highly-stressed columns at ground floor level	The Imposed Loading on any floor is not be increased from current levels pending the outcome of the Detail Engineering Assessment.	Immediate - Now
4	Highly-stressed columns at ground floor level	A Detail Engineering Assessment of the Factory is to be commenced, see attached scope.	Immediate - Now
5	Highly-stressed columns at ground floor level	Detail Engineering Assessment to be completed	6-weeks
6	Highly-stressed columns at ground floor level	Produce and actively manage a loading plan for all floor plates within the Building, giving consideration to floor capacity and column capacity	6-weeks

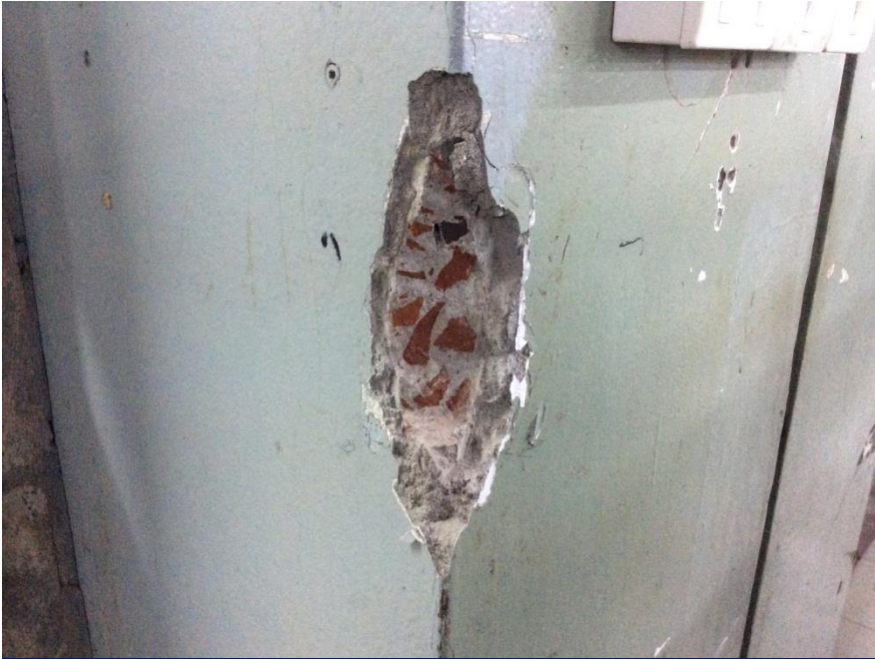
Brick aggregate exposed in columns on both sides of movement joint

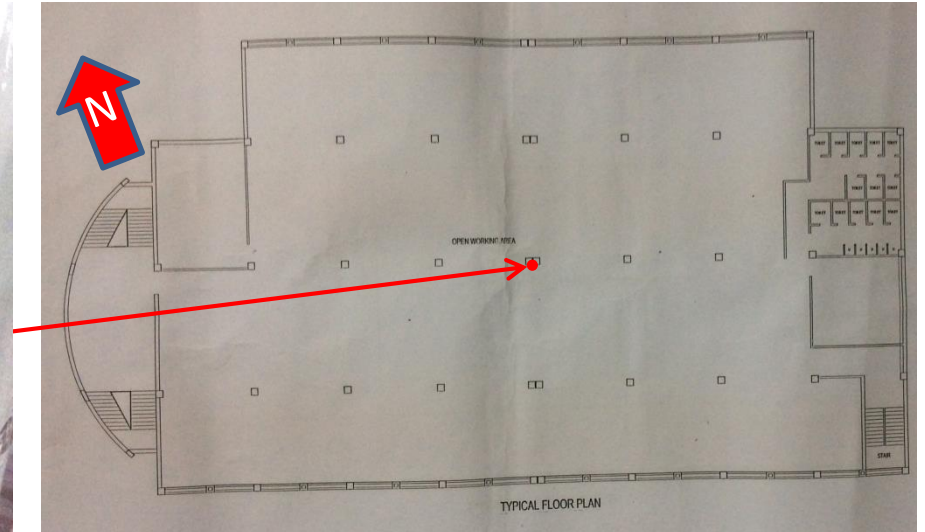
Columns tested for aggregate type on either side of movement joint

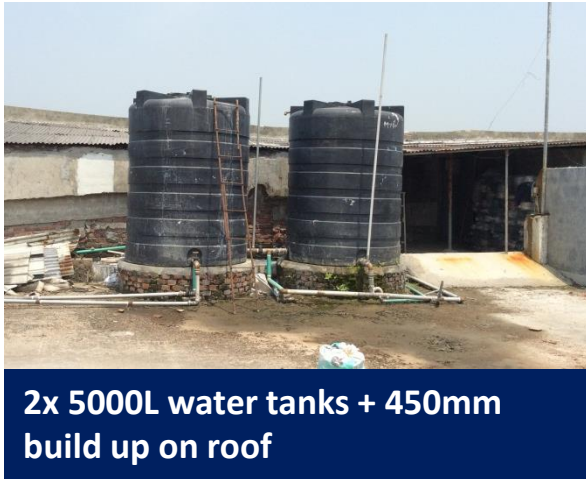
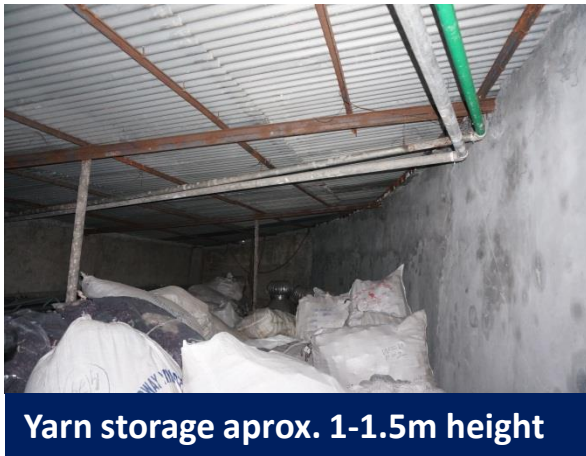
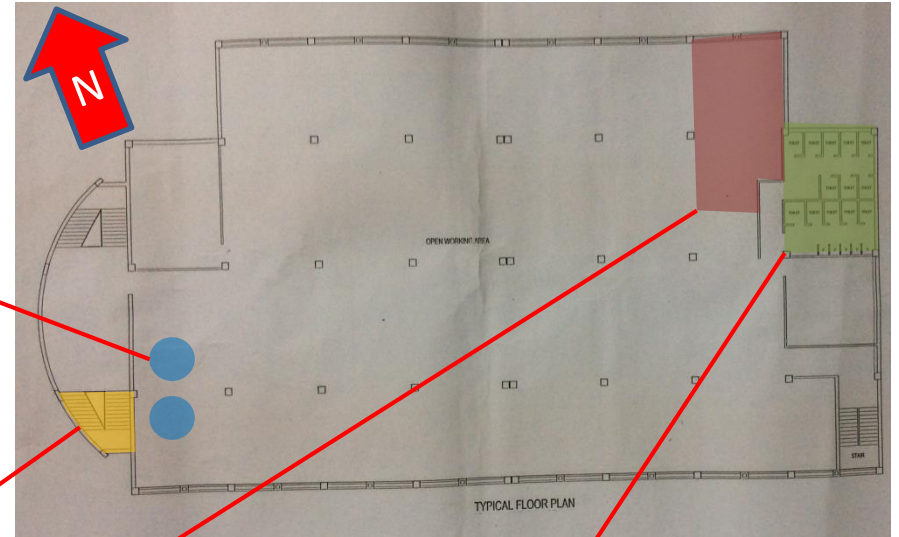
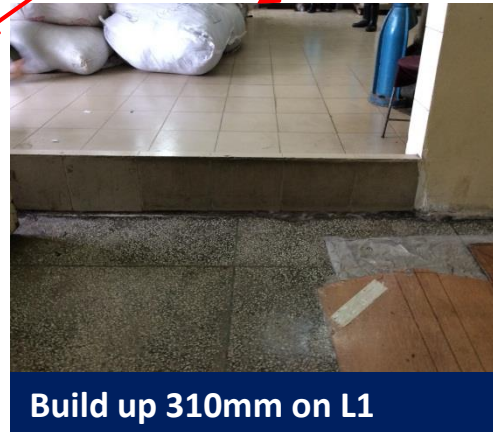
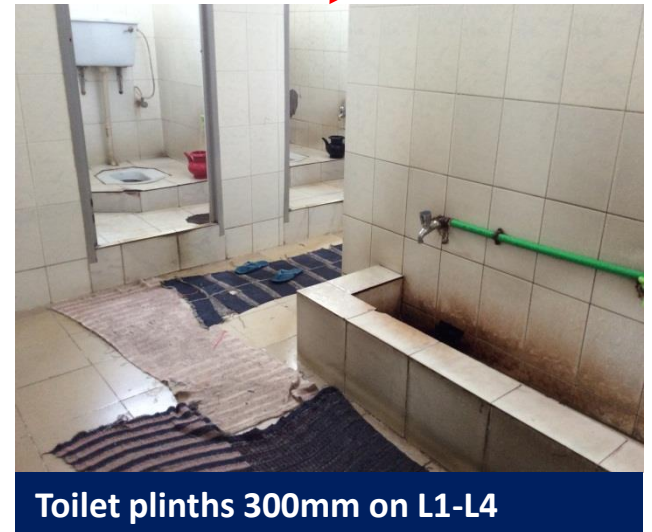
High loading on floor slabs

Design check required to assess the structural capacity of the floor slab to support (a) the toilet plinths and build-up, (b) the water tanks and (c) the yarn storage

Item No.	Observation	Recommended Action Plan	Recommended Timeline
9	Localised areas of high loading	As part of Detail Engineering Assessment (see Item 1), Building Engineer to check if beams/slabs have sufficient capacity to support fully-filled water tanks, toilet plinths & build-up, and yarn storage.	6-weeks
10	Localised areas of high loading	Continue to implement loading plan	6-months
11	New extension over entrance	As part of Detail Engineering Assessment (see Item 1), Building engineer to check the 1st floor slab for loading from brick piers under lateral and vertical load.	6-weeks
12	New extension over entrance	Building engineer to check lateral stability of extension and how it is connected to main building.	6-weeks
13	New extension over entrance	Implement any actions arising from checks.	6-months
14	Cracking in beams supporting roof	As part of Detail Engineering Assessment (see Item 1), Building engineer to investigate cause of cracking and the need for any remedial works / structural repairs	6-weeks

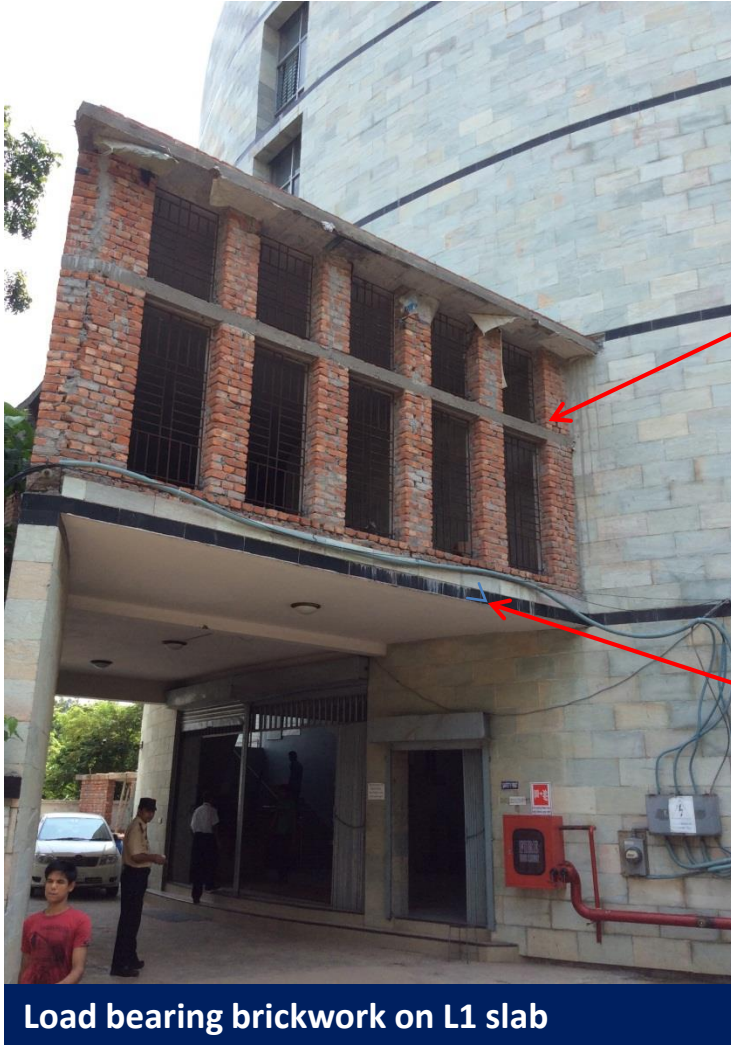
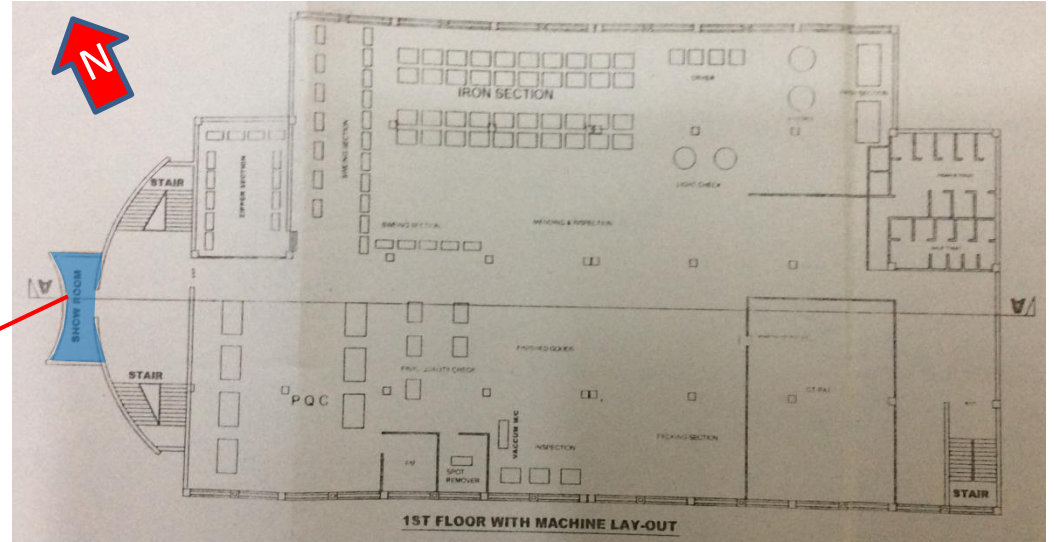
New extension over entrance

Structural capacity check required for floor extension at the West façade

Building engineer to check slab capable of carrying load from masonry piers.

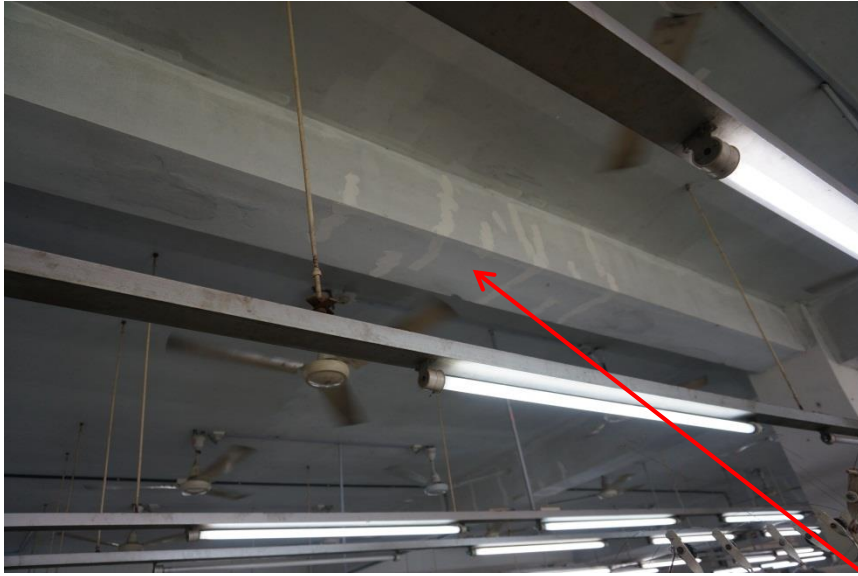
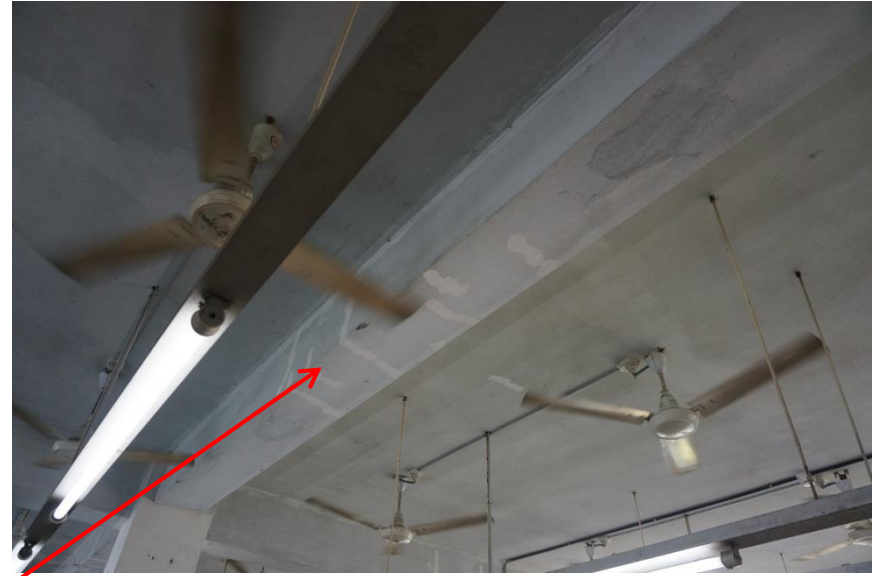
Cracking in beams supporting roof slab

Repaired cracks on roof slab beams

Crack repairs on beams supporting roof slab

15	Cracking in beams supporting roof	Carry out remedial works / structural repairs as required.	6-months

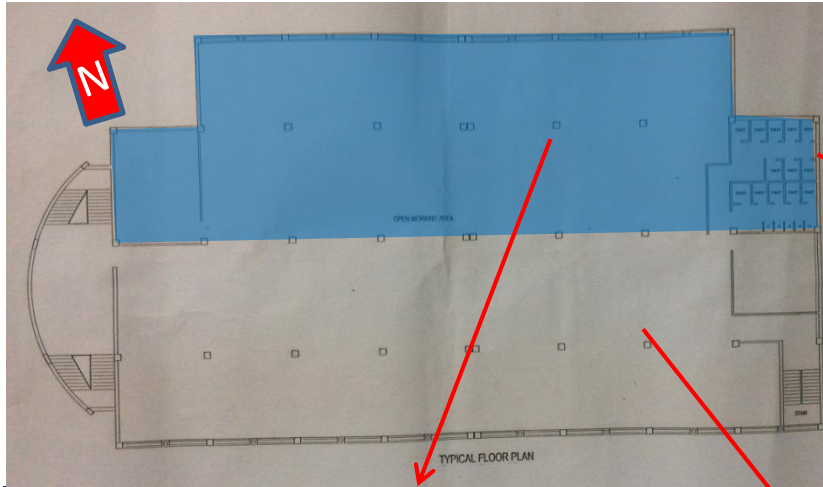
Undocumented steel roof structure

Structural capacity of steel roof elements to be checked

Highlighted part indicates steel roof area. Steel roof not shown on engineers drawings. In-plane bracing to be confirmed and checked by engineer.

Item No.	Observation	Recommended Action Plan	Recommended Timeline
16	Undocumented and lightweight roof structure	As part of Detail Engineering Assessment, Building Engineer to provide detailed calculations for the lightweight steel roof structure. These should confirm its ability to withstand all wind loading pressure, suctions and uplift forces.	6-weeks
17	Undocumented and lightweight roof structure	Implement any remedial works arising from Detail Engineering Assessment.	6-months
18	Undocumented and lightweight roof structure	Provide accurate as-built drawings.	6-months
19	RC beam size constructed on roof does not match the section size shown on the original drawings	As part of Detail Engineering Assessment, Building Engineer to provide detailed calculations for the roof beam noted above.	6-weeks
20	RC beam size constructed on roof does not match the section size shown on the original drawings	Carry out remedial works / strengthening to beam as required.	6-months

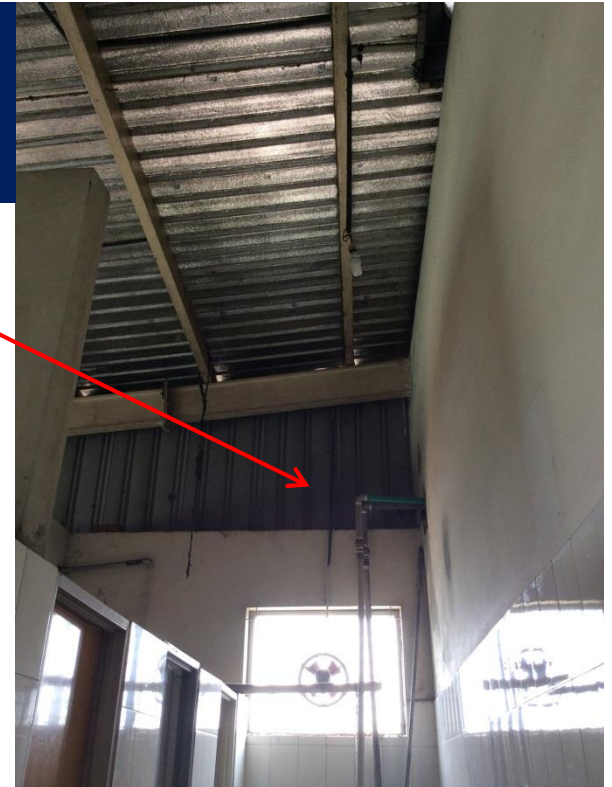
Cladding frame with no secondary steel work

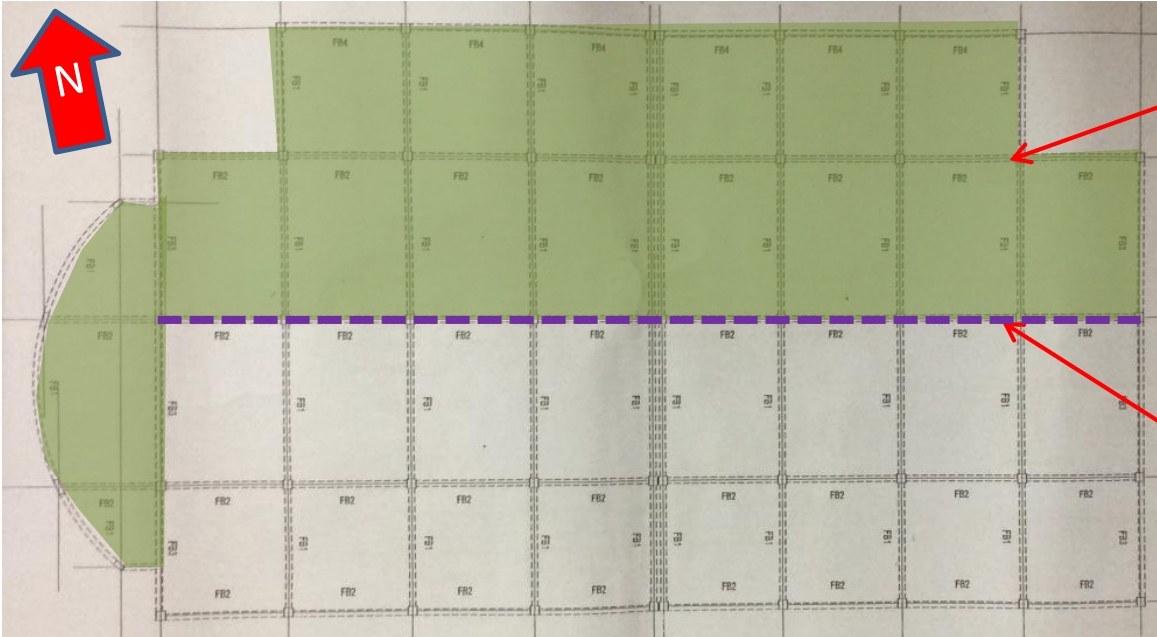
Original structural plans differ from as-built condition

Beam supporting roof slab does not match the beam depth shown on the structural engineers drawings.

Steel frame roof over 4th floor.

Beam constructed is shallower than on drawings.

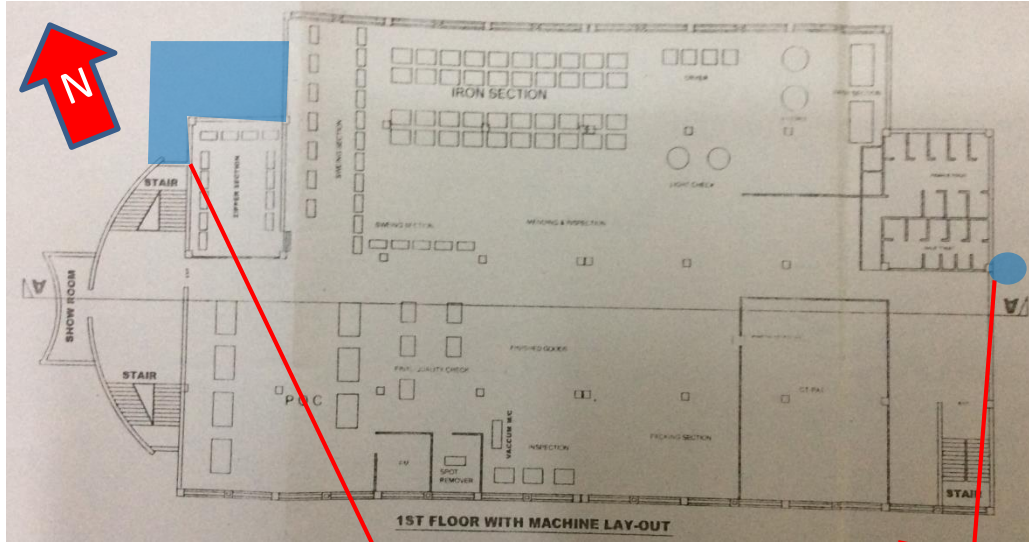
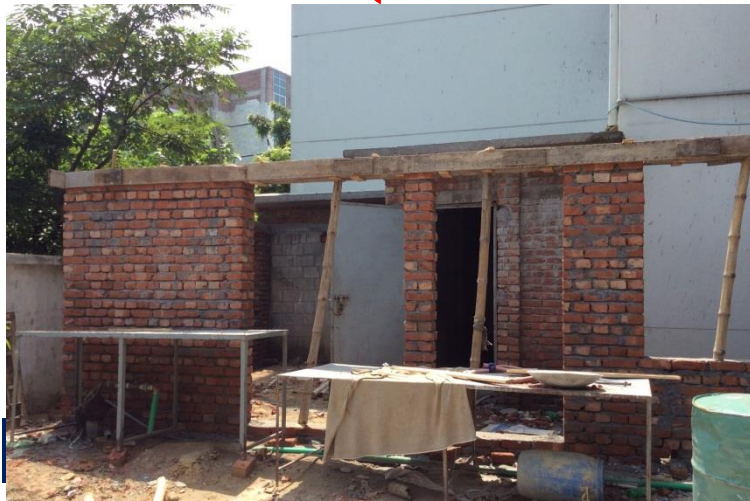
Non-engineered utility structures

Structural capacity check required for non-engineered utility buildings surrounding main building

Brick building under construction on north-west side of main building. No record drawings. Building engineer to check.

Item No.	Observation	Recommended Action Plan	Recommended Timeline
21	Non-engineered utility structures	Utility structures to be checked by the Building Engineer for their capacity to withstand code vertical and horizontal loads	6-weeks
22	Non-engineered utility structures	Carry out remedial works as required, or vacate and remove.	6-months
23	Movement Joint at roof level	As part of Detail Engineering Assessment, movement joint details at roof level to be developed by Building Engineer.	6-weeks
24	Movement Joint at roof level	Carry out works to incorporate movement joint at roof level.	6-months

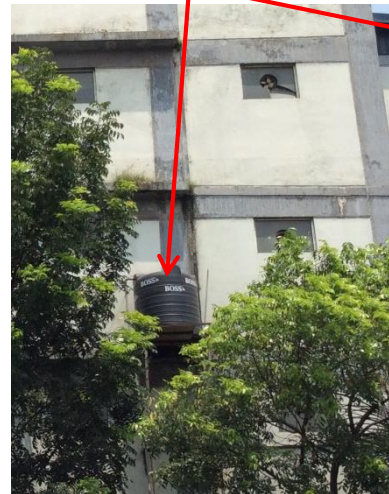
Steelwork supporting water tank at east façade.

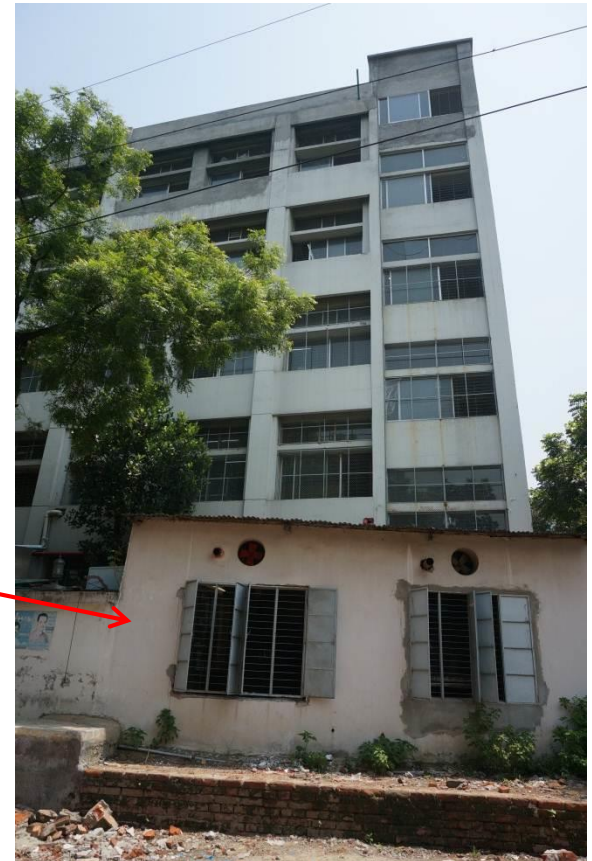
Single storey brick building on south side of main building. No record drawings. Building engineer to check.

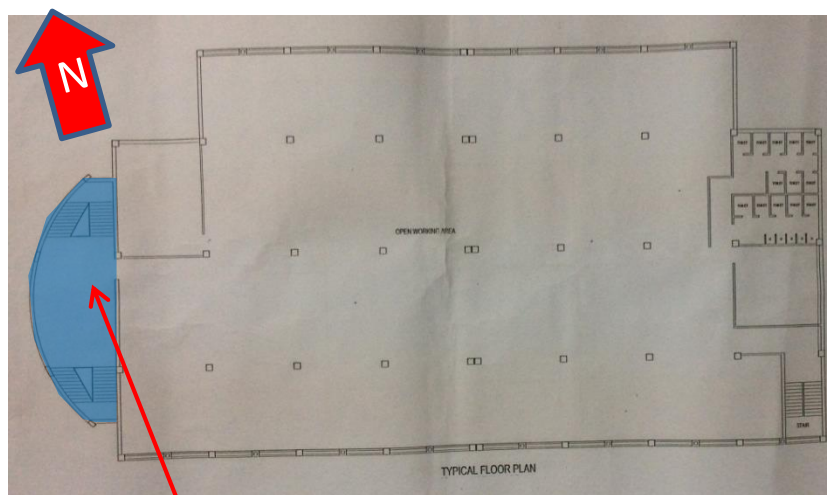
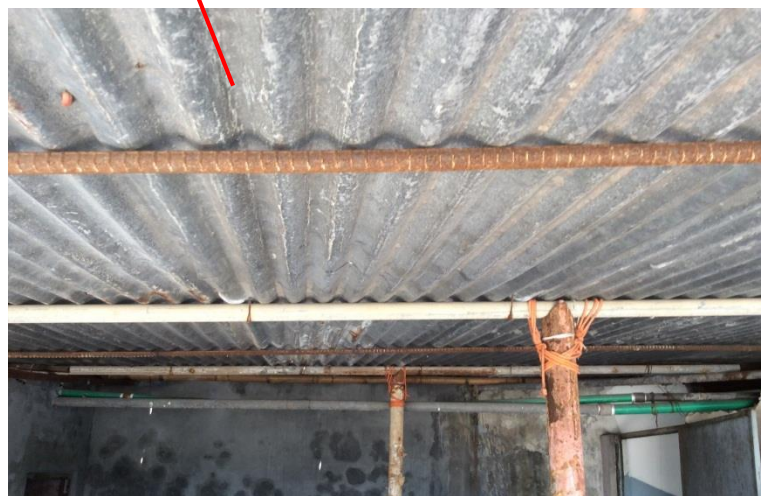
Structural capacity check required for non-engineered utility buildings surrounding main building

Steel roof supported by bamboo and rebar

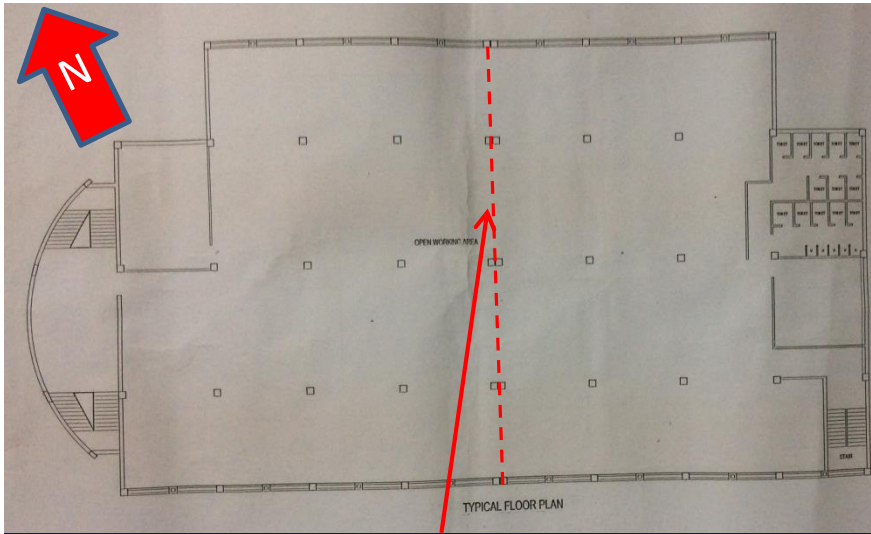
Movement Joint

Movement joint not carried through at roof level and potentially prone to water ingress

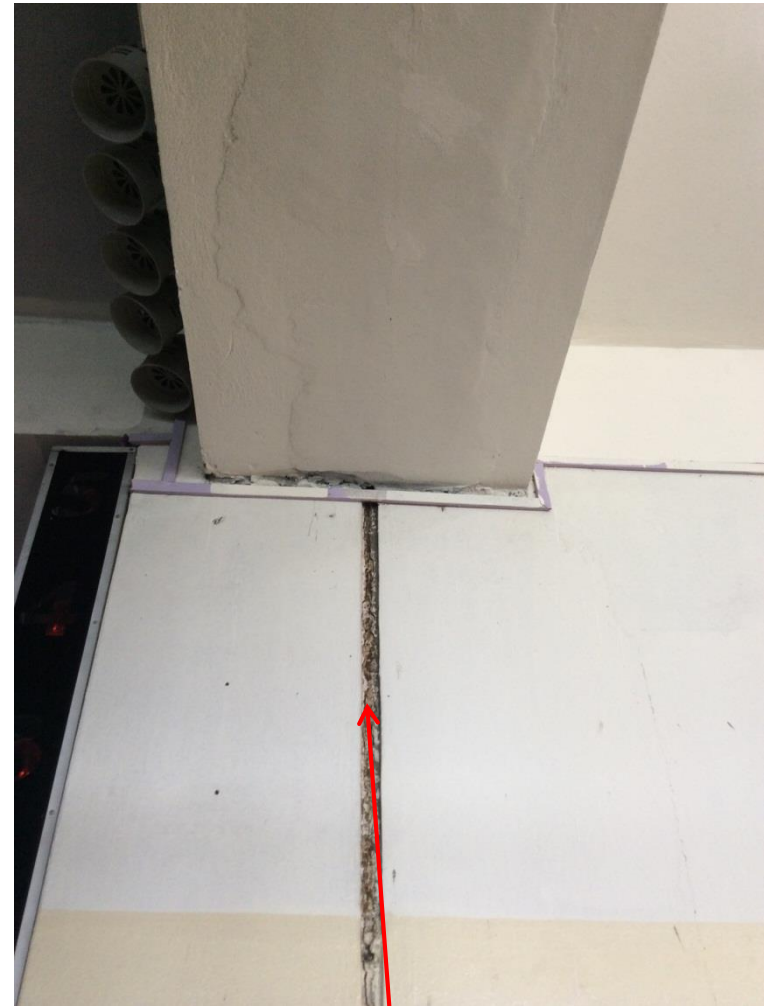
Movement joint on roof

Movement joint not apparent in beam supporting roof
