# Modiste (CEPZ) Ltd.

Plot 1-4, Sector #6, Export Processing Zone, Chittagong

22 June 2014

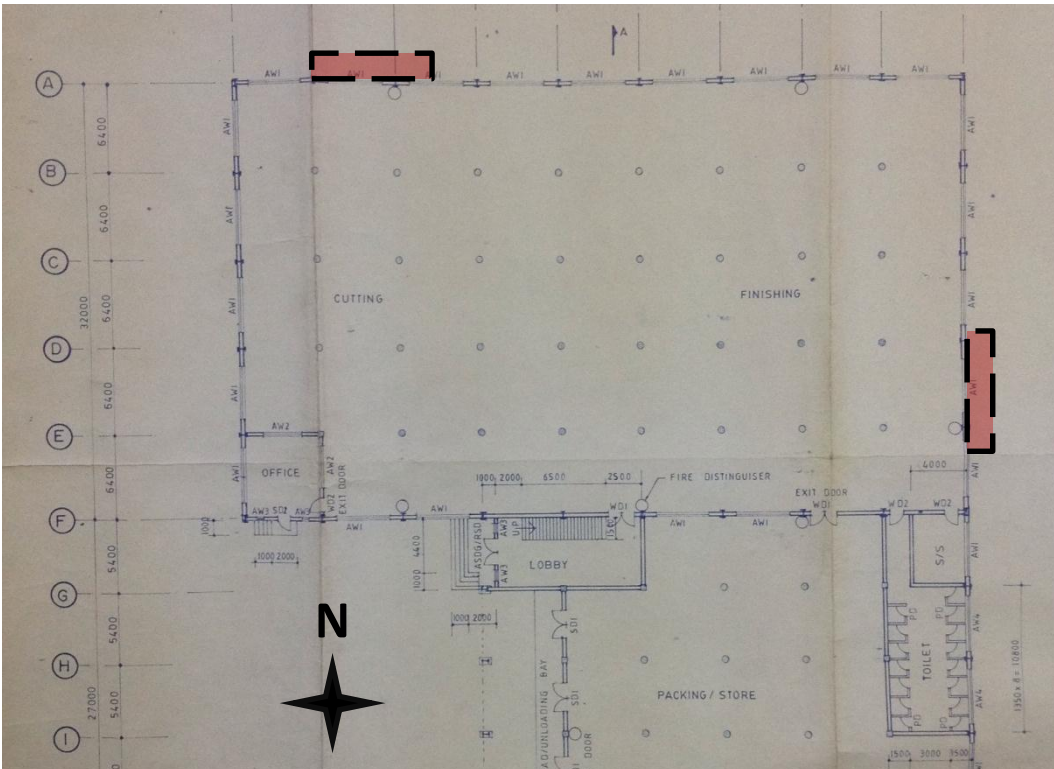
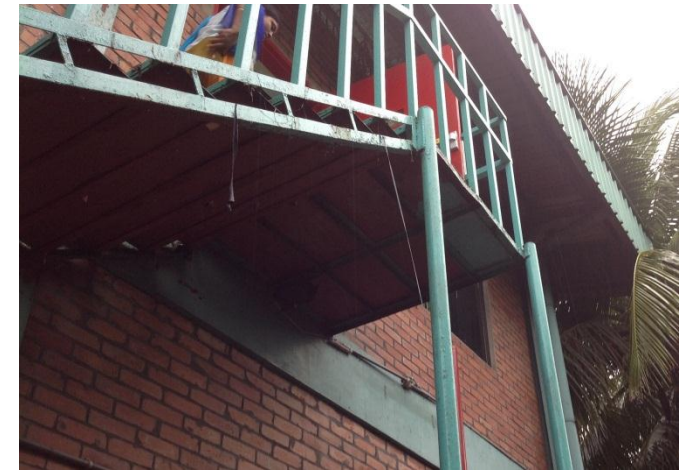
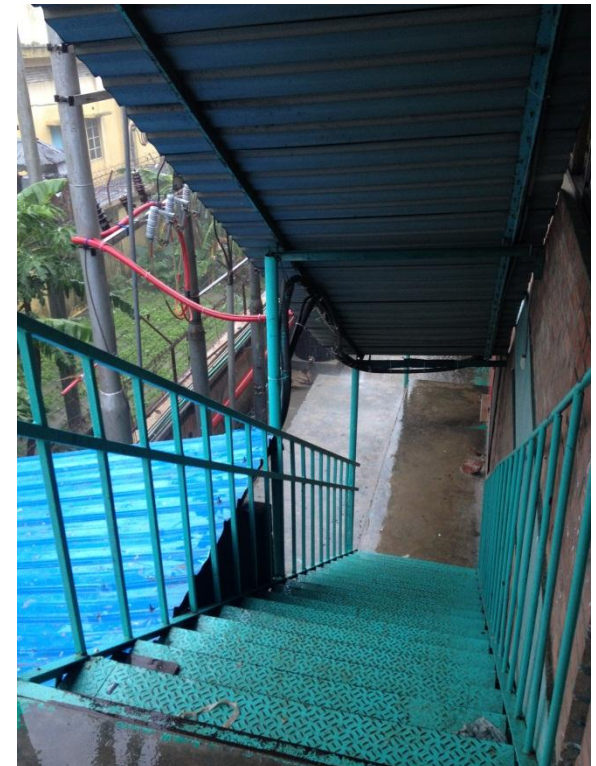
## Apparently Non-Engineered Escape Stairs

**External steel escape stairs appear  
non-engineered**

External staircases to First Floor of Building 1 intended as emergency exit routes appear non-engineered . Connections and treads appear weak and insubstantial – the stairs may not have been engineered to carry the full load during an evacuation event.

| Item No. | Observation | Recommended Action Plan | Recommended Timeline |
|---|---|---|---|
| 1 | External steel escape stairs appear non-engineered | The stairs should be surveyed and assessed in detail by a structural engineer for adequacy to support the expected loading in an evacuation event and strengthened or replaced as necessary. | Immediate - Now |

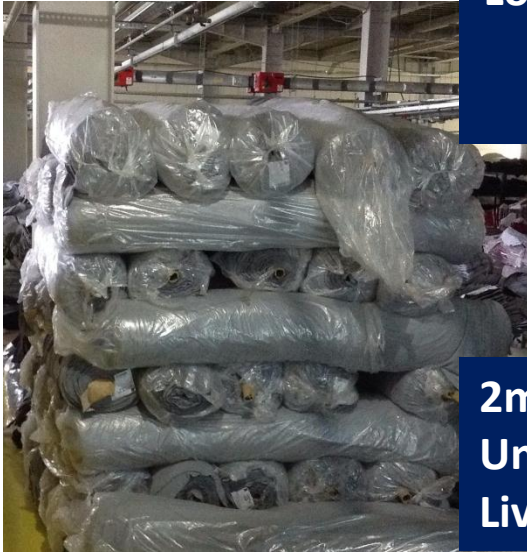
**Loading Observed  
Building No.2  
First Floor**

# Localised areas of high loading observed in Building 2

**2m High Rolled  
Unworked Fabric,  
Live Load  $7\text{kN/m}^2$**

| Item No. | Observation | Recommended Action Plan | Recommended Timeline |
|---|---|---|---|
| 2 | Localised areas of high loading observed in Building 2 | Stored materials to be spread apart such that the total live load is limited to no more than 350kg/m <sup>2</sup> in accordance with the structural design. | 6-weeks |
| 3 | Localised areas of high loading observed in Building 2 | Loading plans for buildings to be correctly implemented throughout Buildings 1, 2 and 3. | 6-months |

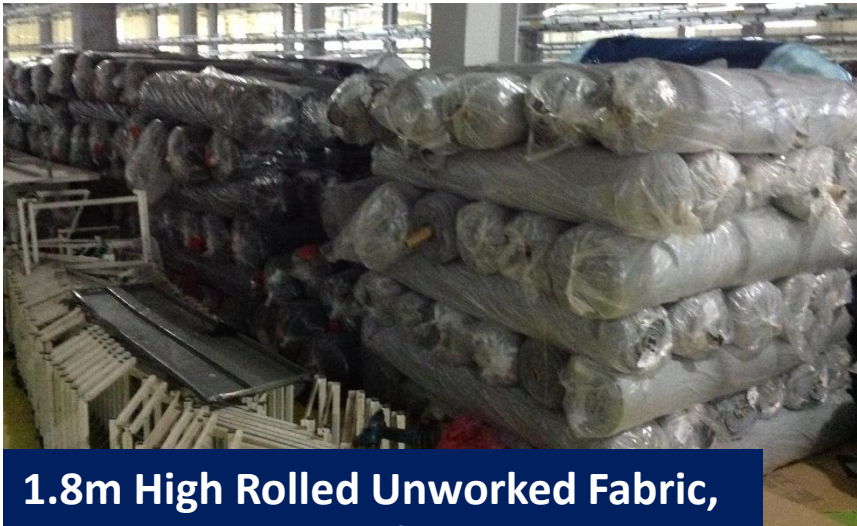
**1.8m High Rolled Unworked Fabric,  
Live Load  $6.3\text{kN/m}^2$**

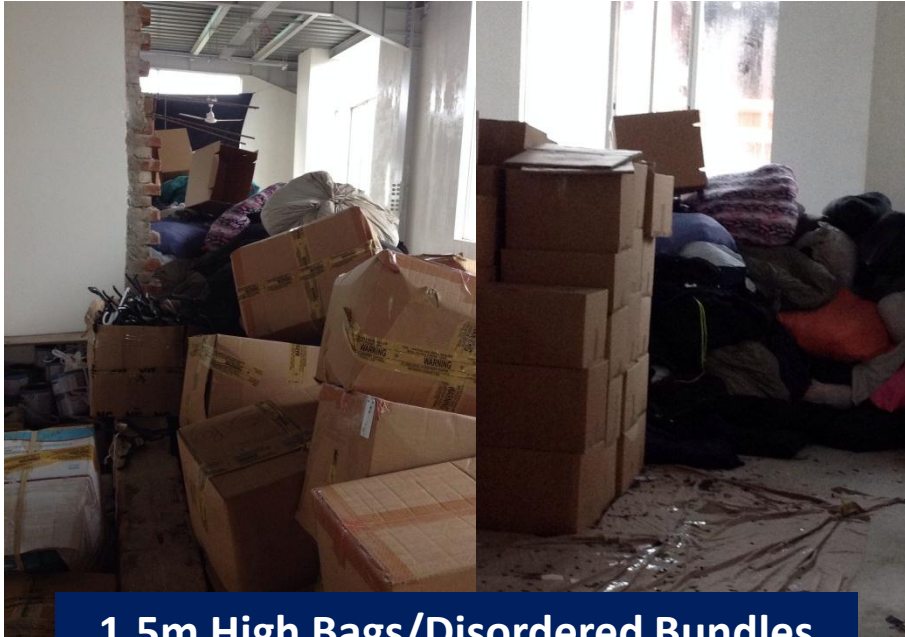
## Loading Observed Building No.2 Second Floor

**1.5m High Bags/Disordered Bundles  
and Stacked Boxes of Clothes,  
Live Load up to  $4\text{kN/m}^2$**

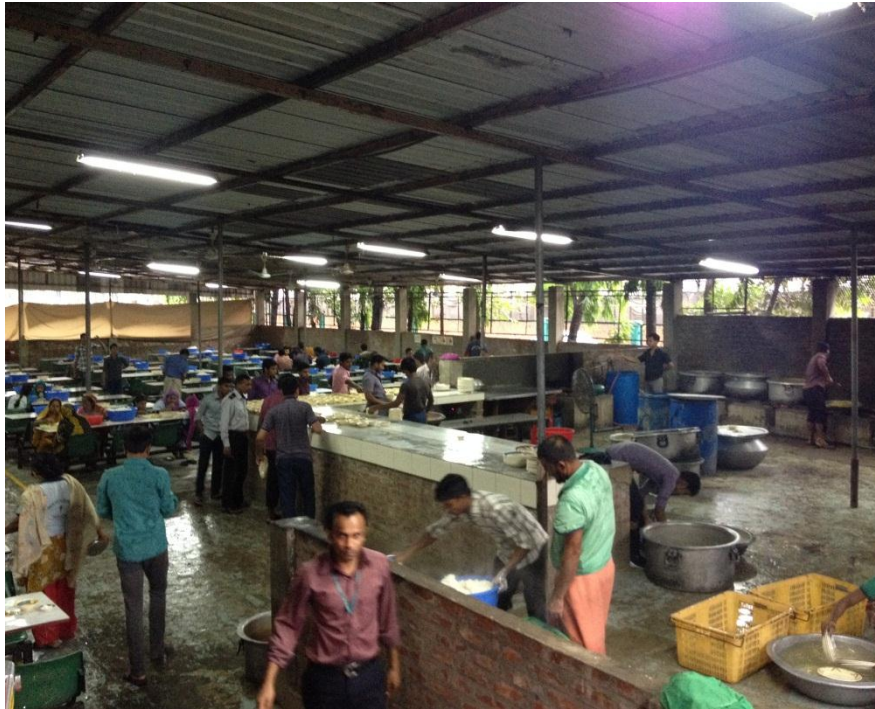
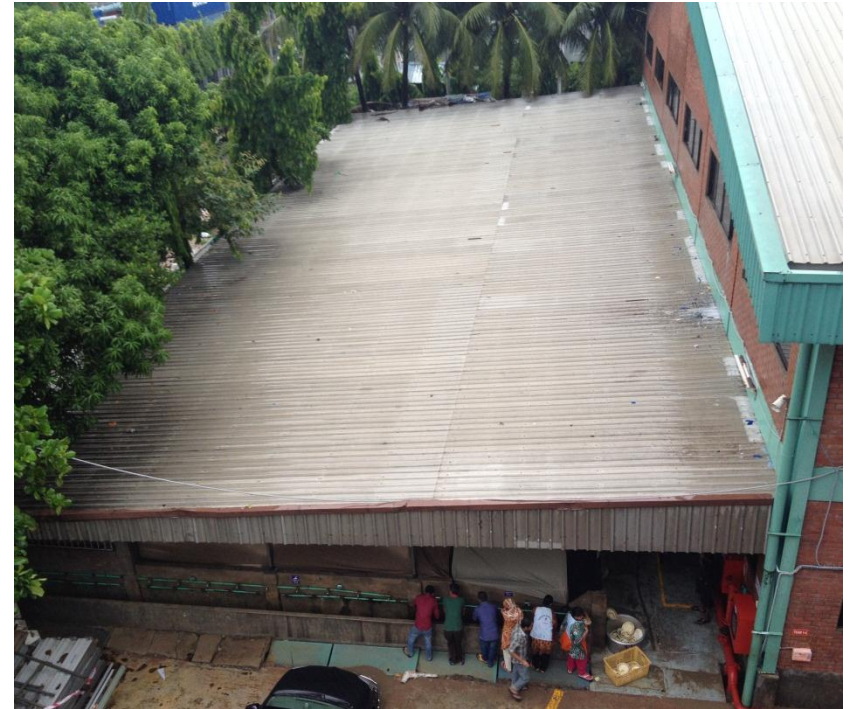
## Apparently non-engineered Canteen Shed

Large lightweight steel roofed canteen has been built on West face of Building 1. The structure appears non-engineered; no drawings or structural design information available. There is no obvious lateral stability system, columns appear slender. (Note – General Manager stated that canteen will be moved to third floor of Building 3 once fit-out of the new kitchens has been completed - est. July 2014)

| Item No. | Observation | Recommended Action Plan | Recommended Timeline |
|---|---|---|---|
| 4 | Undocumented and non-engineered canteen shed and utility buildings | Steel structures should be assessed to code vertical and wind loads by the Structural Engineer. | 6-months |
| 5 | Undocumented and non-engineered canteen shed and utility buildings | Carry out any remedial actions as directed by the Structural Engineer. | 6-months |

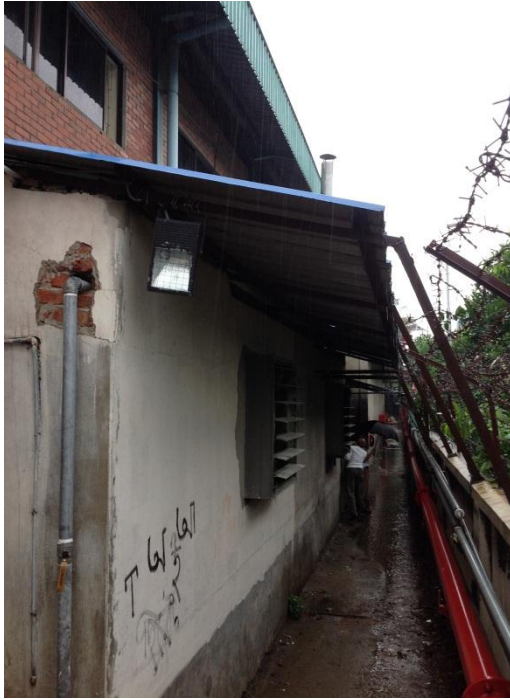
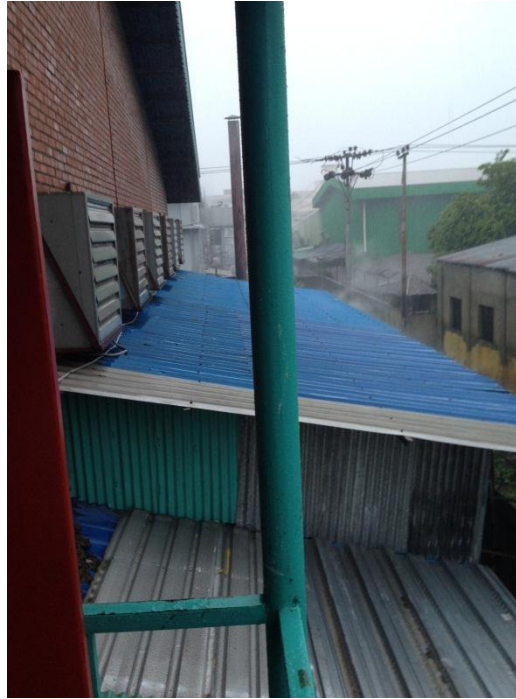
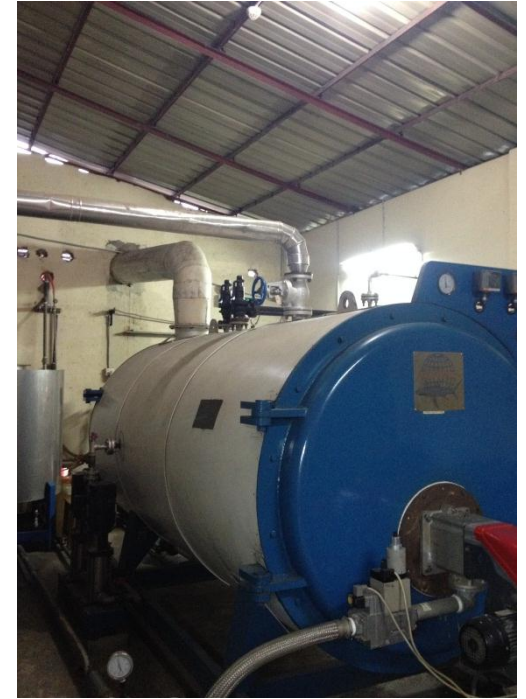
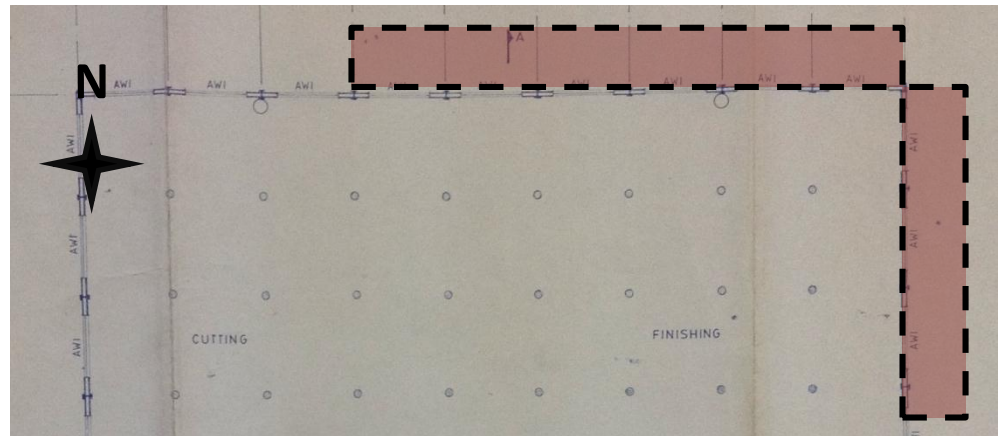
**Apparently Non-Engineered Utility Buildings**

Additional Utility Buildings and production buildings along Northeast corner of Building 1 appear non-engineered.

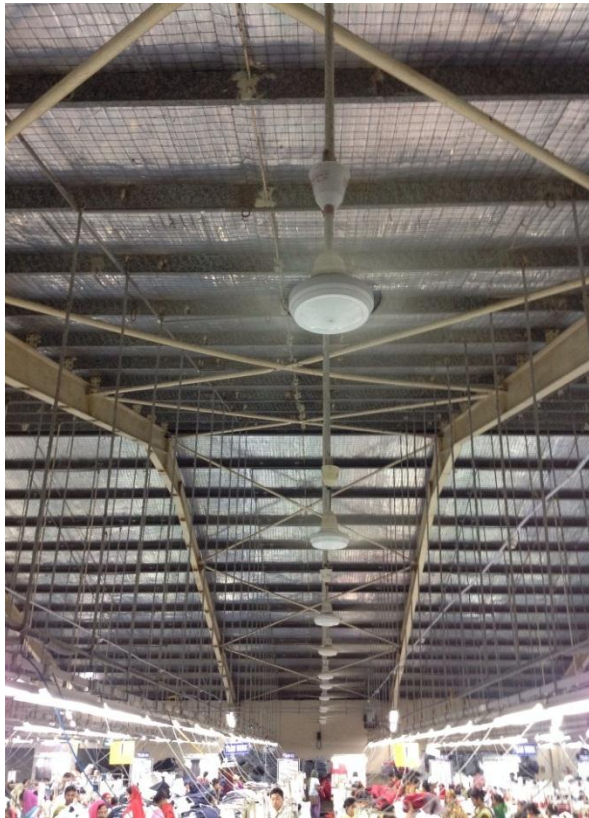
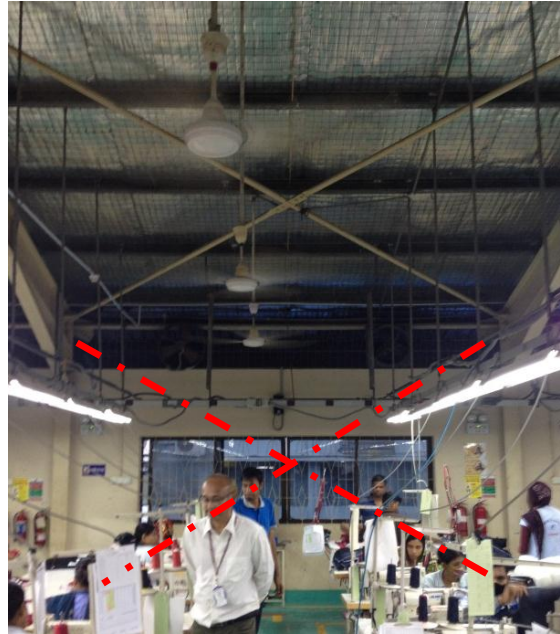
## Incomplete Lateral Stability System

Stability system designed as braced frame in east-west direction.

| Item No. | Observation | Recommended Action Plan | Recommended Timeline |
|---|---|---|---|
| 6 | Incomplete lateral stability system to Building 1 | Structural Engineer to carry out a stability analysis of Building 1 and propose a suitable east-west lateral stability system | 6-months |
| 7 | Incomplete lateral stability system to Building 1 | Carry out any remedial actions as directed by the Structural Engineer. | 6-months |

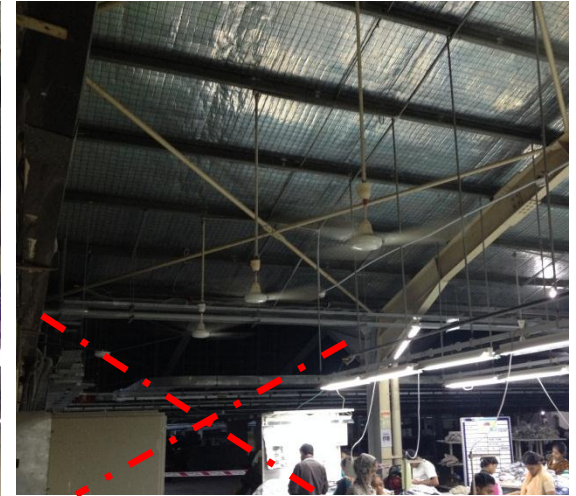
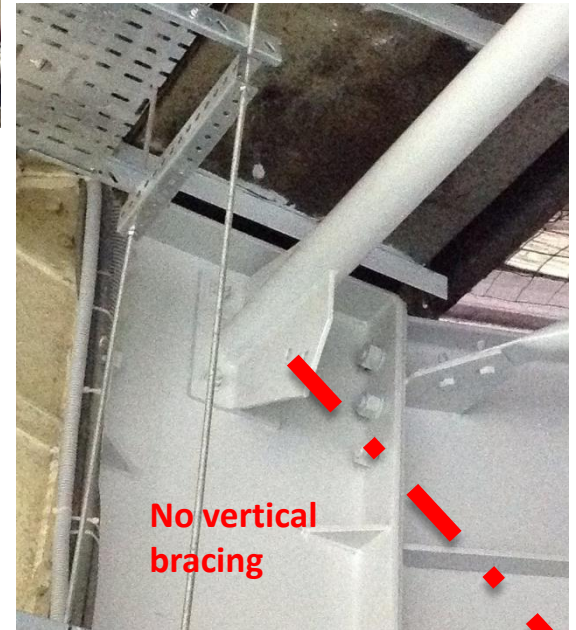
No bracing provided in the vertical direction to column base.

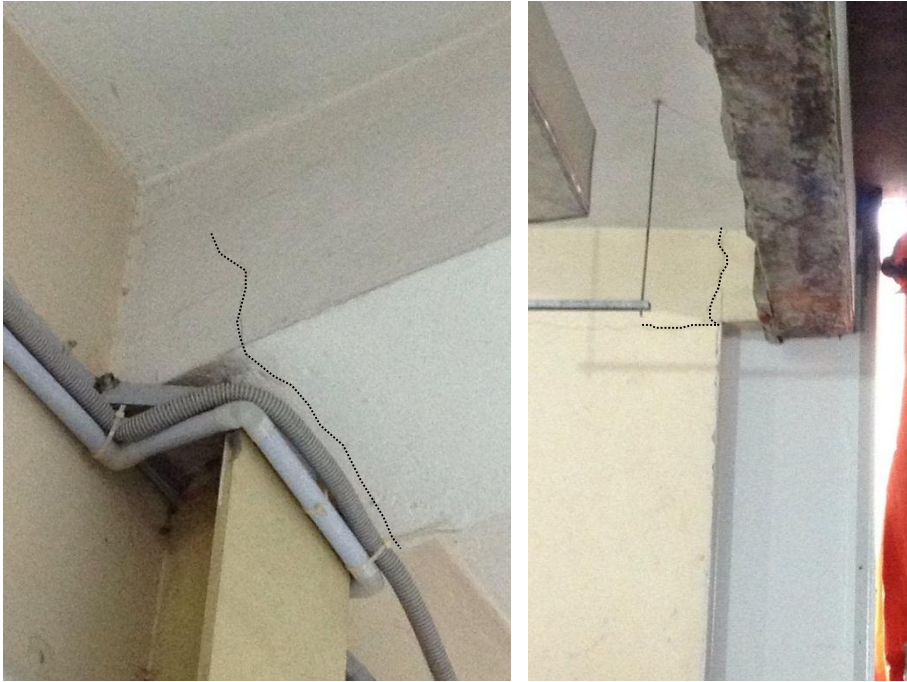
## Cracking at Beam – Column Connection

**Cracking observed at connection between  
RC beam and steel column**

Horizontal cracking observed at the RC Beam to Steel Column connection.  
Observed in a large number of connections.  
No standard drawing/detail provided showing connection type.

| Item No. | Observation | Recommended Action Plan | Recommended Timeline |
|---|---|---|---|
| 8 | Cracking observed at the connection between RC beam and steel column | Structural Engineer to assess the as-built connection detail provided between concrete beam and steel column. | 6-months |
| 9 | Cracking observed at the connection between RC beam and steel column | Retrofitting to be carried out as directed by the Structural Engineer. | 6-months |

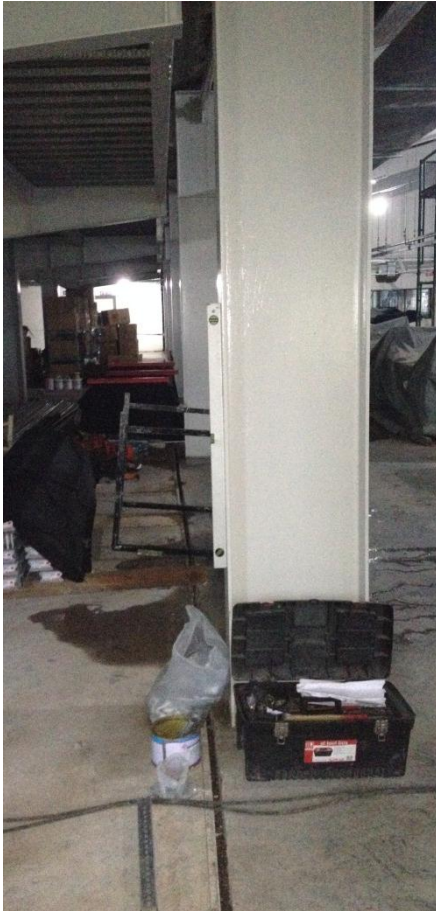
Existing movement joint between Building No.1 and 2

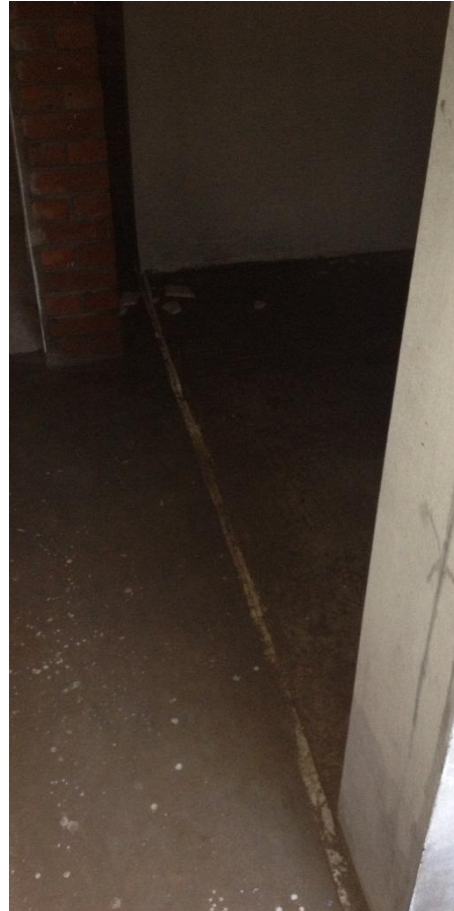
**Movement joint between  
Building 1 and 3 is discontinuous**

Existing movement joint between Building No.1 and 3

| Item No. | Observation | Recommended Action Plan | Recommended Timeline |
|---|---|---|---|
| 10 | Movement joint between Buildings 1 and 3 is discontinuous | Structural Engineer to determine the location of the interface between Building 1 and 3. | 6-months |
| 11 | Movement joint between Buildings 1 and 3 is discontinuous | Form a properly detailed expansion joint between both buildings as directed by the Structural Engineer. | 6-months |

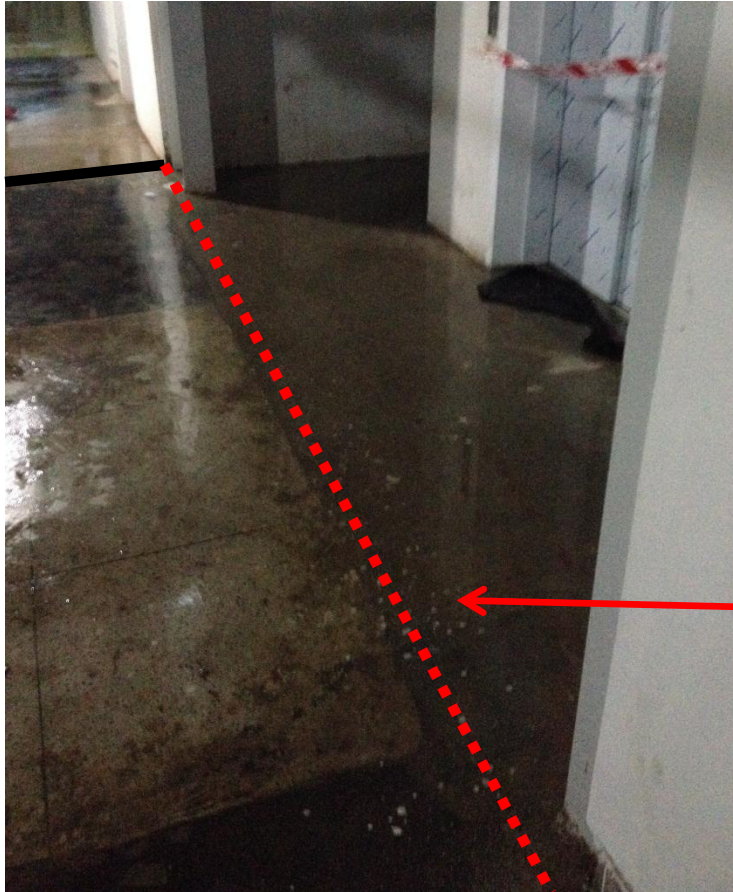
**Movement joint does not extend the full length between Building No.1 and No.3**
