# MG Niche Flair Limited Ltd. (Unit-2)

H-240, Bhuyanpara, Siddirgonj, Narayangonj  
(23.654738, 90.511708)

18<sup>th</sup> May 2017

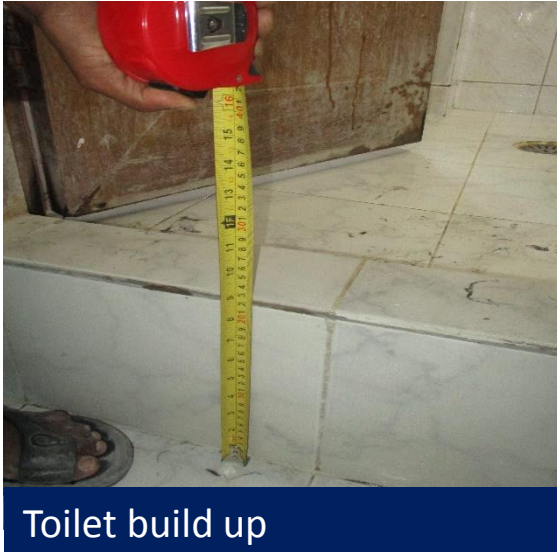
Cursory calculations indicate that the working stress of the column under toilet area would appear to be stressed in excess of normal design limits. Refer to Action 1. Building Engineer to verify in-situ concrete strength and confirm grade of steel reinforcement used.

Toilet build up

| Item No. | Observation | Recommended Action Plan | Recommended Timeline |
|---|---|---|---|
| 1 | (Production building)<br>Column to be stressed above normal design limits | Factory Engineer to review design, loads and columns stresses in area identified above. | <b>Immediate - Now</b> |
| 2 | (Production building)<br>Column to be stressed above normal design limits | Verify insitu concrete stresses either by 100mm dia. cores or existing cylinder strength data for [the identified columns] or [100mm dia. cores from 4 columns]. | <b>Immediate - Now</b> |

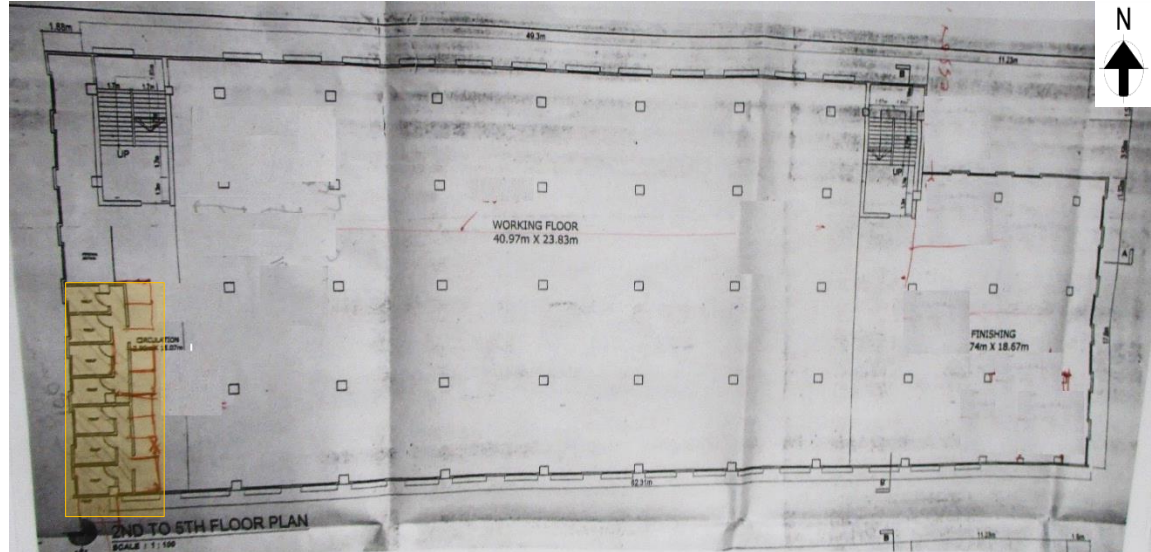
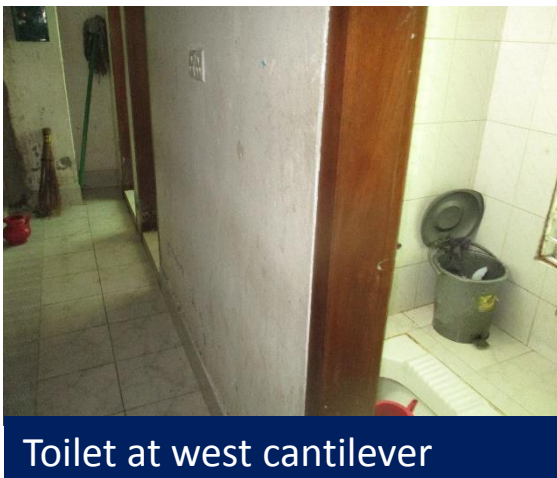
Toilet at west cantilever

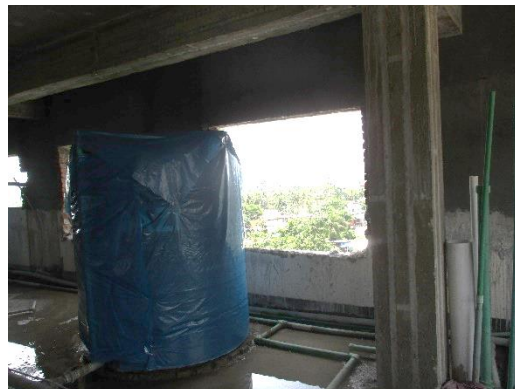
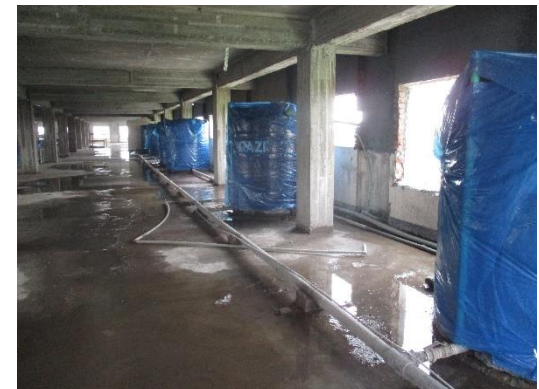
Plastic water tank having 3000 liters capacity each

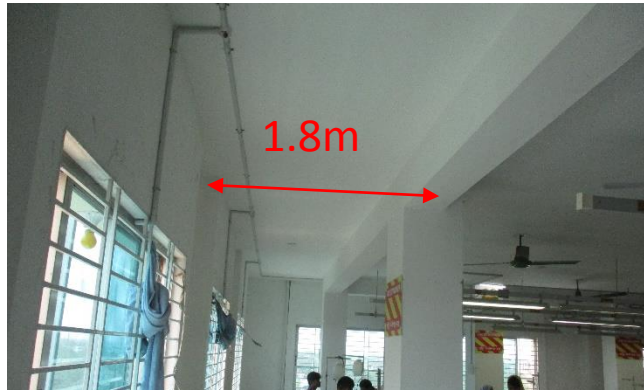
Cantilever slabs were observed on the all elevations of the building. Building Engineer to check structural adequacy of the cantilever and propose and implement any strengthening works if required.

Cantilever at East

| Item No. | Observation | Recommended Action Plan | Recommended Timeline |
|---|---|---|---|
| 8 | (Production Building)<br>Absence of relevant technical documentations | Building Engineer to confirm that the cantilever slabs have been designed to take the floor and façade loads applied, as part of DEA (See Item 1). | 6-weeks |

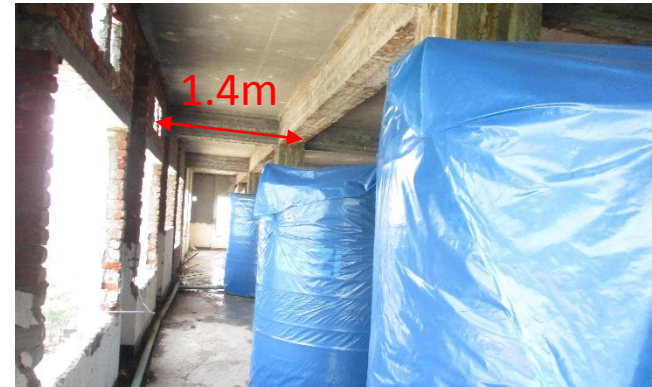
Cantilever at South

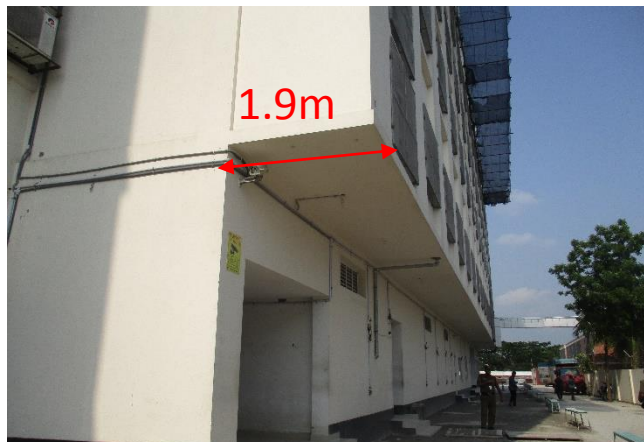
Cantilever at North

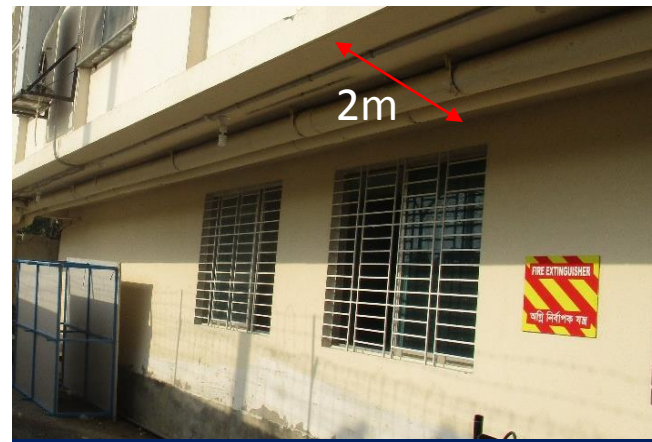
Cantilever at west

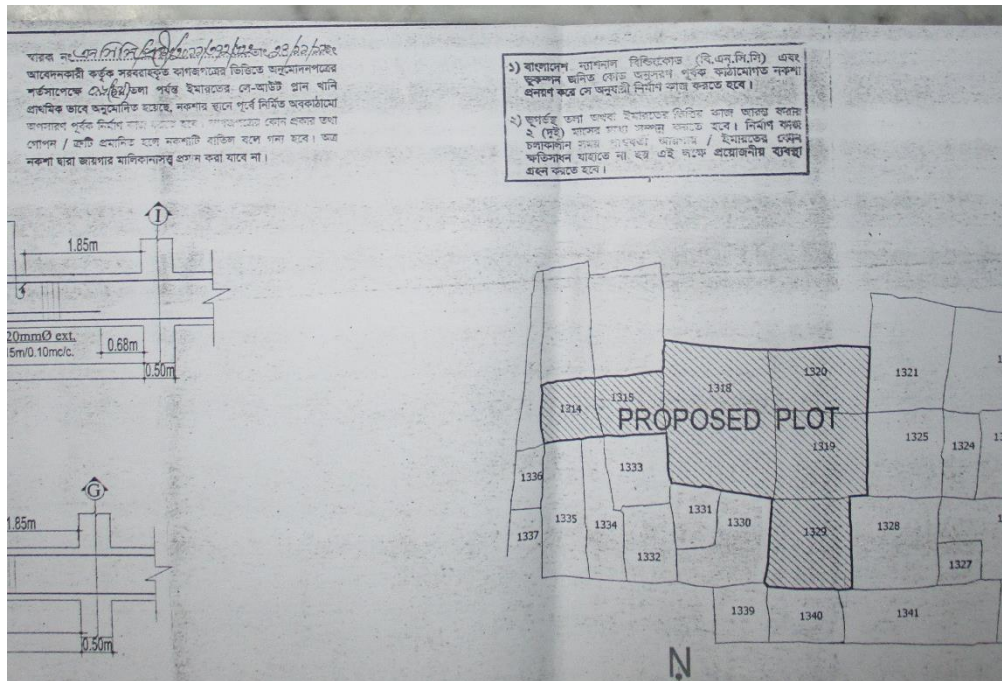
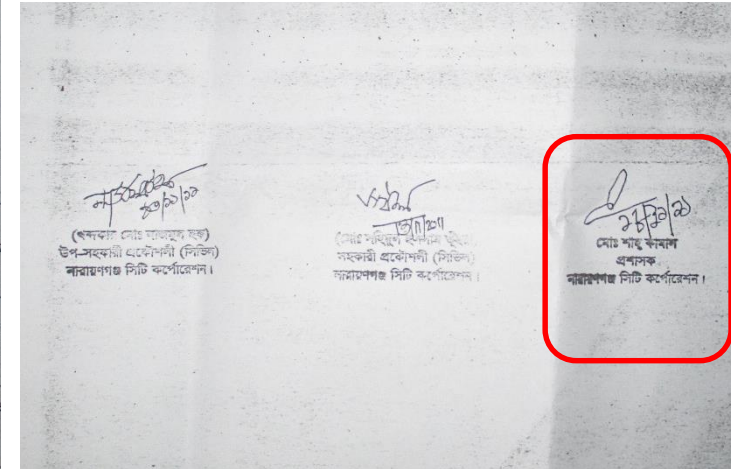
No structural and architectural documents were available. The only presented building permit drawings were dated on 18<sup>th</sup> Nov 2011 . But the construction history of the building is unknown.

| Item No. | Observation | Recommended Action Plan | Recommended Timeline |
|---|---|---|---|
| 9 | (Production Building)<br>Absence of relevant technical documentations | Certified copy of the original design documents to be made and the existing As-built drawings to be updated accordingly. | 6-weeks |

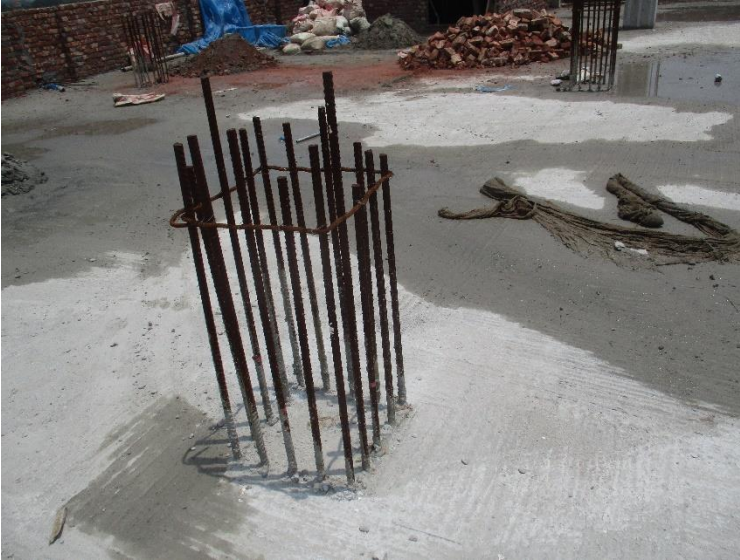
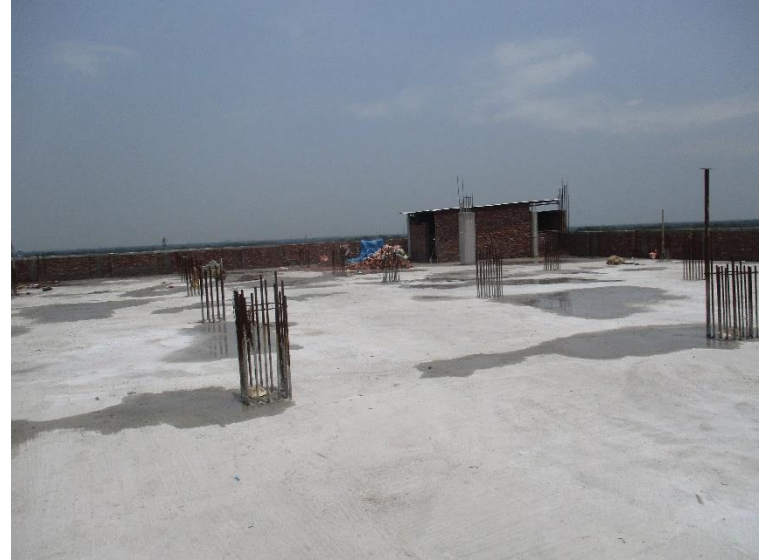
Columns reinforcement were exposed at roof level.

| Item No. | Observation | Recommended Action Plan | Recommended Timeline |
|---|---|---|---|
| 12 | Expose rebar at roof | All exposed reinforcement is required to protect from corrosion which may cause degradation of the concrete. | 6-weeks |

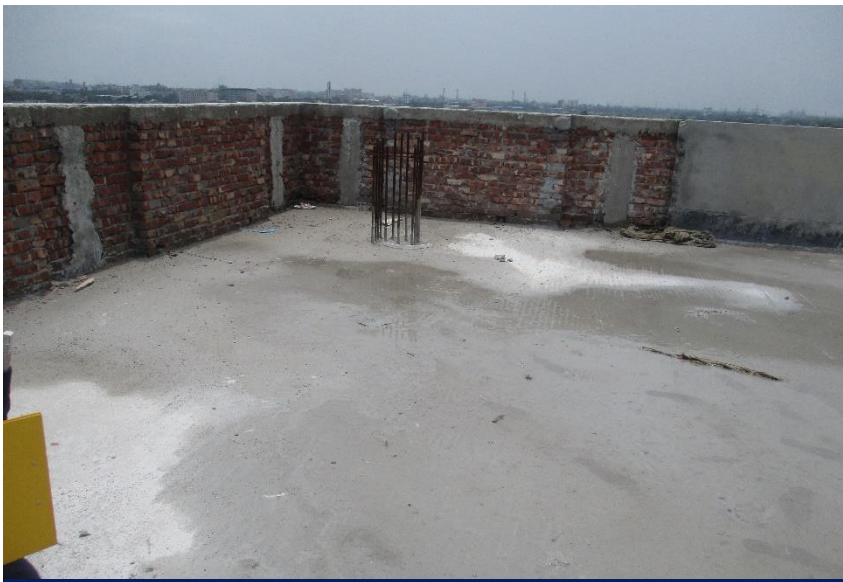
Signage of water applied for curing

The newly constructed roof slab. Water proofing material hasn't applied to roof.

Waterproofing on the roof slab is to be applied as well as drainage system has to be improved.

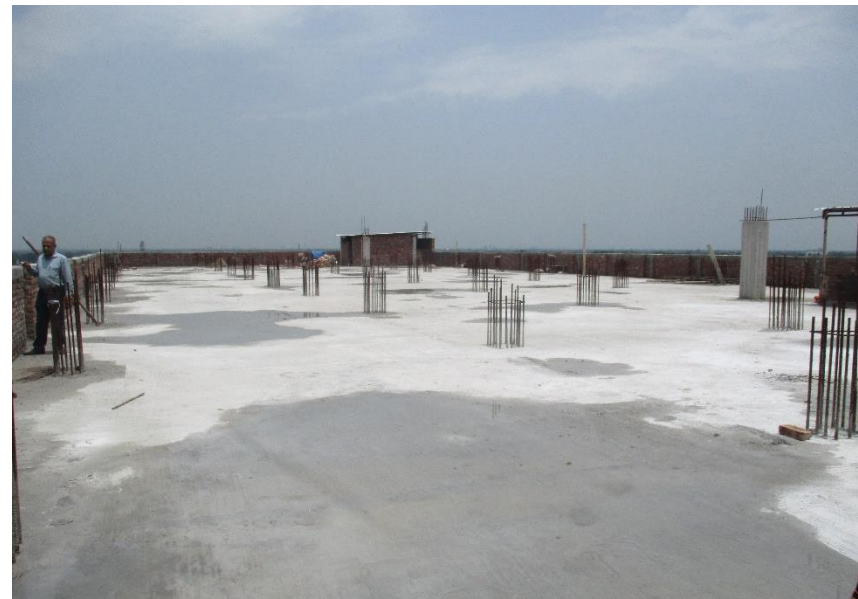
Newly constructed roof slab

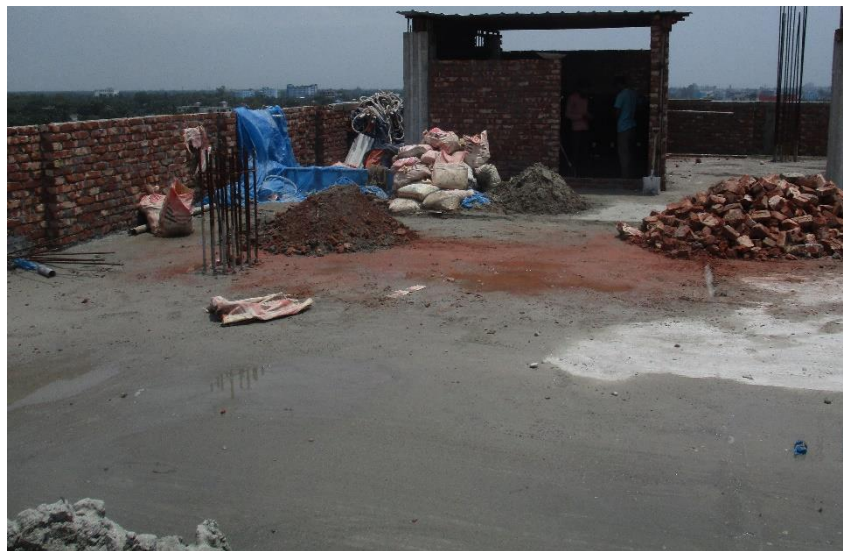
On going construction work at roof

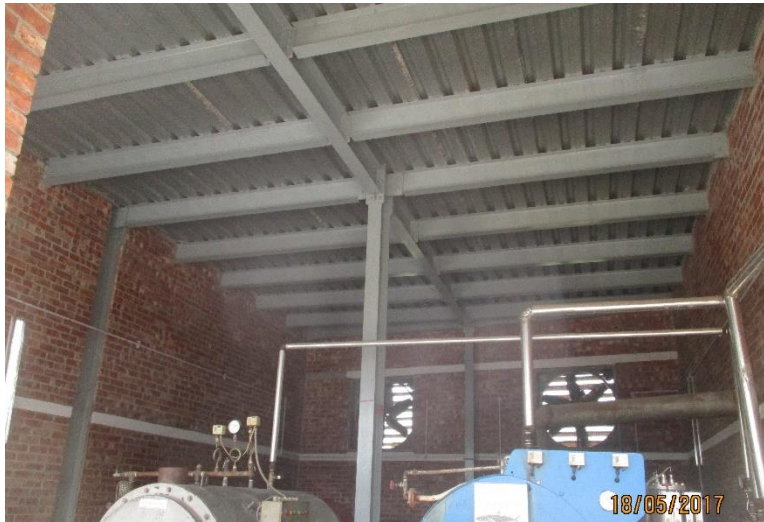
Boiler building

There is no structural and architectural drawings for all the utility buildings.

| Item No. | Observation | Recommended Action Plan | Recommended Timeline |
|---|---|---|---|
| 14 | (Utility Buildings)<br>Missing drawings | Engage an Engineer to produce an “as constructed” drawings which reflect the actual site dimensions with complete structural and architectural information's. | 6-weeks |

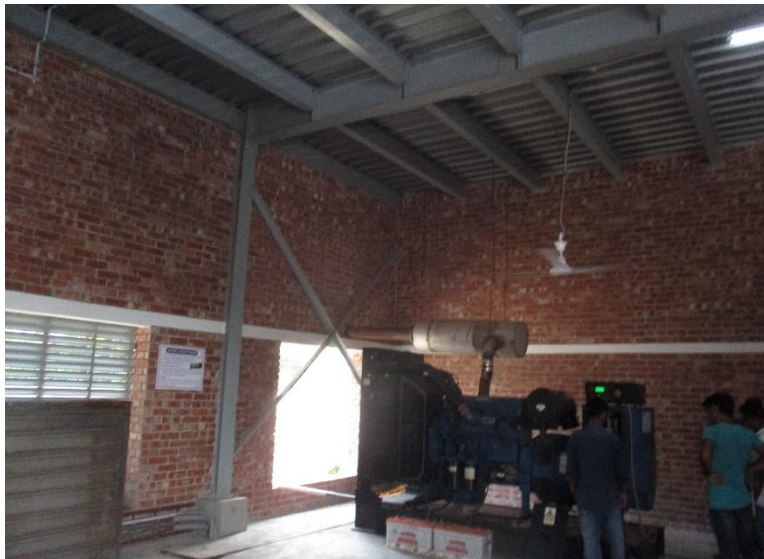
Generator & Sub-station building

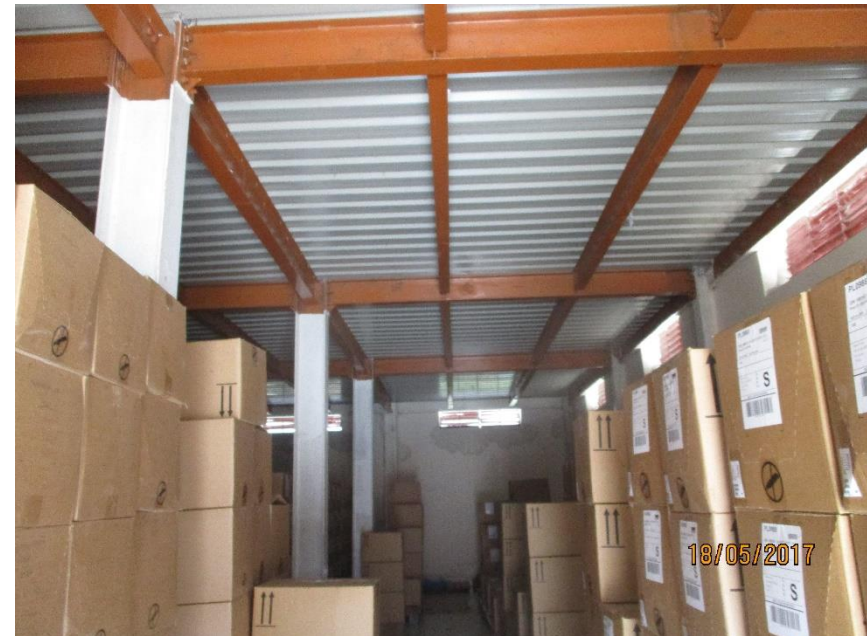
Finish good storage building

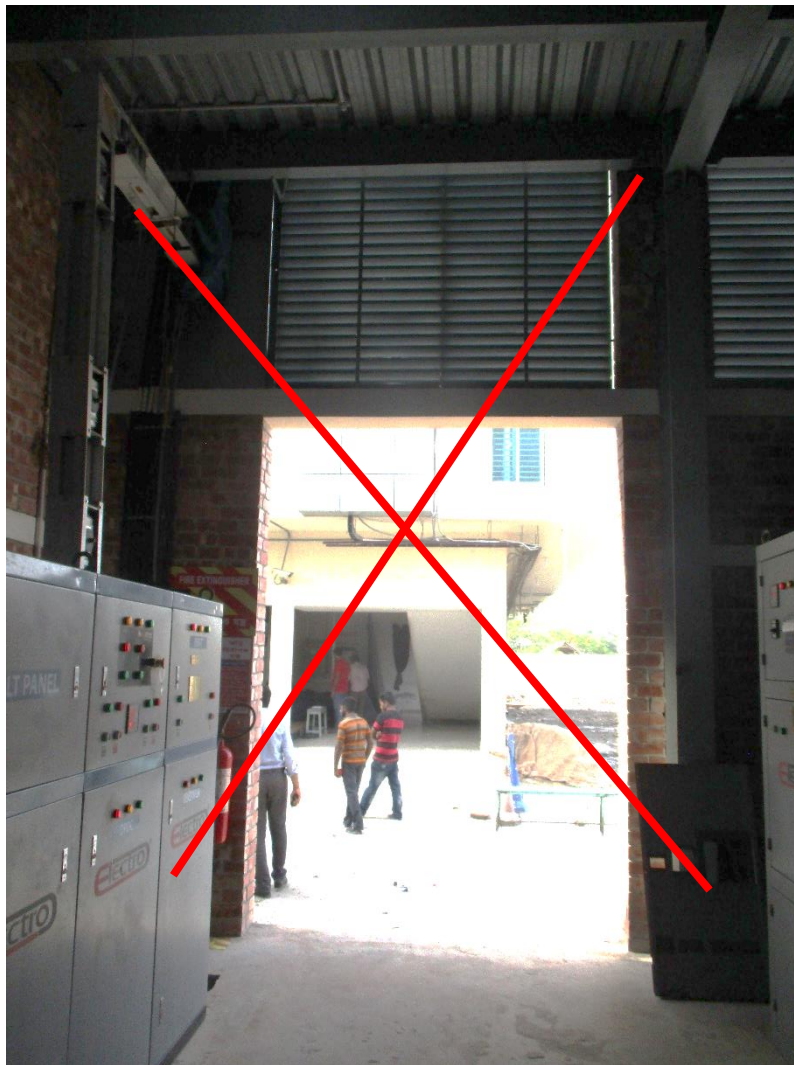
Bracings are not installed at front opening of generator & sub-station building.

Factory is required that these items to be investigated in an Engineering Assessment

| Item No. | Observation | Recommended Action Plan | Recommended Timeline |
|---|---|---|---|
| 15 | (Utility Buildings)<br>Overall stability | Factory Engineer to perform a Engineering Assessment regarding the resistance of the building to wind and seismic load in both directions as per BNBC. | 6-weeks |
| 17 | (Utility Buildings)<br>Overall stability | Especially, add bracing in the direction perpendicular to the Moment Resisting Frames, as required. | 6-months |

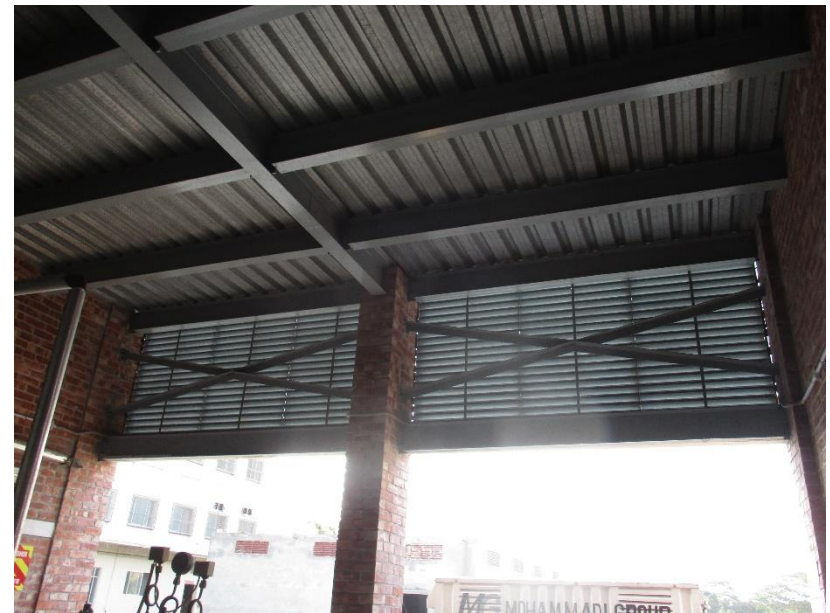
Bracings are only installed over lintel at front of boiler building

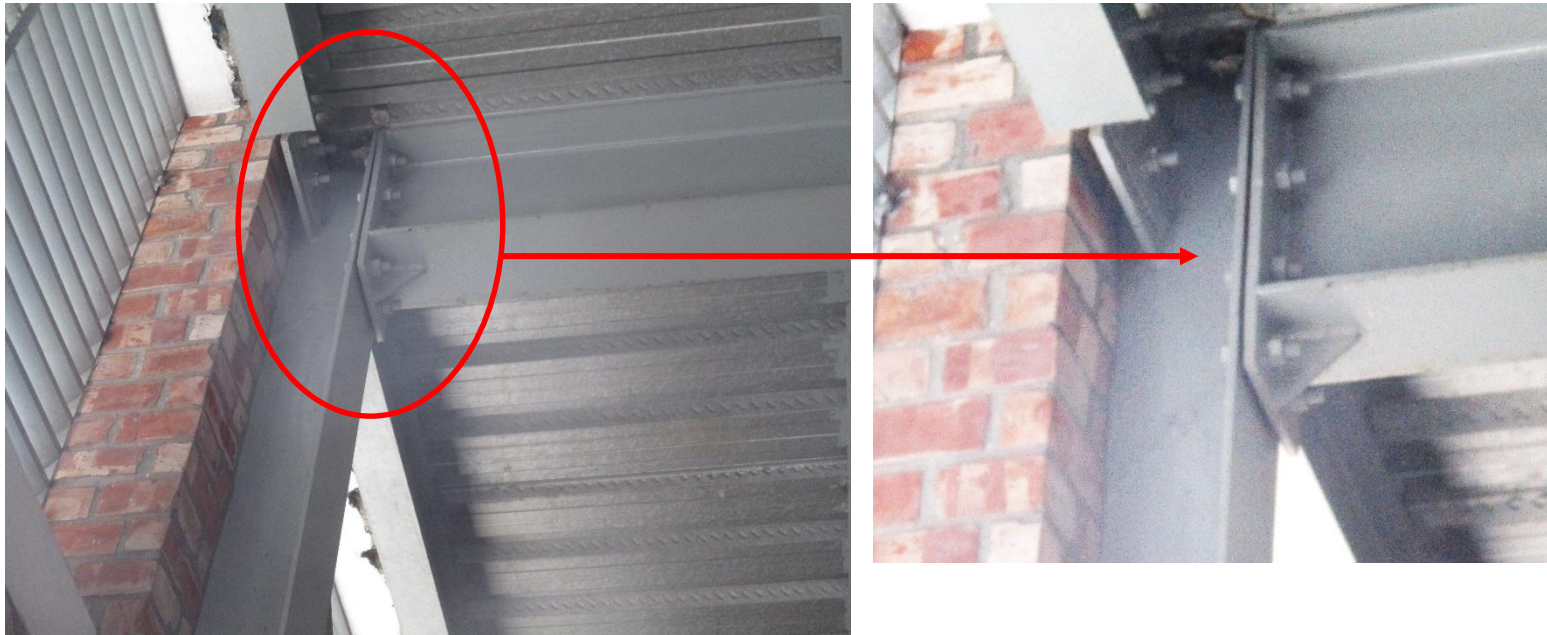
At generator & sub-station building gap found in between steel I-beam and column.

| Item No. | Observation | Recommended Action Plan | Recommended Timeline |
|---|---|---|---|
| 18 | (Utility Buildings)<br>Gap between steel beam-column | Engage an Engineer to check that the connections are adequate. | 6-weeks |
| 19 | (Utility Buildings)<br>Gap between steel beam-column | Provide sim plate if required. | 6-months |
