# Samad Sweater Limited

Kalmeshwar (Battala Road) Board Bazar, Gazipur  
(23.945658, 90.385032)

07<sup>th</sup> May 2017

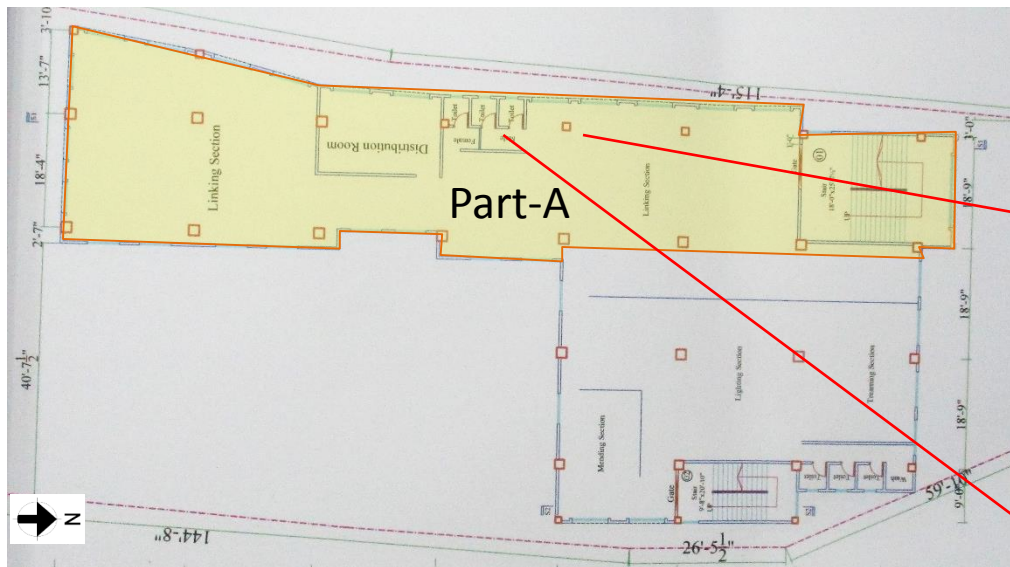
Second Floor Layout Plan

Cursory calculations indicate that punching shear stresses in flat slab floors at corner columns around toilets and at internal columns are in excess of normal design limits.

| Item No. | Observation | Recommended Action Plan | Recommended Timeline |
|---|---|---|---|
| 1 | (Production Building)<br>Punching shear stress levels in flat slabs. | Factory Engineer to review design, loads and punching shear stresses in all slabs at internal columns and in toilet areas. | <b>Immediate - Now</b> |
| 2 | (Production Building)<br>Punching shear stress levels in flat slabs. | Verify insitu concrete strength by taking 100mm diameter cores from a minimum of 4 non-critical locations in slabs. | <b>Immediate - Now</b> |
| 3 | (Production Building)<br>Punching shear stress levels in flat slabs. | A Detail Engineering Assessment of Factory to be commenced, see attached Scope. | <b>Immediate - Now</b> |
| 4 | (Production Building)<br>Punching shear stress levels in flat slabs. | Make structural alterations as advised by Factory Engineer. | <b>6-weeks</b> |
| 5 | (Production Building)<br>Punching shear stress levels in flat slabs. | Produce and actively manage a loading plan for all floor plates within the factory, giving consideration to slab capacity and column capacity. | <b>6-weeks</b> |

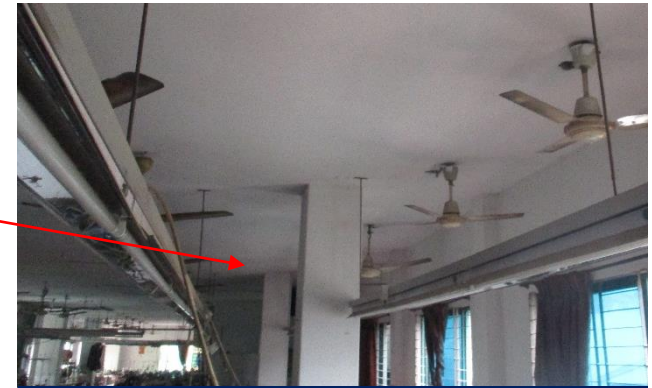
Flat slab up to 2<sup>nd</sup> floor

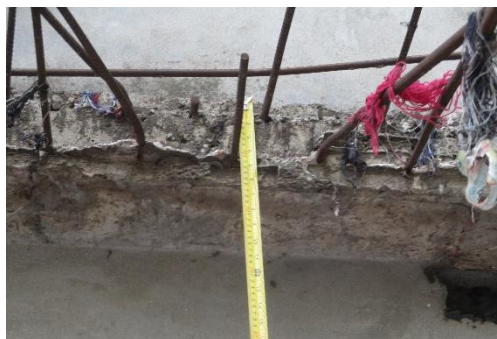
Brick aggregate observed

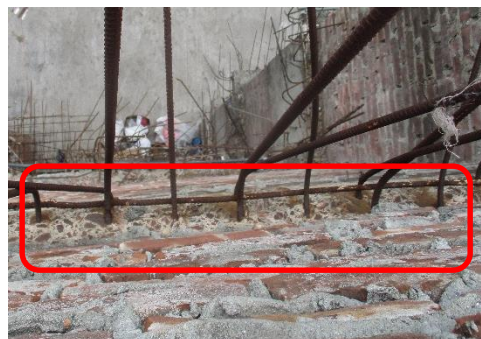
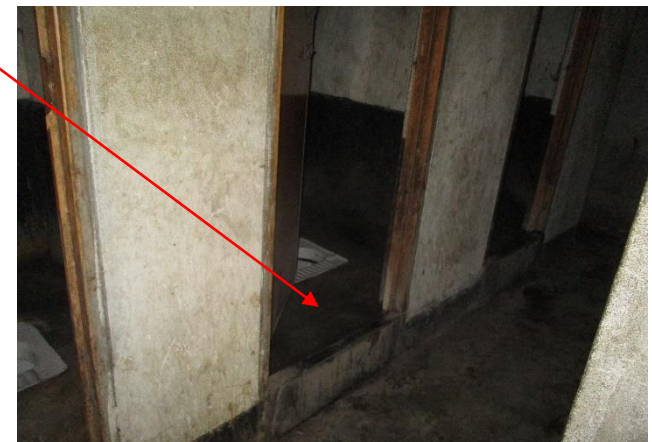
Toilet zone with build up

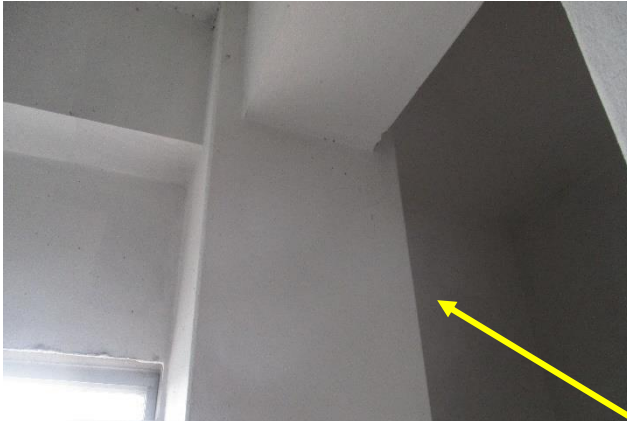
In beam layout of Part-B conceal beam was shown but 10" x 20" size beam found. All floor beams are shown as conceal beam in drawings. Also in Part-A cantilever beams were not found in stair and north side toilet which were shown in beam layout.

Cantilever without beam

| Item No. | Observation | Recommended Action Plan | Recommended Timeline |
|---|---|---|---|
| 8 | (Production Building)<br>Mismatch in beam layout | Building Engineer is required to survey the as-built structure and prepare the accurate as-built structural drawings. | 6-weeks |

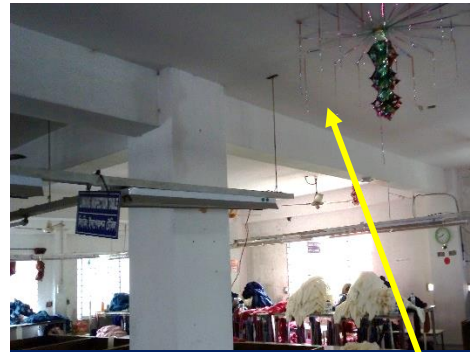
Floor beam at part-B

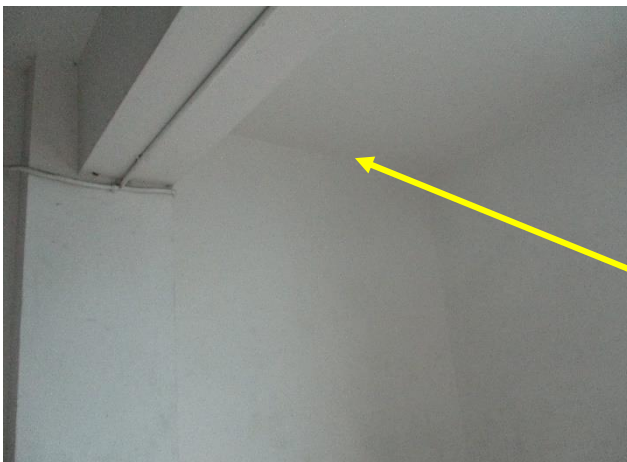
Cantilever at stair without beam

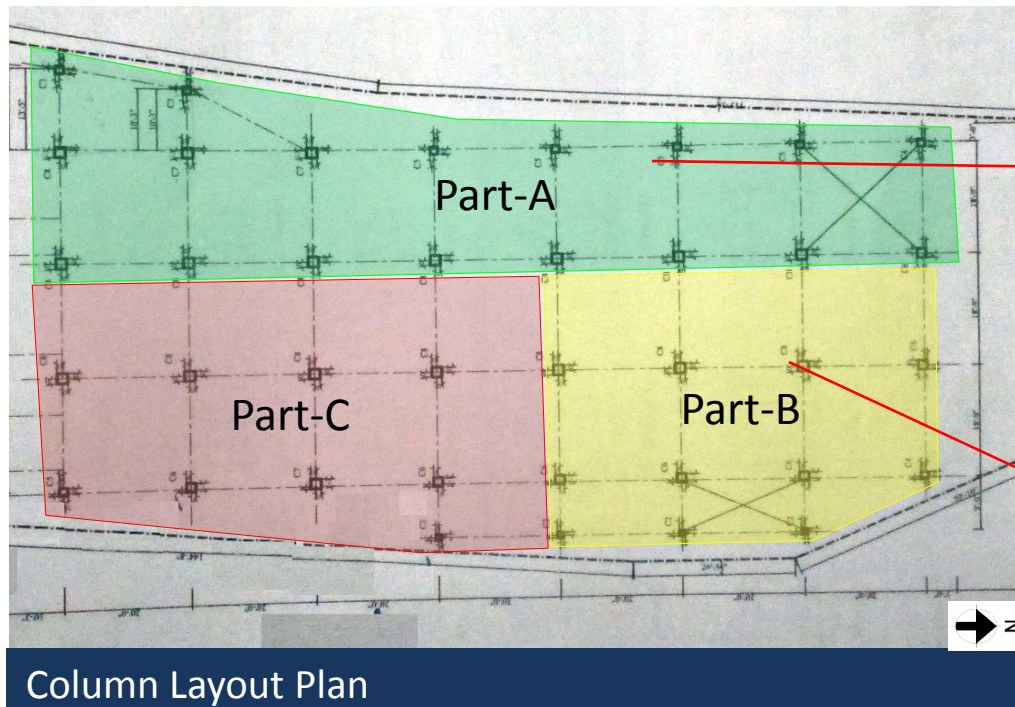
Column Layout Plan

Concerns on the stability system for lateral loading and seismic loading. Flat slab system lack of lateral load resistance.

| Item No. | Observation | Recommended Action Plan | Recommended Timeline |
|---|---|---|---|
| 9 | (Production Building)<br>Overall stability system | Carry out a Detail Engineering Assessment on the buildings to verify that they are stable under lateral loading. | 6-weeks |
| 10 | (Production Building)<br>Overall stability system | Carry out all recommendations of the Detail Engineering Assessment. | 6-months |

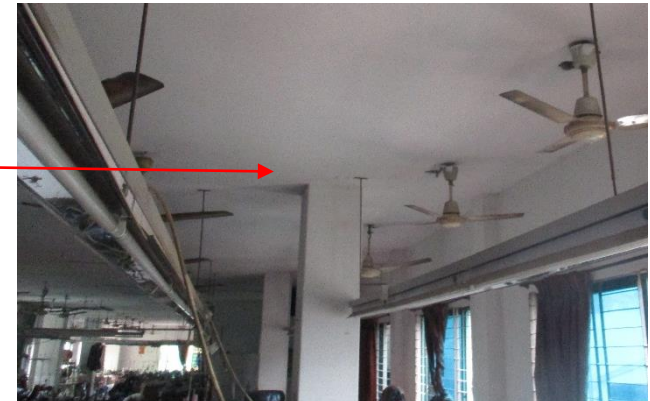
Flat slab up to 2<sup>nd</sup> floor

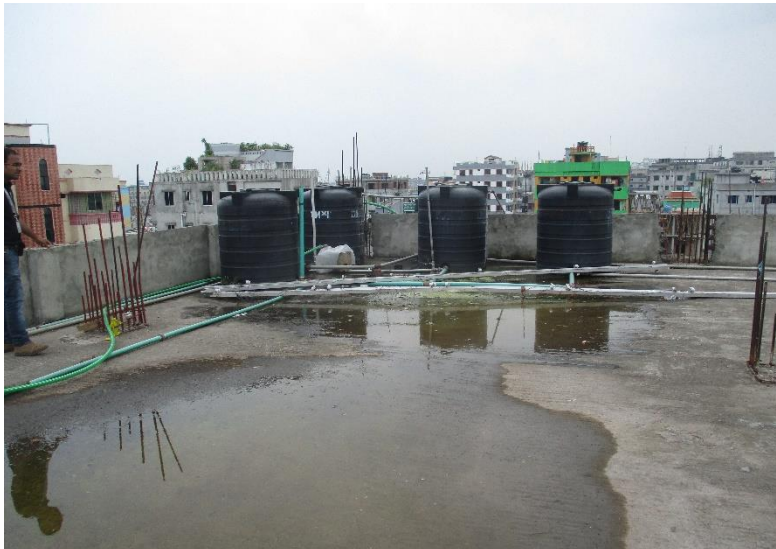
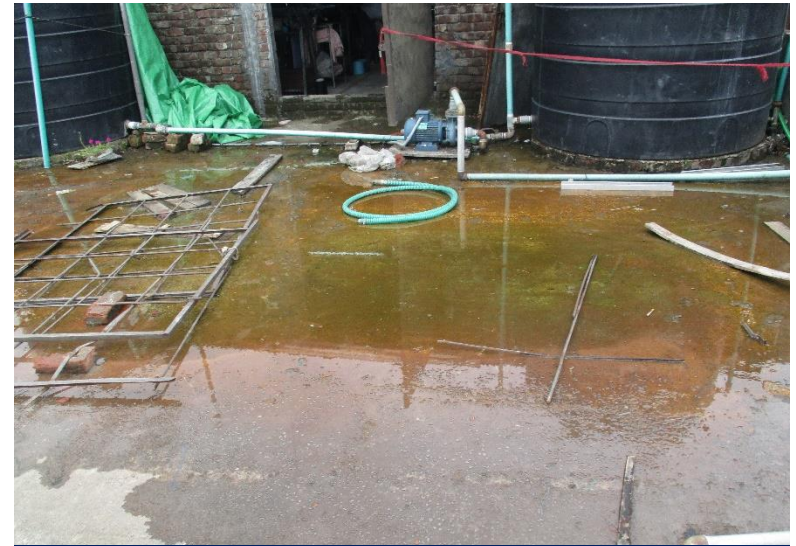
Water ponding at roof

Water ponding was noted on the roof slab.

| Item No. | Observation | Recommended Action Plan | Recommended Timeline |
|---|---|---|---|
| 12 | (Production Building)<br>Water logging at roof and dampness due to water logging. | Waterproofing on the roof slab is to be applied. In addition, the roof slab drainage system should be investigated and improved if required. | 6-weeks |

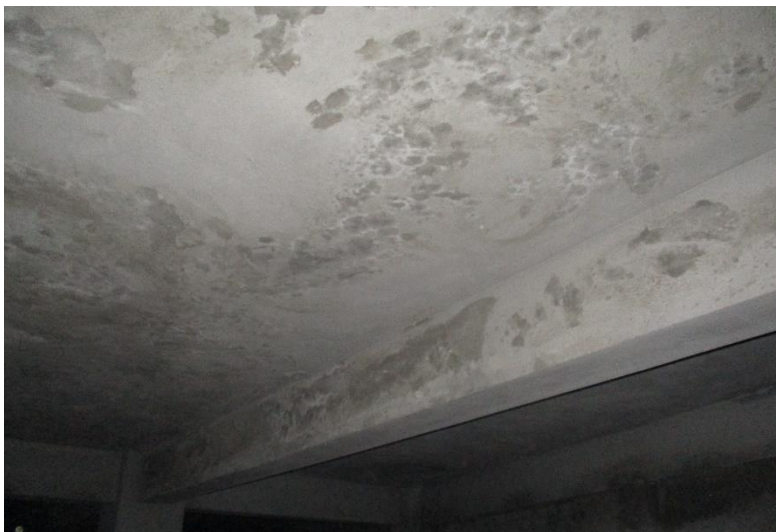
Water ingress at 4<sup>th</sup> floor slab soffit

Water ingress was found on the 4<sup>th</sup> floor slab soffit.

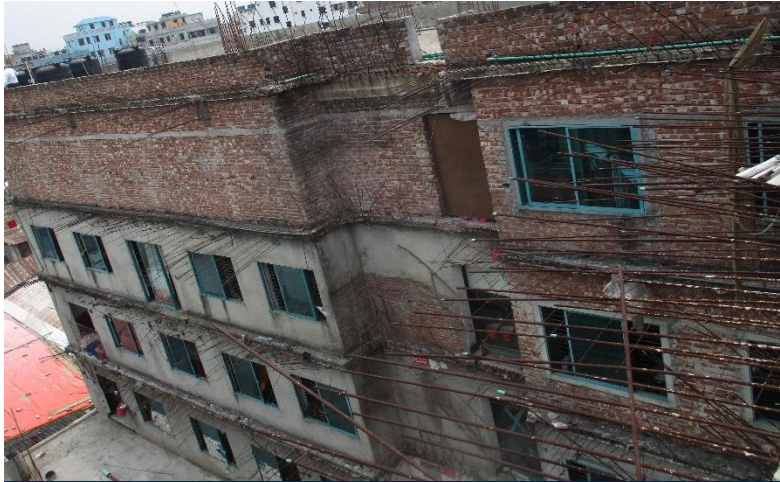
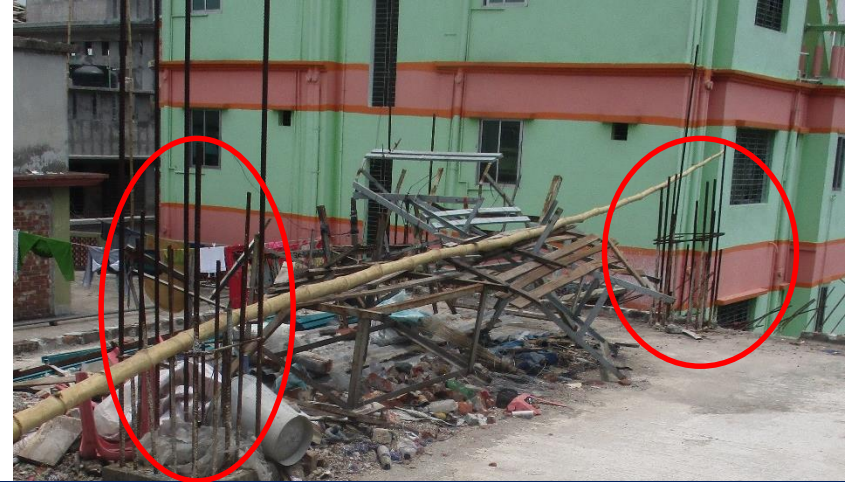
Slab reinforcement is left exposed at South and East. Column reinforcement is also exposed at roof. It is unclear whether rust proof paint is applied.

| Item No. | Observation | Recommended Action Plan | Recommended Timeline |
|---|---|---|---|
| 13 | (Production Building)<br>Expose rebar and wastage on roof | All exposed reinforcement is required to protect from corrosion which may cause degradation of the concrete. | 6-weeks |

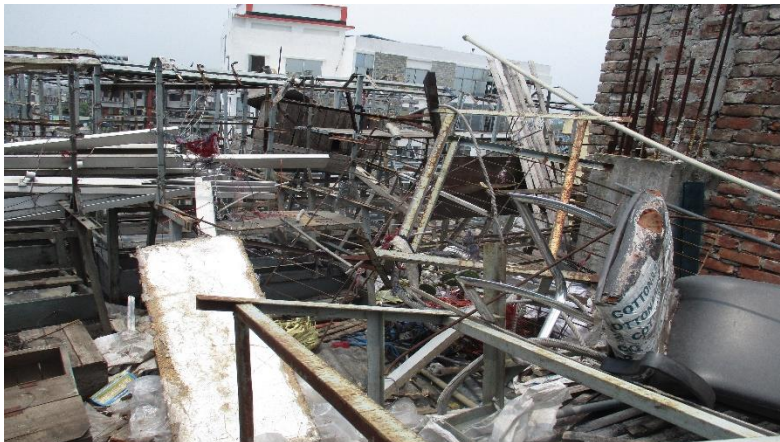
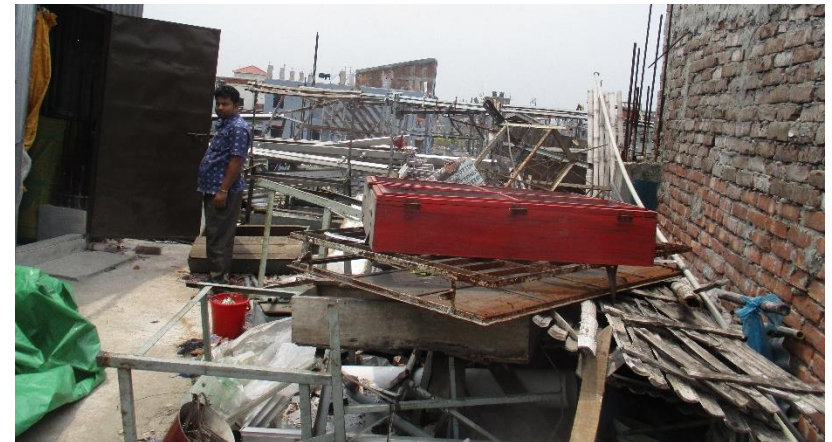
Wastage materials are stacked at roof. Factory is required remove all the wastage from roof.

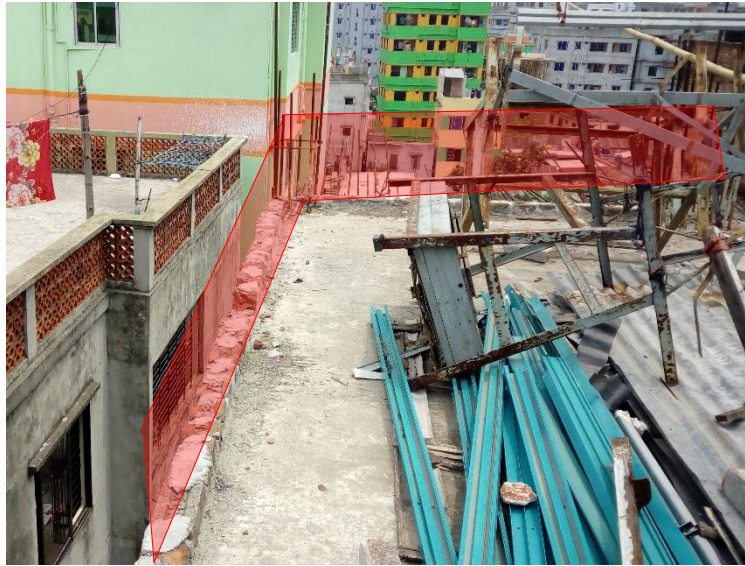
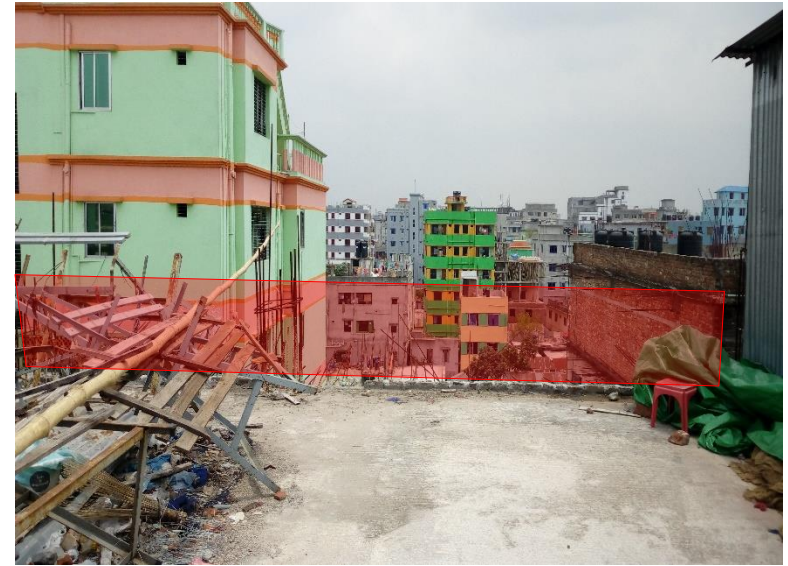
No edge protection provided at North-east to the roof

| Item No. | Observation | Recommended Action Plan | Recommended Timeline |
|---|---|---|---|
| 14 | (Production Building)<br>No edge protection at North-east side on roof | Provide proper edge protection to the roof. | 6-weeks |

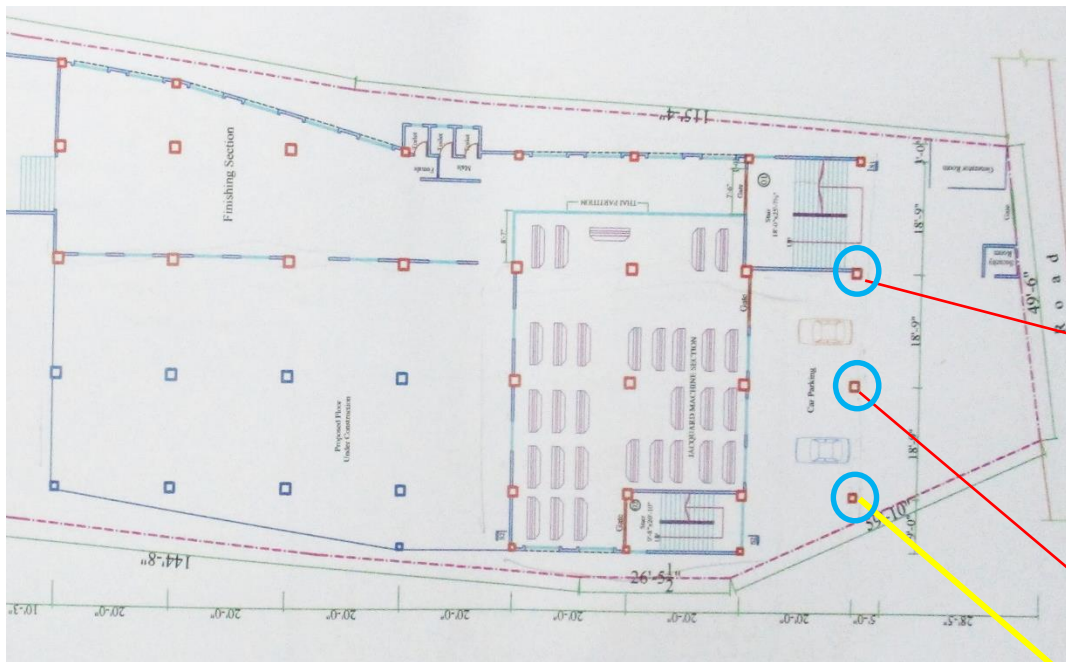
Ground floor layout plan (Loading/unloading area)

Impact protection not provided to columns at loading – unloading area. Columns were suspected to have impact loading from vehicles.

| Item No. | Observation | Recommended Action Plan | Recommended Timeline |
|---|---|---|---|
| 15 | (Production Building)<br>Columns suspected to vehicle impact | Install a barrier to prevent vehicle impact in column. | 6-weeks |

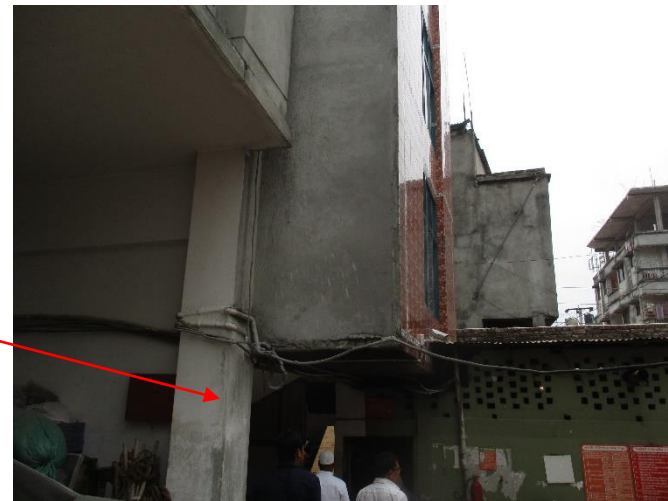
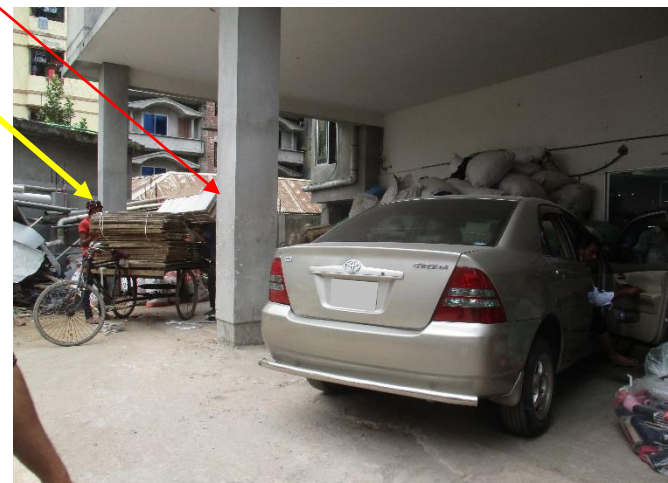
Loading/unloading area

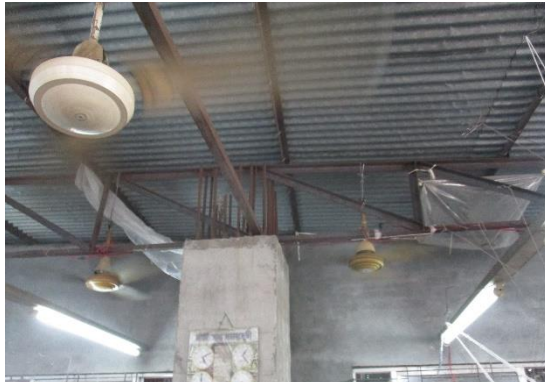
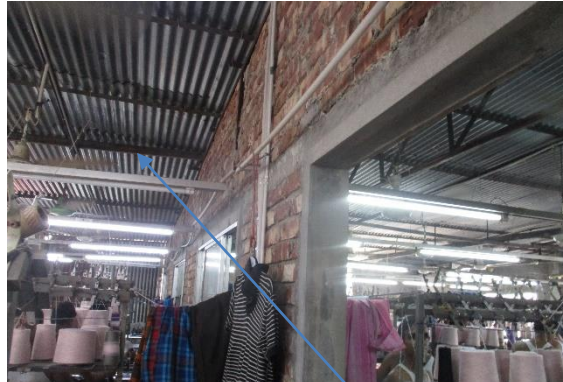
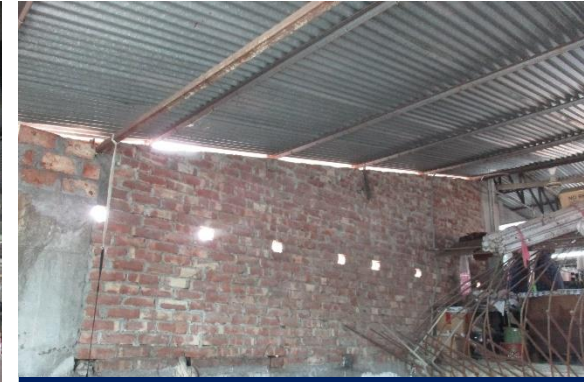
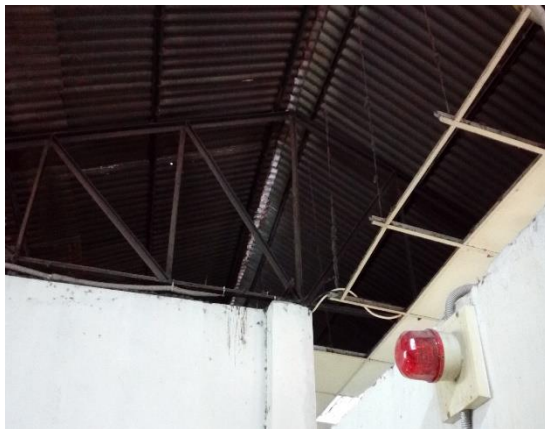
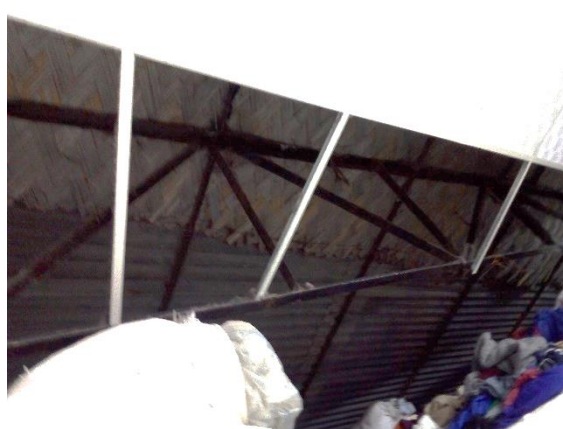
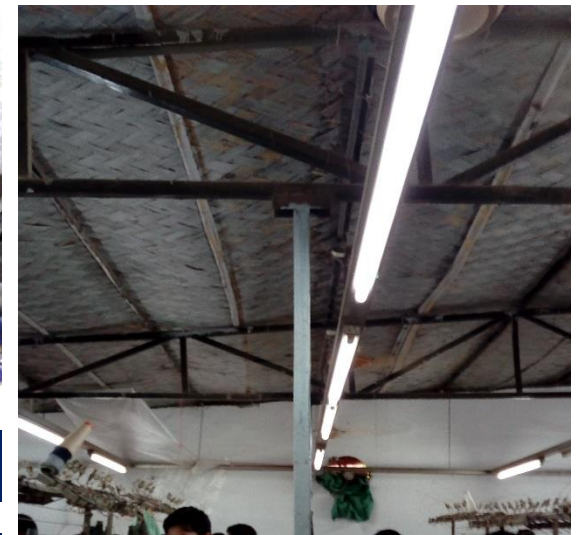
Structural and architectural drawings were not available for all sheds. Only layout plan was available for shed -1 & 2 which didn't match with as-built condition.

| Item No. | Observation | Recommended Action Plan | Recommended Timeline |
|---|---|---|---|
| 16 | (Shed-1, 2 & 3)<br>Lack of drawings for all sheds | Building Engineer to survey as-built structure and prepare accurate as-built survey information for steel part. | 6-weeks |

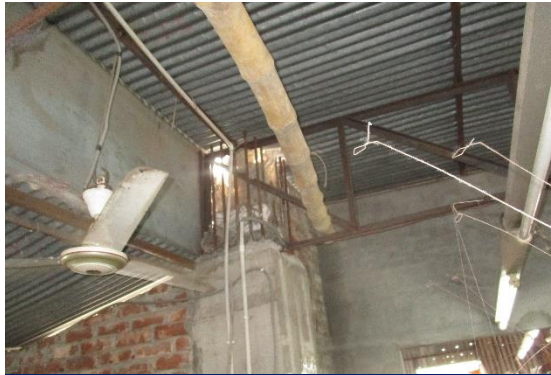
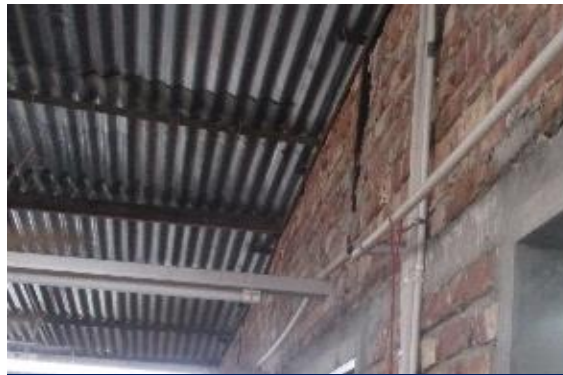
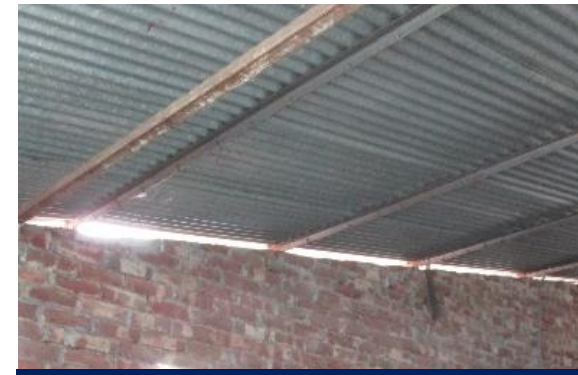
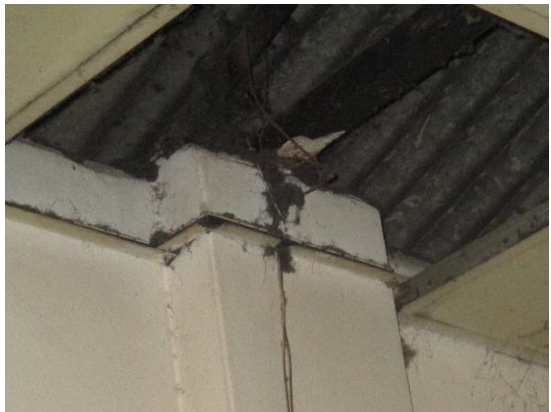
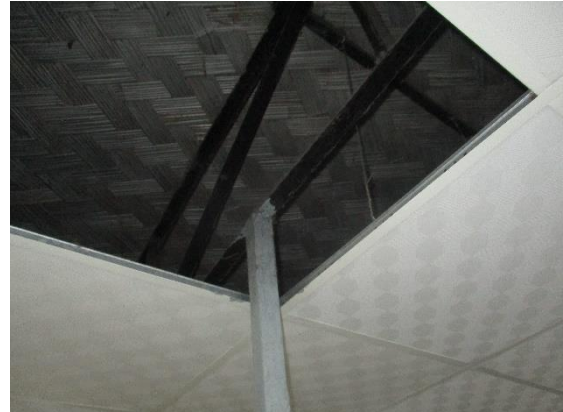
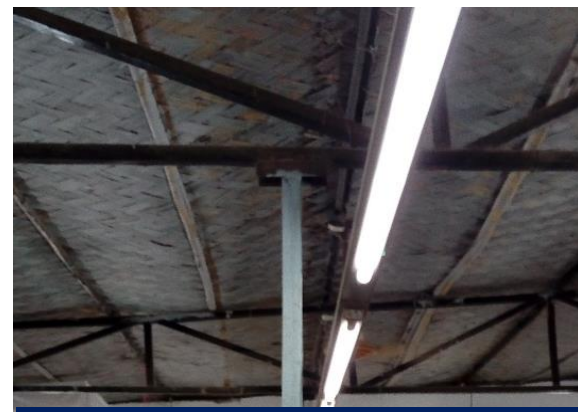
Steel structures to the shed buildings contain small steel sections and lateral stability structural systems are unclear. Building Engineer to carry out a lateral stability analysis of the shed buildings.

| Item No. | Observation | Recommended Action Plan | Recommended Timeline |
|---|---|---|---|
| 17 | (Shed- 1, 2 & 3)<br>Apparently non engineered shed | Engage a qualified structural engineer to confirm satisfactory structural performance of these shed under wind loading. | 6-weeks |
| 18 | (Shed- 1, 2 & 3)<br>Apparently non engineered shed | Remedial works to be carried out if required | 6-months |
