# Louietex Manufacturing Ltd. S2L Fashions PVT Ltd

Shondha Sharifpur, National University, Gazipur, Bangladesh  
(+23.967791N, 90.374339E)

24th June 2014

# Observations

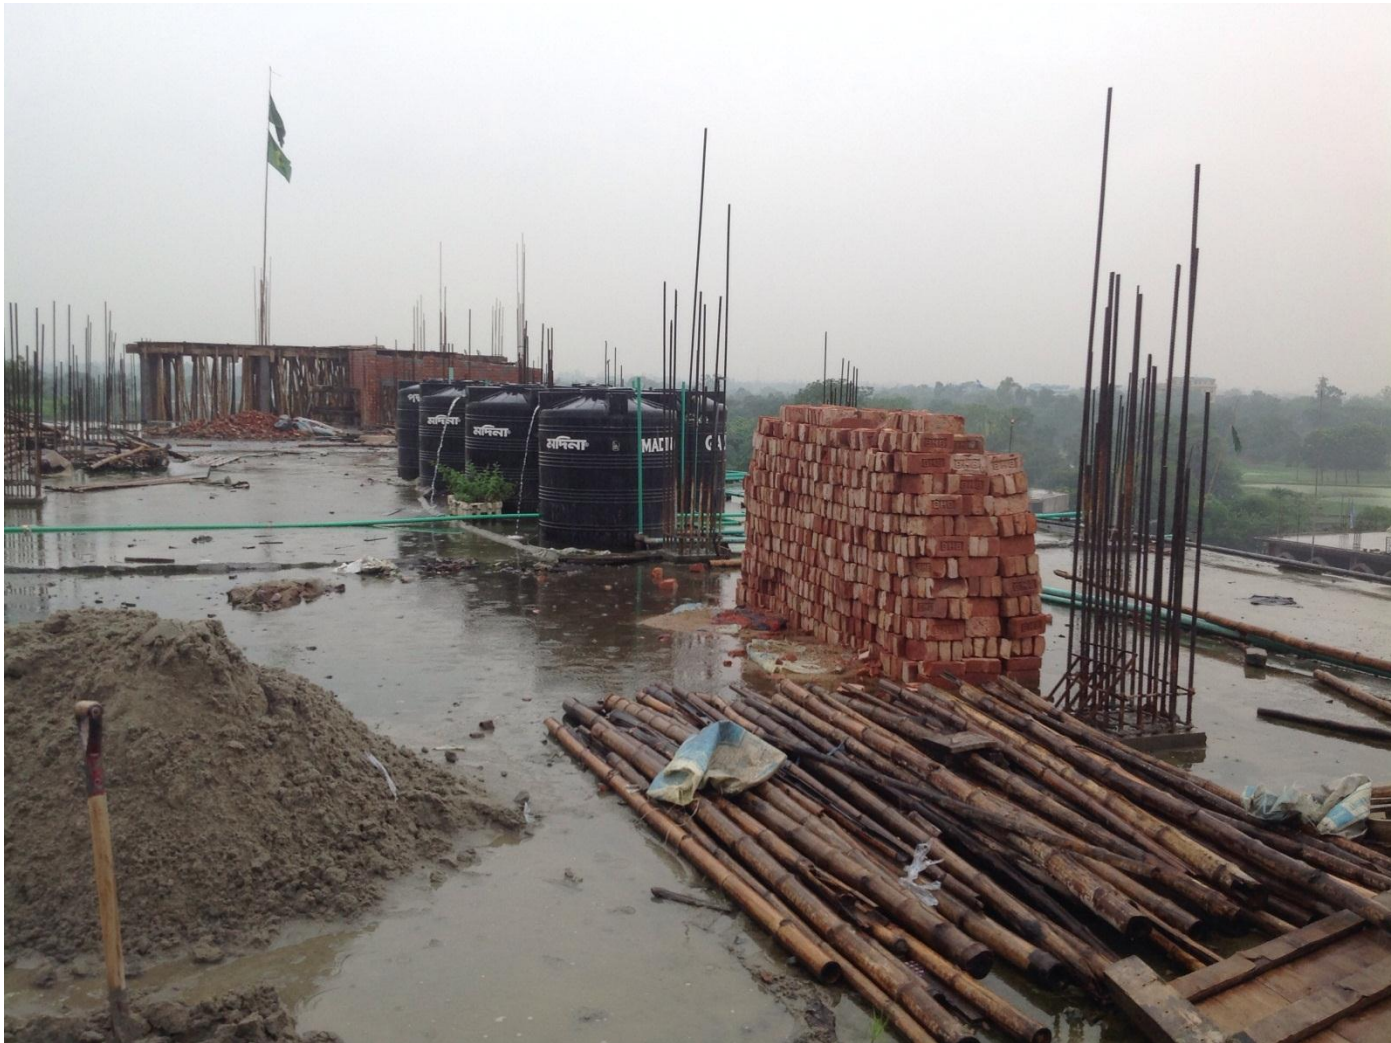
## Load Management

Construction materials and water tanks at roof level. This imparts a significant load to localised slabs and columns.

Item No.	Observation	Recommended Action Plan	Recommended Timeline
1	Check localised high loading from water tanks, construction materials, storage areas and toilet finishes	Building Engineer to check that slab has sufficient capacity to support areas of locally high loading described above.	6-weeks
2	Check localised high loading from water tanks, construction materials, storage areas and toilet finishes	Building Engineer to produce and actively manage a loading plan for all floor plates within the factory giving consideration to floor capacity and column capacity.	6-months
3	Local damage of floor slab due to pipe penetrations	Building Engineer to undertake design checks to confirm that penetrations are acceptable in the design of the slab. Allowable floor loading plans to be updated.	6-weeks
4	Any proposed additions to the existing building structure, including additional storeys, should be reviewed by the Building Engineer	If any additions to the building structure are proposed, the Building Engineer shall provide calculations showing the structural adequacy of all columns taking into account any additions to the existing structure, the loading plans and as built structure, including insitu concrete strength testing.	6-months

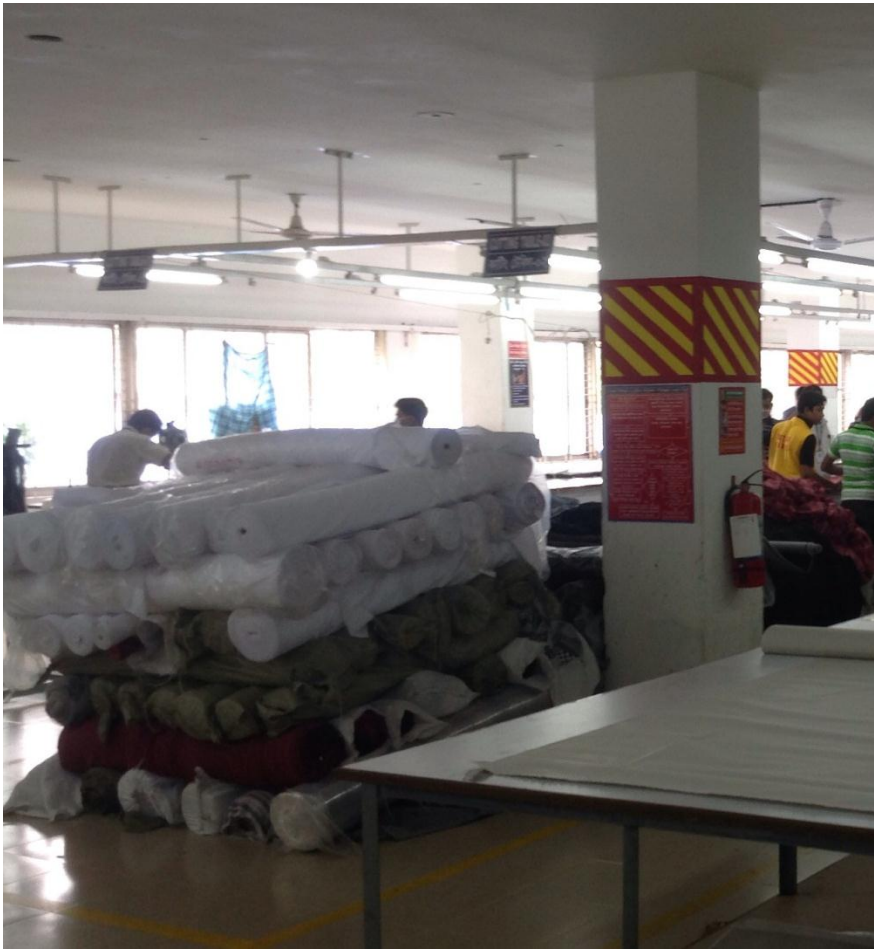
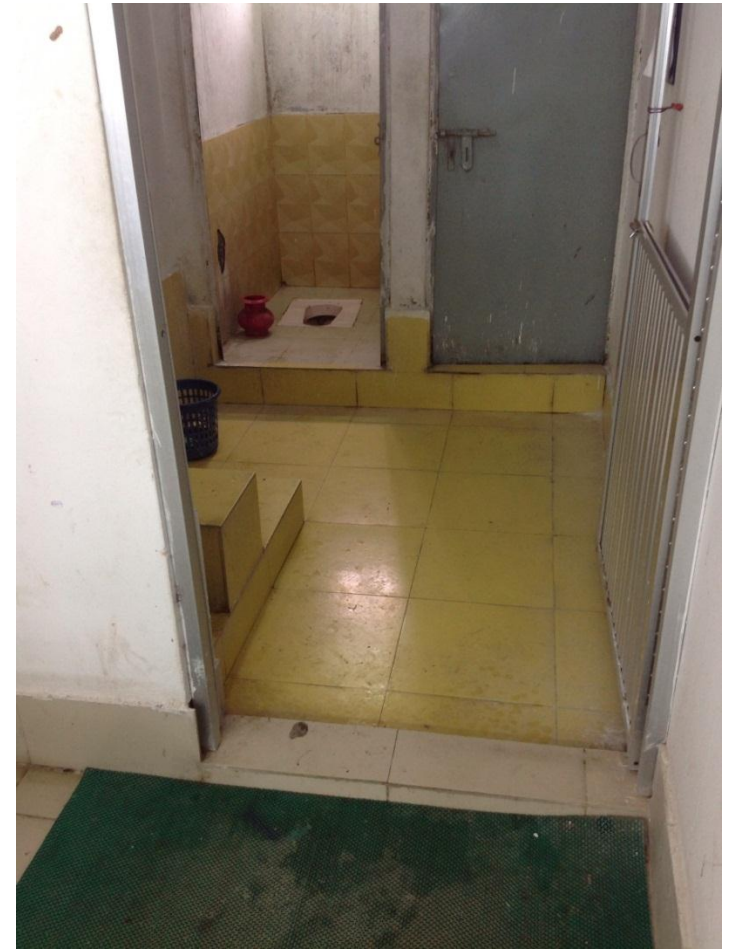
## Load Management

Storage loading and significant finishes to the toilet areas impart significant load to localised slabs and columns

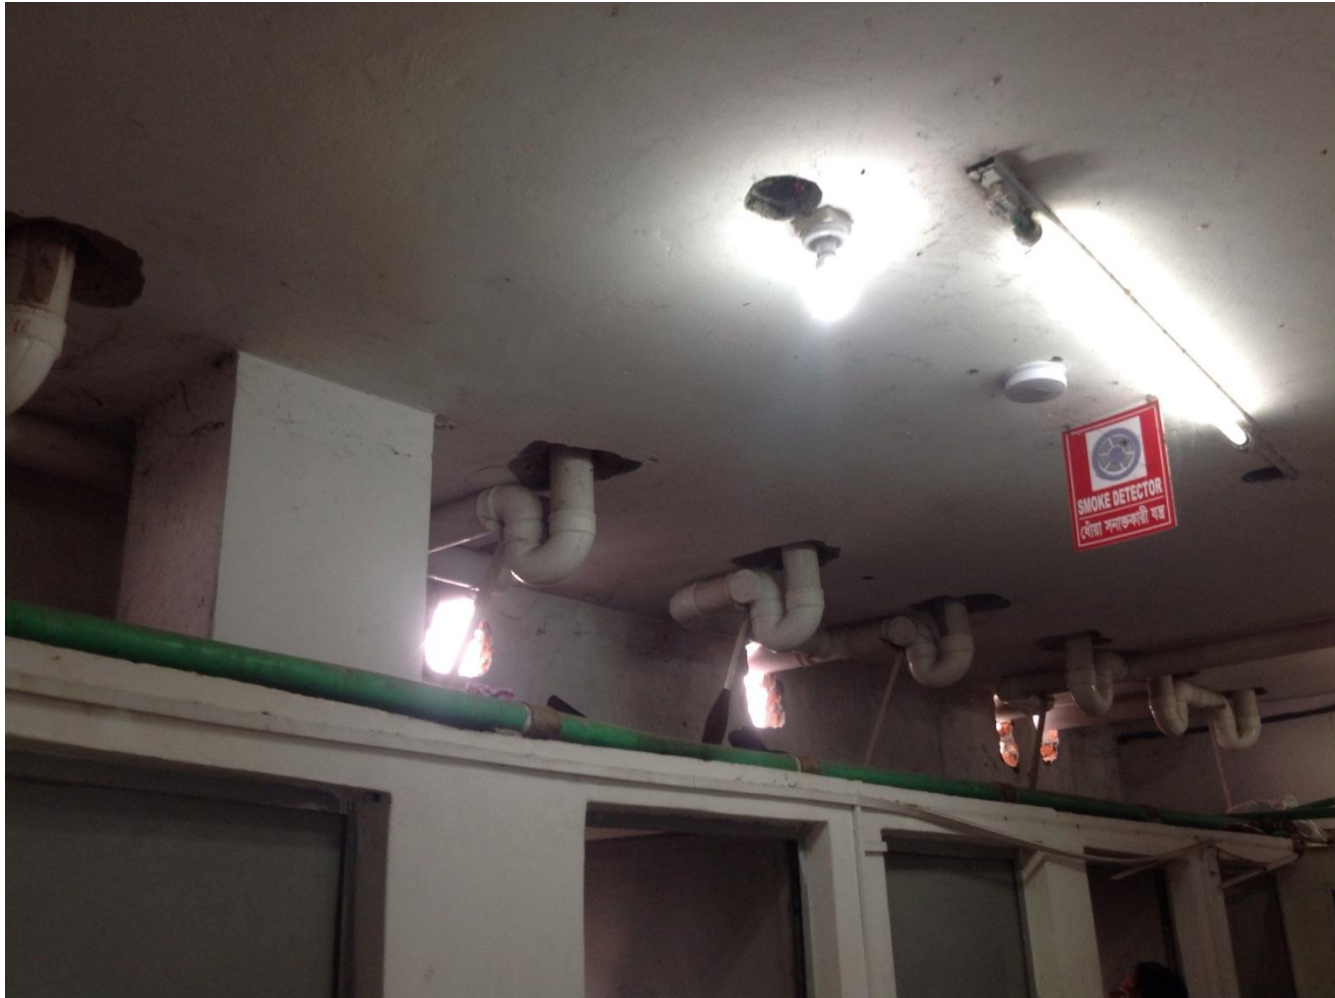
## Floor slab penetrations

Toilet waste pipe penetrations have been formed in the slab column strips after casting. Damage to reinforcement may have occurred.

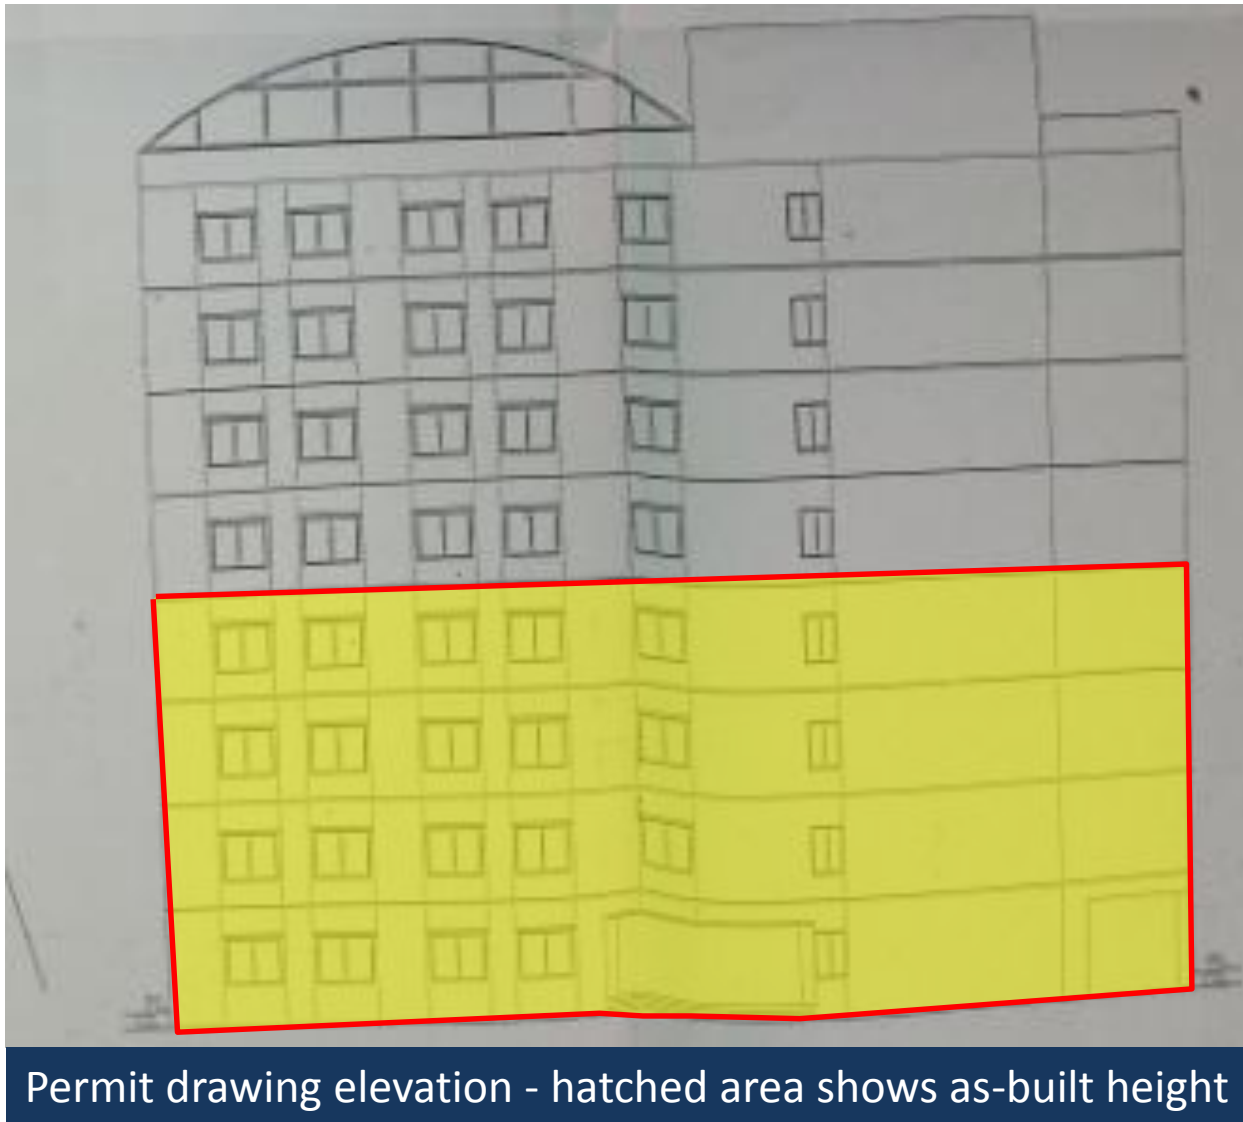
## Future Building Extension

During the visit only 4 storeys were constructed but a permit existed for 8 storeys plus a roof shed. If the 8 storeys are constructed the column stresses will need to be reviewed by the Building Engineer.

Permit drawing elevation - hatched area shows as-built height

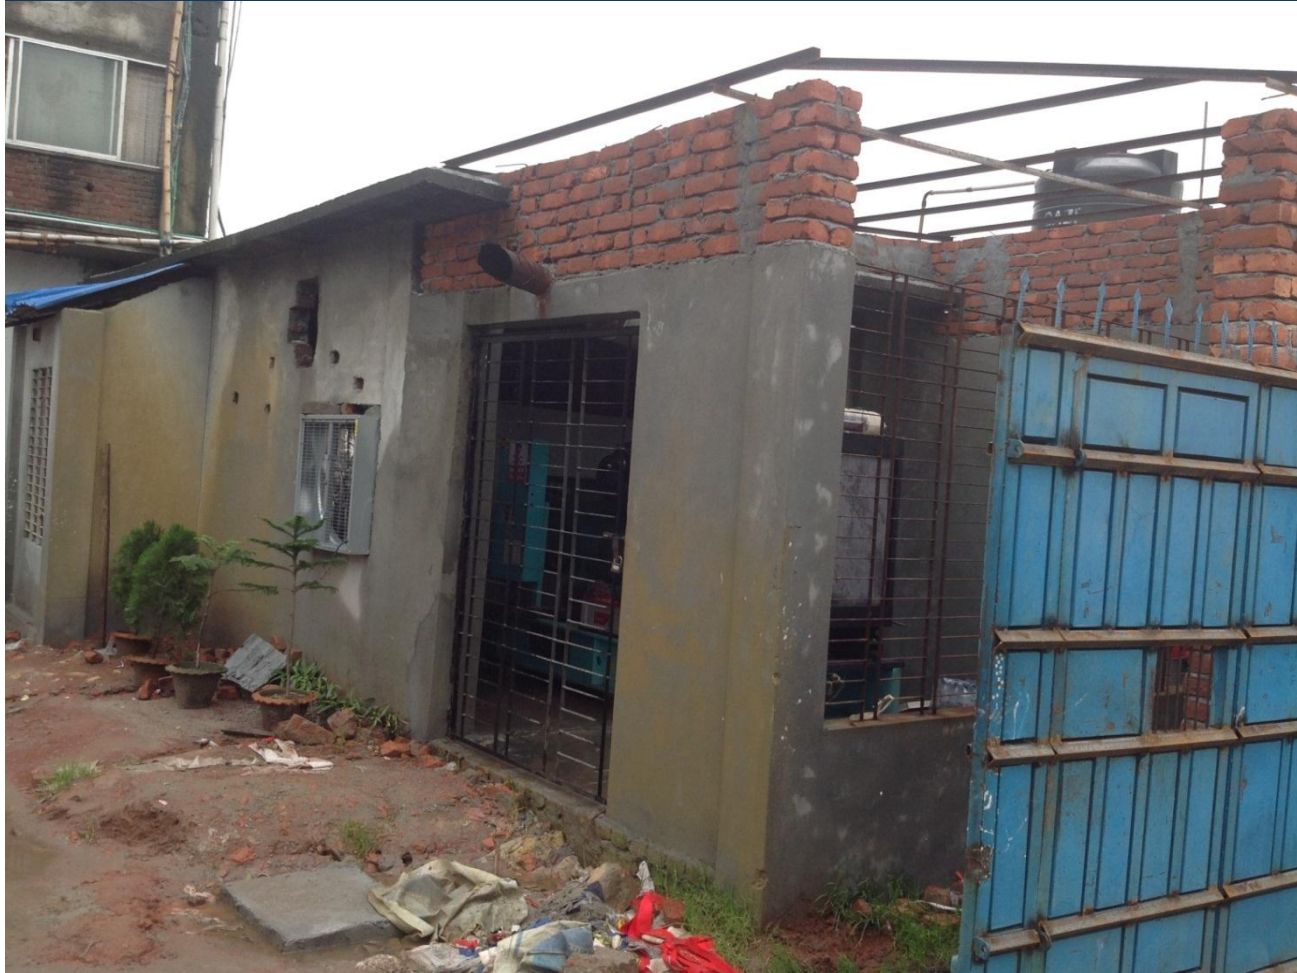
## Non-engineered structures

Ancillary buildings and generator room appear to be non-engineered. Structural adequacy of these structures to be assessed for design imposed and wind loads.

Item No.	Observation	Recommended Action Plan	Recommended Timeline
5	Non-engineered structures	Ancillary structures should be designed and upgraded to support code vertical and wind loads by the Building Engineer.	<b>6-months</b>
6	Structural drawings do not match current arrangement of the structure	Building Engineer to commence checking, collecting information and produce accurate and complete as-built documentation.	<b>6-weeks</b>
7	Structural drawings do not match current arrangement of the structure	Complete issue of as-built documentation.	<b>6-months</b>
8	Water damage to masonry façade	Repair/install render and/or waterproofing to ensure prevention of water ingress.	<b>6-weeks</b>
9	Water damage to masonry façade	Inspect structure to ensure no deterioration.	<b>6-weeks</b>

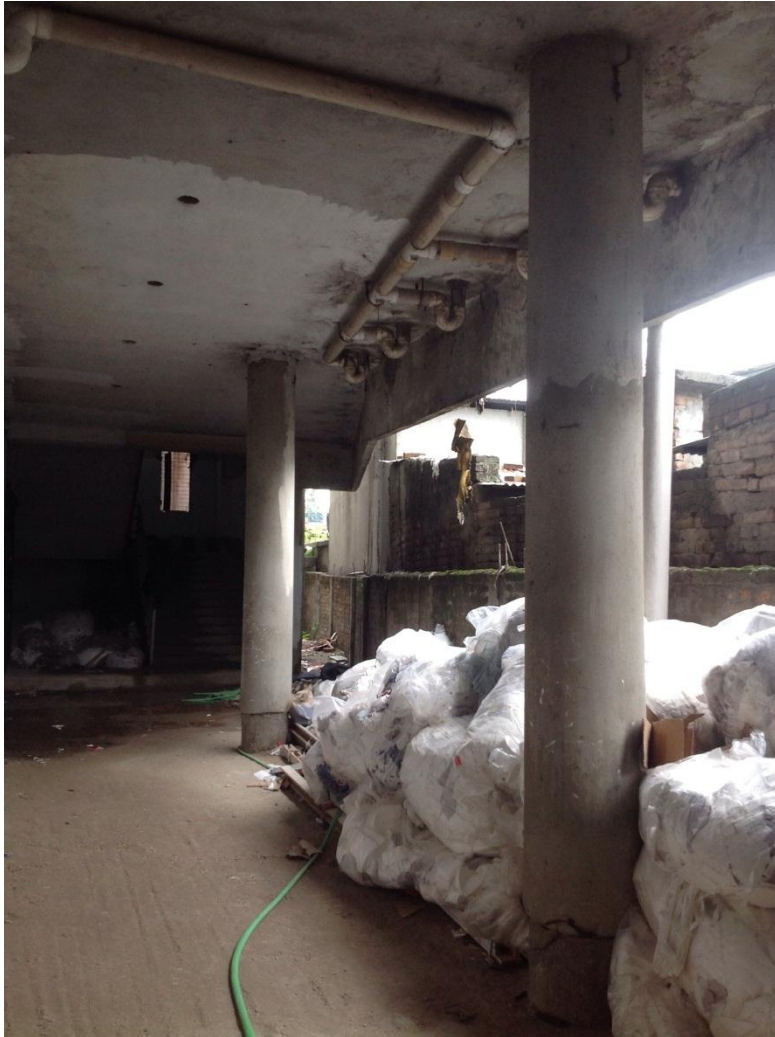
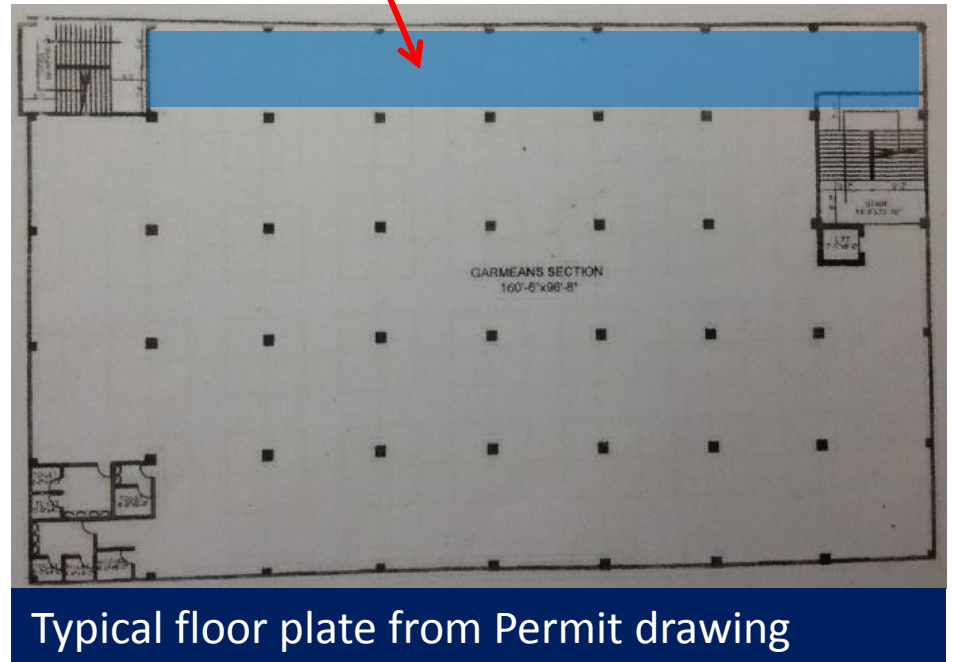
## Documentation

Permit drawings were different to what was seen on site. Cantilever slabs and irregular column grids were identified in area shaded below. No as-built architectural or structural information was available.

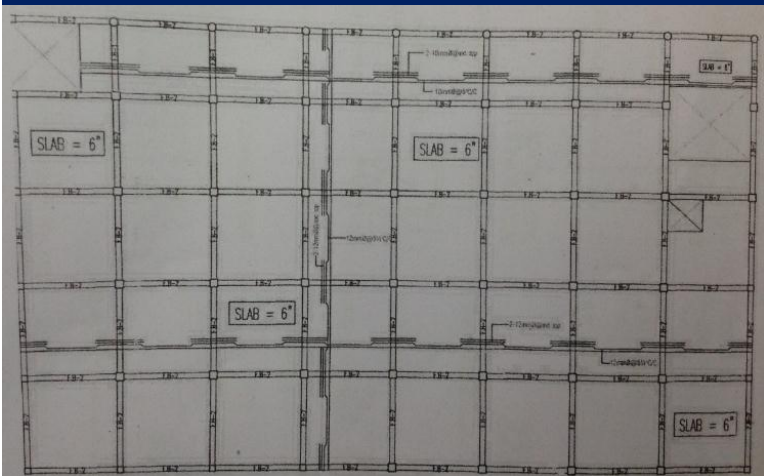
Beam & slab reinforcement drawing

A flat slab was viewed on site. Structural drawings were unclear. We were shown drawings with both downstand beams and flat slabs. Both drawing sets were incomplete.

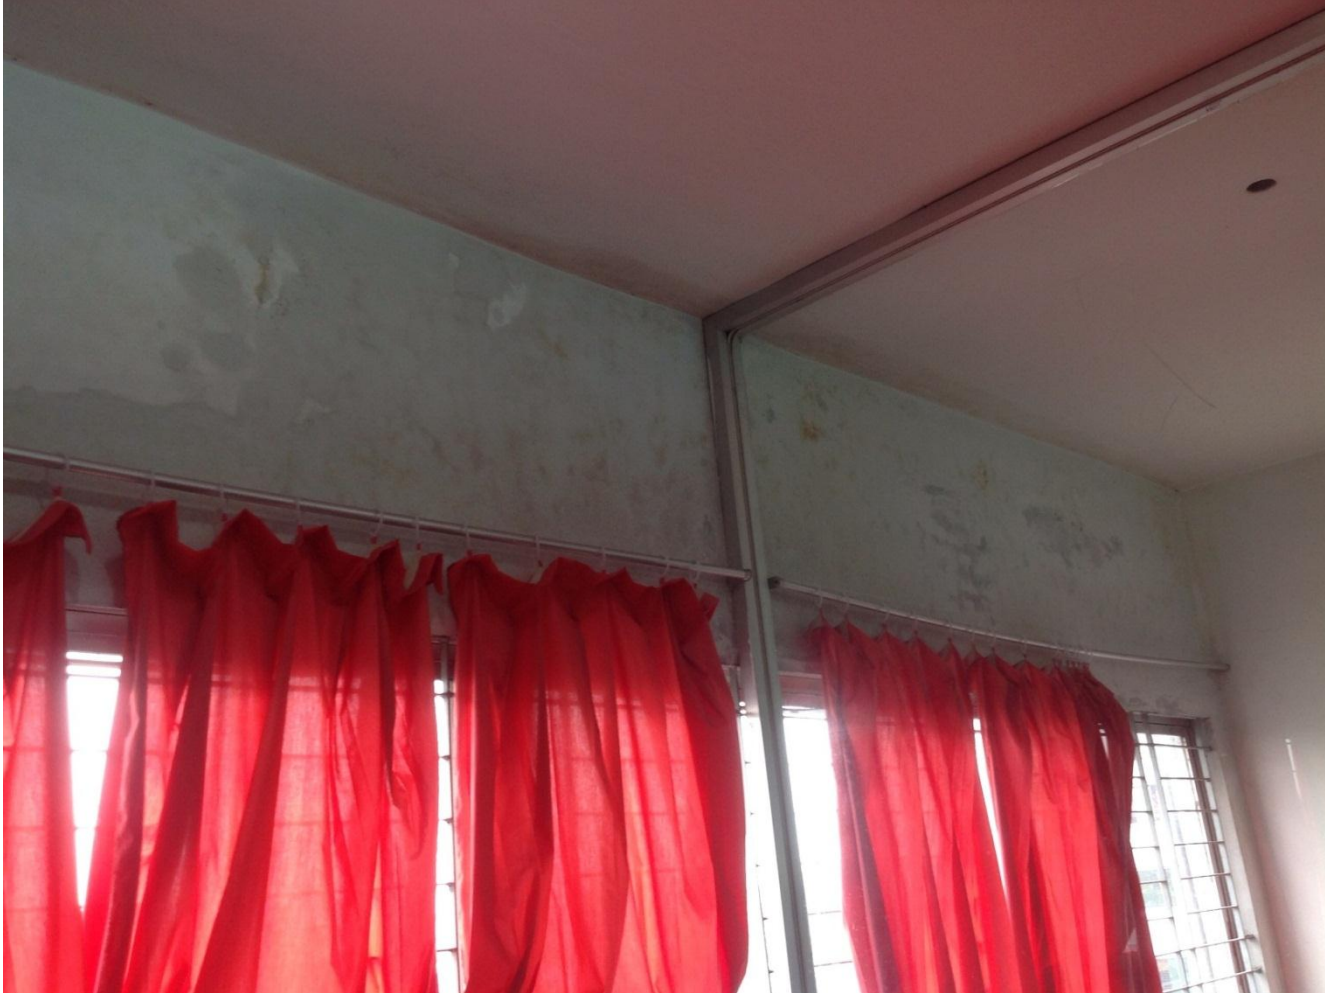
## Water Ingress

Masonry façade showing signs of water ingress in a number of locations.
