Chorka Textiles Ltd.

Kazirchor, Danga, Plash, Narshingdi
(23.896728 90.573490)
04 May 2014

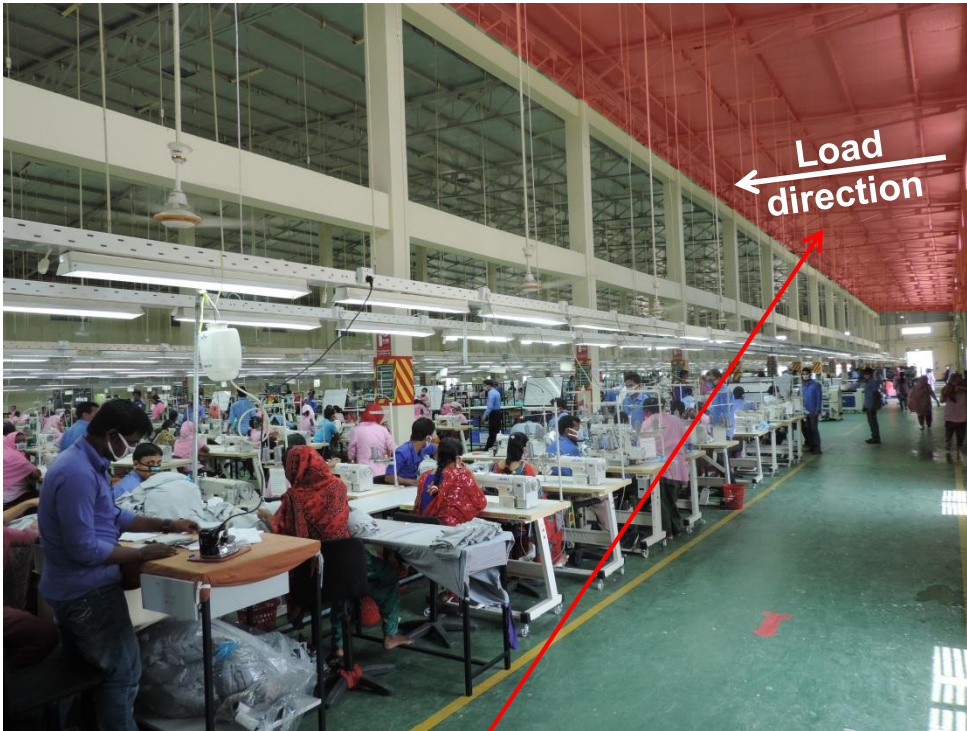
Stability: lack of obvious restraint of typical building frame

- No bracing provided in shaded region.
- Building appears to be unable to resist horizontal load as indicated

- Concrete columns used throughout buildings on compound, with solid masonry façades.
- For Production and generator buildings, internal RC beams are provided in longitudinal direction only.
- No evidence of bracing or moment connections between outer face of building and internal frame in transverse direction.
- It is unclear how the structure can withstand transverse horizontal loading. Of particular concern are Production Buildings 1 and 3, as the height of the perimeter walls is 7m and therefore subject to high wind forces.

| Item No. | Observation | Recommended Action Plan | Recommended Timeline |
|---|--|--|---|
| 4 | The design for lateral loads within Buildings 1 and 3 | Building Engineer to carry out calculations with a model-based design check to assess the safety and serviceability of the building against loading as set out in BNBC-2006, | 6-weeks |
| 5 | The design for lateral loads within Buildings 1 and 3 | Lateral stability of the production buildings to be part of check. | 6-weeks |
| 6 | The design for lateral loads within Buildings 1 and 3 | The lateral stability system to be clearly laid out and member sizes checked for this loading condition. | 6-weeks |
| 7 | The design for lateral loads within Buildings 1 and 3 | Amend building as required from engineering assessment. | 6-months |

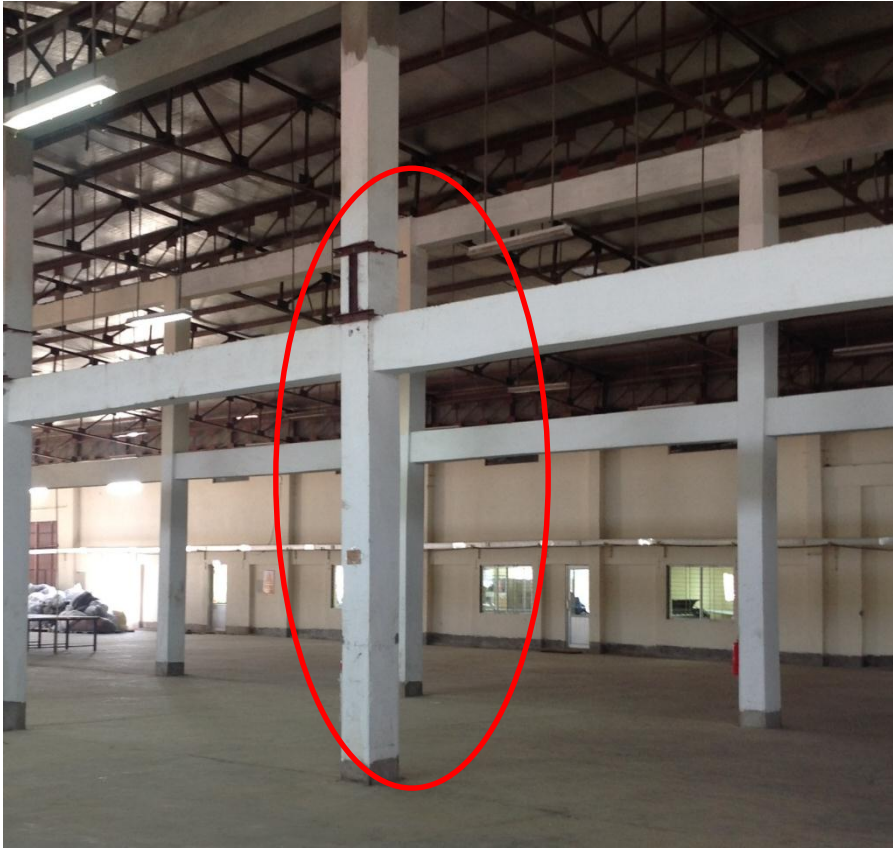
Columns out of plumb in Production buildings

- In several columns in both Production Buildings 1 and 3, columns appeared out of plumb. This was also visible in the façade on the eastern face of Building 3.
- This could be due to poor workmanship when the building was being constructed, or due to settlement of the foundations.

| Item No. | Observation | Recommended Action Plan | Recommended Timeline |
|---|---|--|---|
| 13 | Concrete internal columns noted off-plumb in production buildings | Building Engineer to investigate the cause and impact of the internal off-plumb RC columns. | 6-weeks |
| 14 | Concrete internal columns noted off-plumb in production buildings | Carry out remedial works as required by engineering investigation. | 6-months |

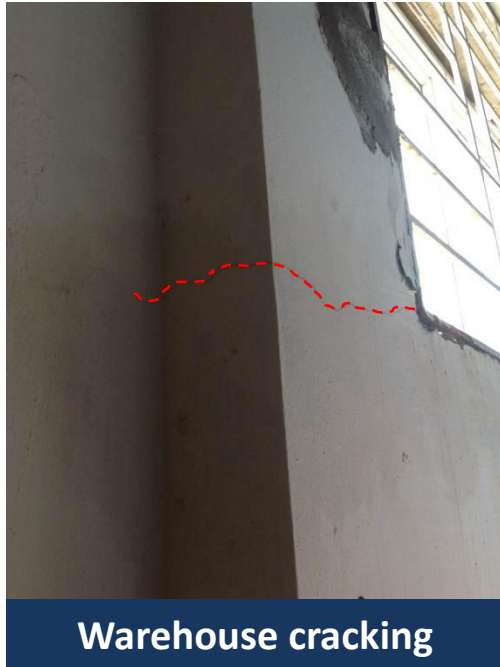
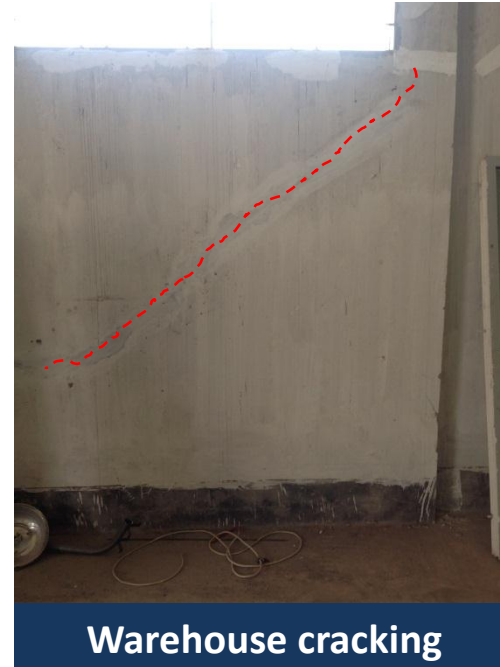
Cracking in Warehouse and Facility Buildings

- In the warehouse building, cracking was observed at the bottom corner of each of the windows on ground floor.
- A diagonal crack was also noticed on the inside of one of the wall panels on the northern side of the building.
- Some hairline cracking was noticed on the walls of the facility building.
- This cracking appeared from visual inspection to be due to settlement.

| Item No. | Observation | Recommended Action Plan | Recommended Timeline |
|---|---|--|---|
| 11 | Cracking noted in the wall panels of the warehouse | Building Engineer to investigate wall panel cracking noted in the warehouse building. | 6-weeks |
| 12 | Cracking noted in the wall panels of the warehouse | Carry out any remedial / strengthening works following engineering investigation. | 6-months |

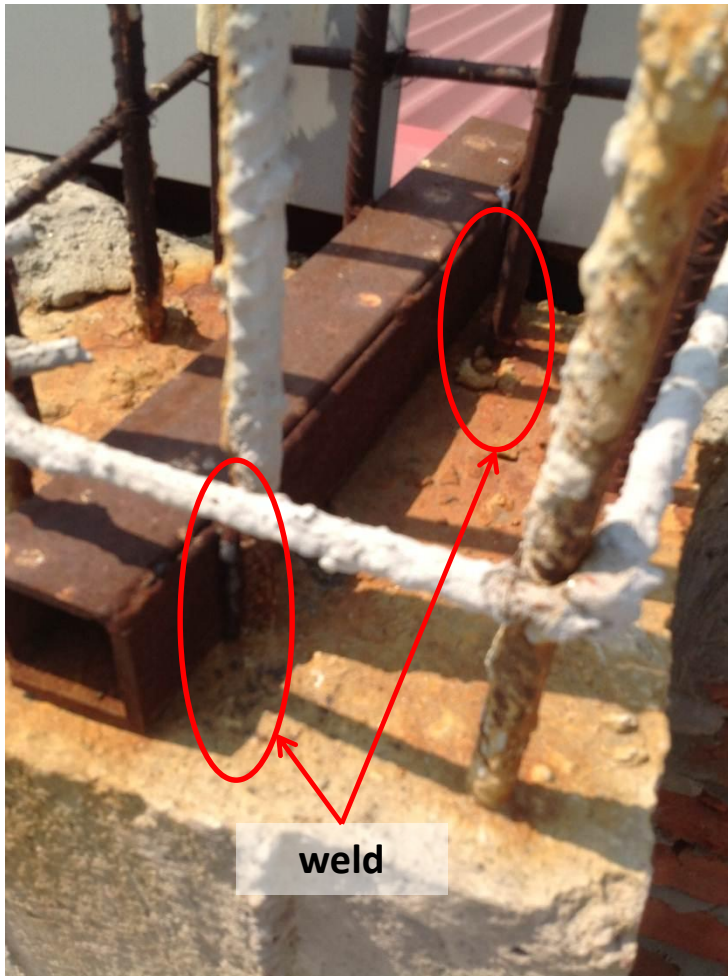
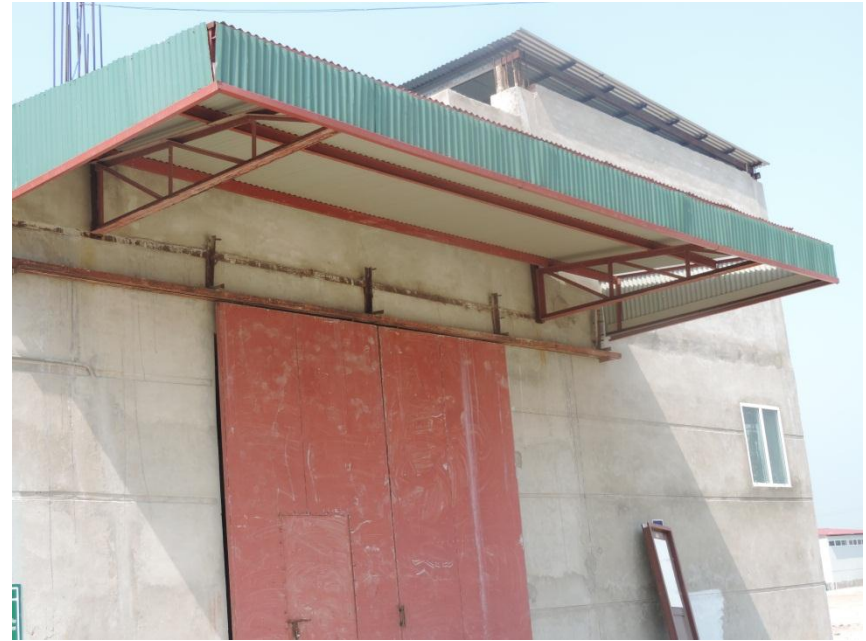
Anchorage of canopies in warehouse

Canopy bracket welded to rebar

- Metal canopies over each of the loading bays in the warehouse.
- Supporting trusses hung from the top where a bracket extended into the building column and was welded to the exposed rebar.
- This support mechanism is inadequate and could be unstable under wind loading/uplift

| Item No. | Observation | Recommended Action Plan | Recommended Timeline |
|---|---|--|---|
| 17 | Canopy Fixings in the warehouse not properly engineered | The canopy fixings to the warehouse building have not been properly engineered. Building Engineer to review and make recommendations | 6-weeks |
| 18 | Canopy Fixings in the warehouse not properly engineered | Carry out the above works | 6-months |

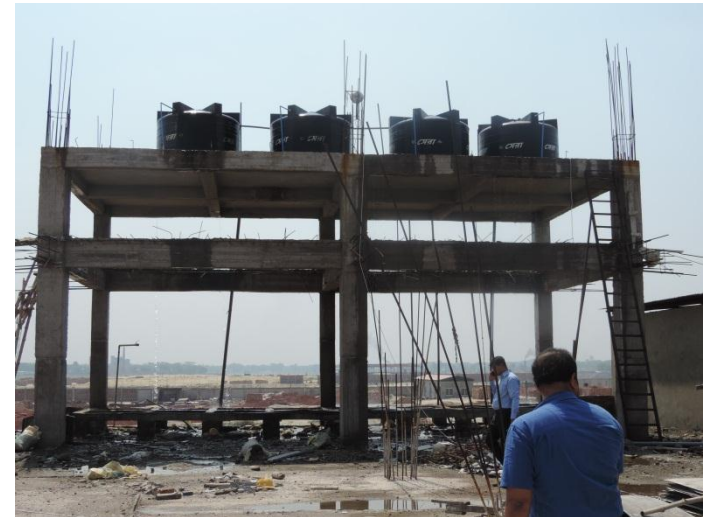
Water tanks on warehouse

- Four 10,000 litre water tanks on the roof of the warehouse.
- Building Owner advised that in the future this capacity was to increase to 60,000 litres.
- Structural drawings show six 5,000 litres tanks.
- Column head on gridline A1-01 has 9 bars, where the drawing calls for 12 bars.
- Services mast was observed on the roof of toilet block on the southern side of Production Unit 1. This was not present on any of the drawings.

| Item No. | Observation | Recommended Action Plan | Recommended Timeline |
|---|---|--|---|
| 10 | Documents do not match the as-built in the Warehouse, or show Masts | Building Engineer to survey and amend drawings to include alterations to warehouse and additional structures such as the two masts. | 6-weeks |

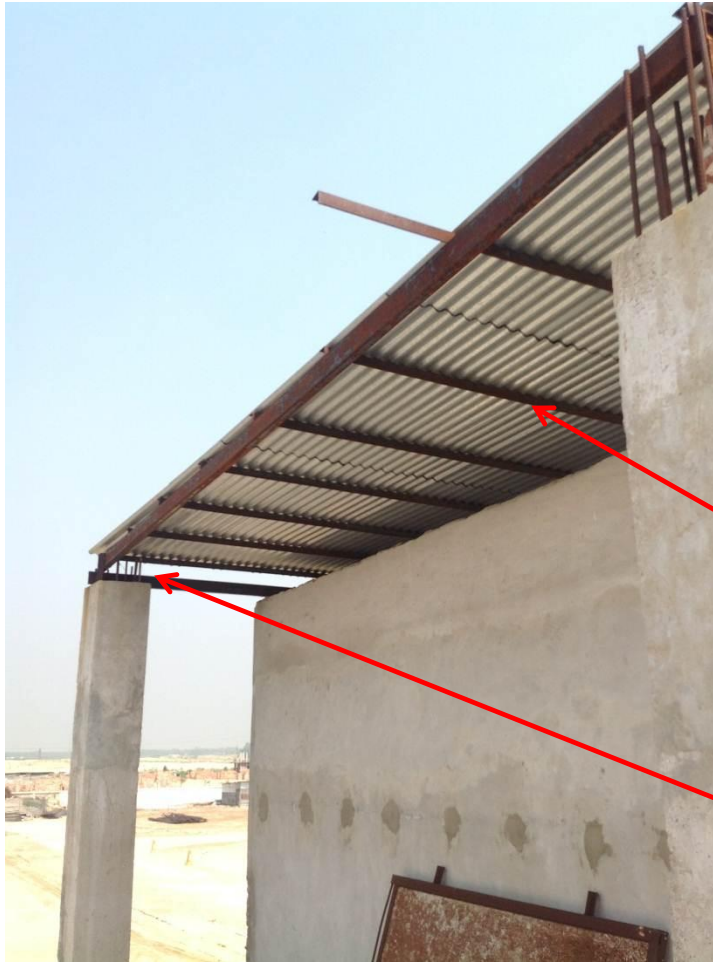
Non-engineered roof over stairwells in warehouse

A light metal roof was provided over each of the stairwells in the warehouse building. These appeared to be light and non-engineered.

Light section sizes used as purlins

Roof structure welded to exposed rebar in columns

| Item No. | Observation | Recommended Action Plan | Recommended Timeline |
|---|---|--|---|
| 15 | Non-engineered roofs to the stair wells of the warehouse and over the water treatment plant | The roofs to the stair wells in the warehouse and the roof over the Water treatment plant to be assessed by Building Engineer. | 6-weeks |
| 16 | Non-engineered roofs to the stair wells of the warehouse and over the water treatment plant | Implement actions arising from assessment. | 6-months |

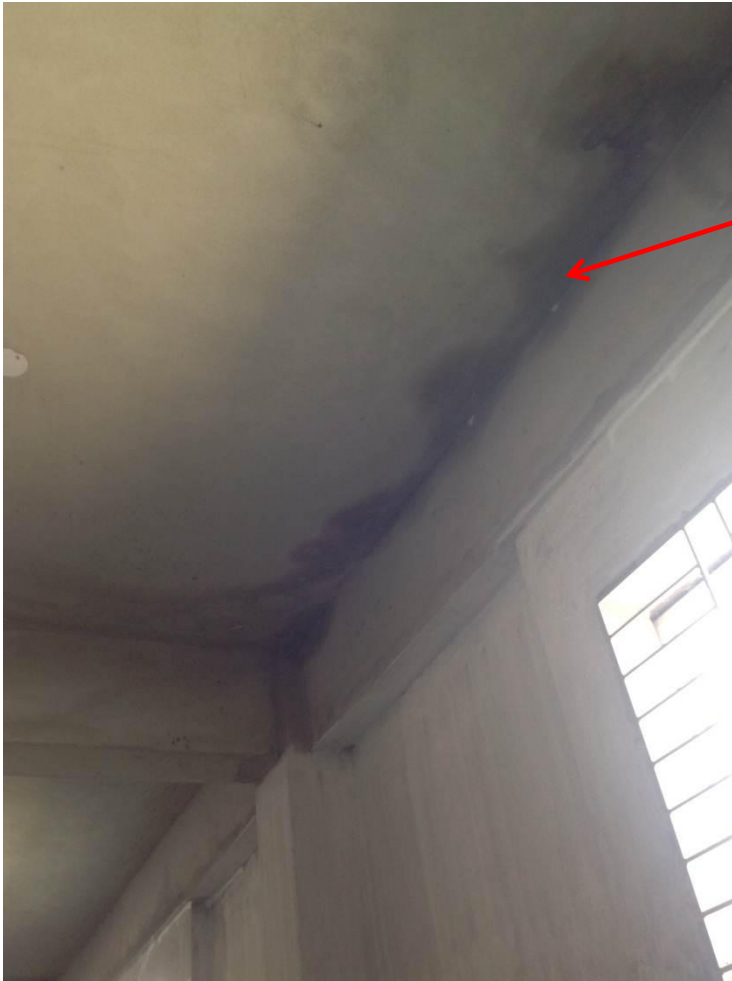
Water damage in soffit of 1st floor below water tanks in warehouse

Water staining

- Under the water tank locations, staining of the soffit of the 1st floor beam was evident.
- During our inspection, there was a significant leak in these tanks. The building owner was notified of this leak and ensured us that this would be rectified.

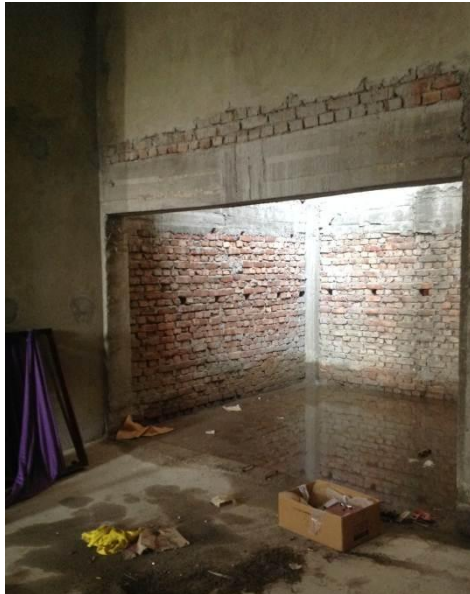
Lift shaft opening

- The lift shaft on ground floor was left open. This should be blocked off.
- The stair well was not closed off. Only authorised staff should be allowed to the roof.
- No edge protection around perimeter of 1st floor.

These observations should be acted upon immediately.

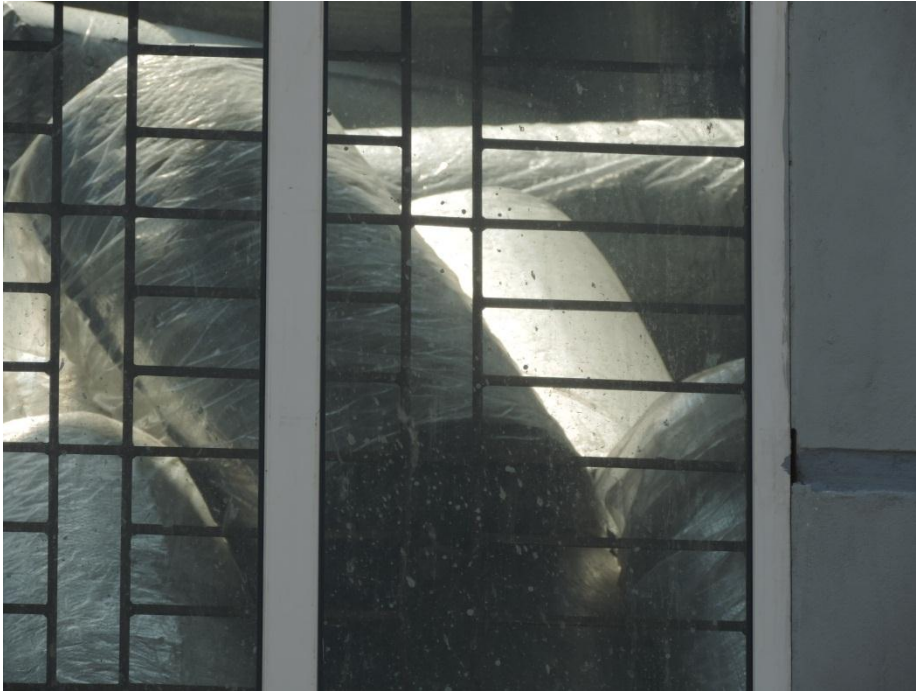
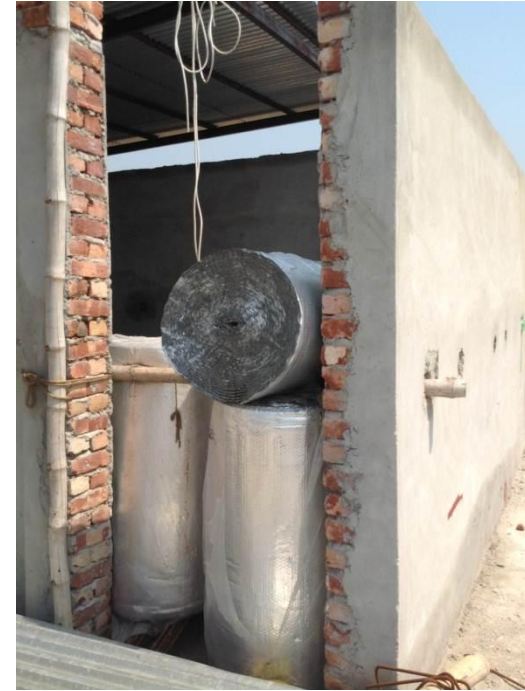
Storage in eastern stairwell of warehouse

The stairwell on the northern side of the warehouse building is used for construction material storage.

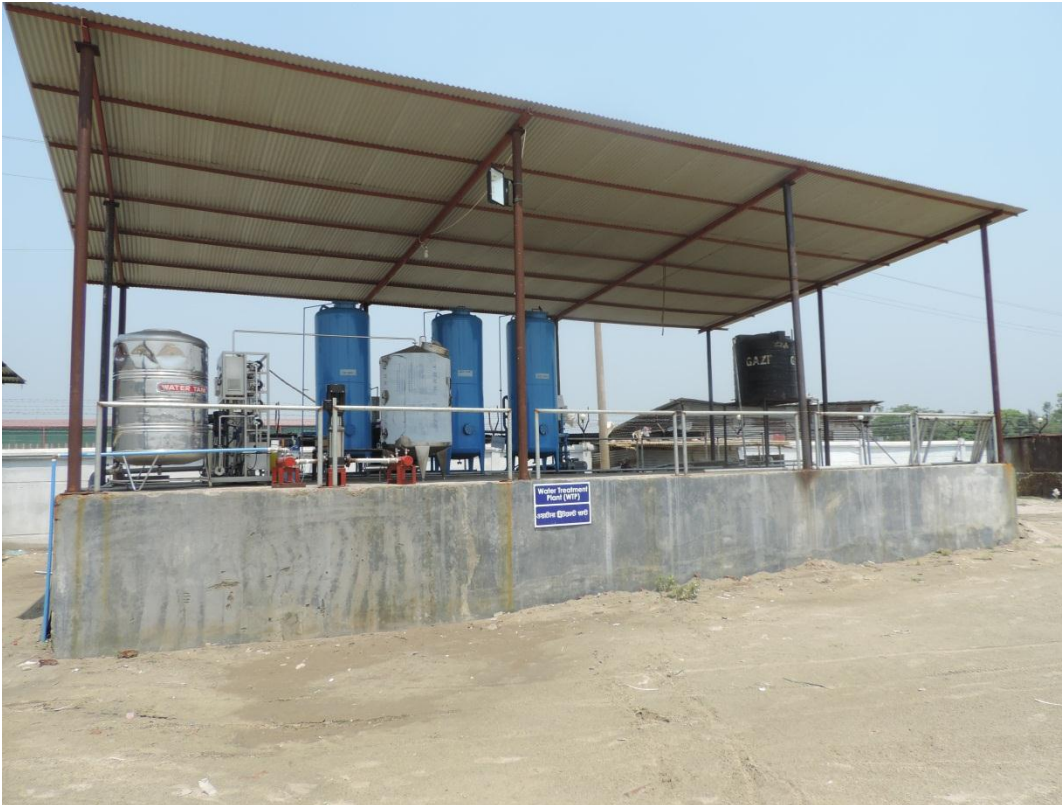
Non-engineered roof over water treatment plant

A roof covering the water treatment plant appears to be non-engineered. The main issues observed are:

- No bracing provided to the structure.
- Structure does not appear to be designed to withstand wind load.
- Section sizes appear to be light.

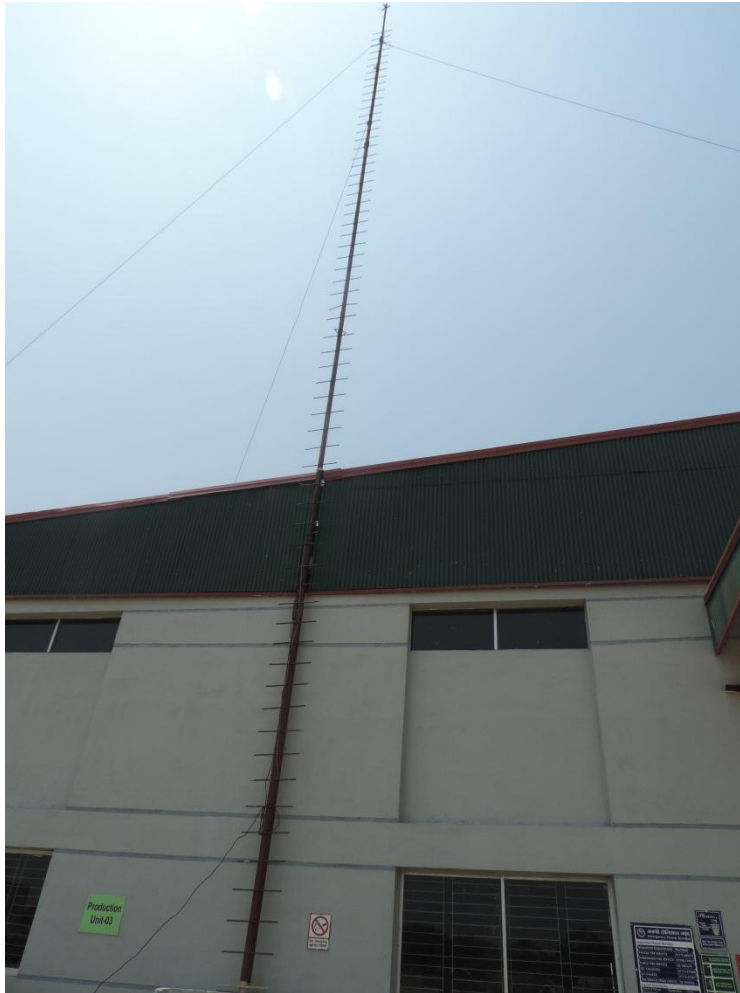
Radio mast is unsecure

- The radio mast located on the Northern side of Production Building 3 is unstable.
- Three cables are currently in place but offer no structural support in their current state.

This mast requires urgent attention.

| Item No. | Observation | Recommended Action Plan | Recommended Timeline |
|---|--|--|---|
| 1 | The telecoms mast at the front of Building 3 to be made safe | The telecoms mast is currently un-restrained. Mast to be restrained/stayed or taken down immediately, stayed system to be engineered prior to placement. | Immediate - Now |
| 2 | The telecoms mast at the front of Building 3 to be made safe | Permit to be sought for mast | 6-weeks |
