# Asrotex

Dharmaganj, Enayetnagar, Fatullah, Narayanganj  
(90.46031E, 23.62652N)  
17 June 2014

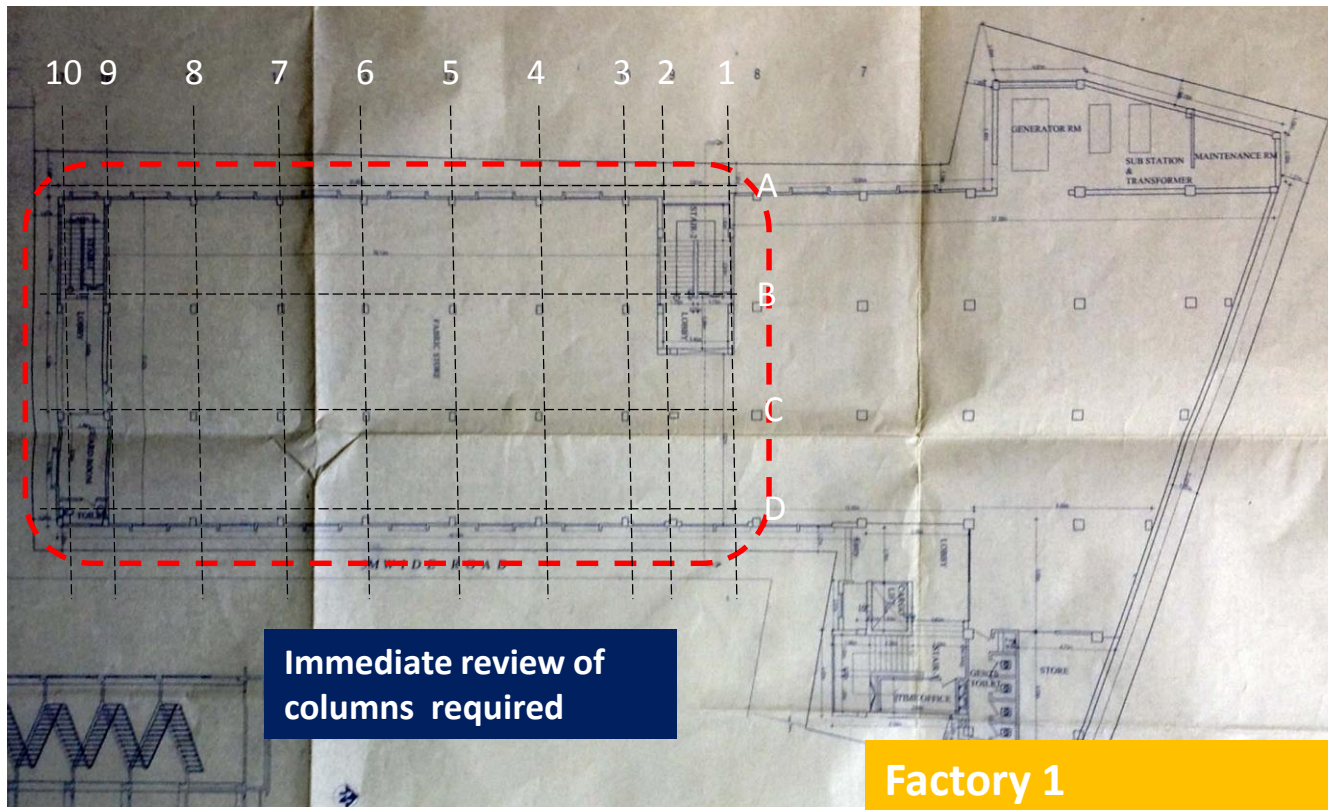
**Columns appear to be stressed to levels  
that require immediate review**

Preliminary calculations suggest that columns are stressed to levels that require immediate review in Factory 1

| Item No. | Observation | Recommended Action Plan | Recommended Timeline |
|---|---|---|---|
| 1 | Factory 1 Columns appear to be stressed to levels that require immediate review<br>Cantilever section of Factory 1 not indicated on permit drawings | Existing loading intensity on all floors is to be maintained or reduced. | <b>Immediate - Now</b> |
| 2 | Factory 1 Columns appear to be stressed to levels that require immediate review<br>Cantilever section of Factory 1 not indicated on permit drawings | Factory Engineer to review design, loads and column stresses for all columns. | <b>Immediate - Now</b> |
| 3 | Factory 1 Columns appear to be stressed to levels that require immediate review<br>Cantilever section of Factory 1 not indicated on permit drawings | Verify insitu concrete strength using min. 4 no. 100mm dia. Cores taken from the ground floor columns (or existing cylinder strength data if available for 4 column locations). | <b>Immediate - Now</b> |
| 4 | Factory 1 Columns appear to be stressed to levels that require immediate review<br>Cantilever section of Factory 1 not indicated on permit drawings | Verify existing reinforcement (steel grade, bar diameter and spacing) in columns. | <b>Immediate - Now</b> |
| 5 | Factory 1 Columns appear to be stressed to levels that require immediate review<br>Cantilever section of Factory 1 not indicated on permit drawings | A Detailed Engineering Assessment of factory to be commenced, see attached scope | <b>Immediate - Now</b> |

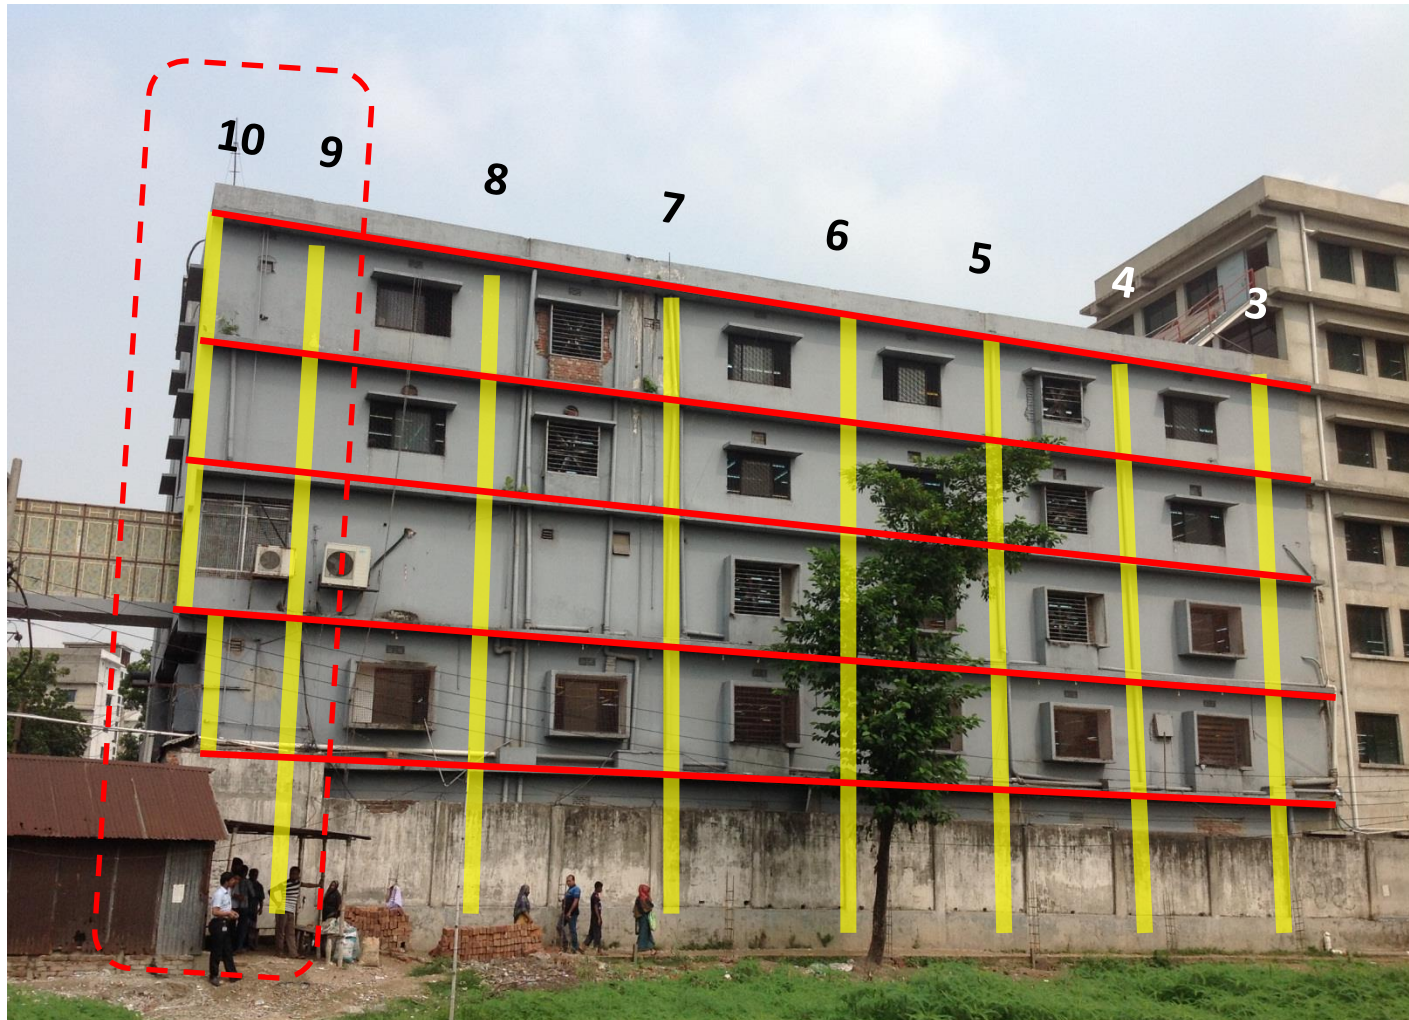
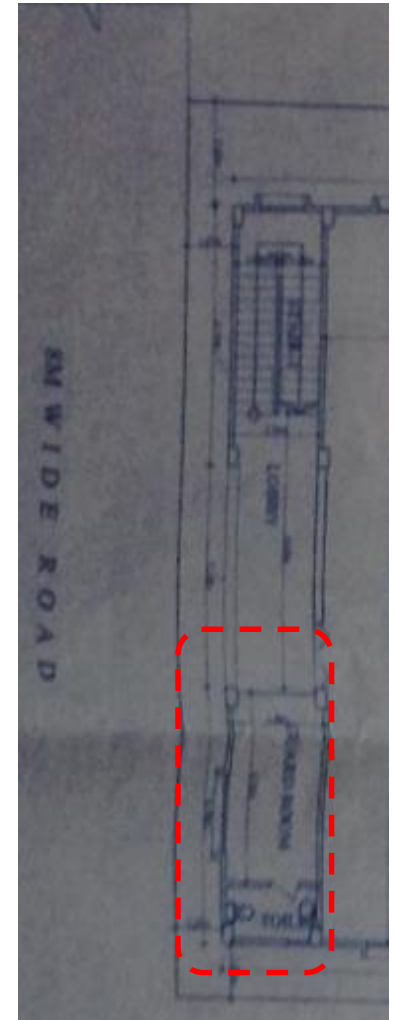
Construction Permit Drawing provided

**Cantilever section of Factory 1 not indicated on permit drawings**

Columns C/10 and D/10 do not extend to ground and are supported on cantilever beams at first and second floors – this is not shown on the construction permit drawings

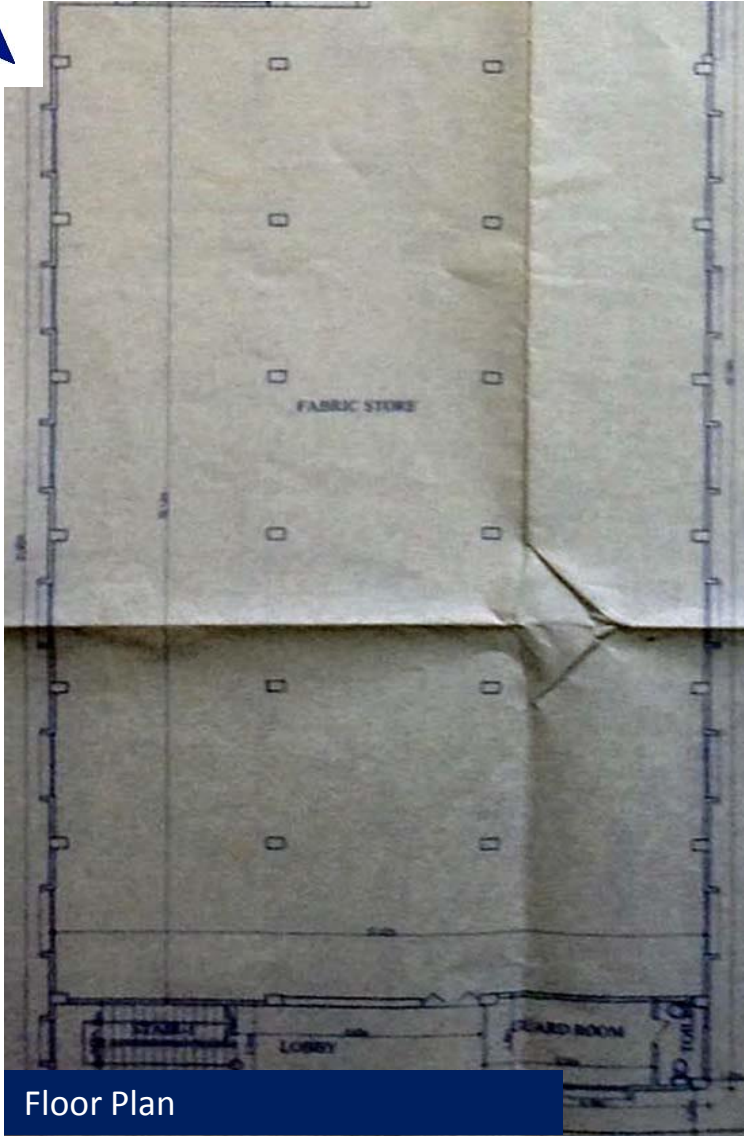
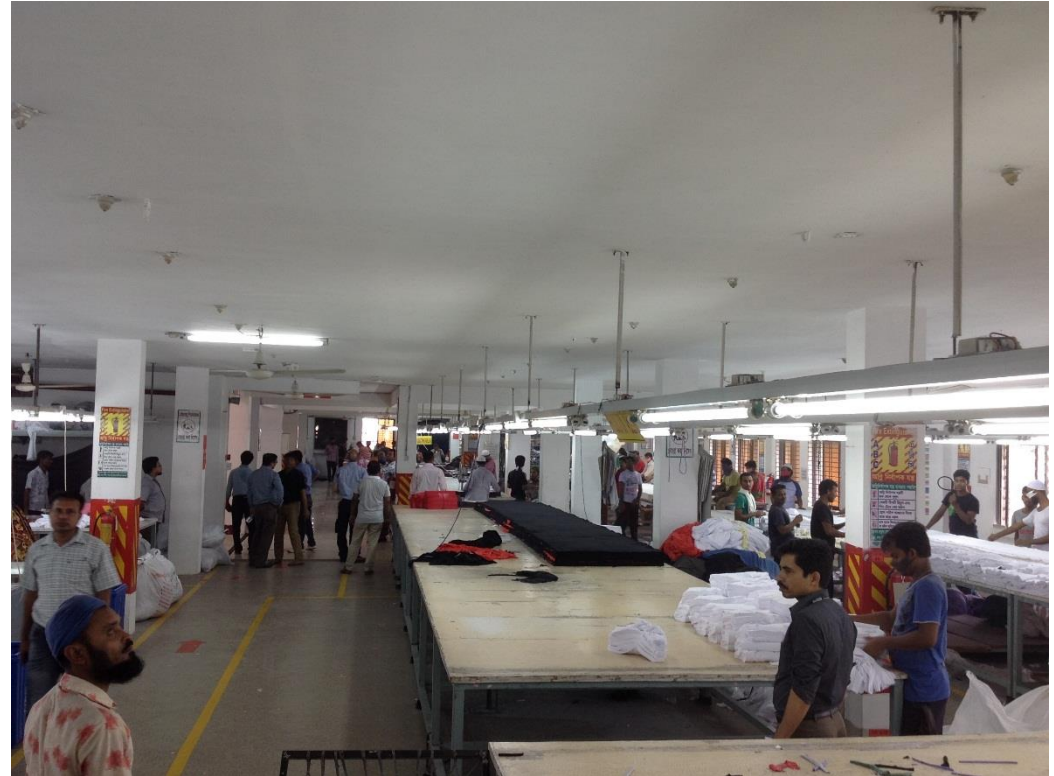
Floor Plan

## Flat slab to 5<sup>th</sup> floor of Factory 1

Moment frame stability system (column/beam) does not extend to top of building.

No punching shear reinforcement indicated on structural drawings provided

| Item No. | Observation | Recommended Action Plan | Recommended Timeline |
|---|---|---|---|
| 10 | Flat slab to 5th floor of Factory 1<br>Calculations indicate high punching shear stresses in suspended slab | A Detail Engineering Assessment of the building to be commenced, see attached Scope | <b>Immediate - Now</b> |

| Item No. | Observation | Recommended Action Plan | Recommended Timeline |
|---|---|---|---|
| 11 | Flat slab to 5th floor of Factory 1<br>Calculations indicate high punching shear stresses in suspended slab | Factory Engineer to review design, loads and punching shear stresses in slab. | <b>6-weeks</b> |
| 12 | Flat slab to 5th floor of Factory 1<br>Calculations indicate high punching shear stresses in suspended slab | Verify insitu concrete strengths (using minimum of 4 No. 100mm dia. cores taken from slabs). Verify existing reinforcement (steel grade, bar diameter and spacing) in slabs. | <b>6-weeks</b> |

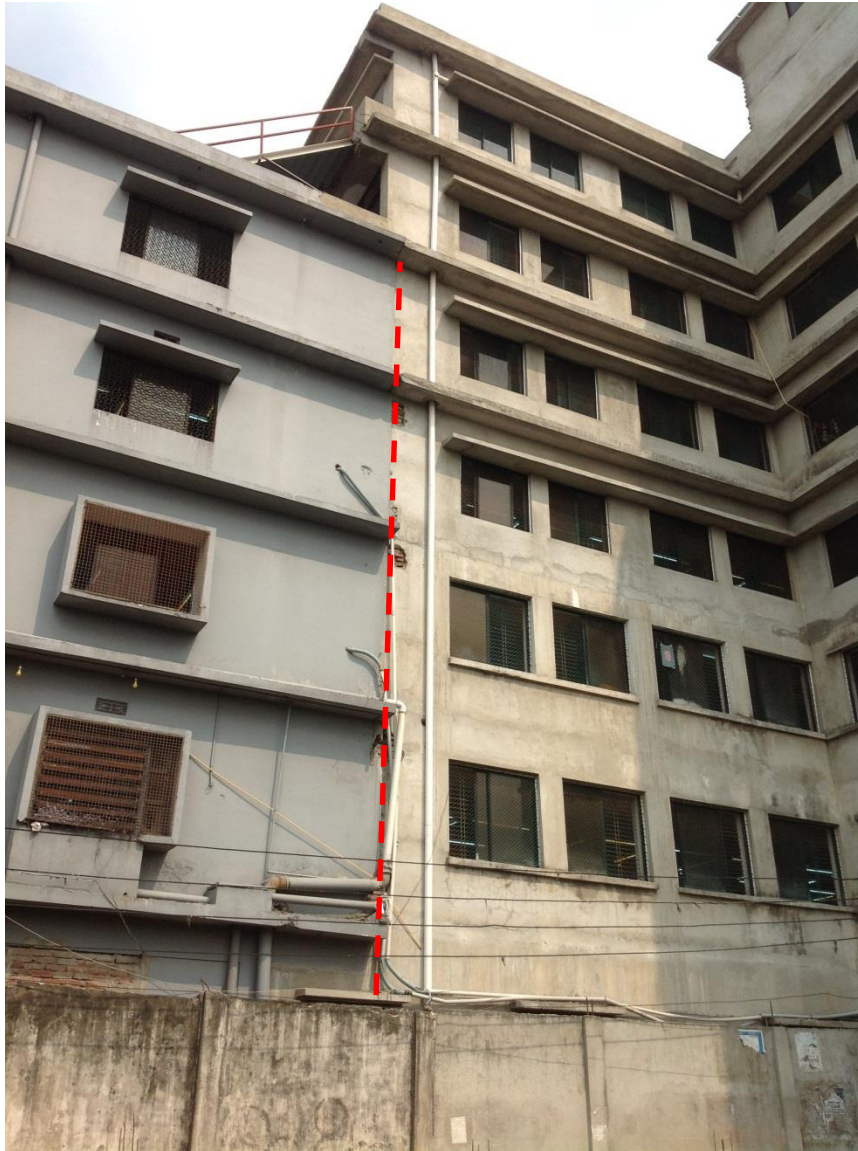
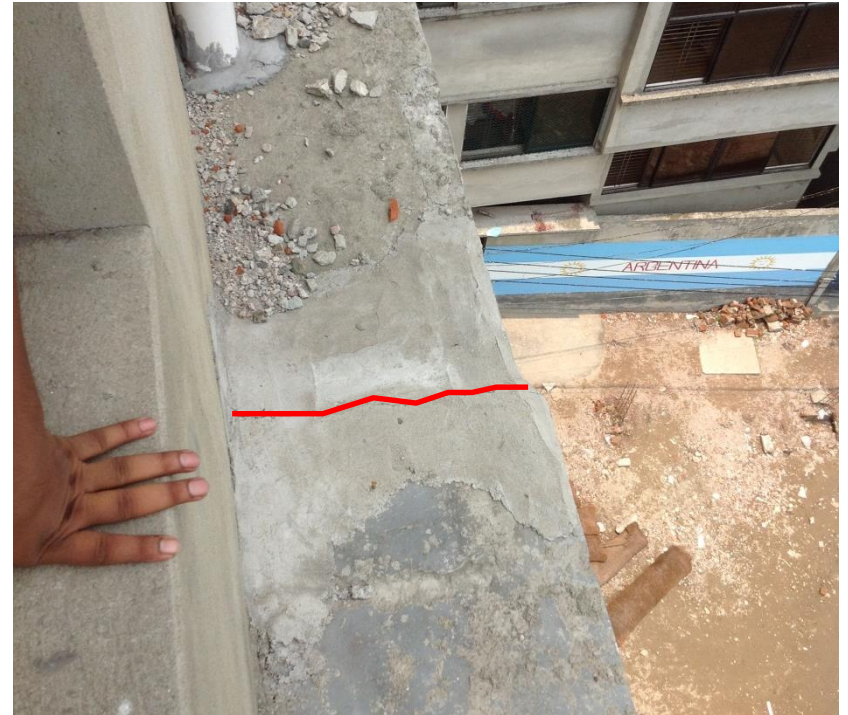
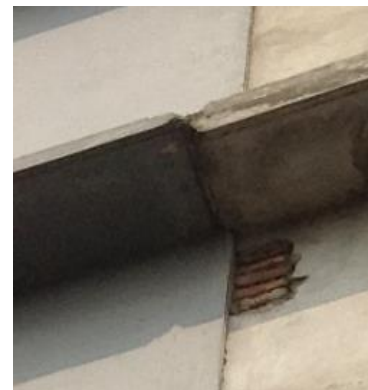
**Movement joint between Factory 1 and  
Factory 2 buildings is stitched across**

Factory 1 and 2 appear to have been built with no expansion joint. At 6<sup>th</sup> and 7<sup>th</sup> floors, Factory 2 is built across the connection line between the 2 buildings below

| Item No. | Observation | Recommended Action Plan | Recommended Timeline |
|---|---|---|---|
| 15 | Movement joint between Factory 1 and Factory 2 buildings is stitched across | Factory Engineer to assess the connectivity of Factory 1 and Factory 2 and the impact on their stability systems | 6-weeks |
| 16 | Movement joint between Factory 1 and Factory 2 buildings is stitched across | Carry out ant structural alterations and waterproofing repairs as advised by the Structural Engineer. | 6-months |

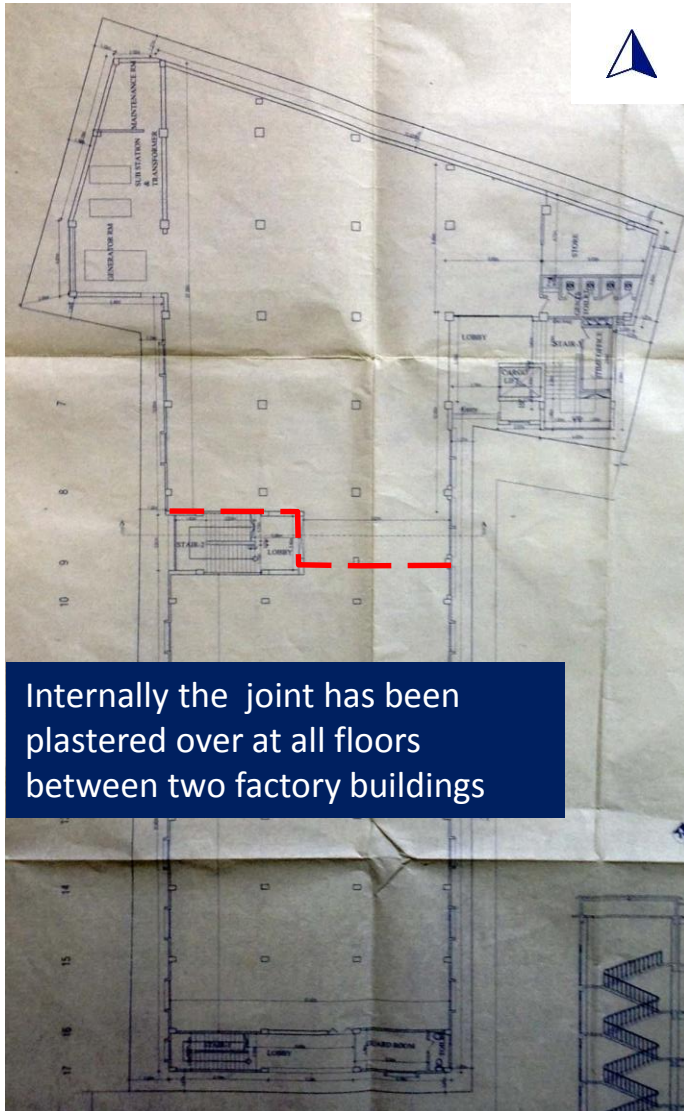
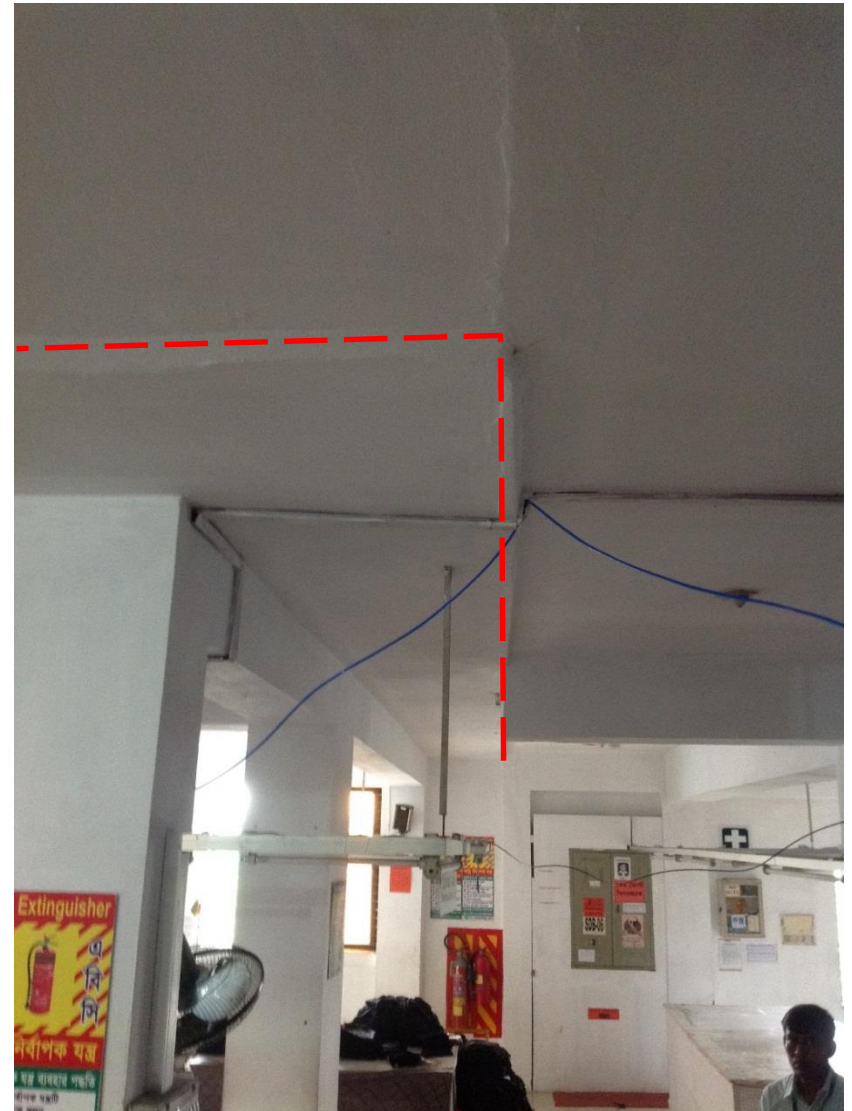
Internally the joint has been plastered over at all floors between two factory buildings

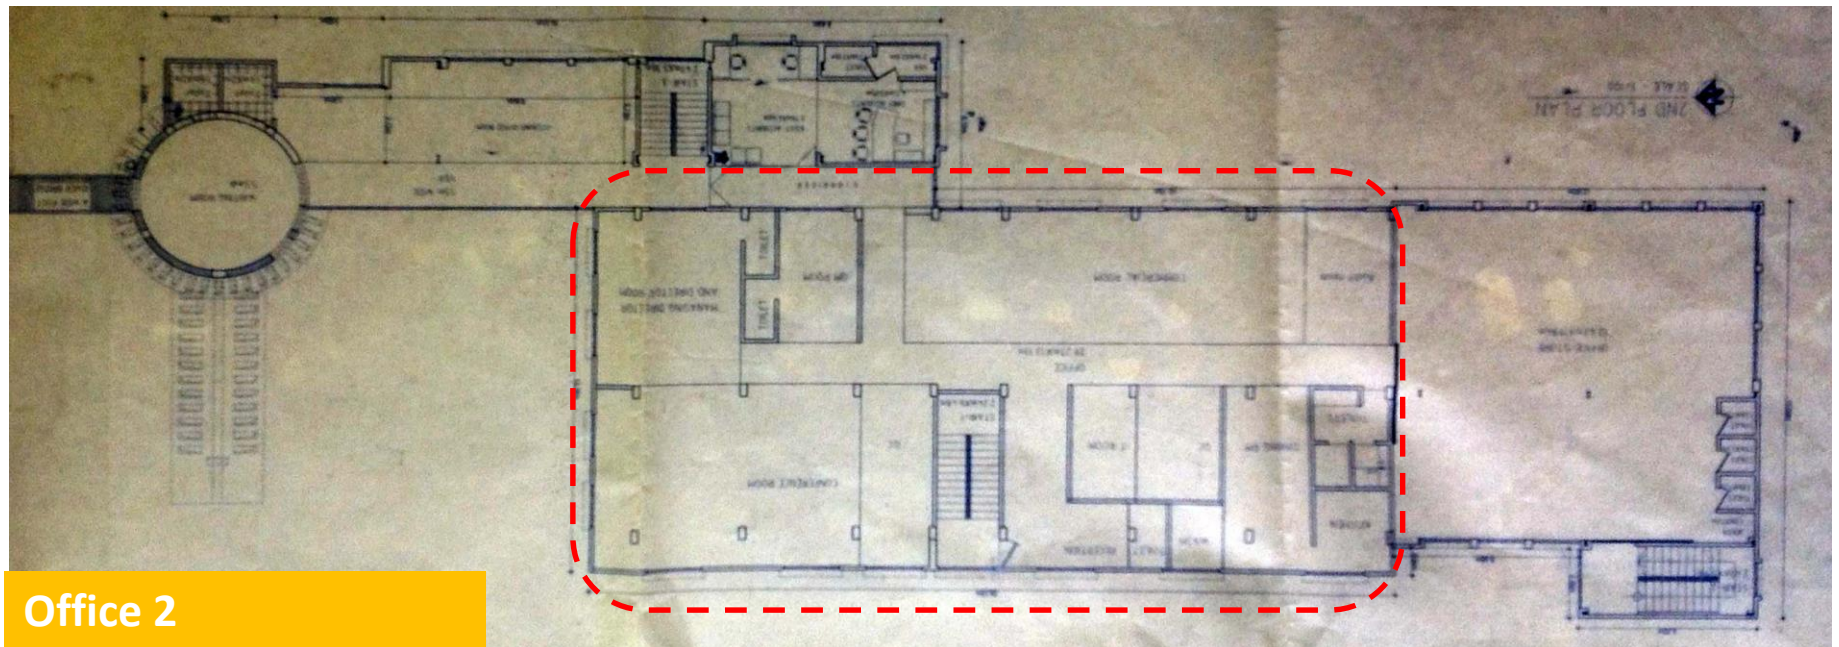
**Columns appear to be stressed to levels  
that require review**

Preliminary calculations suggest that all columns are stressed to levels that require further review in Office 2

| Item No. | Observation | Recommended Action Plan | Recommended Timeline |
|---|---|---|---|
| 17 | Office 2 Columns appear to be stressed to levels that require review<br>Uncontrolled Storage Loads in Office 2 | Building Engineer to review design, loads and stresses in all columns. | 6-weeks |
| 18 | Office 2 Columns appear to be stressed to levels that require review<br>Uncontrolled Storage Loads in Office 2 | Building Engineer to verify insitu concrete strength by taking 100mm diameter cores from 4 columns. | 6-weeks |
| 19 | Office 2 Columns appear to be stressed to levels that require review<br>Uncontrolled Storage Loads in Office 2 | Building Engineer to verify grade of steel reinforcement and no. and diameter of main column bars. | 6-weeks |

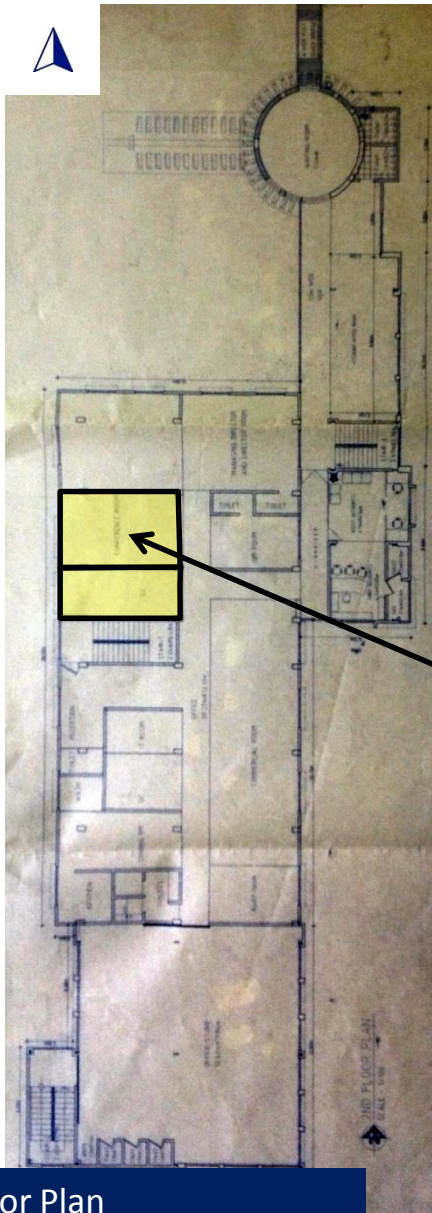
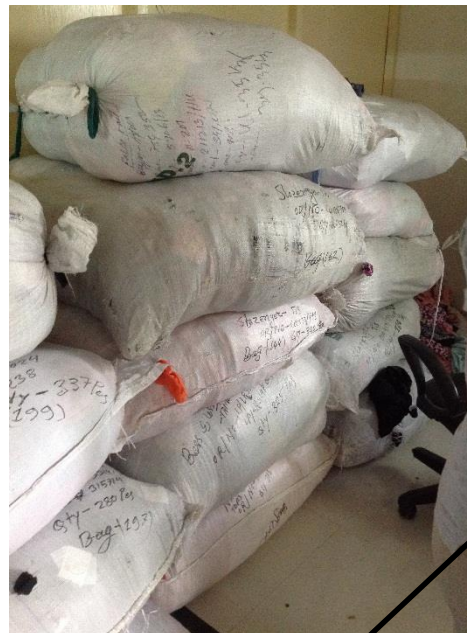
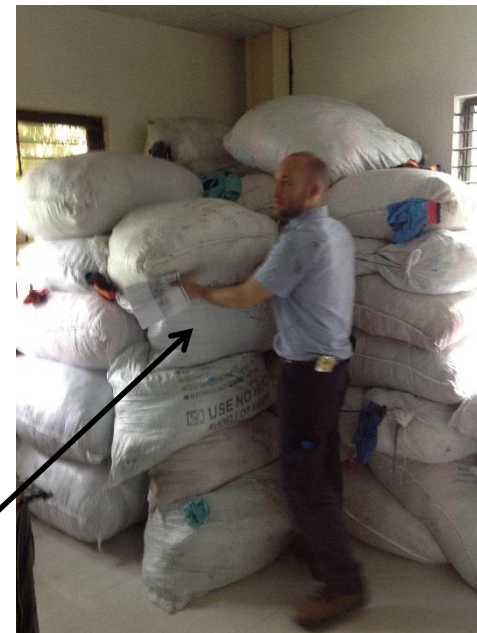
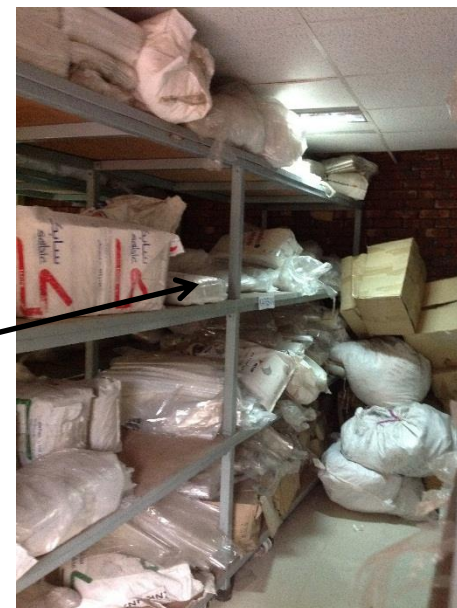
Floor Plan

## Uncontrolled Storage Loads in Office 2

2m high bags of fabric off-cuts =  
3.6kPa approx.

| Item No. | Observation | Recommended Action Plan | Recommended Timeline |
|---|---|---|---|
| 20 | Office 2 Columns appear to be stressed to levels that require review<br>Uncontrolled Storage Loads in Office 2 | Produce and actively manage a loading plan for all floor plates within the factory giving consideration to floor capacity and column capacity | 6-weeks |

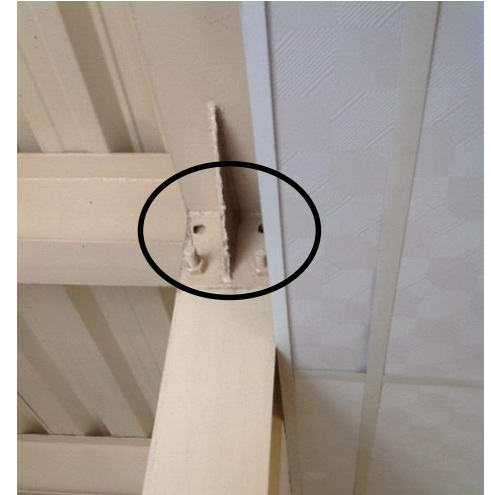
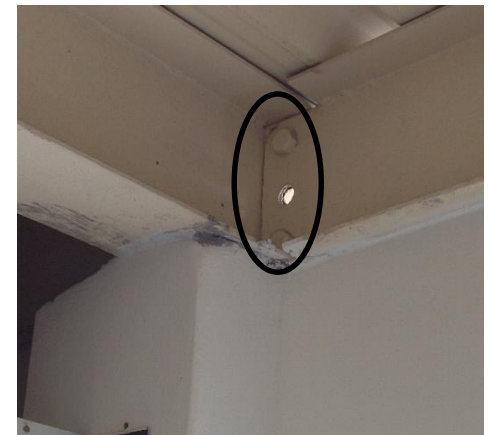
Steel-concrete connections in Office 3  
(1<sup>st</sup> Floor slab, near entrance)

Beam web has been cut back before it reaches the supporting RC wall

Steel-concrete connection detail unknown – reportedly the concrete was broken out locally and rebar exposed, with end plate welded direct to rebar

Missing bolts observed in Office 3

| Item No. | Observation | Recommended Action Plan | Recommended Timeline |
|---|---|---|---|
| 23 | Deficiencies observed to steelwork connections in the Office buildings | Building Engineer to inspect the steel connections and advise on any necessary remedial actions. | 6-months |

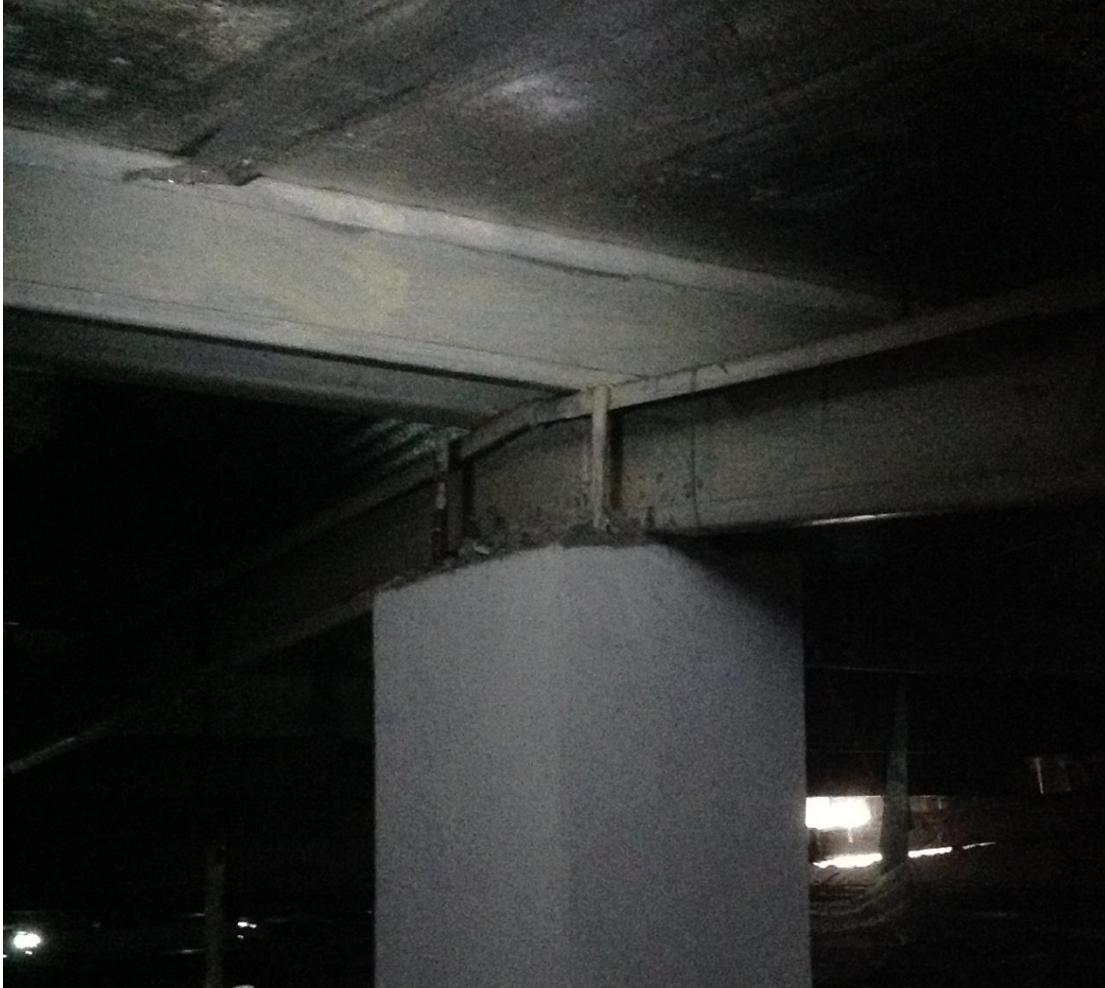
Steel deck roof to Office 2 appears inadequately tied down to the main structure

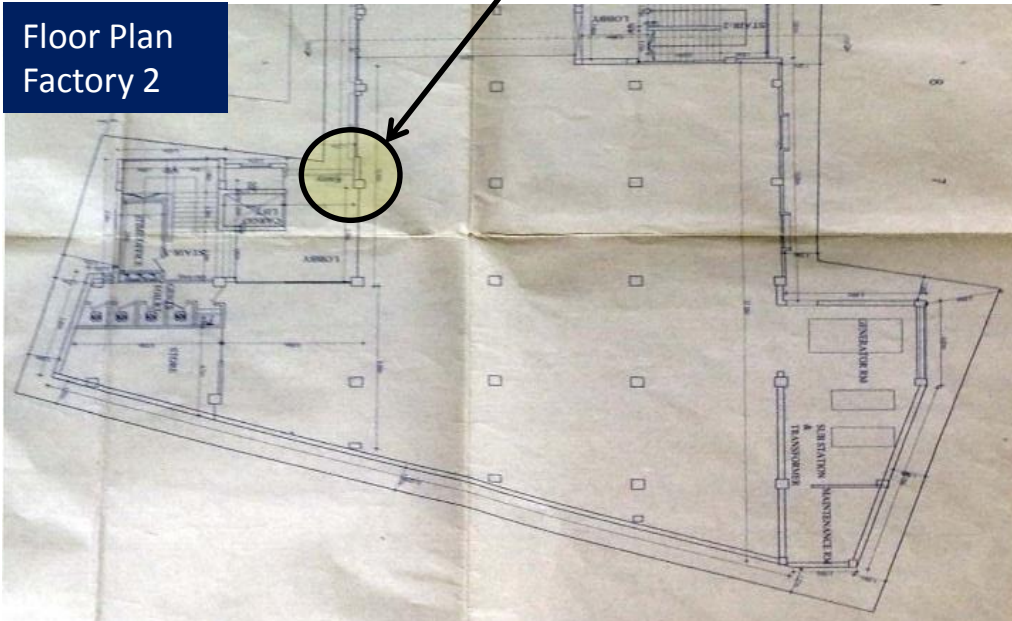
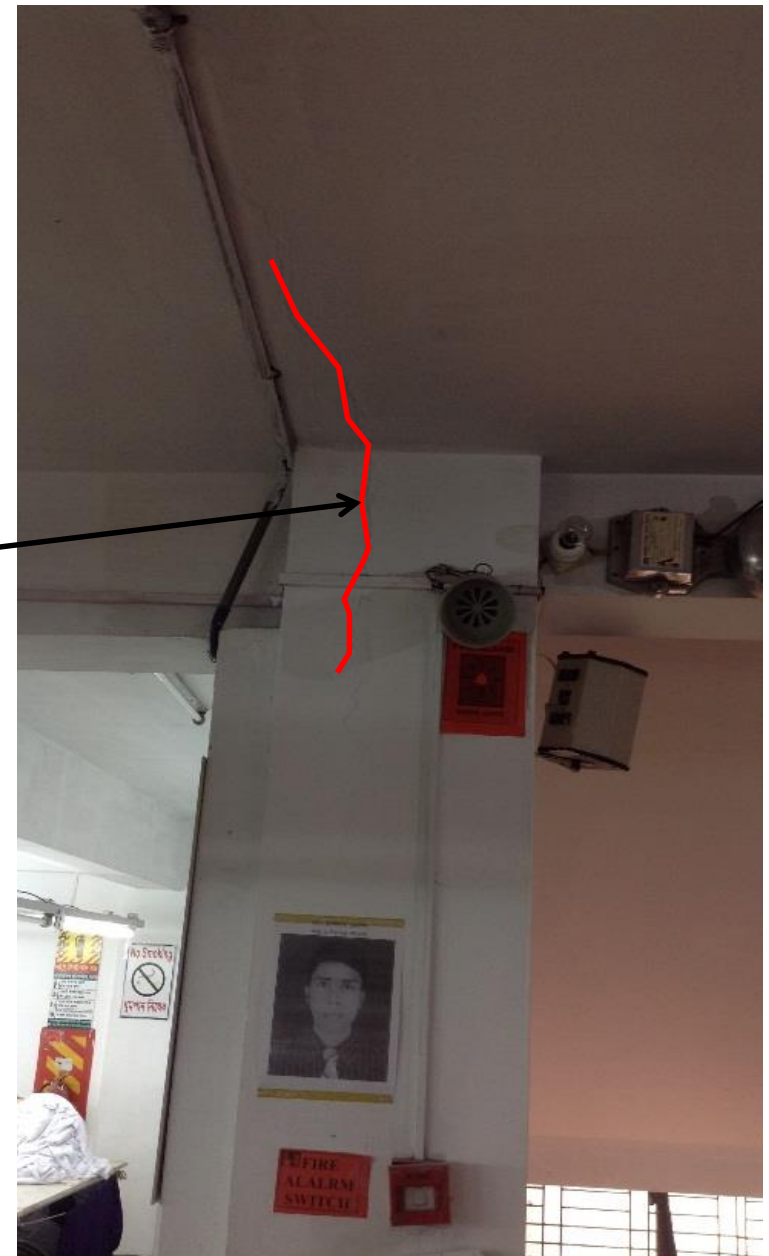
Floor Plan  
Factory 2

Crack in the column under the beam requires review

| Item No. | Observation | Recommended Action Plan | Recommended Timeline |
|---|---|---|---|
| 24 | Cracks to internal RC columns<br>Factory 2 and Office 2 | Sections of plaster finish to columns to be removed to investigate if cracks penetrate the building structure. | 6-weeks |
| 25 | Cracks to internal RC columns<br>Factory 2 and Office 2 | Building Engineer to review design of elements to confirm if cracks are structural | 6-months |
| 26 | Cracks to internal RC columns<br>Factory 2 and Office 2 | Cracks in structural members to be repaired as necessary | 6-months |

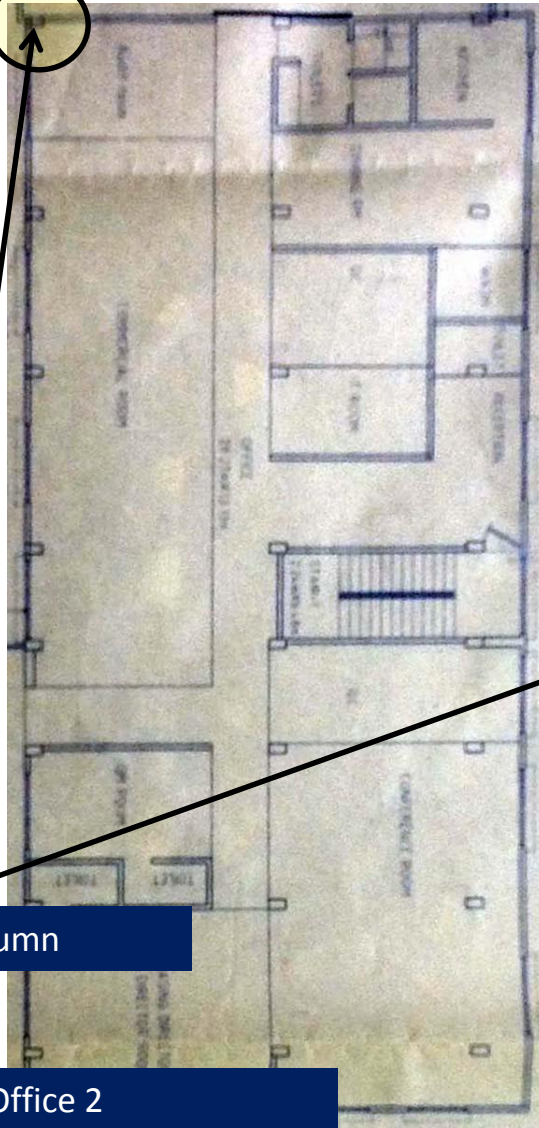
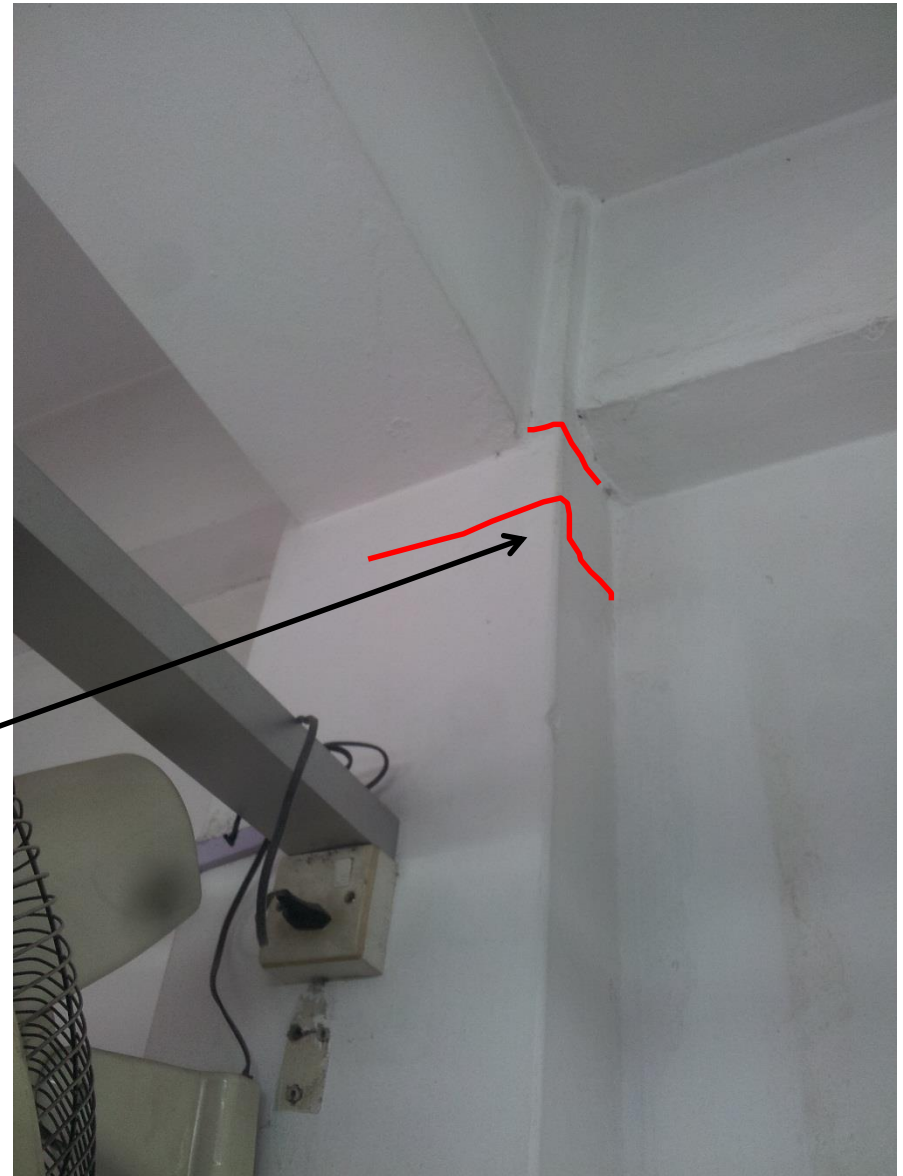
Floor Plan – Office 2

Crack in the corner column

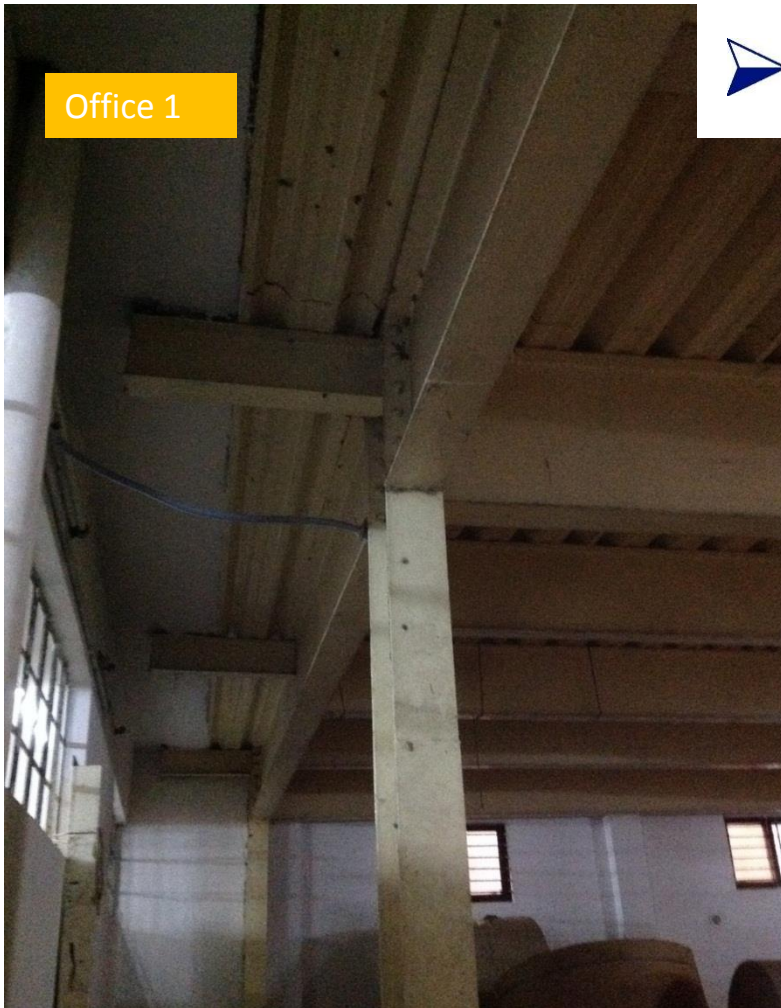
**No distinct lateral stability system in  
Office 1 and Office 3**

No vertical bracing was found in Office 1 steel structure. Composite decks assumed to act as diaphragms but connectivity to beams is unknown

| Item No. | Observation | Recommended Action Plan | Recommended Timeline |
|---|---|---|---|
| 27 | No apparent distinct lateral stability system in Office 1 and Office 3 | Structural Engineer to carry out a full stability analysis of the Office buildings | 6-months |
| 28 | No apparent distinct lateral stability system in Office 1 and Office 3 | Any retrofitting or strengthening to be carried out as directed by the Structural Engineer. | 6-months |

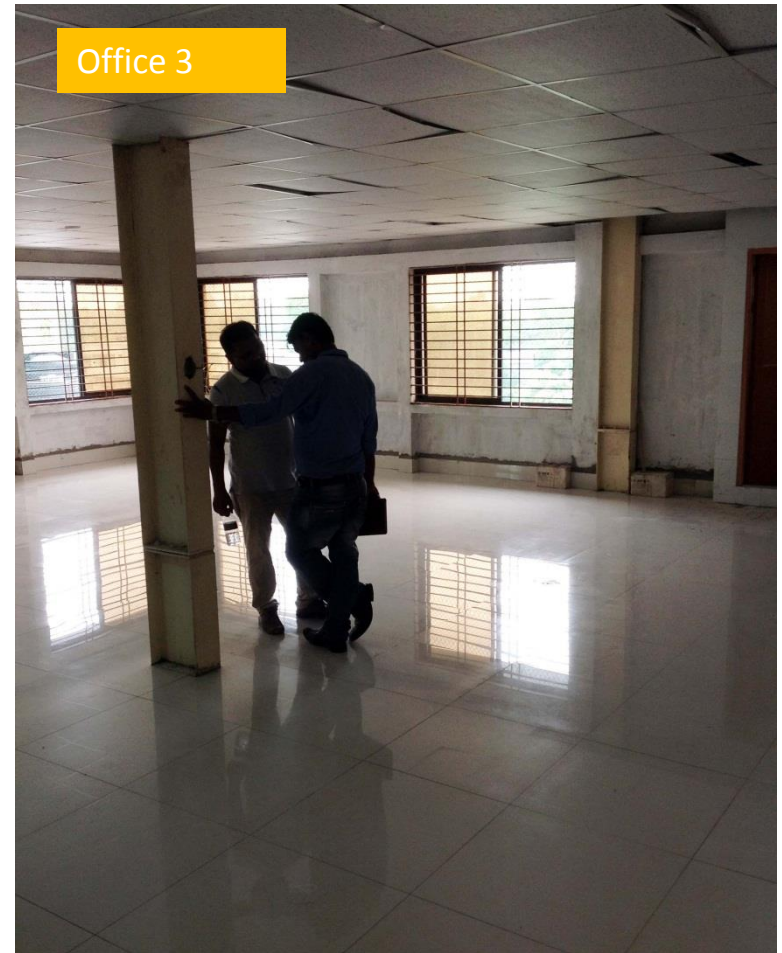
Office 3

Simple connections and slender (minor axis) columns suggests the building is not a moment frame. Large window openings in perimeter walls
