AKH Stitch Art Ltd.

Chandanpur, Rajfulbariya, Hemayetpur, Savar, Dhaka, 1340.

07 May 2014

Building Observations

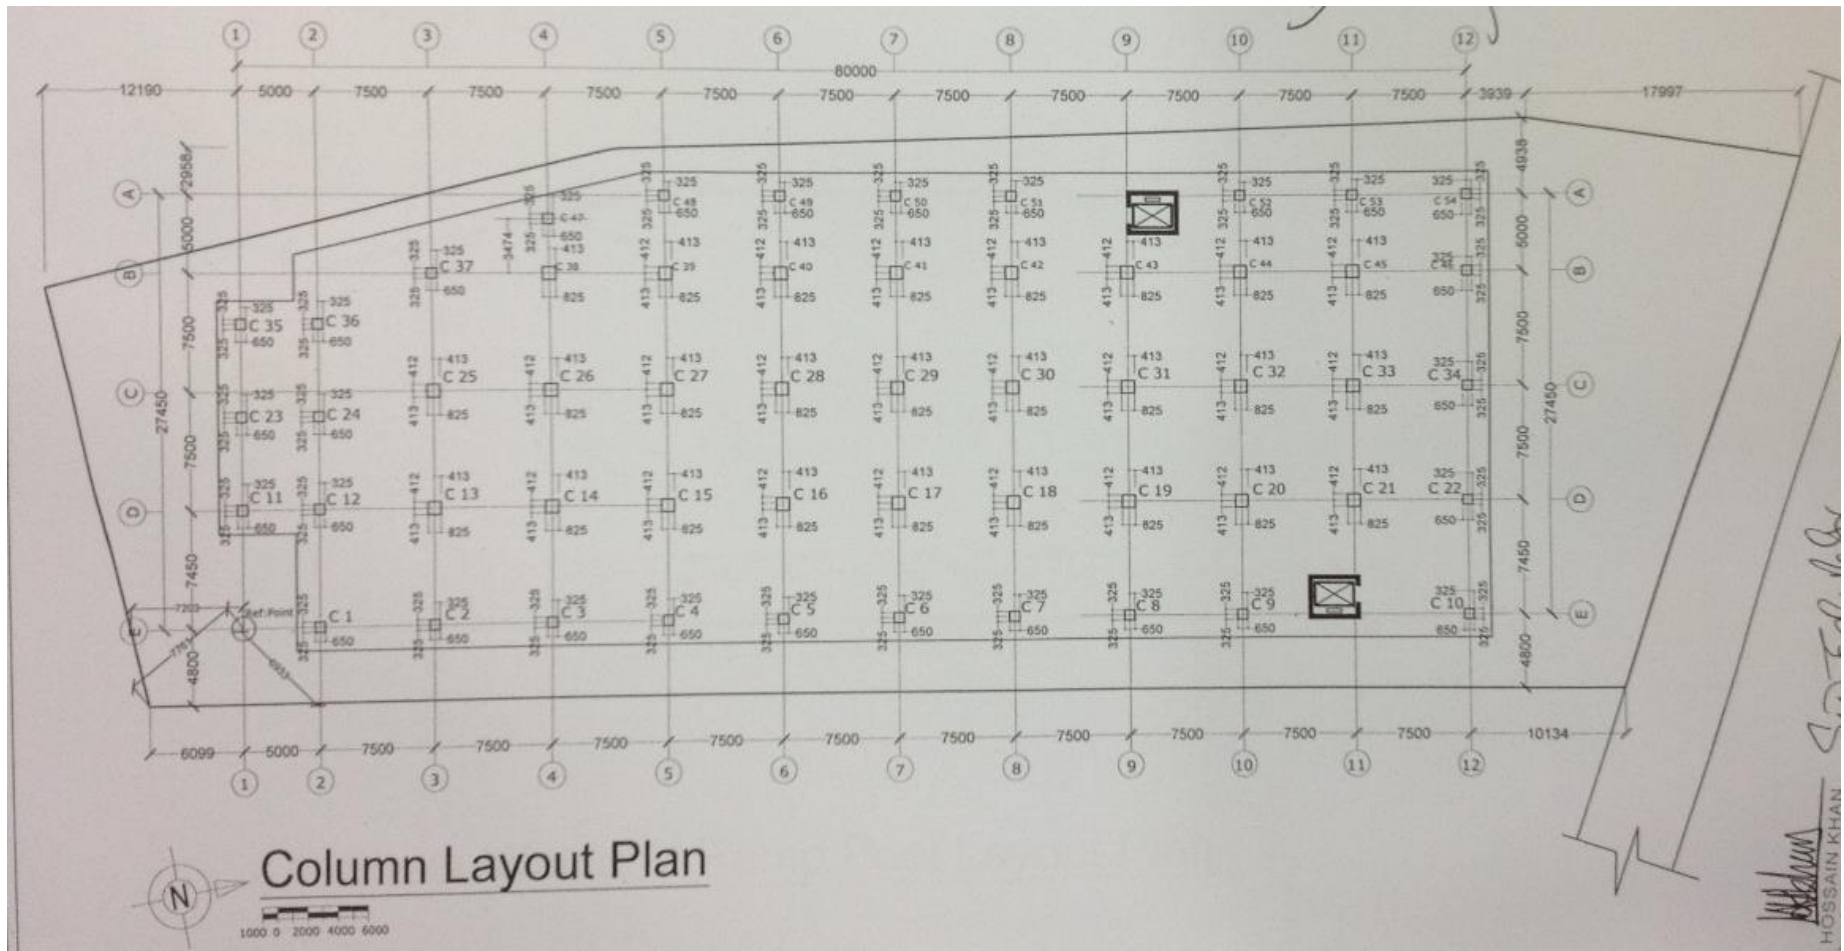
Drawing inconsistencies

Structural drawings not consistent with the as-constructed arrangement of the factory

- Constructed columns smaller than indicated on the structural drawings.
- Building engineer to survey and update drawings as required.

5	Structural drawings not consistent with the as-constructed arrangement of the factory	Building Engineer to survey as-constructed building and update drawings as required.	6-months
6	Non-engineered structures	Building Engineer to verify capacity and connections of the roof structure to the dining area and the link-bridge	6-months
7	Non-engineered structures	All required strengthening works to be completed.	6-months

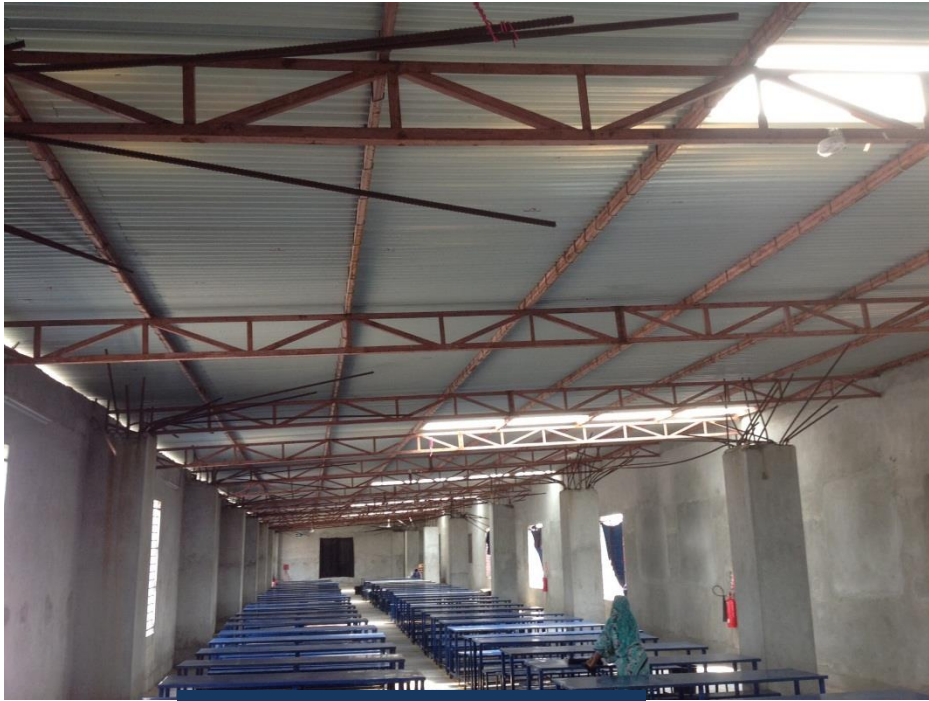
Dining area at roof level

- Roof structure in dining area appears to be non-engineered.
- Roof may be susceptible to uplift.
- Link-bridge from main building to guards' quarters also appears non-engineered.

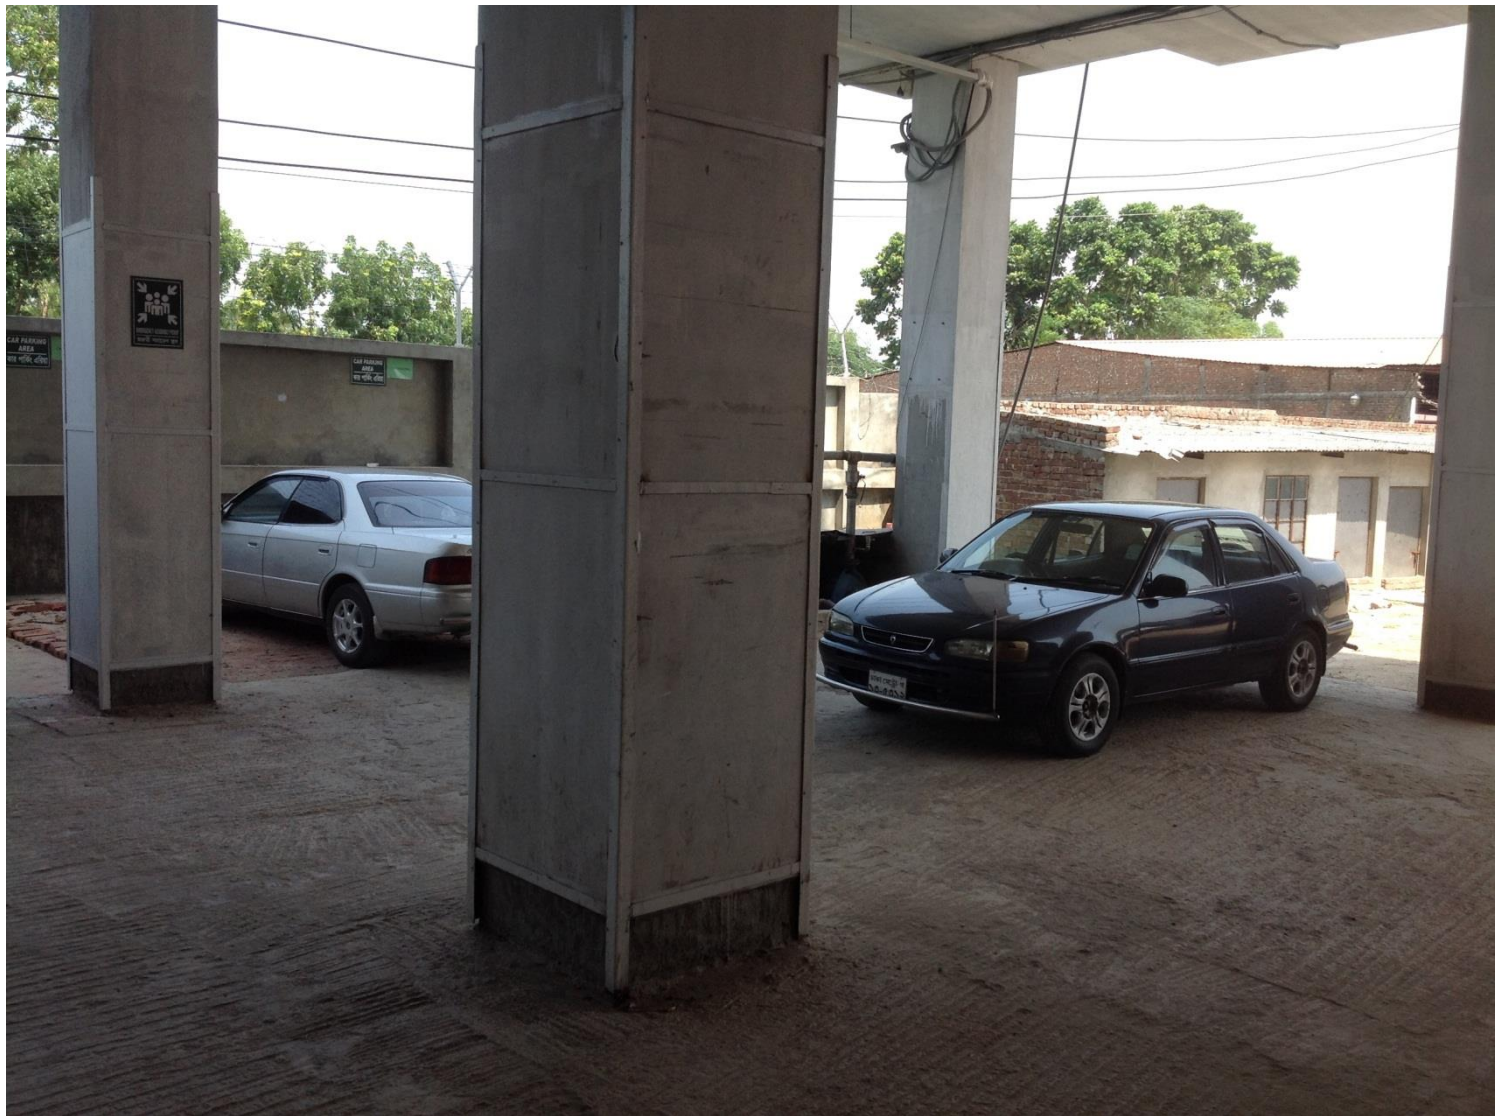
Columns susceptible to impact loading

Columns at Loading Bay are susceptible to impact loading from vehicles.

Item No.	Observation	Recommended Action Plan	Recommended Timeline
8	Columns in the ground floor entrance area are susceptible to impact from delivery vehicles	Building Engineer to review column design and potential for vehicle impact to columns at front of building.	6-months
9	Columns in the ground floor entrance area are susceptible to impact from delivery vehicles	If appropriate, impact protection to be provided.	6-months
10	Management of storage loads	Produce and actively manage a loading plan for all floor plates within the factory giving consideration to floor capacity (see Item 1).	6-months
11	Management of storage loads	Continue to implement load management plan (see Item 1).	6-months
12	Exposed reinforcement	Area identified to be structurally repaired to ensure further corrosion of reinforcement does not occur.	6-months
13	Cracking to structural elements	Building engineer to record all cracking throughout building, make structural repairs as necessary and monitor on an on-going basis.	6-months

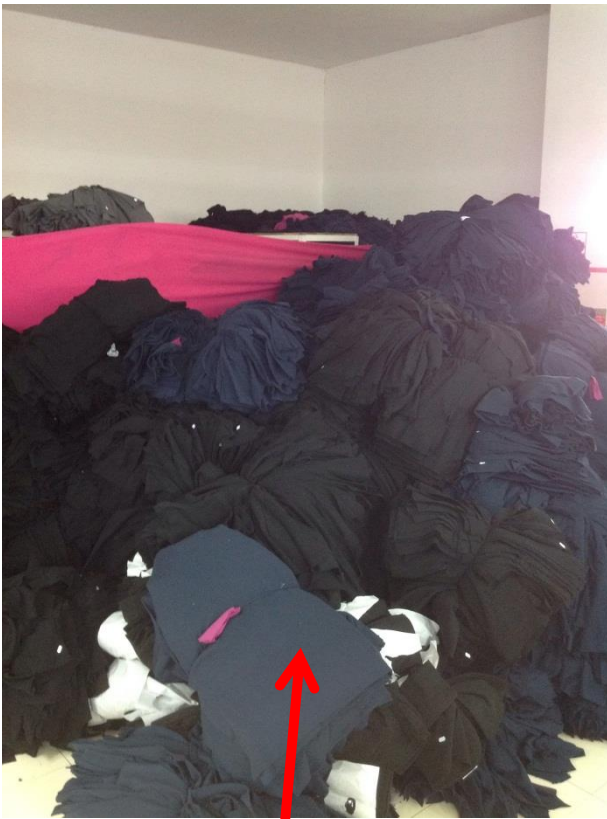
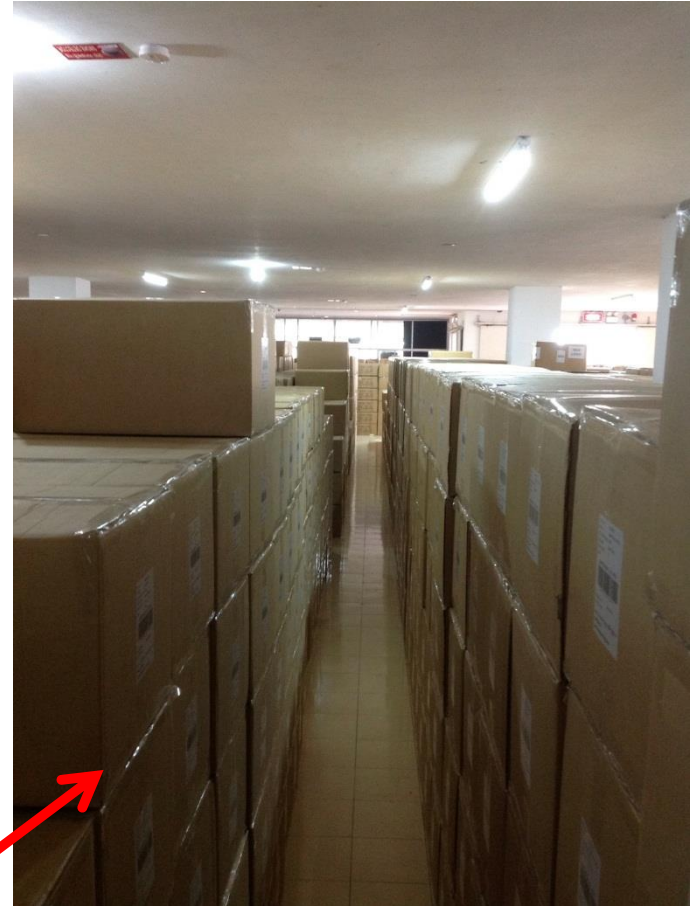
Localised areas of high loading

- Uncontrolled stacking of materials observed.
- No load management system in place.

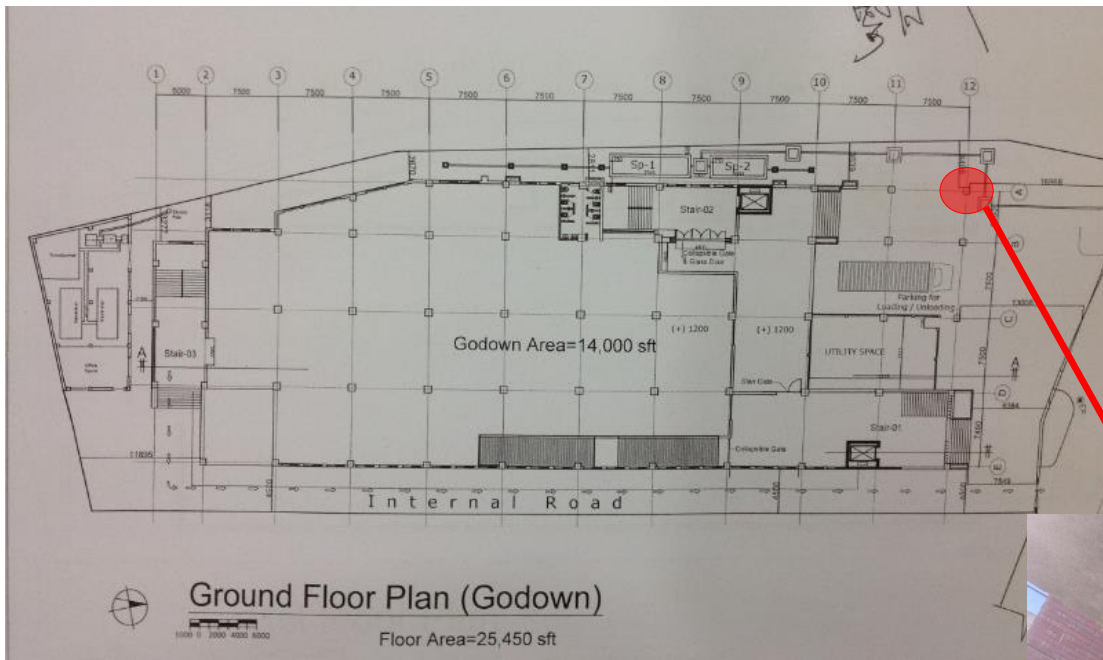
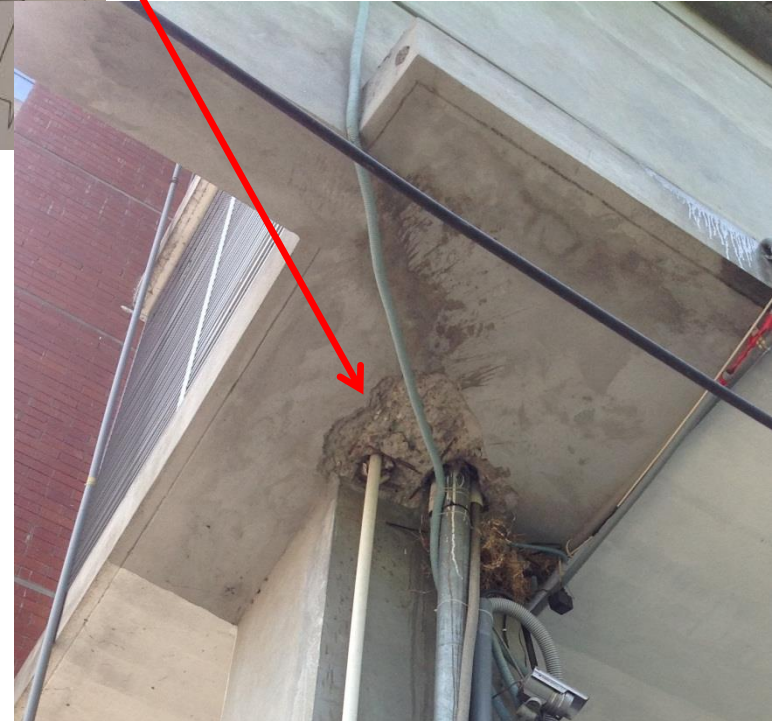
- Exposed reinforcement observed at front of building.
- Reinforcement should be protected and concrete repaired.

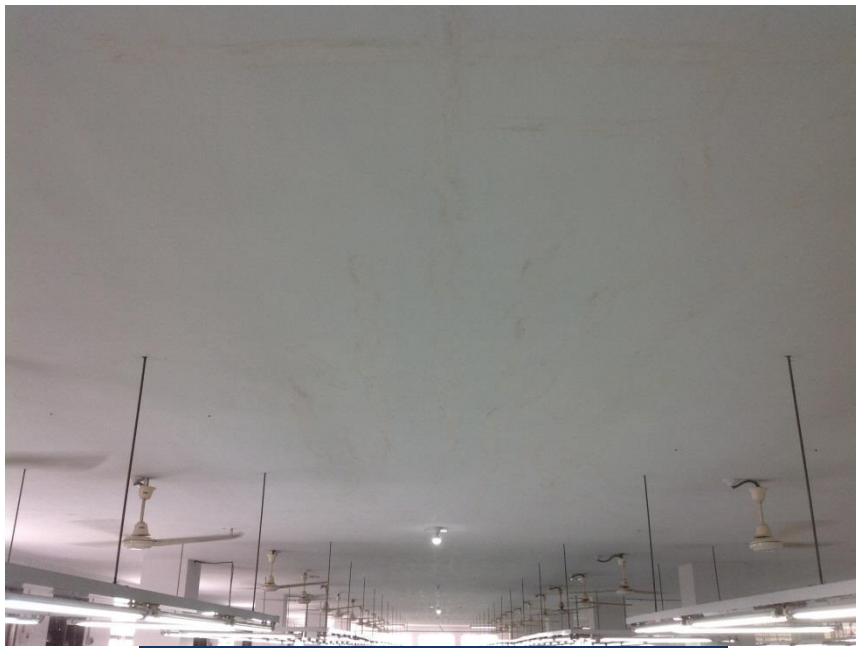
Repairs to soffit of 4th floor slab

- Minor hairline cracking and evidence of repairs were observed on suspended slabs.
- Cracking also observed to retaining wall in basement.

14	Cracking to structural elements	If further cracking occurs, Building Engineer to investigate and remediate as appropriate.	6-months

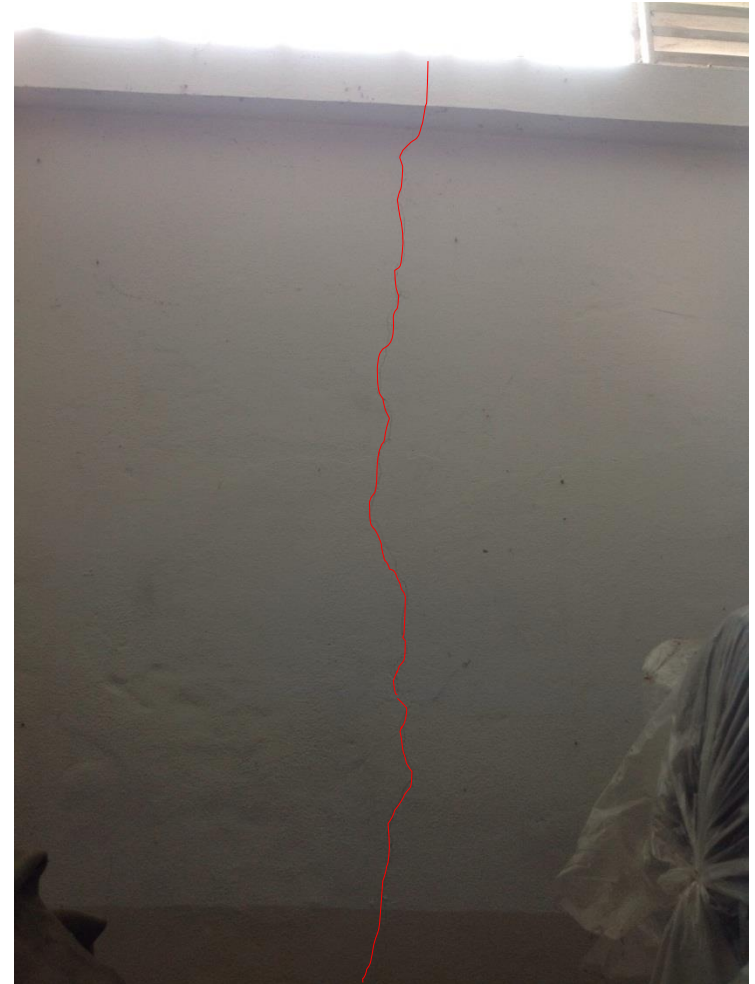
Cracking to retaining wall in basement.
