# Globus Garments Ltd.

Globus Garments Ltd., K.S. Complex, Mouchak, Kaliakoir, Gazipur, Bangladesh.  
(+24.024055N, 90.294271E)

28<sup>th</sup> June 2014

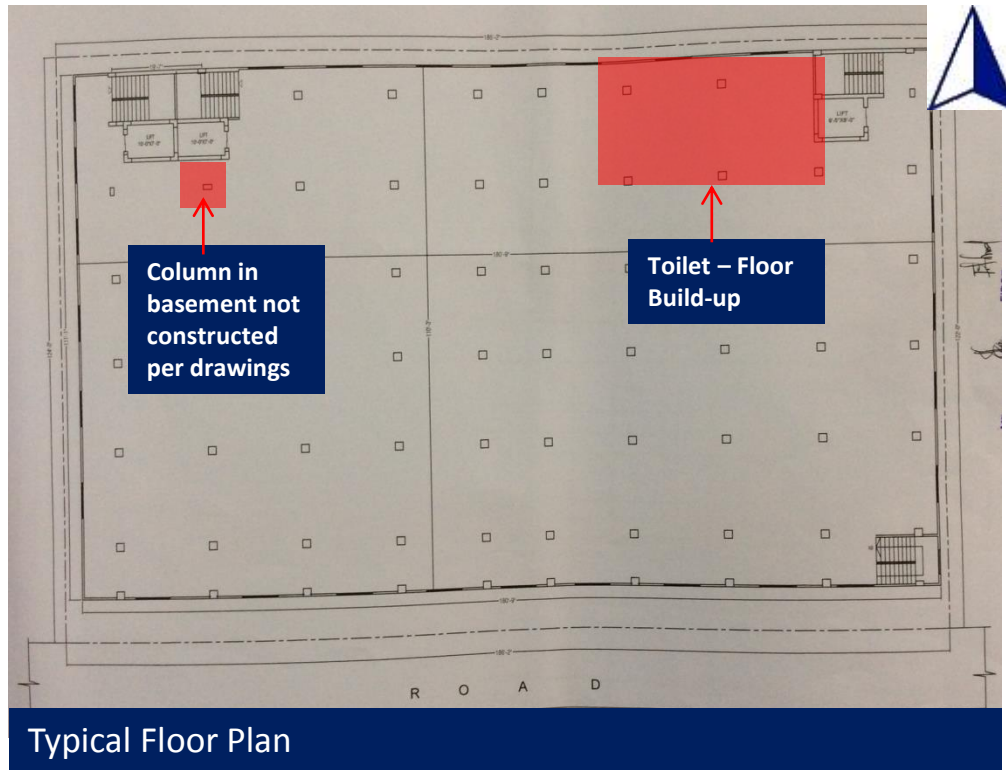
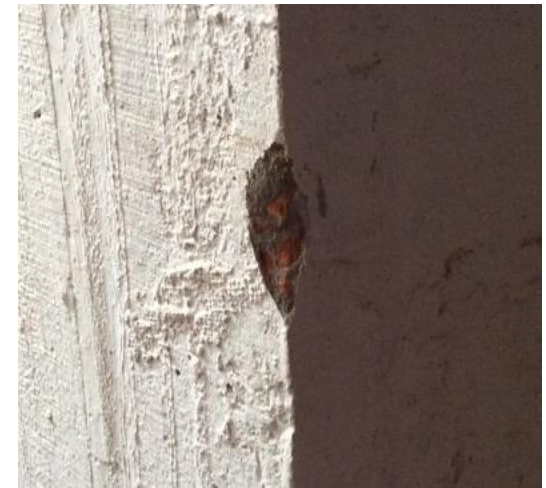
**Columns in the Factory Building (Building 1)  
appear to be stressed in excess of normal  
design limits and require immediate  
review.**

Preliminary calculations indicate that columns generally within the factory building are stressed slightly in excess of normal design limits.

Immediate concern relates to columns which support floor build-up loads in the toilet area and to a single column at the north west side of the building, within the basement, which appears not to be constructed in accordance with the drawings.

Tested Column – Brick Chips

Columns which appear to be highly stressed – Building Engineer to review immediately

| Item No. | Observation | Recommended Action Plan | Recommended Timeline |
|---|---|---|---|
| 1 | Columns in the Factory Building (Building 1) appear to be stressed in excess of normal design limits and require immediate review between Basement and 3rd floor level. | Building Engineer to review design, loads and column stresses in columns throughout the building from basement to 3rd floor. Prioritise review of columns which support floor build-up loads in the toilet area and single column at the north west side of the building, within the basement, which appears not to be constructed in accordance with the drawings. | <b>Immediate - Now</b> |
| 2 | Columns in the Factory Building (Building 1) appear to be stressed in excess of normal design limits and require immediate review between Basement and 3rd floor level. | Verify insitu concrete stresses either by 4 No 100mm diameter cores or existing cylinder strength data. Reinforcement quantities also to be confirmed. | <b>Immediate - Now</b> |

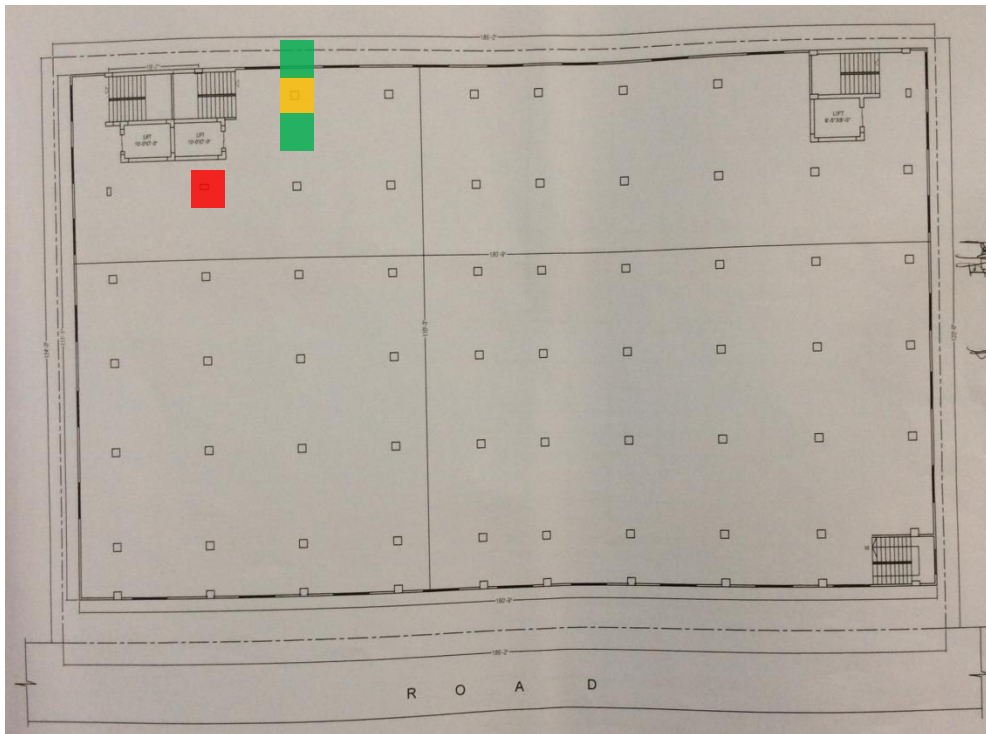
Typical Floor Plan Main Factory Building

- There is a an undersized column in the main factory building, which reduces in size at Basement level – design check required;
- The width of the beams is smaller than is called up in the drawings – design check required;
- There are irregularities in the column layout plans for both buildings – design check required;
- The soil investigation report for the main factory building recommends shallow foundations for buildings up to five storeys, and there is no soil investigation report for the Utility Building which has a permit for eight storeys. Both buildings make use of isolated pad foundations – design check required;
- Cantilevers to the Utility Building are not shown in the design drawings – design check required.

Undersized column at basement level

Incorrect column locations – no column at this location

Actual column locations

| Item No. | Observation | Recommended Action Plan | Recommended Timeline |
|---|---|---|---|
| 5 | Design check required due to irregularities in design documentation | Building Engineer to commence a design check to assess the safety and serviceability of the building with reference to discrepancies between the drawings and as constructed Factory Building and Utility Building. | <b>Immediate - Now</b> |

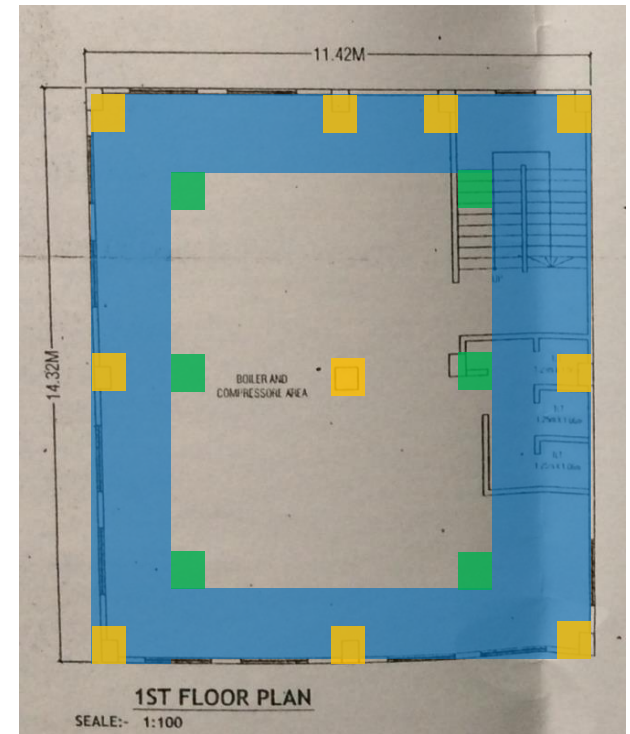
Utility Building – Permit Layout

Cantilevers not shown on drawing

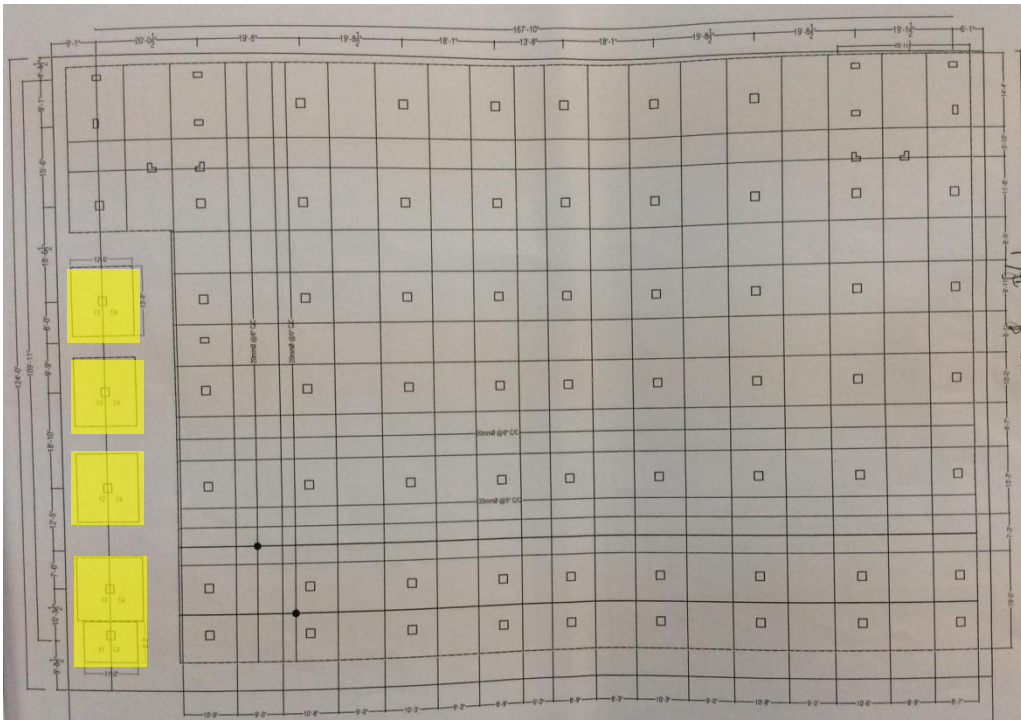
Foundation plan from structural drawings showing pad foundations – as highlighted

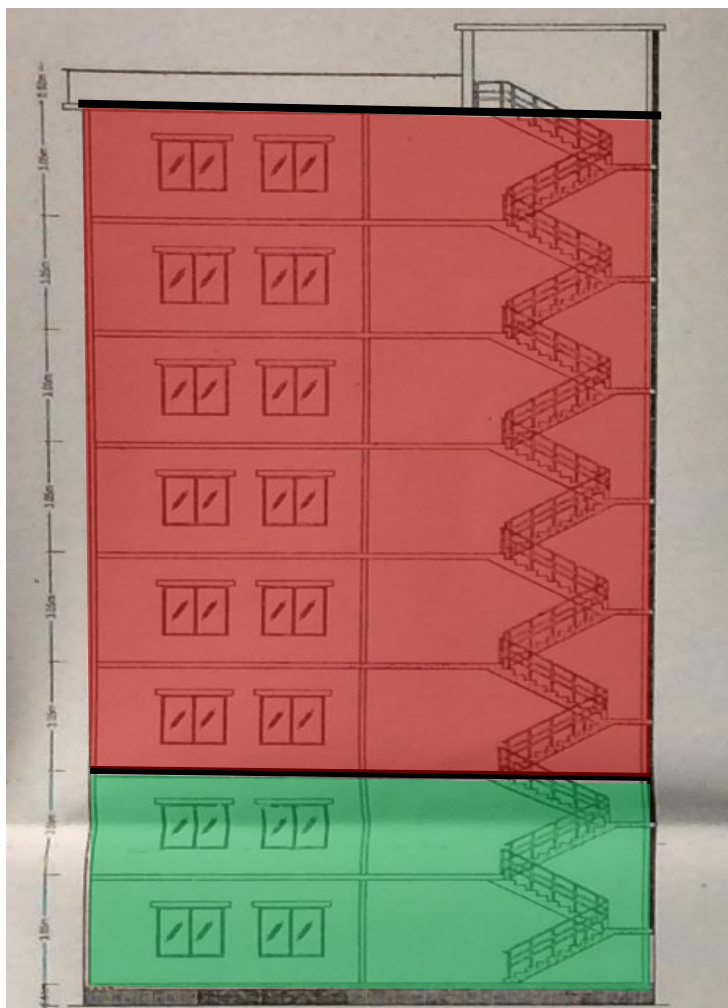
Building 2 – Utility Building – Cross section

2<sup>nd</sup> - 7<sup>th</sup> Floors – Not yet constructed

Existing Ground and 1<sup>st</sup> Floors

Utility Building (Building 2) has LGED-approval for eight-storeys. There are important differences between the design drawings and the as-built structure. Building Engineer to review structural design and concrete strength within existing columns prior to construction of any further building extension above the existing two storeys.

| Item No. | Observation | Recommended Action Plan | Recommended Timeline |
|---|---|---|---|
| 9 | All proposed additions to the existing Utility Building (Building 2) structure, including additional storeys as permitted, are to be reviewed by the Building Engineer | For all proposed additions to the Utility Building (Building 2) structure, Building Engineer to carry out a design check to assess the safety and serviceability of the building, particularly in relation to column sizes and lateral stability, taking into account the additional loads. | <b>6-months</b> |
| 10 | All proposed additions to the existing Utility Building (Building 2) structure, including additional storeys as permitted, are to be reviewed by the Building Engineer | In-situ concrete testing to be carried out as part of any future structural assessments. | <b>6-months</b> |
