# Four H Lingerie Ltd.

BRTC Bus Depot, Baluchara, Hathazari Road, Chittagong, Bangladesh  
(+22.416298N, 91.819663E)

2<sup>nd</sup> July 2014

# Observations

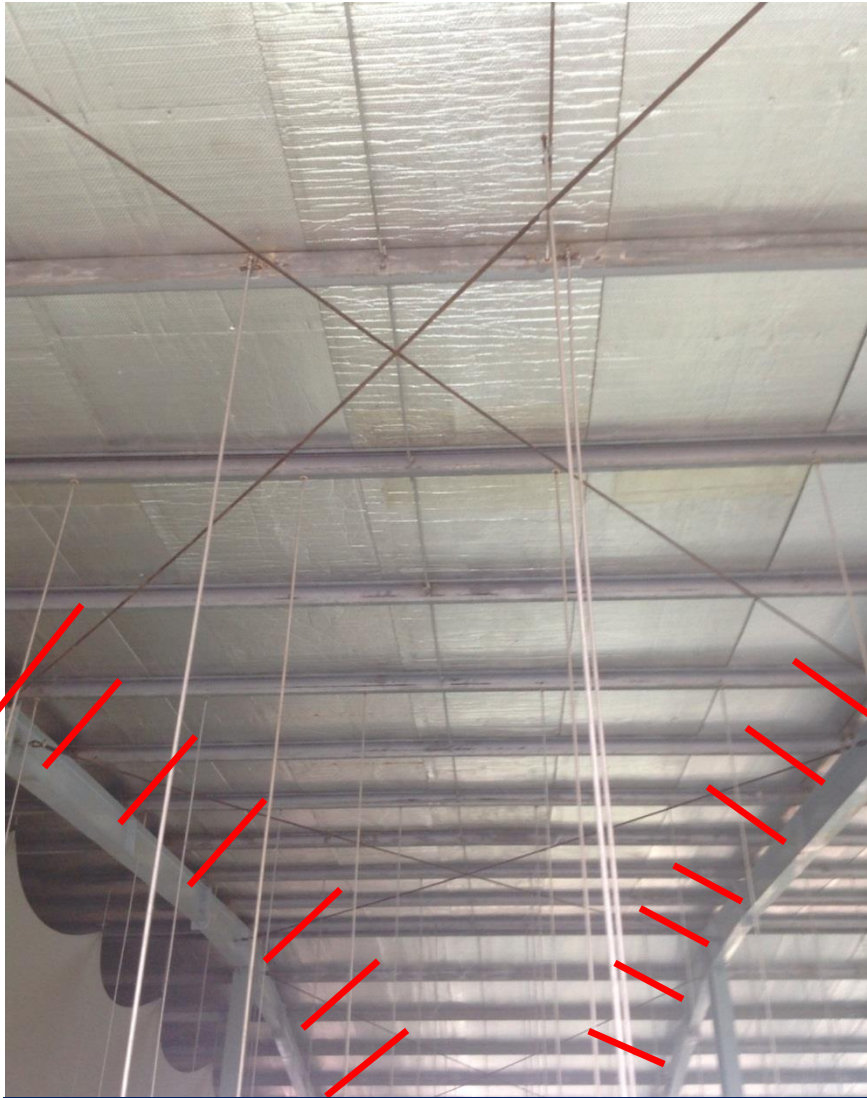
There are significant eccentricities of bracing connections causing minor axis bending to portal frame members. Compression flange braces required for rafters at braced bays also not provided.

Missing compression flange braces

Item No.	Observation	Recommended Action Plan	Recommended Timeline
1	Issues with Bracing System	Building Engineer to review bracing system for lateral wind loading as per BNBC with consideration for minor axis bending of rafters due to eccentricity of members at node points. Review design of rafter considering compression flange restraint.	6-weeks
2	Issues with Bracing System	Building Engineer to design and detail structural upgrading work where necessary to ensure adequate stiffness of bracing system.	6-weeks
3	Issues with Bracing System	Where required, remedial measures to steelwork to be carried out.	6-months
4	Apparently Inadequate Steel Connection Design	Building Engineer to assess connection for vertical and lateral loads as per BNBC with particular attention to moment transfer between portal frames.	6-weeks
5	Apparently Inadequate Steel Connection Design	Building Engineer to design and detail structural upgrading works, as necessary.	6-weeks

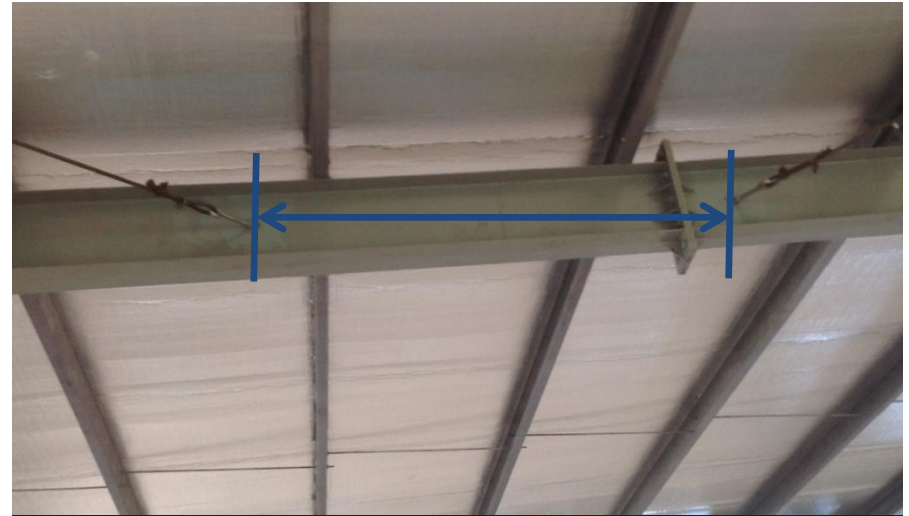
Significant eccentricity to plan bracings

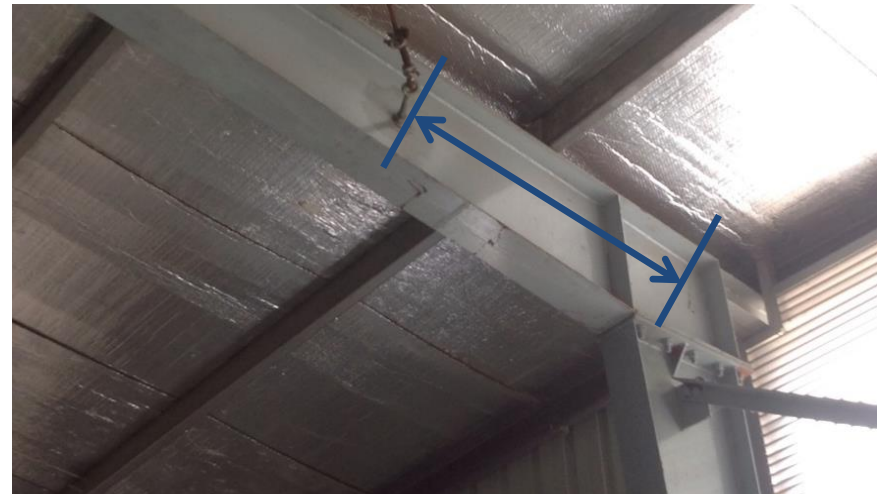
Plan bracing substantially away from vertical supports

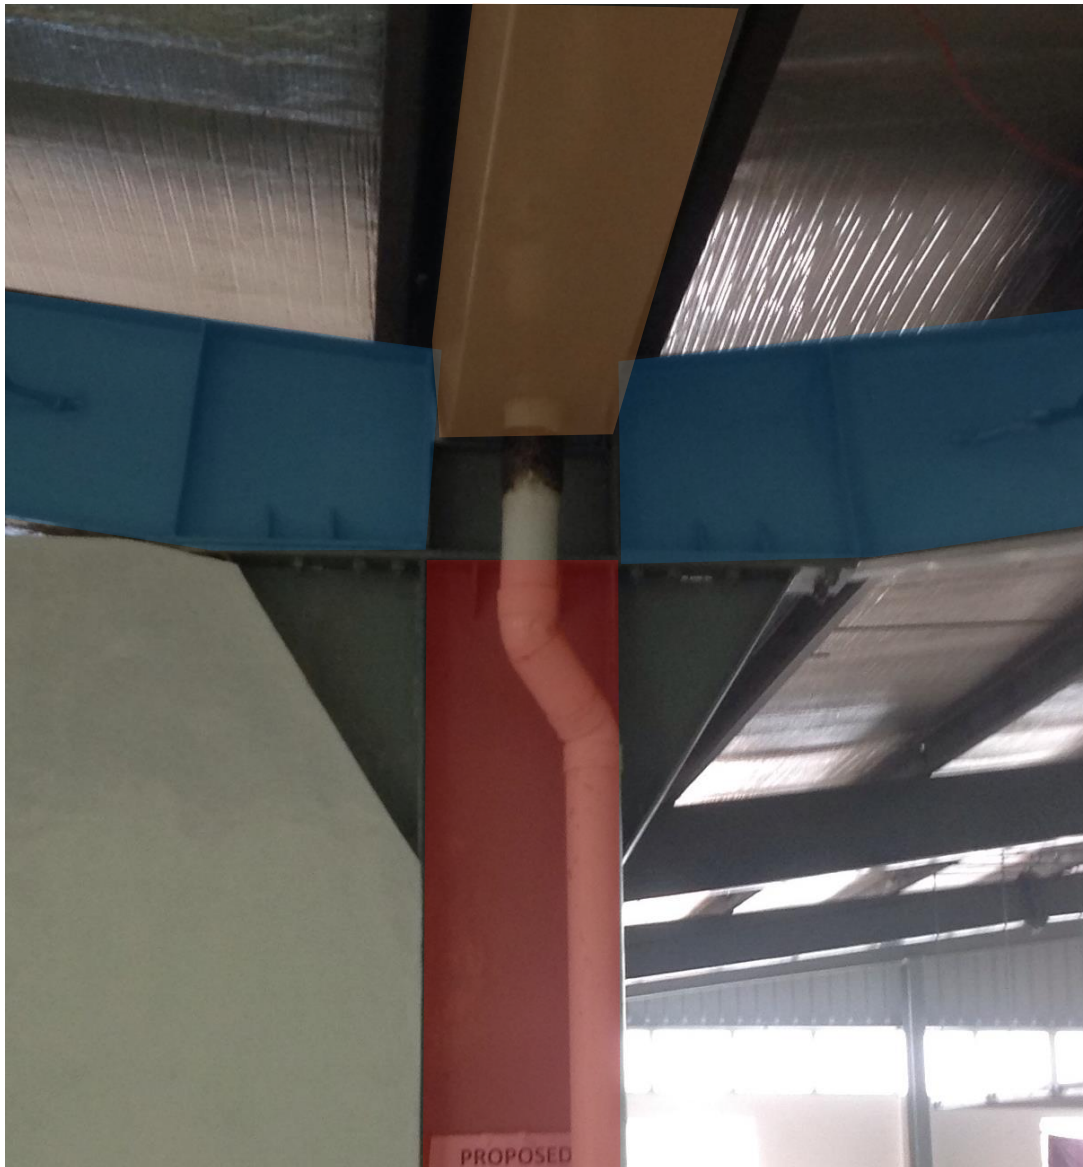
Column-rafter connection at valley

# Moment transfer between portal frames compromised due to connection recess for gutter.

- Column with haunch
- Rafter sitting on top of haunch
- Gutter drain

6	Apparently Inadequate Steel Connection Design	Where required, remedial measures to steelwork to be carried out.	6-months

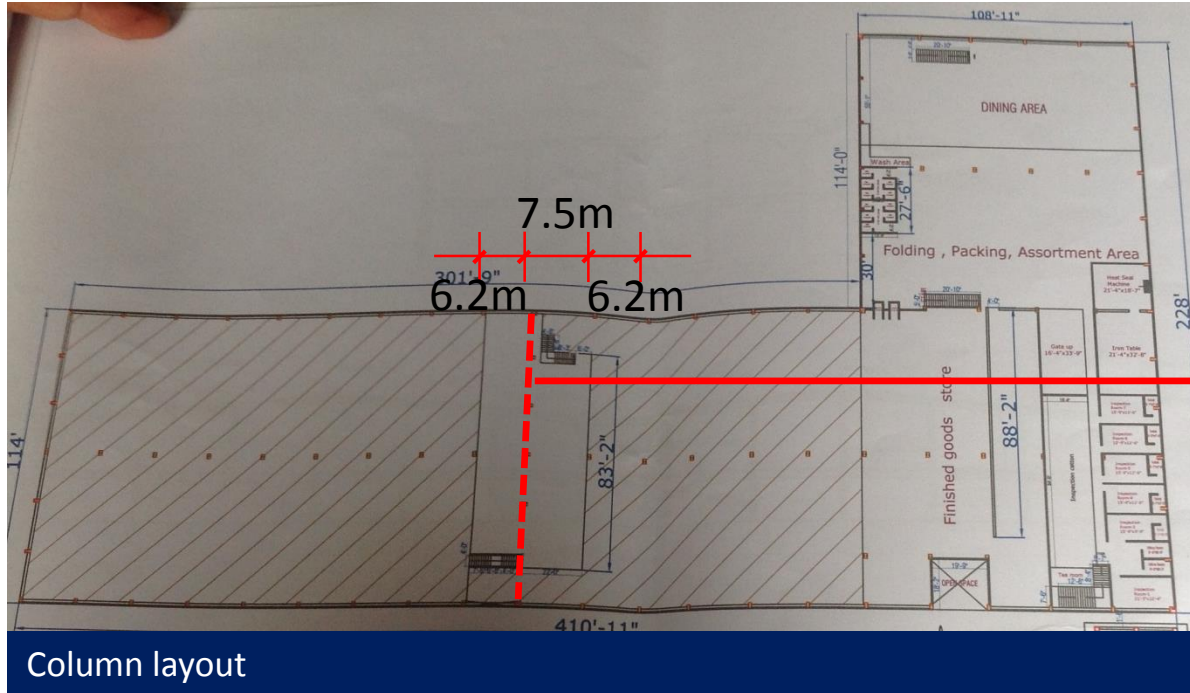
Column layout

We have observed that the member sizes in this bay are smaller than the rest of the bays. It also has a slightly larger tributary wind loading area. The columns are also orientated about the weak axis in relation to wind loading.

Item No.	Observation	Recommended Action Plan	Recommended Timeline
7	Reduced Portal Frame Member Size Resisting Larger Tributary Wind Area	Building Engineer to review lateral capacity of portal frame with reduced member size for wind loading as per BNBC.	6-weeks
8	Reduced Portal Frame Member Size Resisting Larger Tributary Wind Area	Building Engineer to design and detail structural upgrading works, as necessary.	6-weeks
9	Reduced Portal Frame Member Size Resisting Larger Tributary Wind Area	Where required, remedial measures to steelwork to be carried out.	6-months
10	Vertical Support of Portal Frame Unclear	Building Engineer to review existing vertical support and confirm by calculations that the structural capacity of the existing support points are adequate. If necessary, remedial works to be carried out.	6-months
11	Steel Connection Defects	Building Engineer to review connection gaps at member interfaces and add shim plates where necessary.	6-months

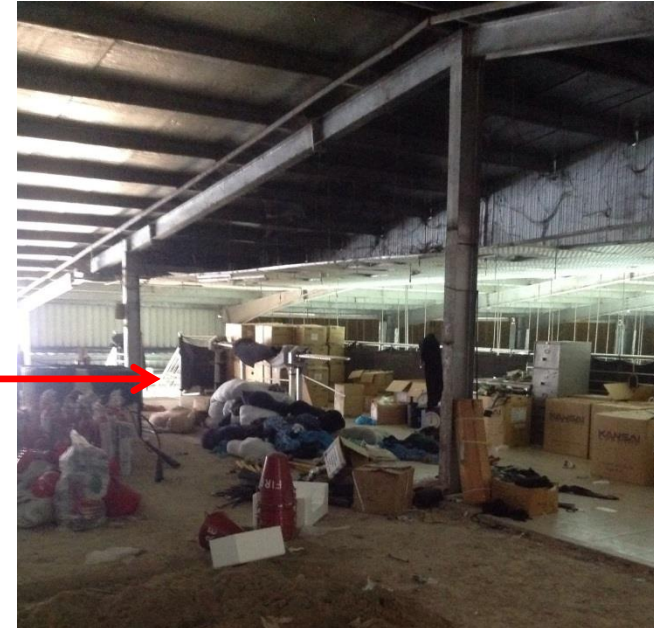
Frame at this bay

Frame with reduced member sizes

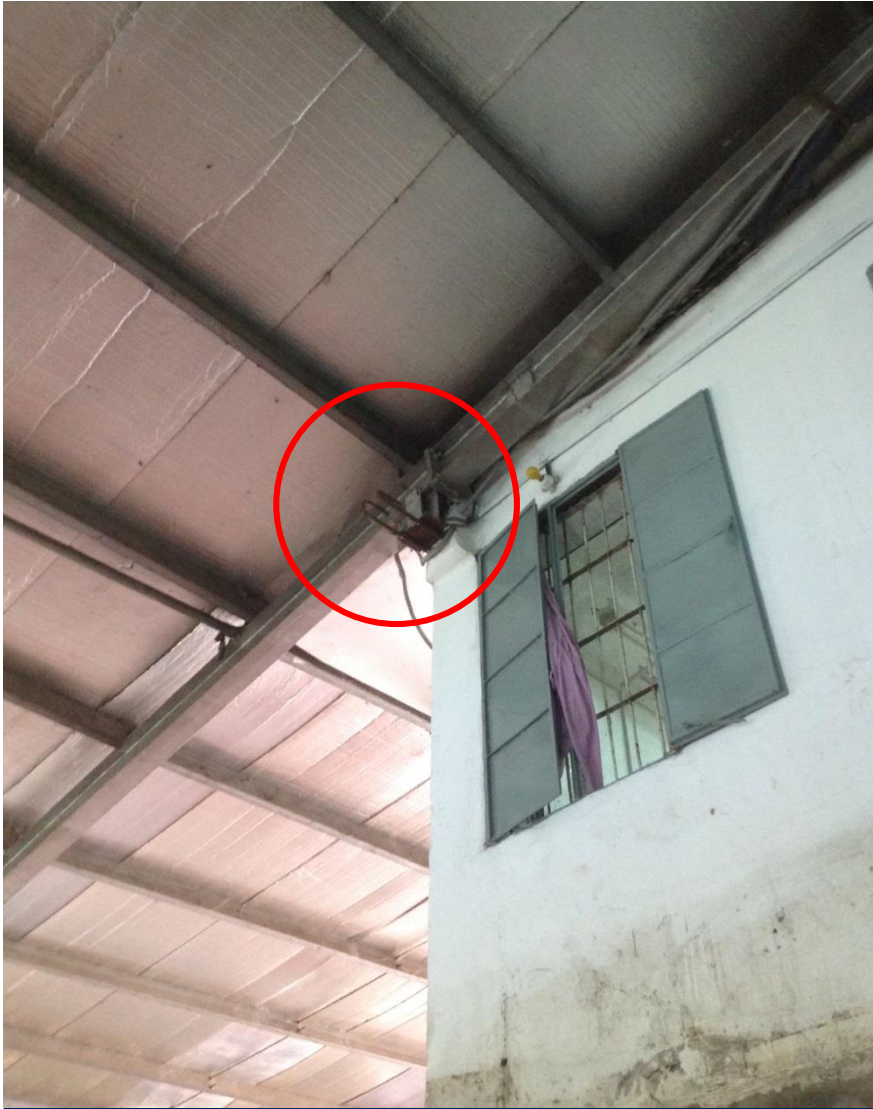
Portal frame apparently supported off corbels from adjacent building.

Capacity of support points of portal frame unclear.

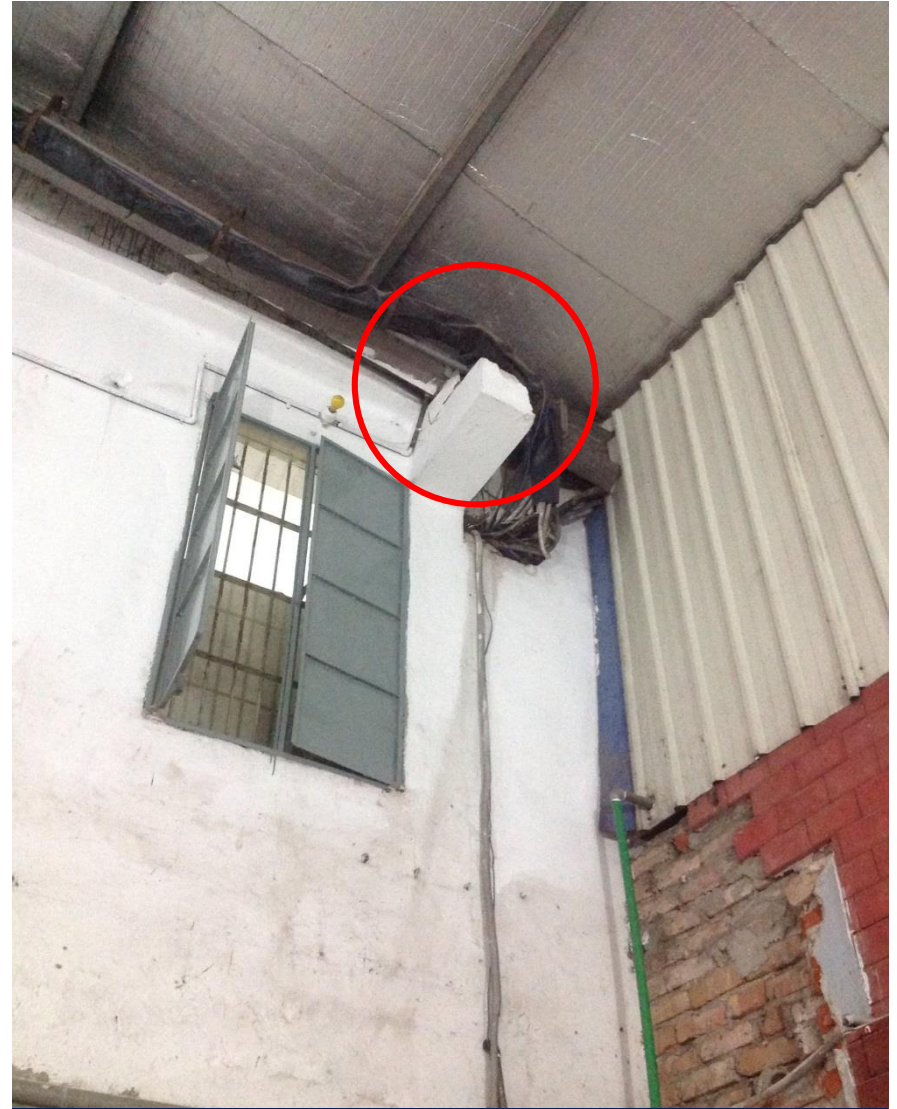
Support points of portal frame unclear.

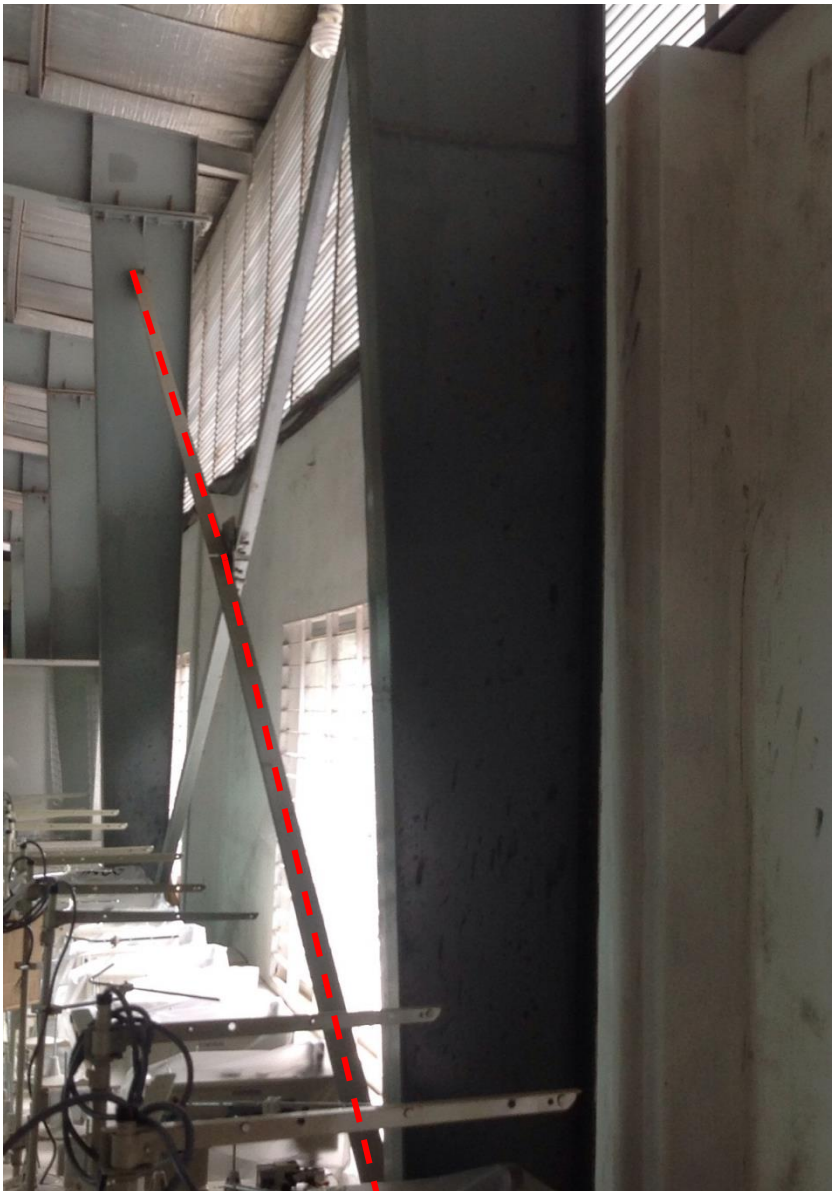
Untightened vertical braces

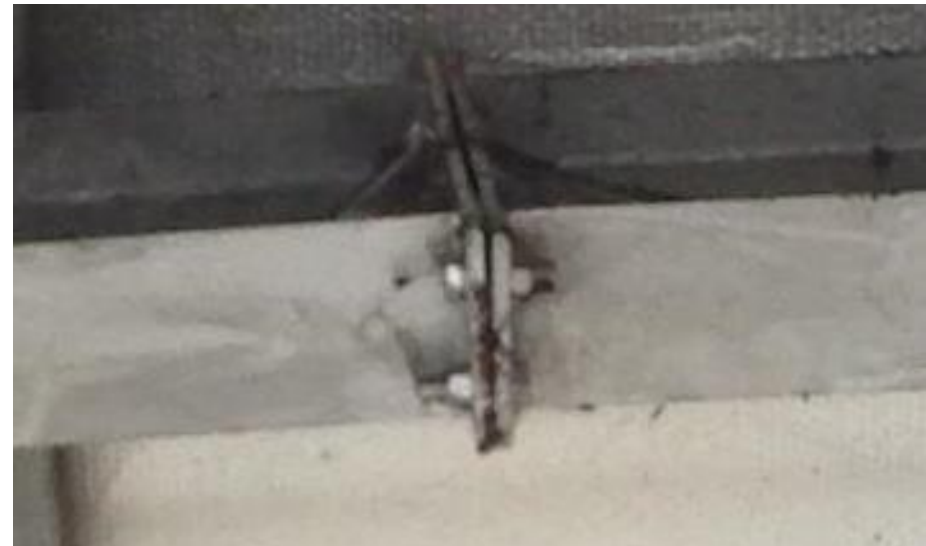
Gaps to connections

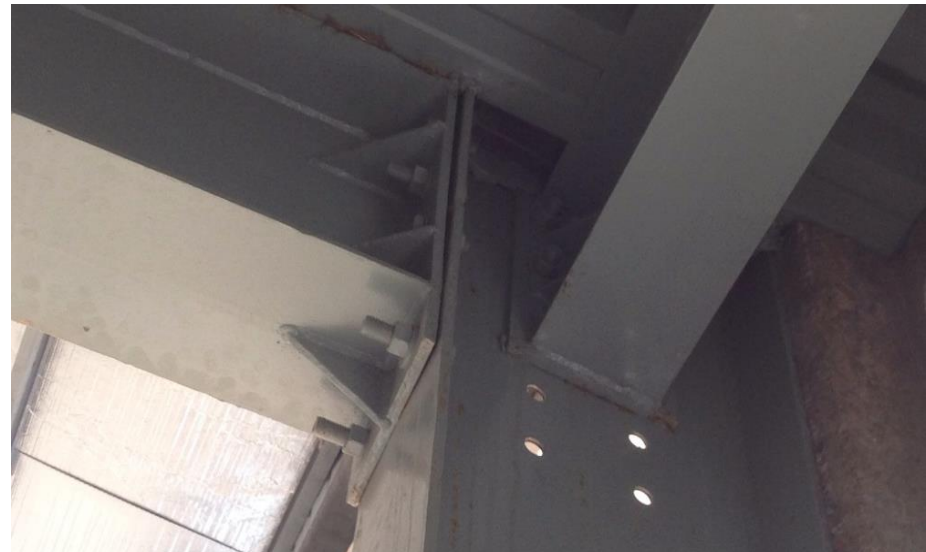
Gaps to connections
