# Nipa Fashion Wear Company Ltd.

Holan Road, Dakkin Khan, Uttara, Dhaka – 1230  
(23.856611N, 90.431042E)

13 July 2014

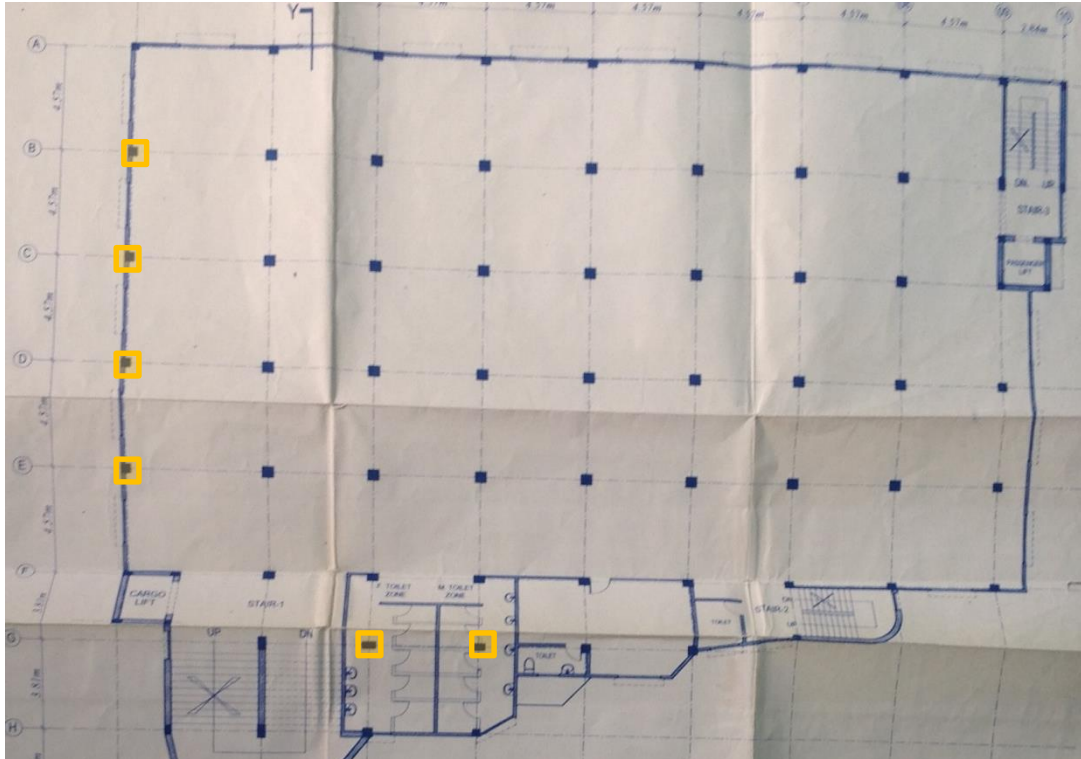
# **Cursory Calculations indicate High Column Stress**

Cursory calculations indicate high column stresses.

| Item No. | Observation | Recommended Action Plan | Recommended Timeline |
|---|---|---|---|
| 1 | Cursory Calculations indicate Column Stress is in Excess of Design Limits | Maintain current use of the floors and don't change use or increase occupation, either of which could increase loading. | <b>Immediate - Now</b> |
| 2 | Cursory Calculations indicate Column Stress is in Excess of Design Limits | Factory Engineer to review design, loads and columns stresses in all columns. | <b>Immediate - Now</b> |
| 3 | Cursory Calculations indicate Column Stress is in Excess of Design Limits | Verify insitu concrete stresses either by 100mm diameter cores or existing cylinder strength data for cores from 4 columns. | <b>Immediate - Now</b> |
| 4 | Cursory Calculations indicate Column Stress is in Excess of Design Limits | A Detail Engineering Assessment of Factory to be commenced, see attached Scope. | <b>Immediate - Now</b> |

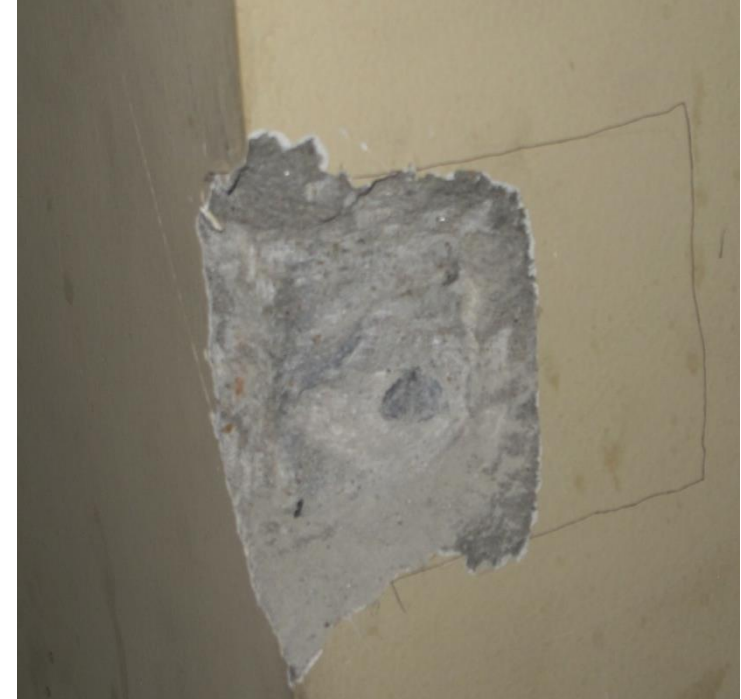
Stone Aggregate observed in columns

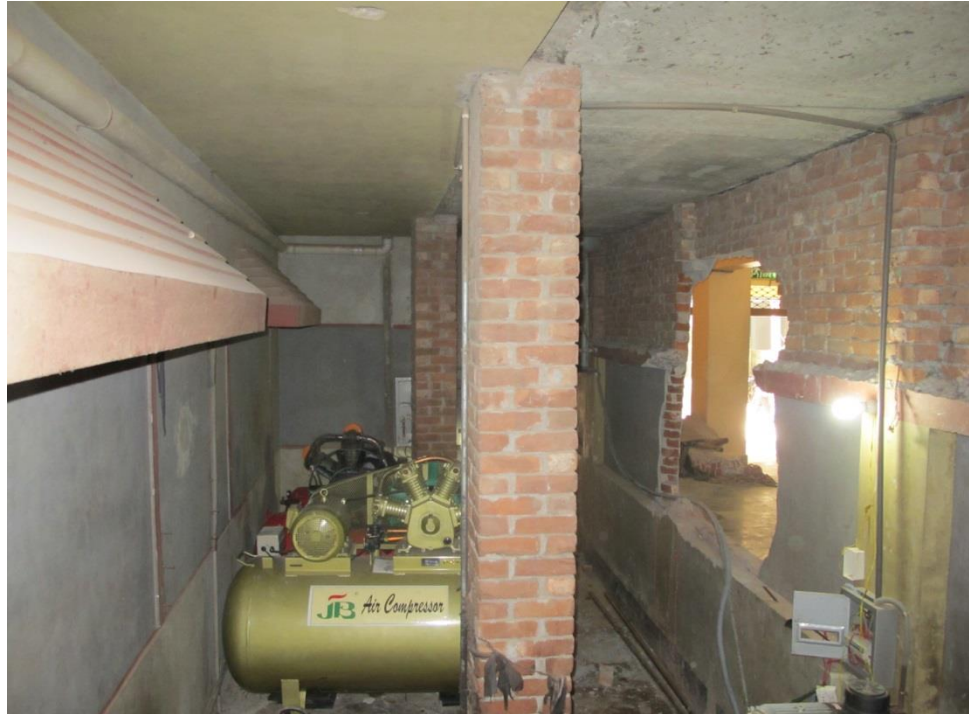
Purpose of masonry columns not apparent.

| Item No. | Observation | Recommended Action Plan | Recommended Timeline |
|---|---|---|---|
| 11 | Function of Masonry Columns at Ground Floor, Centred on Construction Joint, not Apparent | Building Engineer to investigate function and construction method of columns identified above, with particular attention to be paid to location of column in relation to movement joint. | 6-months |
| 12 | Function of Masonry Columns at Ground Floor, Centred on Construction Joint, not Apparent | Building Engineer to Design and detail Structural Upgrading works as necessary | 6-months |

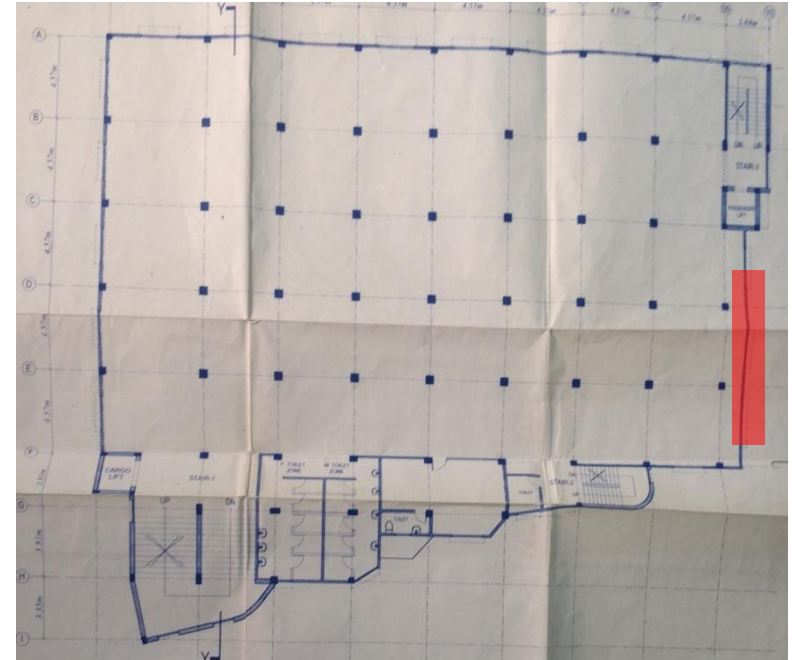
Masonry Columns constructed at junction of factories

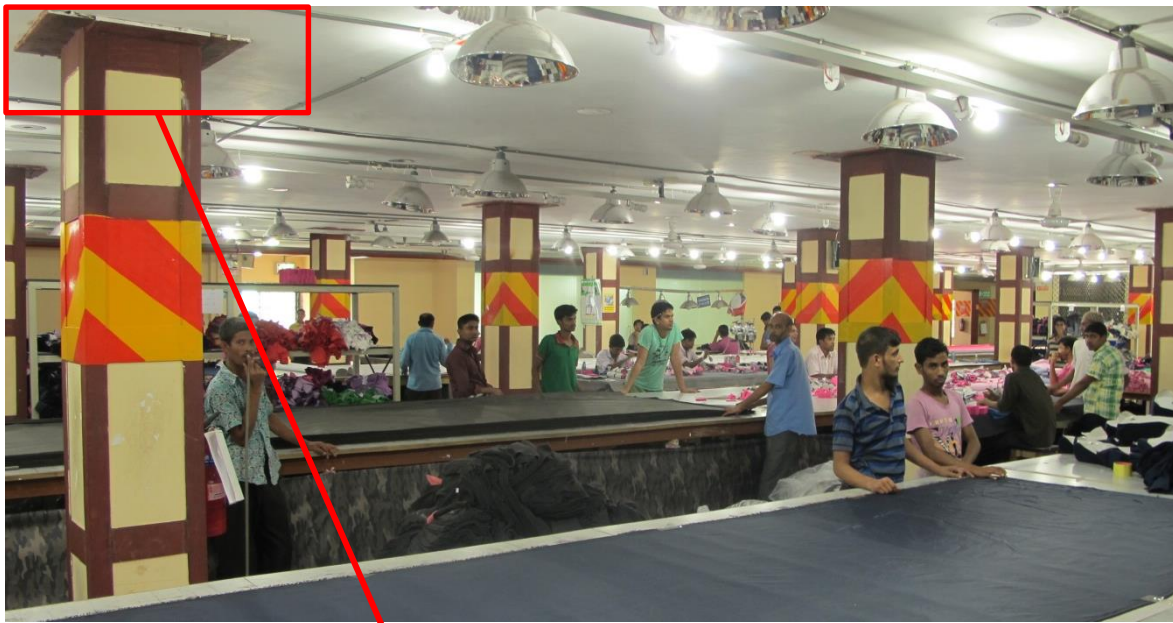
Columns strengthening work observed on internal columns at 1<sup>st</sup> Floor only.

Function of steel angles and plates fixed to columns not apparent.

| Item No. | Observation | Recommended Action Plan | Recommended Timeline |
|---|---|---|---|
| 9 | Function of Column Strengthening Works Not Apparent | Building Engineer to identify function of column strengthening works and confirm adequacy of current measures. | 6-weeks |
| 10 | Function of Column Strengthening Works Not Apparent | Building Engineer to design and detail Structural Upgrading work if necessary | 6-weeks |

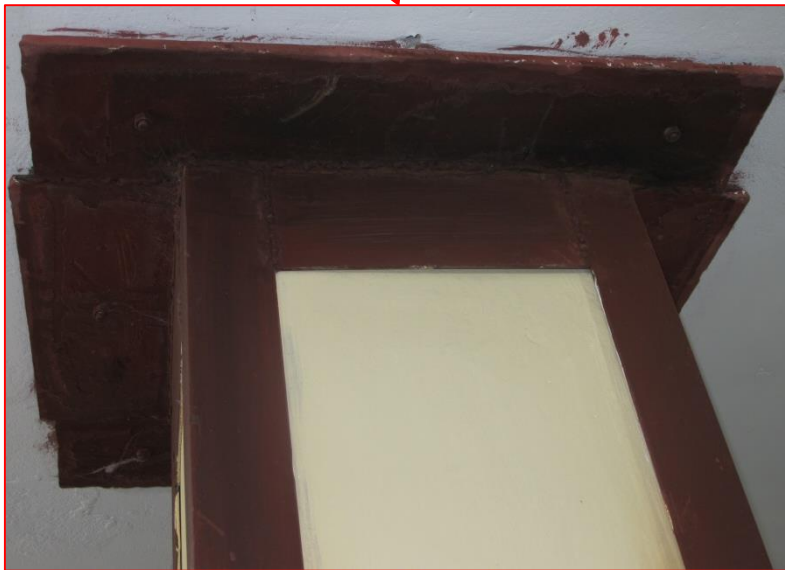
Reason and Function of Plates bolted to underside of flat slab (soffit 1<sup>st</sup> Floor) and welded to steel angles not apparent.

Observed loading on 2<sup>nd</sup> floor slab 2kPa. Use of 2<sup>nd</sup> floor slab was sewing.

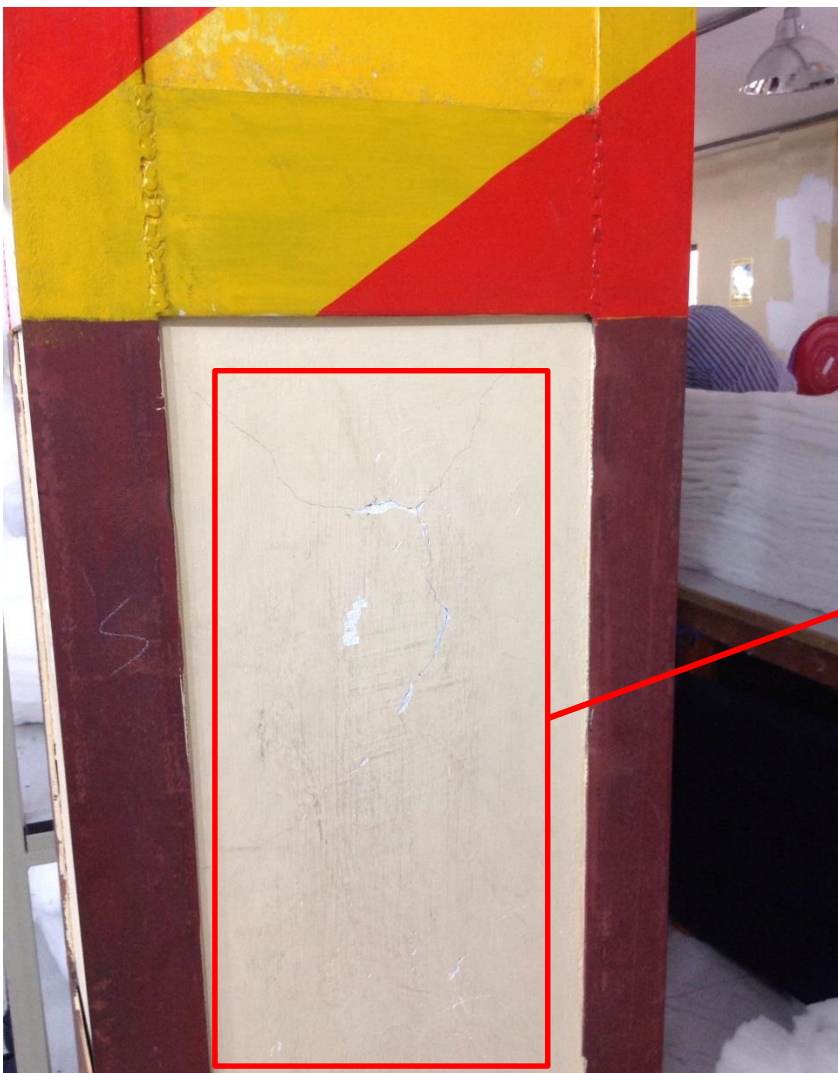
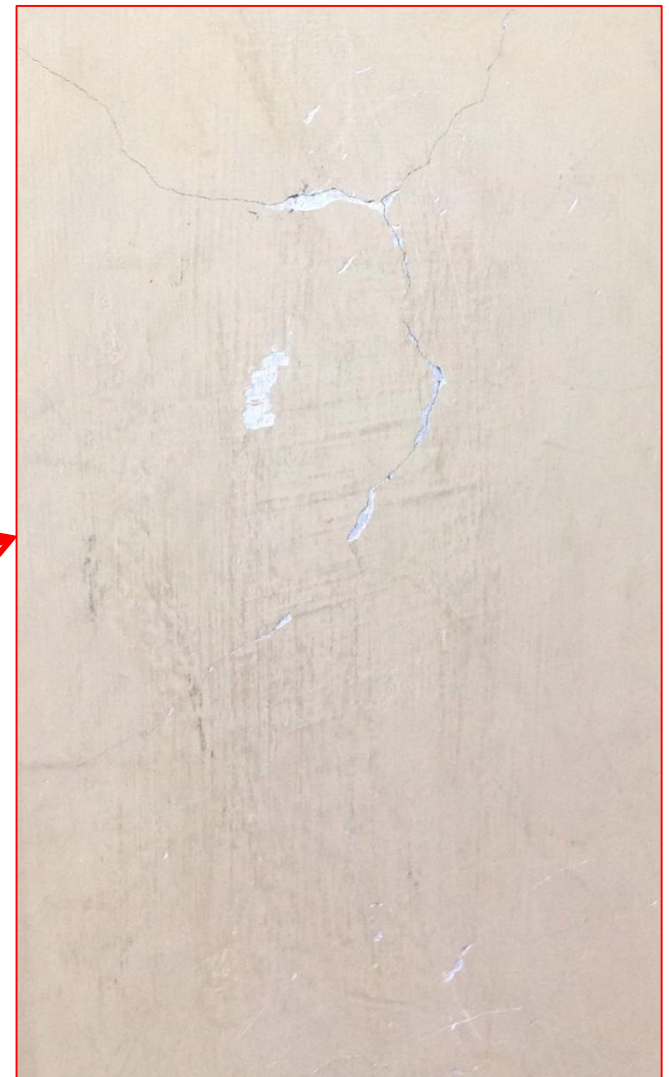
Cracking observed in plaster finish to one of the columns at 1<sup>st</sup> Floor where the column strengthening was observed

| Item No. | Observation | Recommended Action Plan | Recommended Timeline |
|---|---|---|---|
| 8 | Function of Column Strengthening Works Not Apparent | Building Engineer to investigate extent of cracking in column finishes . Finishes should be removed to investigate if crack penetrates concrete column. | 6-weeks |

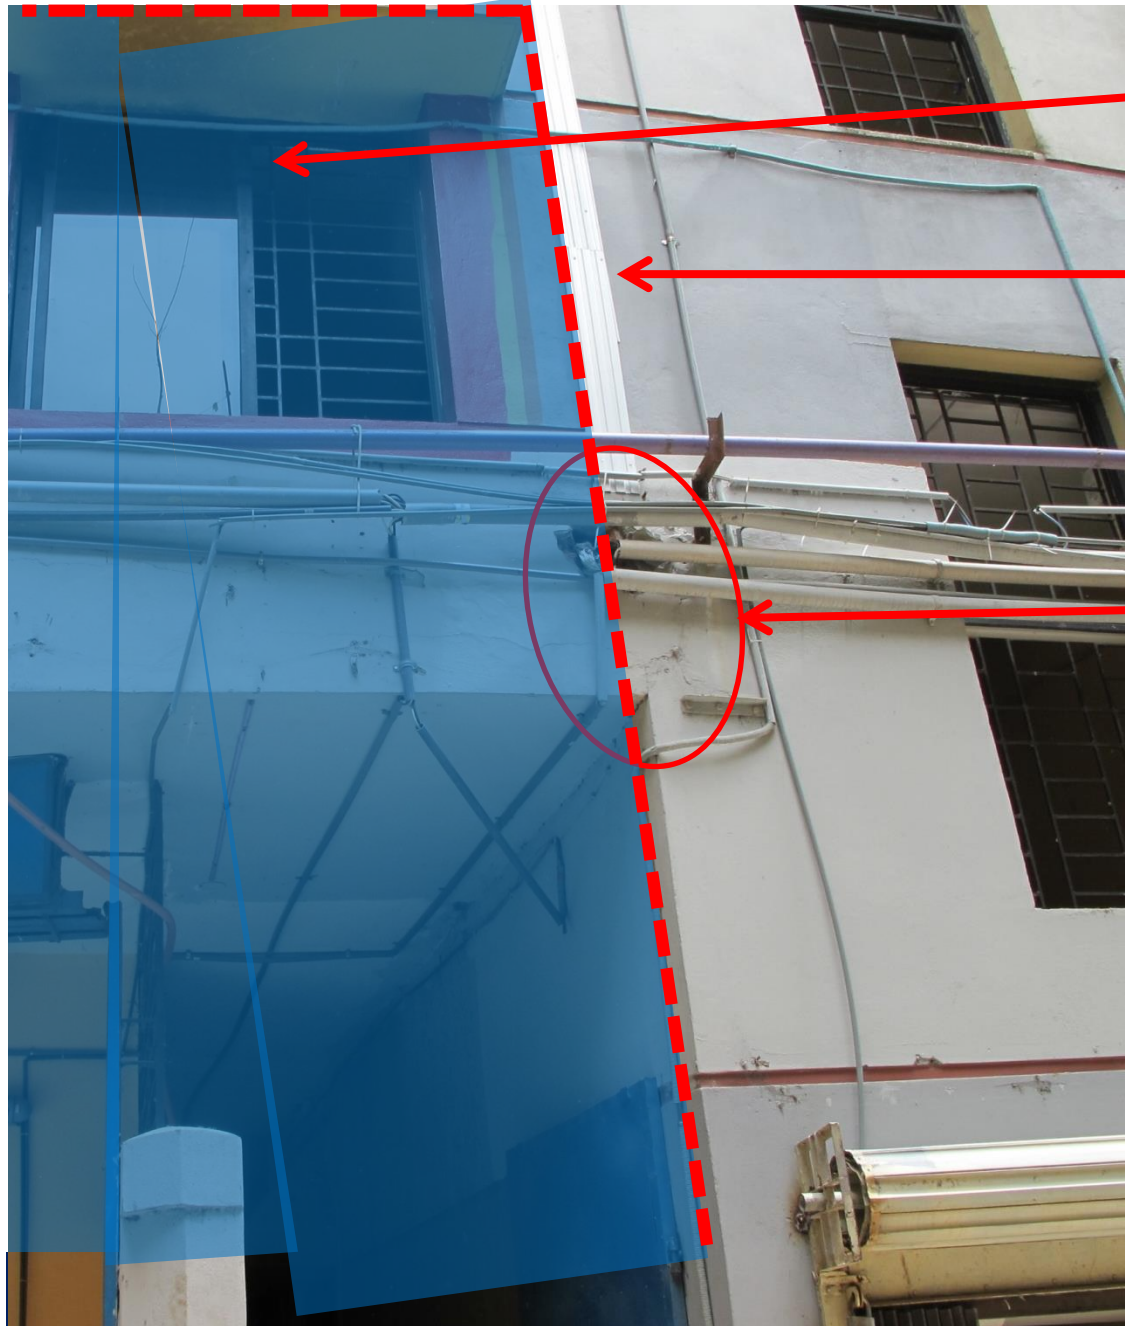
Separate Factory not part of Nipa Fashion Wear Industries Ltd

Movement joint in factory Facade

Correctly detailed movement joint not apparent in masonry façade or slab.

| Item No. | Observation | Recommended Action Plan | Recommended Timeline |
|---|---|---|---|
| 13 | Movement Joint/Structural Separation of Factories Not Identifiable in All Areas | Building Engineer to confirm the line of Structural separation of all structural elements, and confirm adequacy of structure either side of joint. Particular attention to be given to items identified in observations of this report. | 6-months |
| 14 | Movement Joint/Structural Separation of Factories Not Identifiable in All Areas | Building Engineer to update Structural drawings were necessary | 6-months |

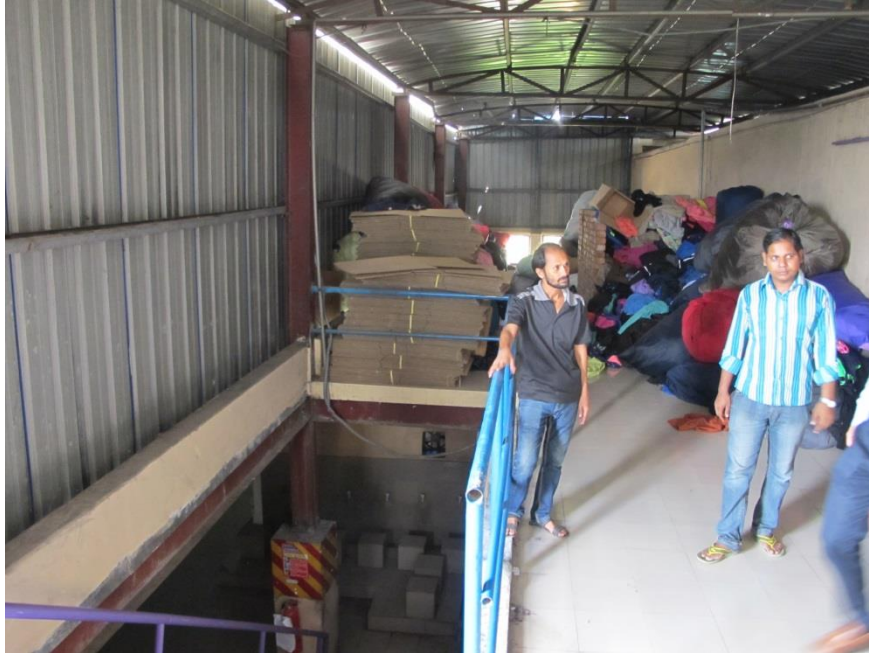
Steel Structure Bridges movement joint at roof level.

Location of movement joint in roof slab not apparent, none in steel roof cover.

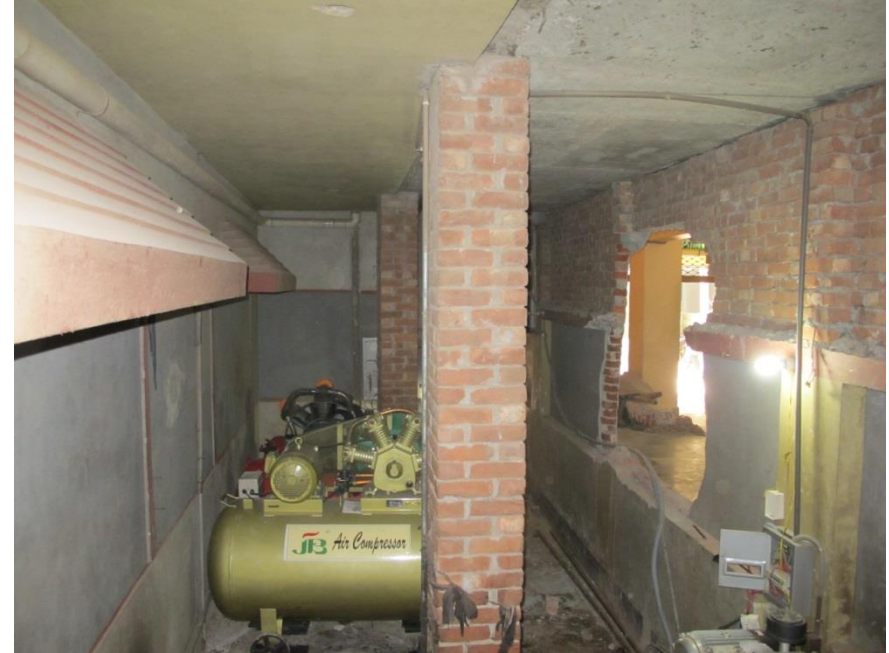
Masonry columns at ground floor apparently centred on movement joint

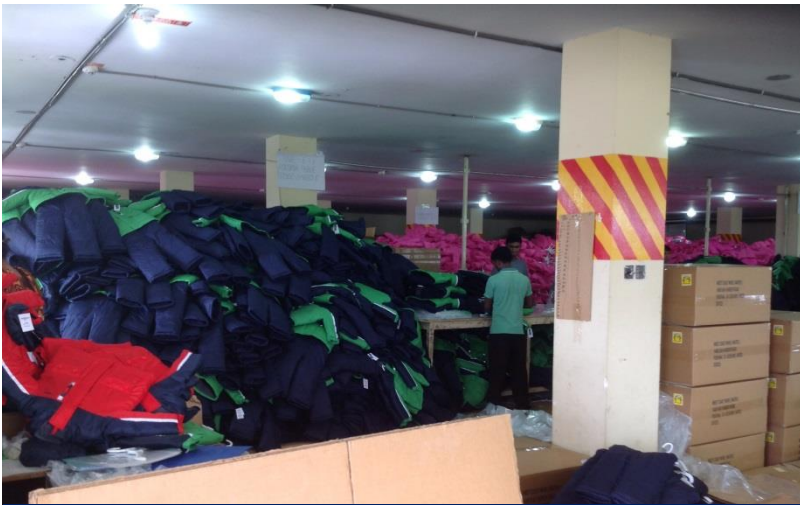
5<sup>th</sup> Floor: Uncontrolled Finished Goods storage

| Item No. | Observation | Recommended Action Plan | Recommended Timeline |
|---|---|---|---|
| 15 | Implementation of load management plan | Building engineer to clearly display allowable floor loading on all floors of factory building based on loading plans in DEA. | 6-months |
| 16 | Implementation of load management plan | Building Engineer to monitor storage on all upper floors and ensure compliance with loading plans. | 6-months |

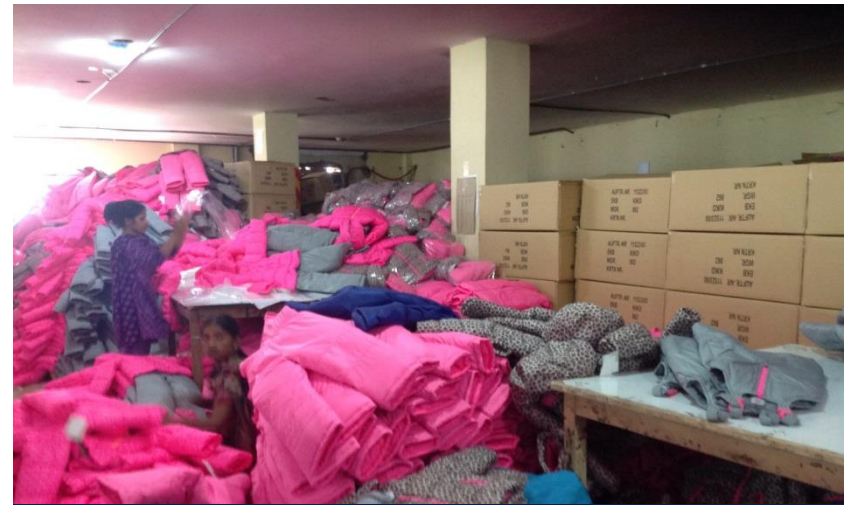
5<sup>th</sup> Floor: Uncontrolled Finished Goods storage

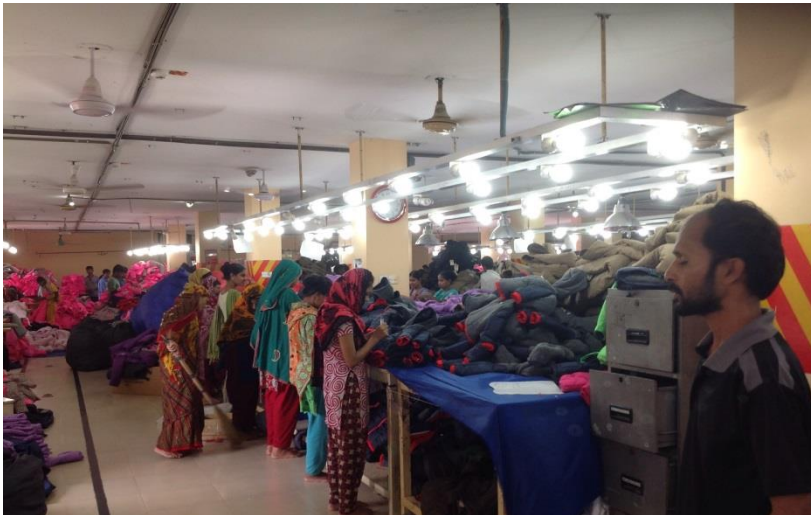
4<sup>th</sup> Floor: Uncontrolled Finished Goods storage

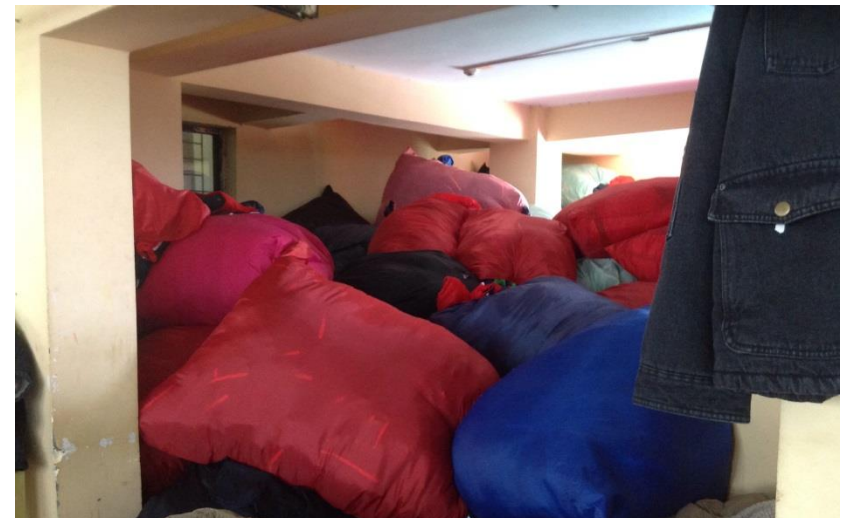
4<sup>th</sup> Floor: Uncontrolled Fabric storage

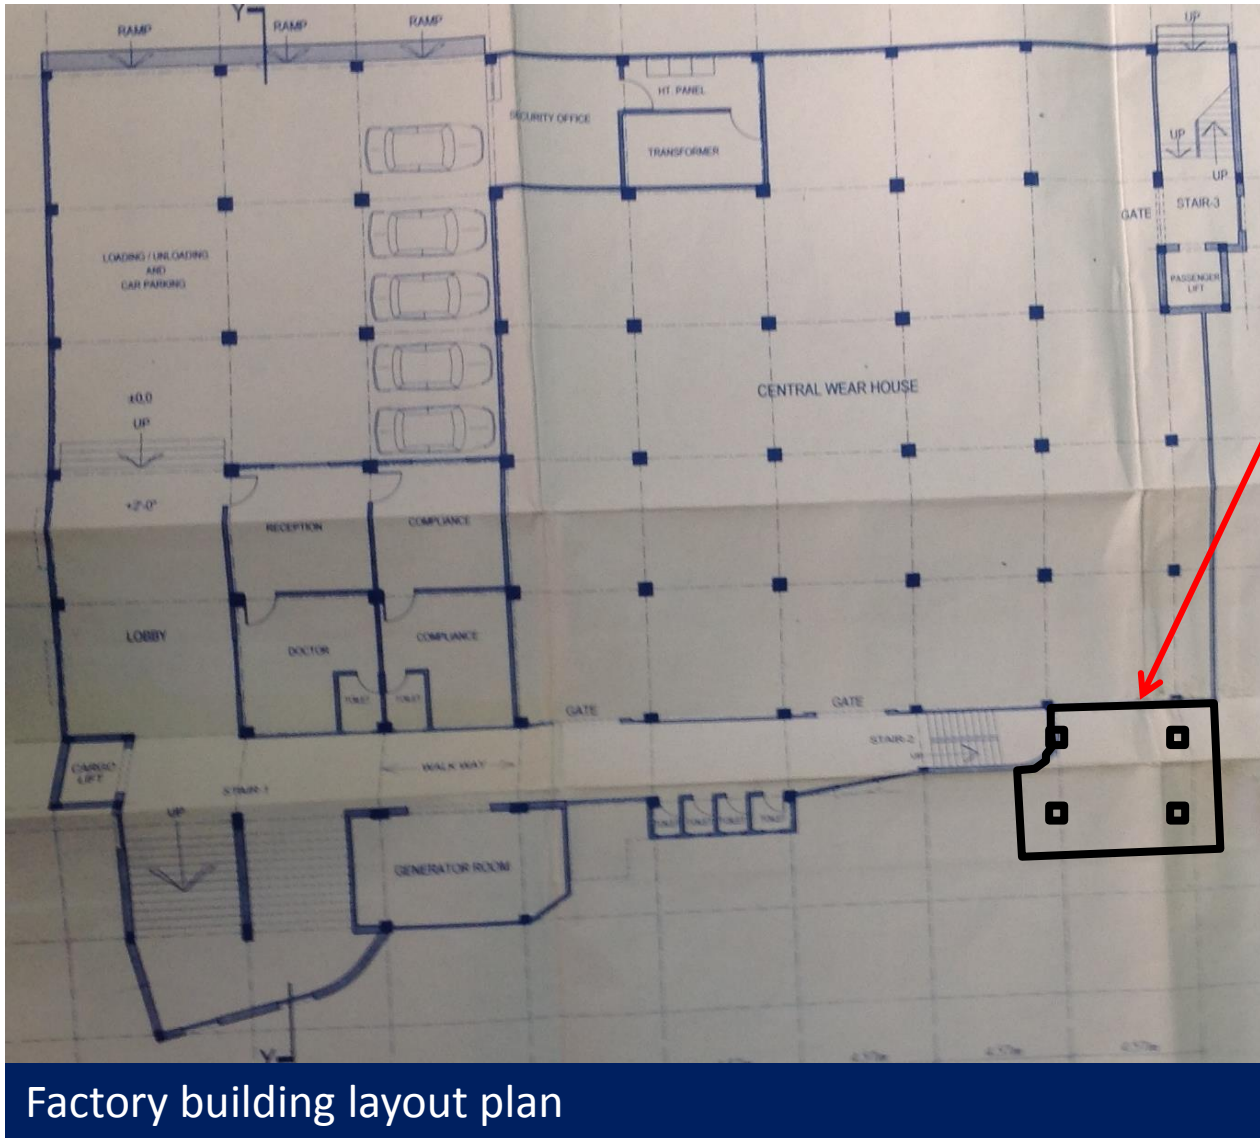
Factory building layout plan

Six storey concrete structure not present on Permit, Structural or Architectural drawings.

No documentation of any kind pertaining to this structure was present on day of factory Inspection

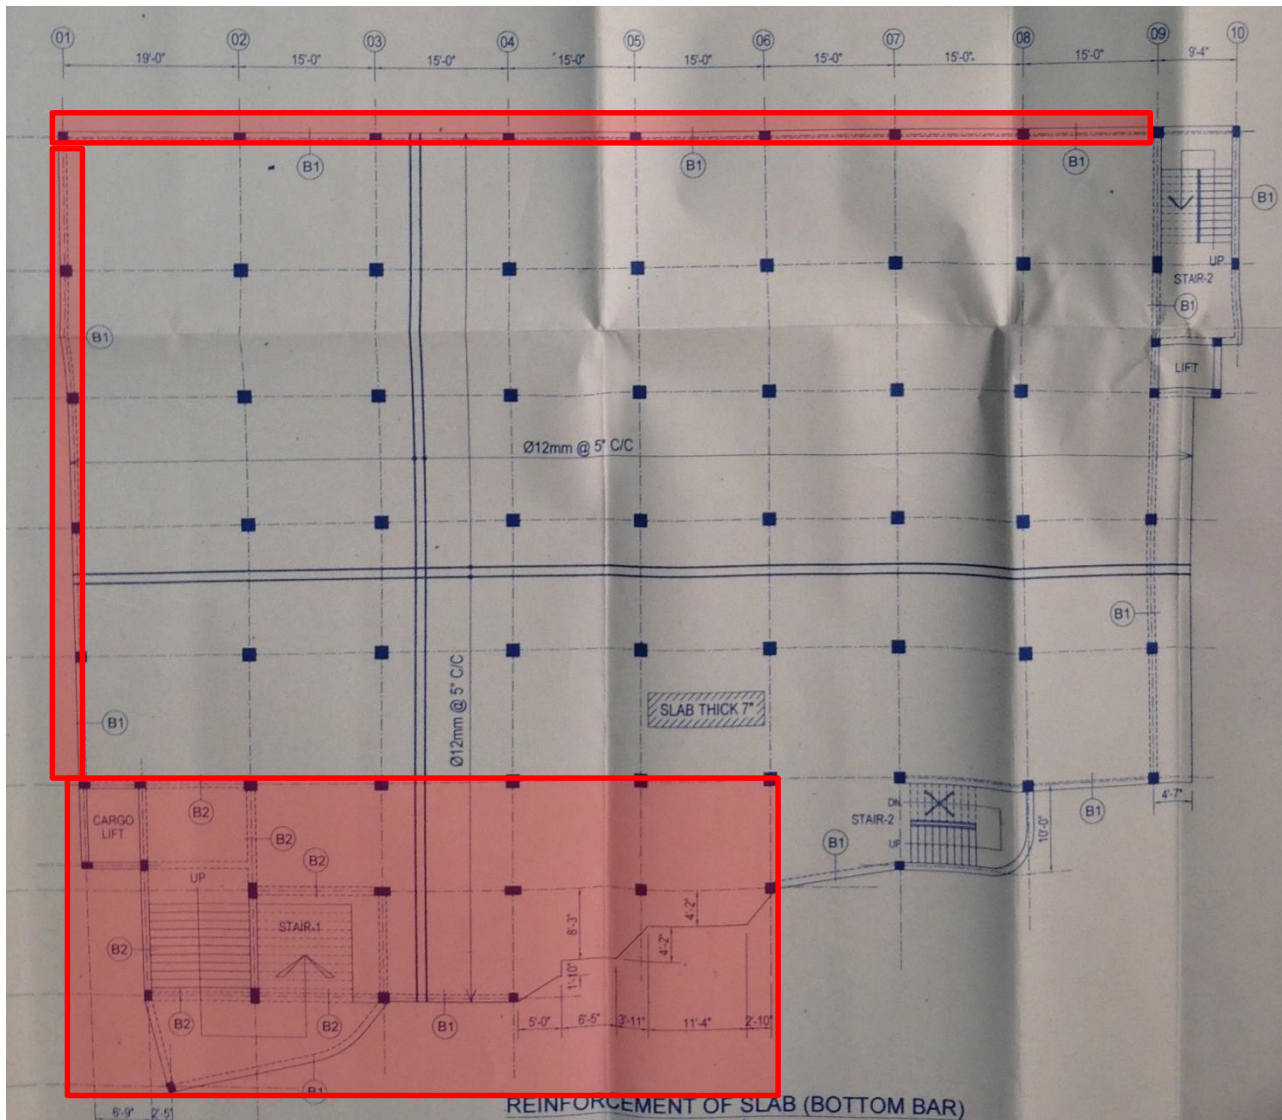
Practical beam layout

Perimeter beams shown on structural drawings not constructed.

As Built beam layout in Stair Core and Toilet area not consistent with structural drawings

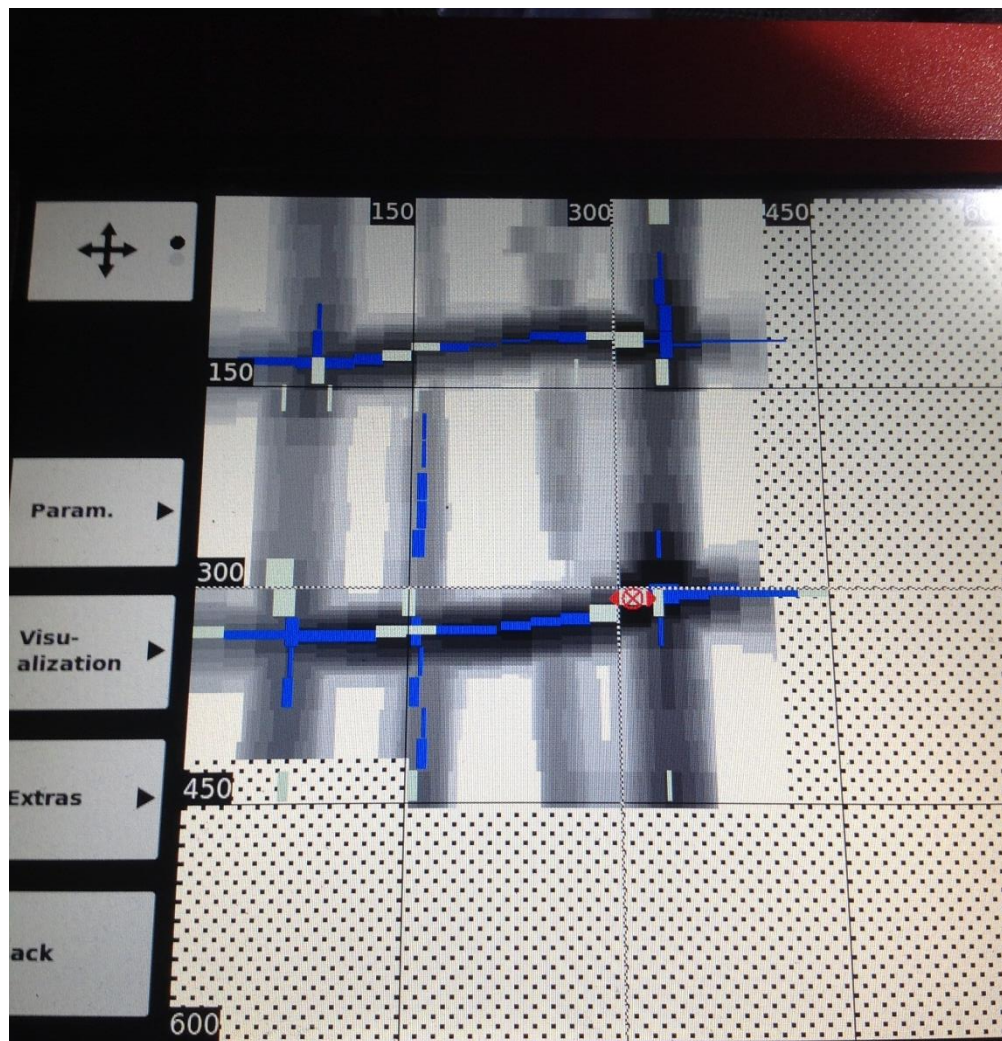
Ferro scan of internal column (C4) confirmed 4 bars in each face.

Column Reinforcement Schedule does not match As Built Construction.

For Column C4 Reinforcement Schedule specifies 16 No. - 25mm diameter bars.

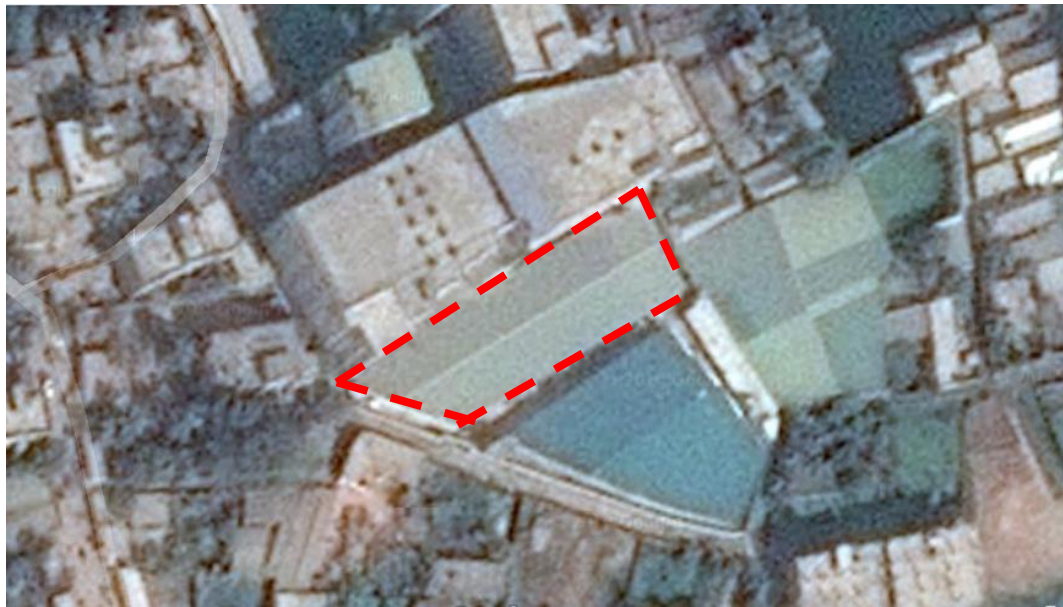
Single Storey Shed only present on Industrial Permit drawing.

No Structural drawing or Structural information pertaining to Single Storey Shed was present on day of inspection
