# **FIRE SAFETY INSPECTION REPORT**

## **PANASIA CLOTHING LTD**

**VOGRA, JOYDEBPUR**

April 28, 2014

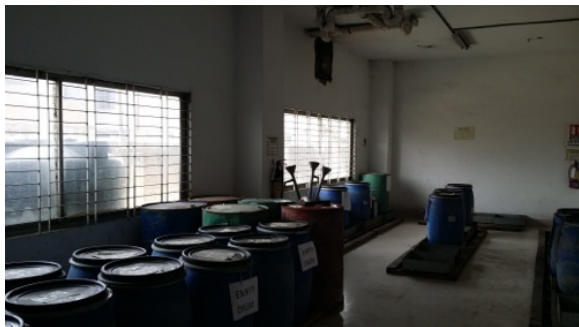
| No. | Category | Finding | Recommendation | Remediation Timeframe |
|---|---|---|---|---|
| F-1 | Fire Rated Construction | Hazardous materials / flammable liquid storage area located on the ground floor, inside the west stairwell, is not separated by fire-rated construction (openings, non-rated doors, penetrations). | Separate the hazardous materials / flammable liquid storage room by a minimum 2-hr fire-rated construction. Seal and/or protected all openings to maintain the required fire separations. | Within 3 months |

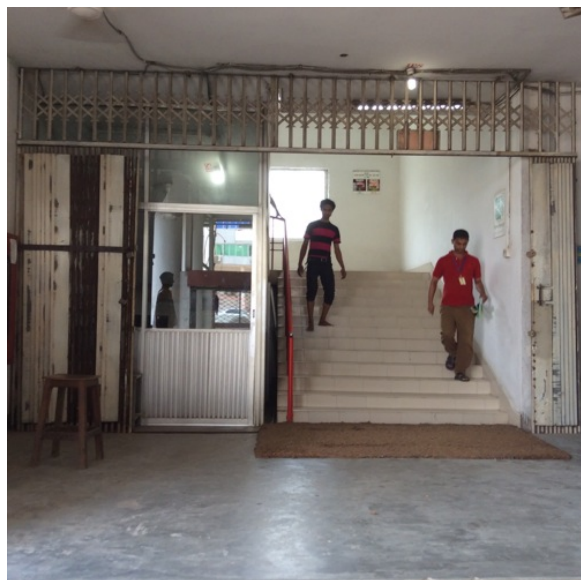
| F-2 | Fire Rated Construction | The exit stairs are not separated from work areas, and other spaces on each floor by fire-rated construction. This was reflected throughout the building on all floors. | Provide minimum 1.5-hr fire rated doors and seal all unprotected openings to separate the exit stairs from work areas and other building spaces on all floor levels. Ensure that the fire doors are self-closing and positive latching and that they are provided with fire exit (panic) hardware where serving production floors. | Within 3 months |

If fire doors are required to be held open for functional reasons, provide automatic-closing devices tied to the fire alarm system.

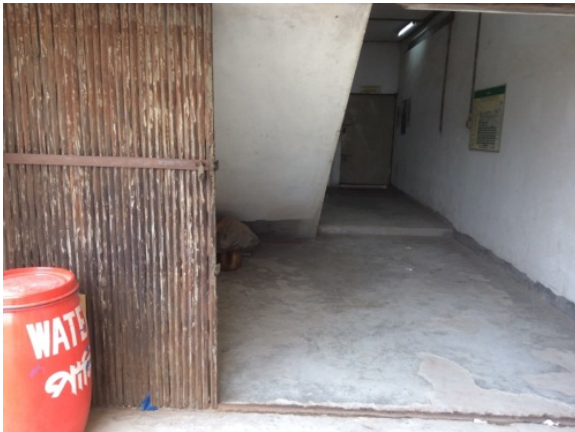
| F-3 | Egress | Egress doors / gates with locking features are provided at building exits, exit stairs, along egress routes, and exit discharge. This was reflected throughout the building on all floors. | Remove locking features from all egress doors / gates.<br><br>If locks are required for security reasons, utilize special door locking features complying with NFPA 101. | Immediate |

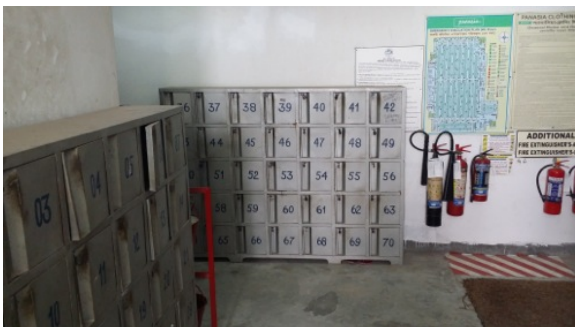
| F-4 | Egress | Storage lockers were provided primarily in the north and south exit stairwell on various floors. | Remove all storage from exit stairs and egress paths. | Immediate |

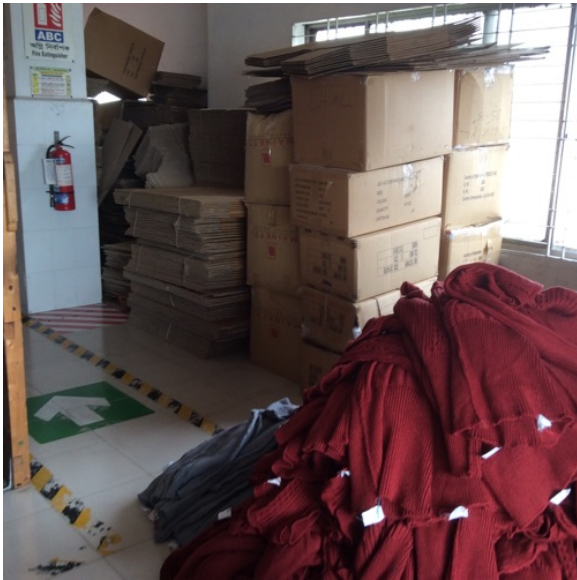
| F-5 | Egress | Storage was located in the egress path, on multiple floors throughout the building. | Keep egress paths and stairs clear of storage. | Immediate |

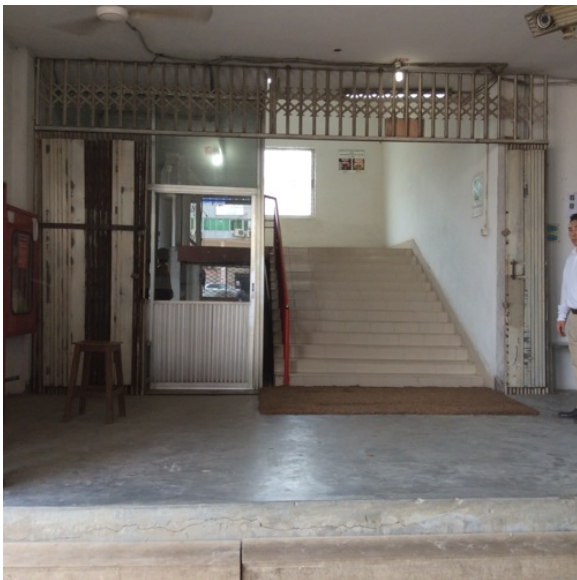
| F-6 | Egress | An office space was located underneath the south stairwell at ground floor. | Remove all storage/office space from exit stairs and egress paths. | Immediate |

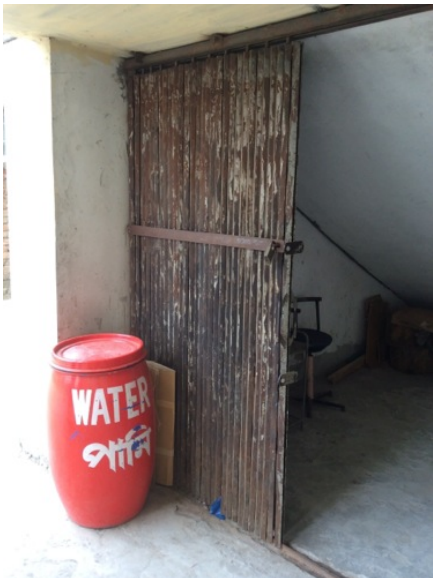
| F-7 | Egress | Collapsible gates / sliding doors are provided at building exits, exit stairs, along egress routes, and exit discharge. This was reflected throughout the building on all floors. | <p>Replace all gates / sliding doors along the means of egress with side-hinged, swinging egress doors.</p> <p>If locks are required for security reasons, utilize special door locking features complying with NFPA 101.</p> | Within 1 month |

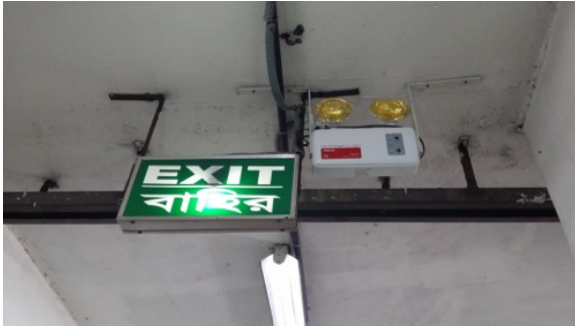
| F-9 | Egress Lighting | Manual on-off switch is provided for emergency lighting units, located throughout the building on various all floors. | Remove manual on/off switches from emergency lighting units to prevent them from being switched off. | Within 1 month |
