# **FIRE SAFETY INSPECTION REPORT**

**N.A.Z BANGLADESH LTD.**

**5, BISHUYA, KURIBARI, MIRZAPUR, GAZIPUR**

August 21, 2014

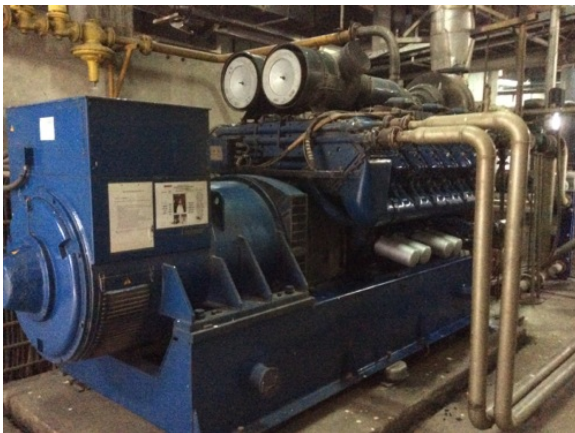
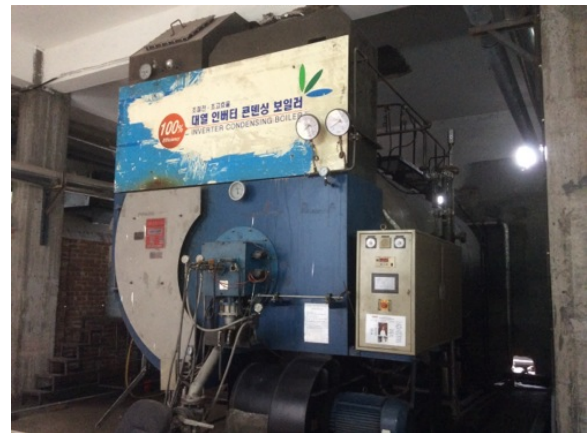
| No. | Category | Finding | Recommendation | Remediation Timeframe |
|---|---|---|---|---|
| F-1 | Fire Rated Construction | The boiler and generator room located on the ground floor, is not separated by fire-rated construction, openings, non-rated doors, and penetrations. | Separate the boiler and generator room by a minimum 2-hr fire-rated construction. Seal and/or protected all openings to maintain the required fire separations | Within 3 months |

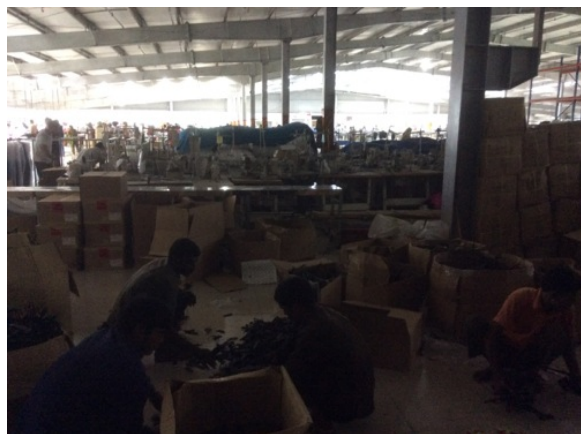
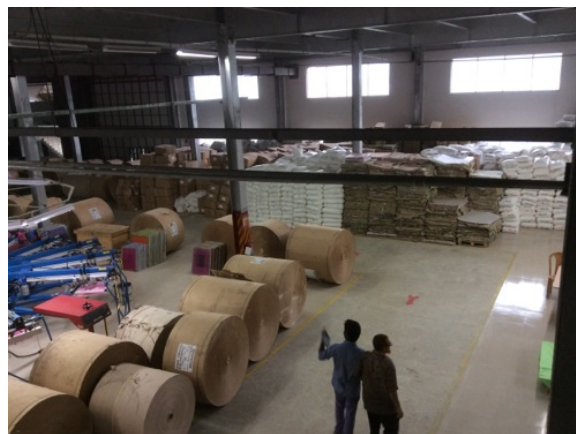
| F-2 | Fire Rated Construction | Areas used for combustible storage on the ground and first floors are not separated by fire-rated construction. | <p>Provide dedicated storage rooms separated by minimum 1-hr fire-rated construction.</p> <p>Where separate storage rooms are not feasible, provide defined storage areas and limit the storage arrangement as follows:</p> <ul style="list-style-type: none"> <li>- Maximum height of 2.4m and maximum area of 23m<sup>2</sup></li> <li>- If sprinkler protected: maximum height of 3.66m and maximum area of 93m<sup>2</sup></li> </ul> <p>Separate areas of unenclosed combustible storage by a minimum clear distance of 3m.</p> | Within 3 months |

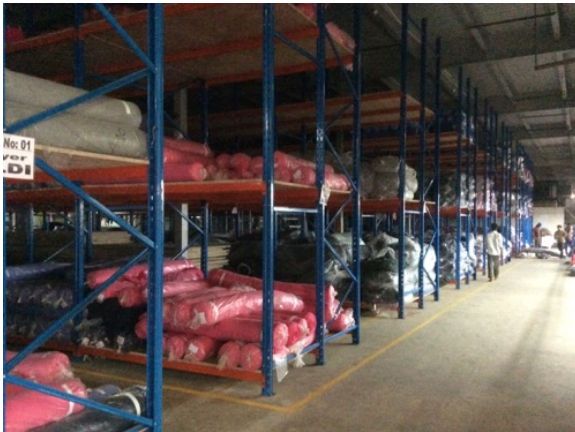
| F-3 | Fire Rated Construction | Storage rooms used for combustible storage on the ground floor are not separated by fire-rated construction. | Provide dedicated storage rooms separated by minimum 1-hr fire-rated construction. | Within 3 months |

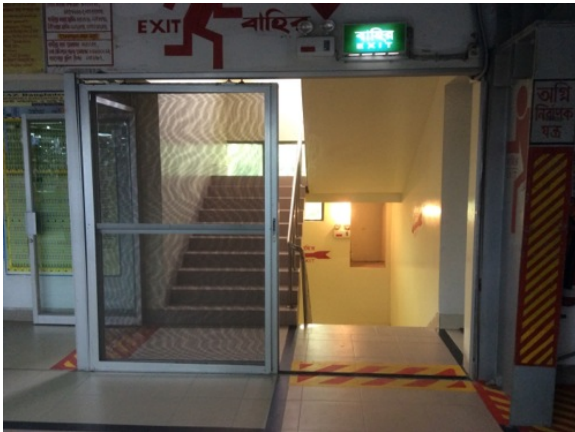
| F-4 | Fire Rated Construction | The exit stairs are not separated from work areas, and other spaces on each floor by fire-rated construction. This was reflected throughout the building on all floors. | Provide minimum 1.5-hr fire rated doors and seal all unprotected openings to separate the exit stairs from work areas and other building spaces on all floor levels. Ensure that the fire doors are self-closing and positive latching and that they are provided with fire exit (panic) hardware where serving production floors.<br><br>If fire doors are required to be held open for functional reasons, provide automatic-closing devices tied to the fire alarm system. | Within 3 months |

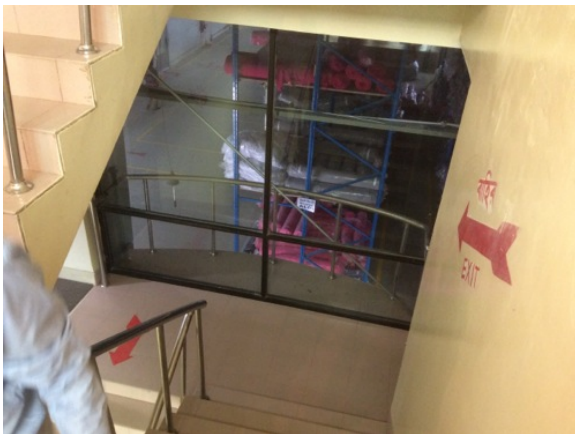
| F-5 | Fire Rated Construction | Unsealed penetrations and openings on all floors are located in each exit stair enclosures. | Seal all penetrations and openings in exit stair enclosure walls to maintain the fire separation. | Within 3 months |

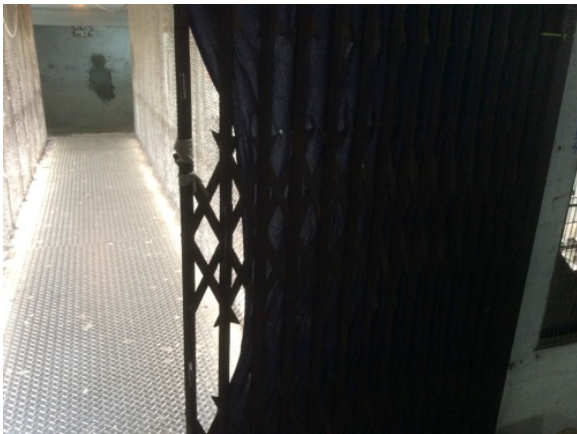
| F-7 | Egress | <p>Egress doors / gates with locking features are provided at building exits, exit stairs, along egress routes, and exit discharge. This was reflected throughout the building on all floors.</p> | <p>Remove locking features from all egress doors / gates.</p> <p>If locks are required for security reasons, utilize special door locking features complying with NFPA 101.</p> | Immediate |

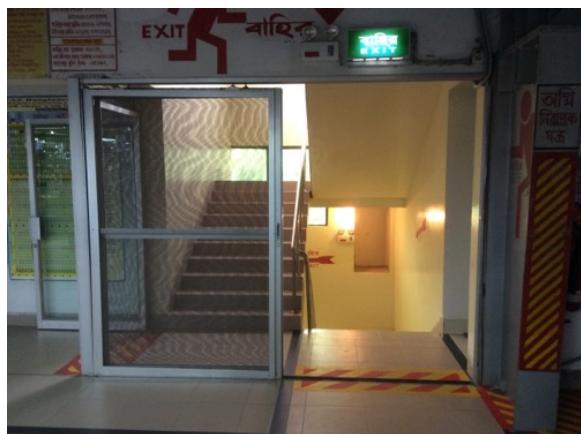
| F-8 | Egress | Collapsible gates / sliding doors are provided at building exits, exit stairs, along egress routes, and exit discharge. This was reflected throughout the building on all floors. | Replace all gates / sliding doors along the means of egress with side-hinged, swinging egress doors.<br><br>If locks are required for security reasons, utilize special door locking features complying with NFPA 101. | Within 1 month |

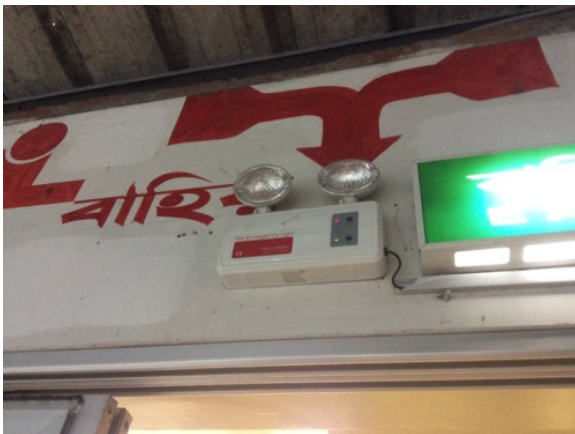
| F-12 | Egress Lighting | Manual on-off switch is provided for emergency lighting units. This was reflected throughout the building in various locations. | Remove manual on/off switches from emergency lighting units to prevent them from being switched off. | Within 1 month |
