FIRE SAFETY INSPECTION REPORT

SONIA SWEATERS LTD.

ACCORD
on Fire and Building Safety in Bangladesh

May 3, 2014

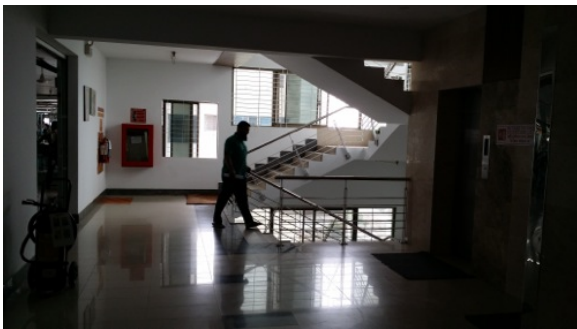
No.	Category	Finding	Recommendation	Remediation Timeframe
F-1	Fire Rated Construction	The exit stairs are not separated from work areas, and other spaces on each floor by fire-rated construction. This was reflected throughout the building on all floors.	<p>Provide minimum 1.5-hr fire rated doors and seal all unprotected openings to separate the exit stairs from work areas and other building spaces on all floor levels. Ensure that the fire doors are self-closing and positive latching and that they are provided with fire exit (panic) hardware where serving production floors.</p> <p>If fire doors are required to be held open for functional reasons, provide automatic-closing devices tied to the fire alarm system.</p>	Within 3 months

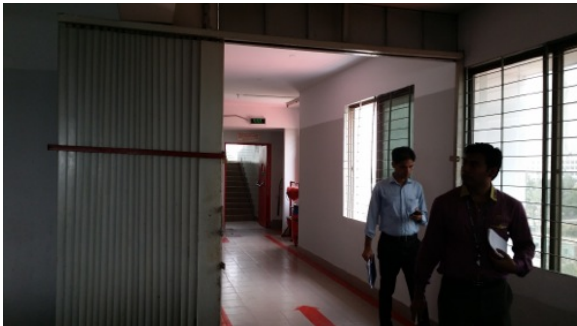
F-2	Egress	<p>While most doors in the Sonia Sweaters building were adequate fire rated doors with the proper locking system. However some egress doors (West stairwell) were of sliding/rolling type gates and were lockable by pad lock, located at building exits, exit stairs, along egress routes, and exit discharge</p>	<p>Remove locking features from all egress doors / gates.</p> <p>If locks are required for security reasons, utilize special door locking features complying with NFPA 101.</p>	Immediate
-----	--------	--	---	-----------

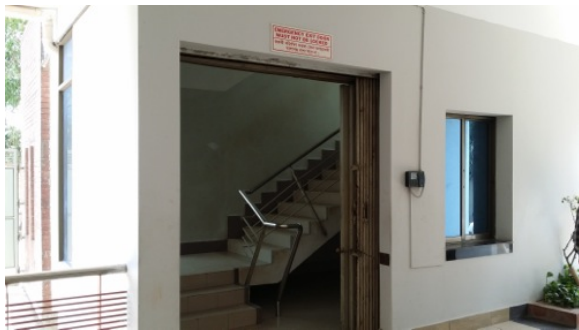
F-3	Egress	<p>Most egress doors within in the Sonia Sweaters LTD building were proper fire rated doors, however egress doors in the West stairwell were of collapsible gates / sliding doors, located at building exits, exit stairs, along egress routes, and exit discharge. This was reflected on all floors preceding it.</p>	<p>Replace all gates / sliding doors along the means of egress with side-hinged, swinging egress doors.</p> <p>If locks are required for security reasons, utilize special door locking features complying with NFPA 101.</p>	<p>Within 1 month</p>
-----	--------	--	---	-----------------------
