Temakaw Fashion Ltd KAW Garments Industry Ltd

808/1 & 808/2 Shewrapara, Mirpur, Dhaka.
(+23.790730N, 90.37535E)

06 May 2014

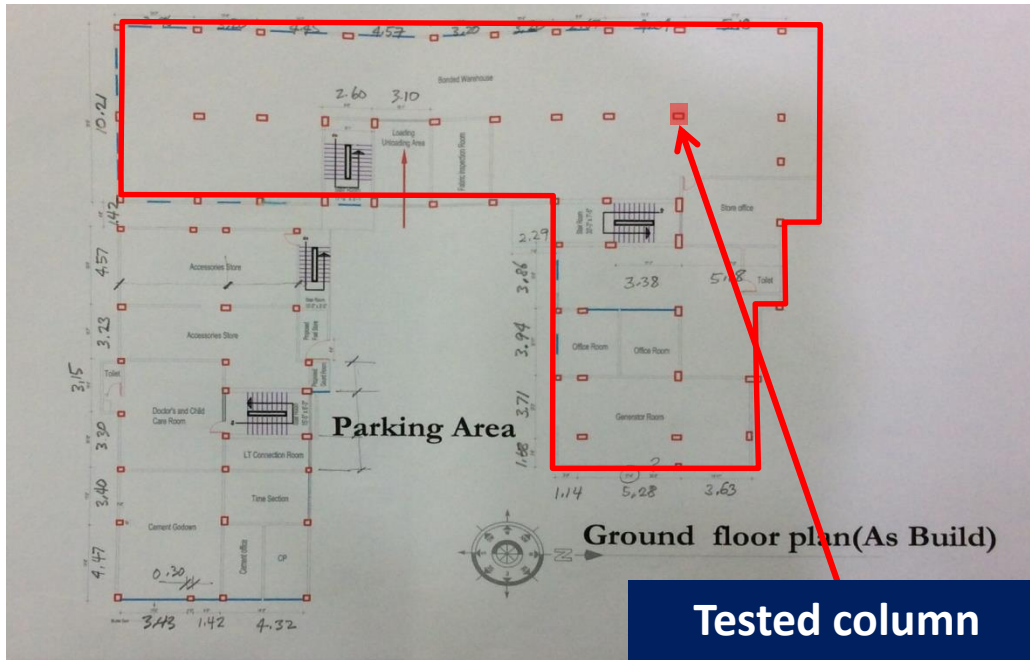
Typical column layout

**Columns appear to be stressed to a
high level and require immediate
review**

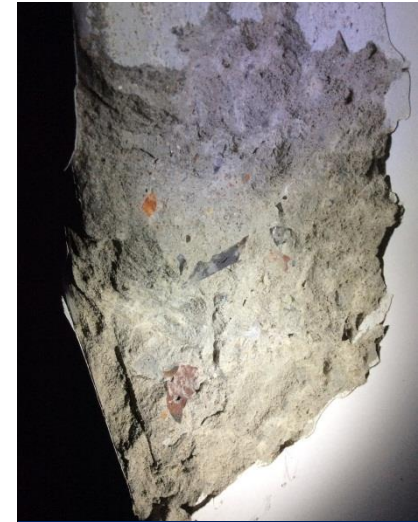
Tested Ground Floor Column – Stone Chips

Cursory calculations indicate that columns are stressed to a high level and require immediate review.

Building Engineer to perform detailed calculations including a Detail Engineering Assessment (see attached scope) and concrete tests to prove adequacy of column sizes, and (if required):

- Reduce loads by vacating floors
- Reinforce columns

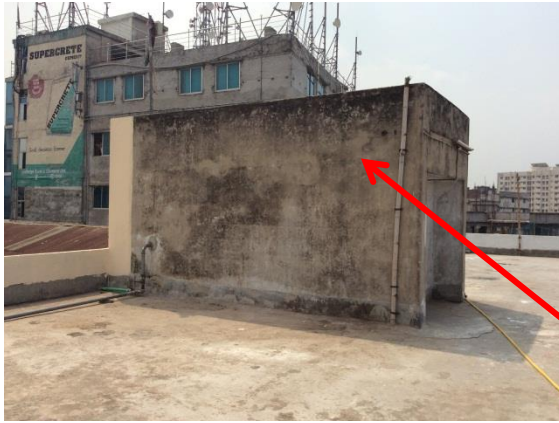
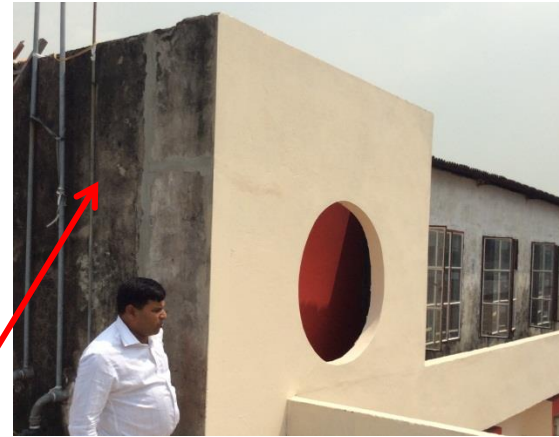
**Concrete water tanks
above roof of stairs**

Building Engineer to prepare controlled loading plans, based on floor slab and column capacity, for all floors which will designate allowable storage density and where storage may be placed.

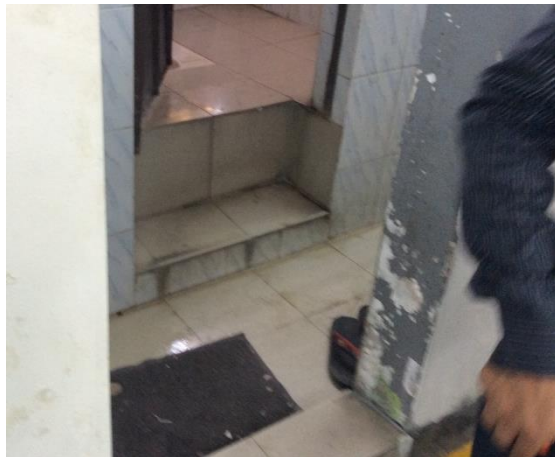
Build up on toilet floors

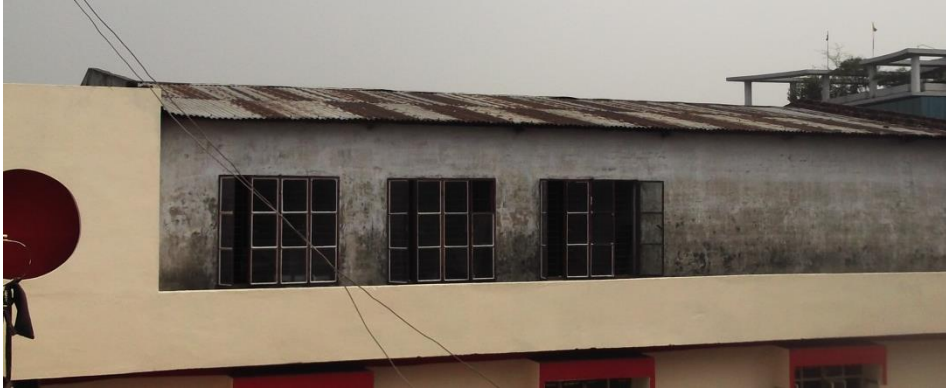
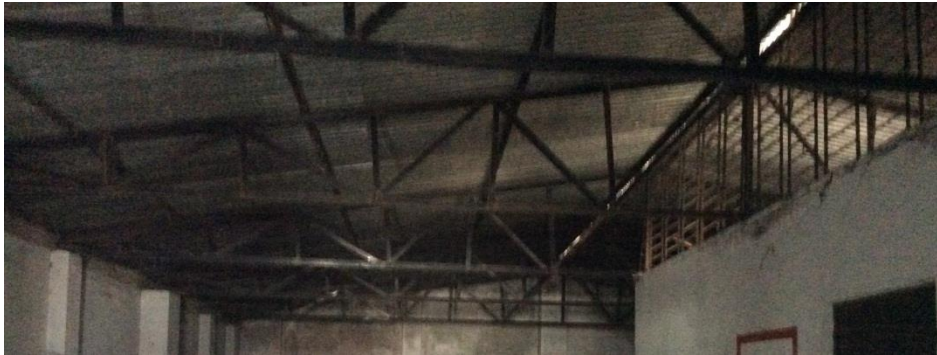
Steel Roof Structures

Structural adequacy of steel roof structures

Building Engineer to check adequacy of the steel roof structure for code specified live load and wind loads

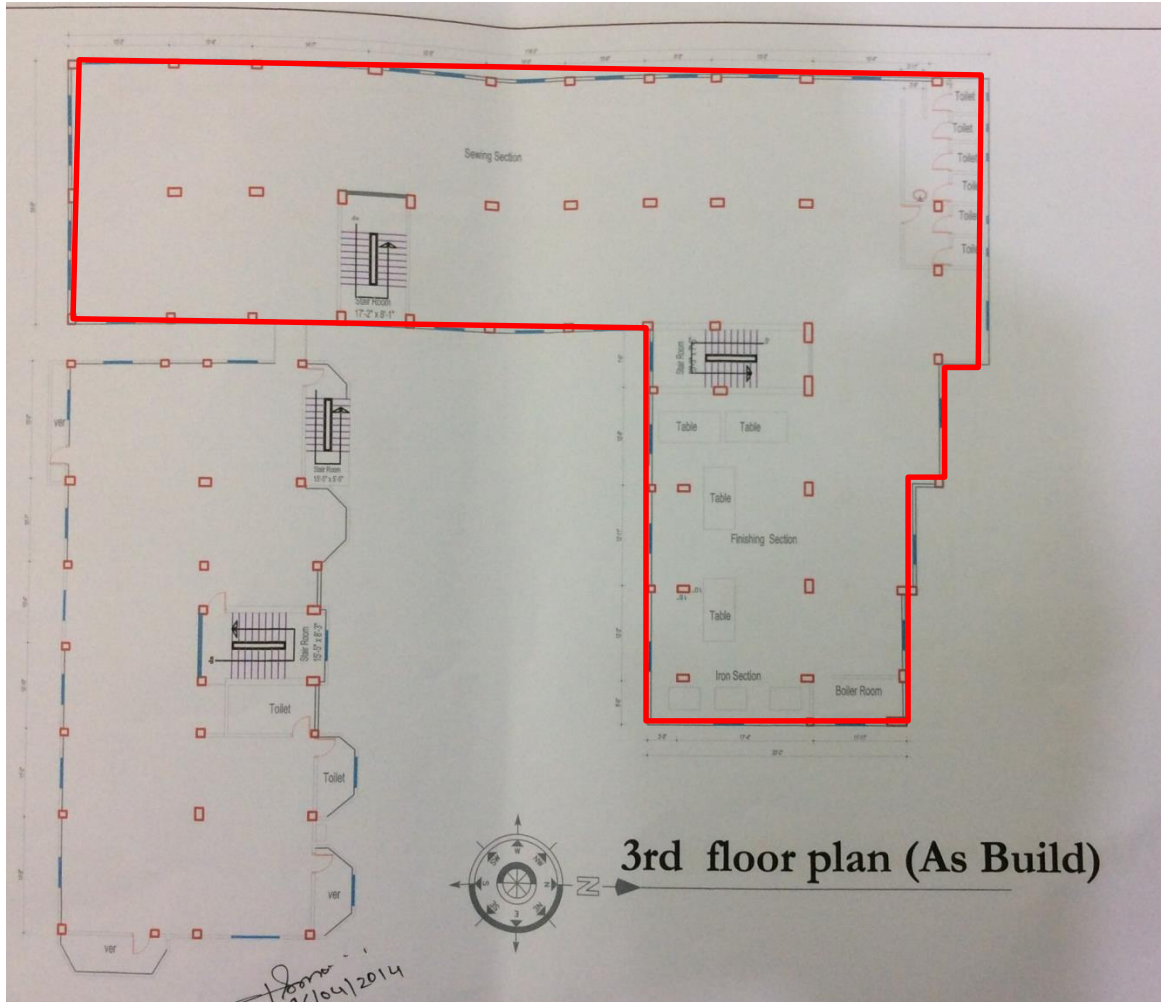
Typical floor plan

Structural drawings for Building 2 - Temakaw were not available

Column sizes/grid dimensions do not all correspond with as built drawings.

Building Engineer as-built survey drawings to be updated.

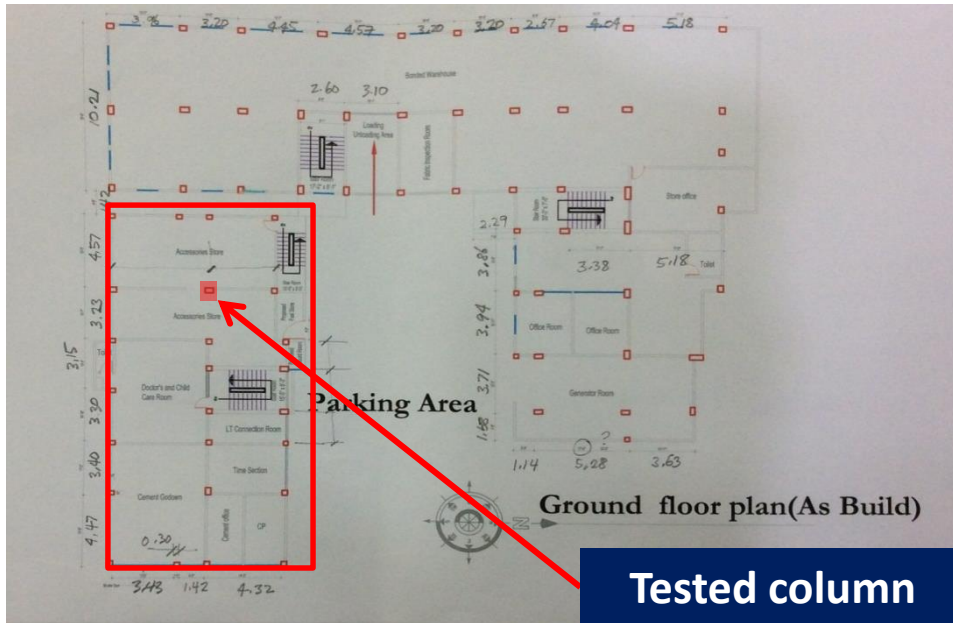
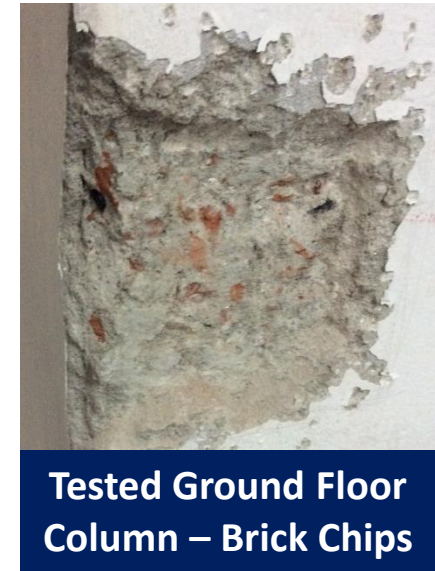
Typical column layout

**Columns appear to be stressed in
excess of normal design limits**

Cursory calculations indicate that columns are stressed in excess of normal design limits and require review.

Building Engineer to review design, loads and column stresses of columns and conduct concrete tests to prove adequacy of all column sizes, and (if required):

- Reduce loads by vacating floors
- Reinforce columns

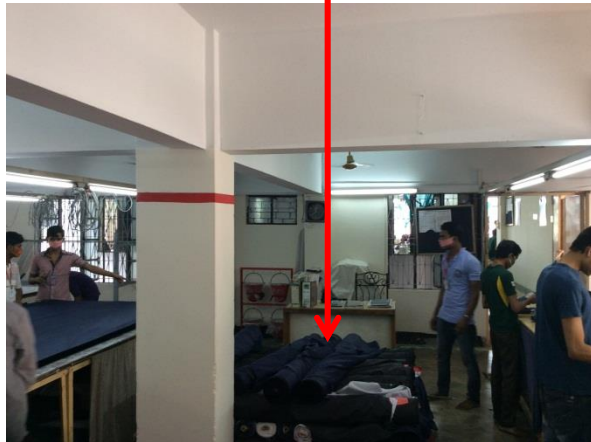
Floor loads at 5th floor

Management of floor loads & water tank loads at roof level

Building Engineer to prepare controlled loading plans, based on floor slab and column capacity, for all floors which will designate allowable storage density and where storage may be placed.

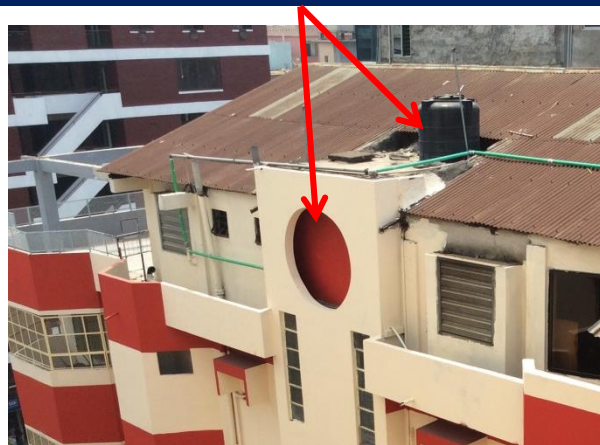
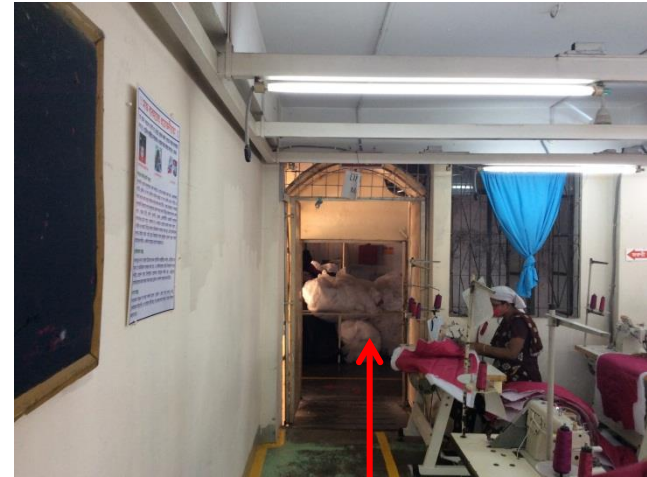
2,000 litre plastic and concrete water tank above roof of stairs

Floor loads at 6th floor

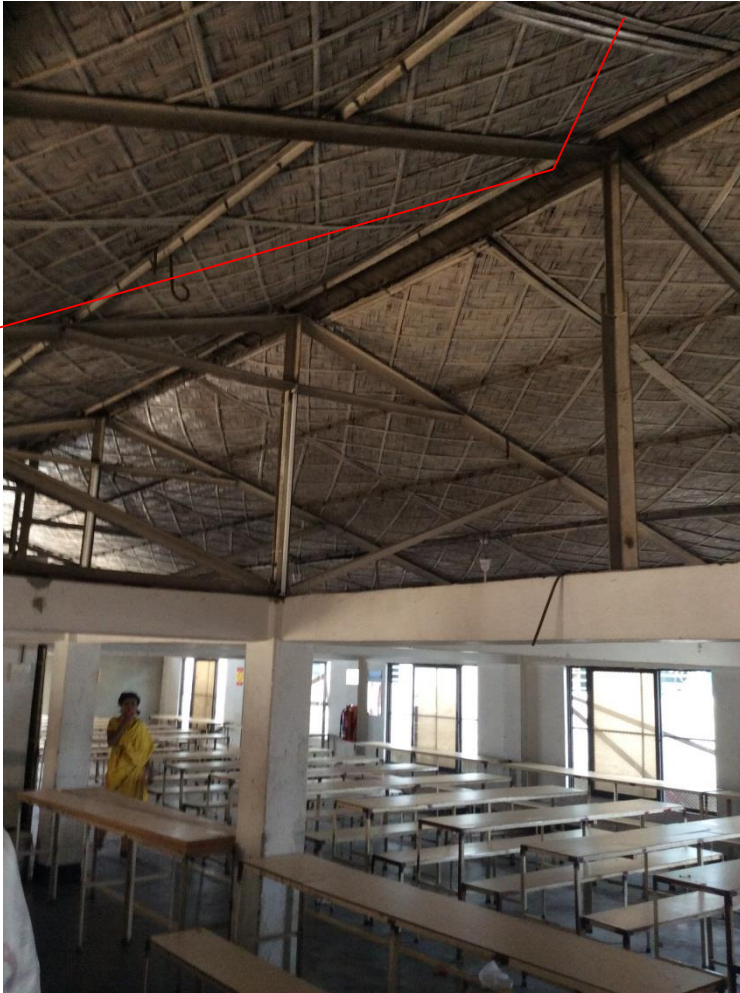
Steel Roof Structures

Structural adequacy of steel roof structures

**Building Engineer to
check adequacy of the
steel roof structure for
code specified live load
and wind loads**

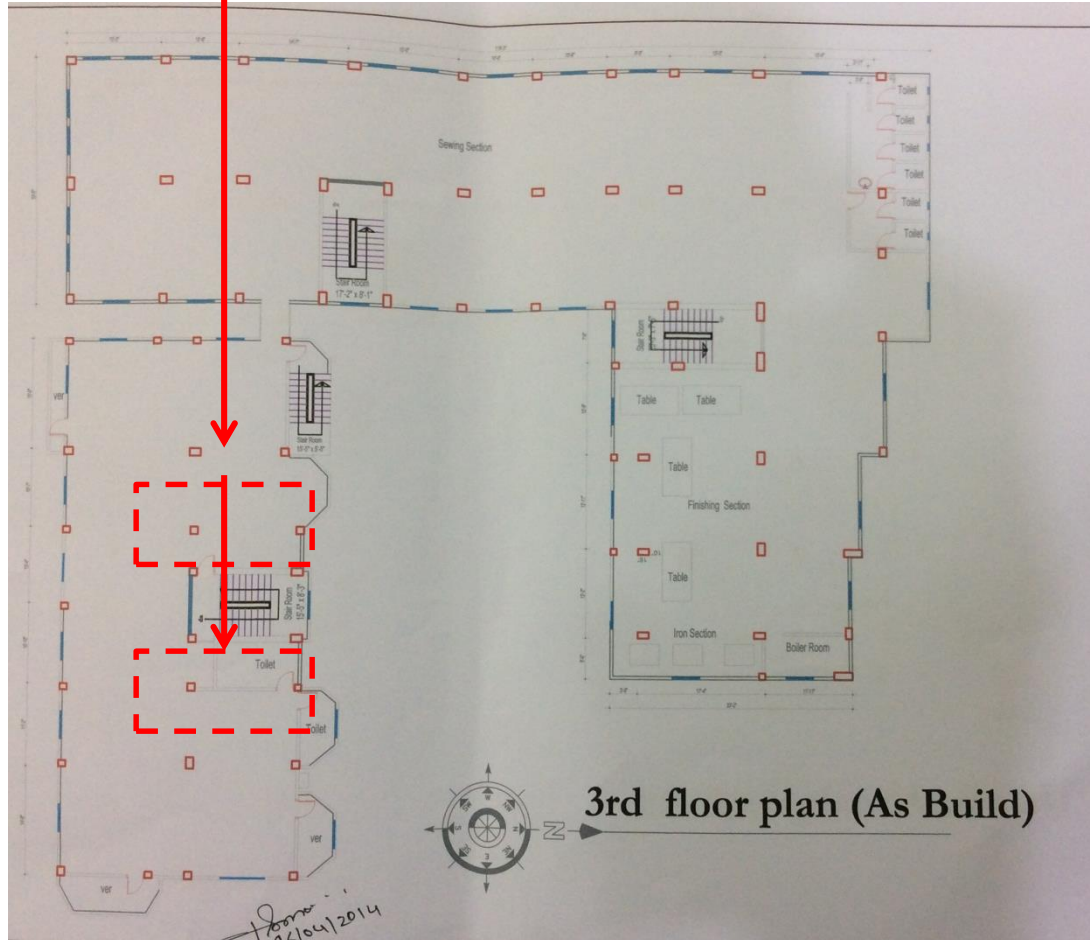
Typical floor level

Column do not line up contrary to layout shown on the survey drawings

Structural drawings for Building 1 KAW were not available

Column sizes do not all correspond with as built drawings.

Building Engineer as-built survey drawings to be updated.
