# **Baxter Brenton (BD) Ltd**

SFB #7, 1st Floor, DEPZ(Old Zone), Ganakbari, Ashulia, Savar, Dhaka - 1349  
(23.94997N 90.27216E)

10th May 2014

# Observations

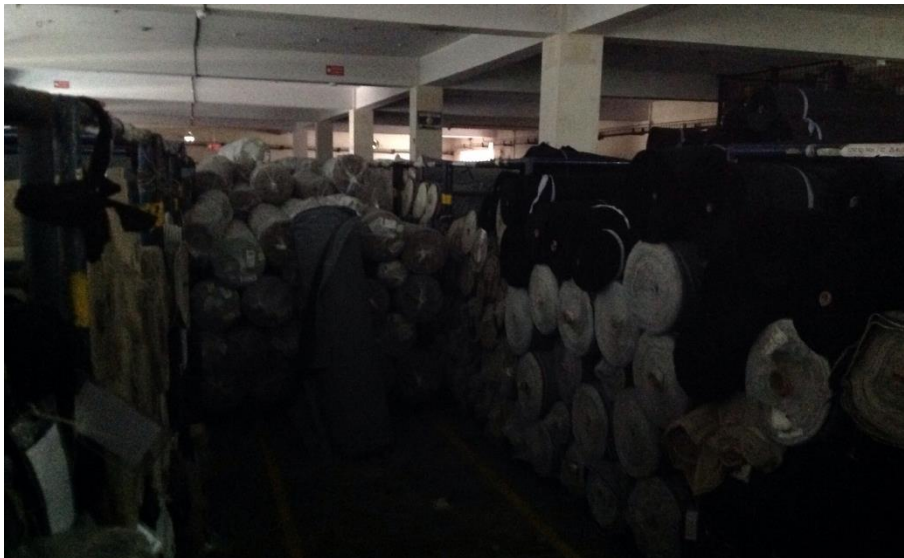
- Areas of very high loading were observed in the fabric storage area at 1<sup>st</sup> Floor level of Building 2.
- This of particular concern as extensive cracking to the top of the 1<sup>st</sup> Floor slab at the location of the beams was evident throughout the floor.
- Further areas of high loading were noted at the water tanks and storage rooms at roof level of both buildings, and the storage areas at 2<sup>nd</sup> Floor level of Building 1.
- Building Engineer to check that the different slab constructions have been adequately designed to accommodate these loadings.
- A Loading Plan for all floor plates is to be produced, implemented on the floor and actively managed.

Building 2 – Stacked rolled fabric at 1<sup>st</sup> Floor level

| Item No. | Observation | Recommended Action Plan | Recommended Timeline |
|---|---|---|---|
| 1 | Heavy loading, particularly at 1st Floor level of Building 2 | Building Engineer to carry out a design check for heavy loads associated with the water tanks and storage areas as indicated, and advise on any necessary alterations, taking account of floor capacity. | 6-weeks |
| 2 | Heavy loading, particularly at 1st Floor level of Building 2 | Building Engineer to produce a loading plan for all floor plates within the Main Factory Buildings, giving consideration to floor capacity and column capacity. | 6-weeks |

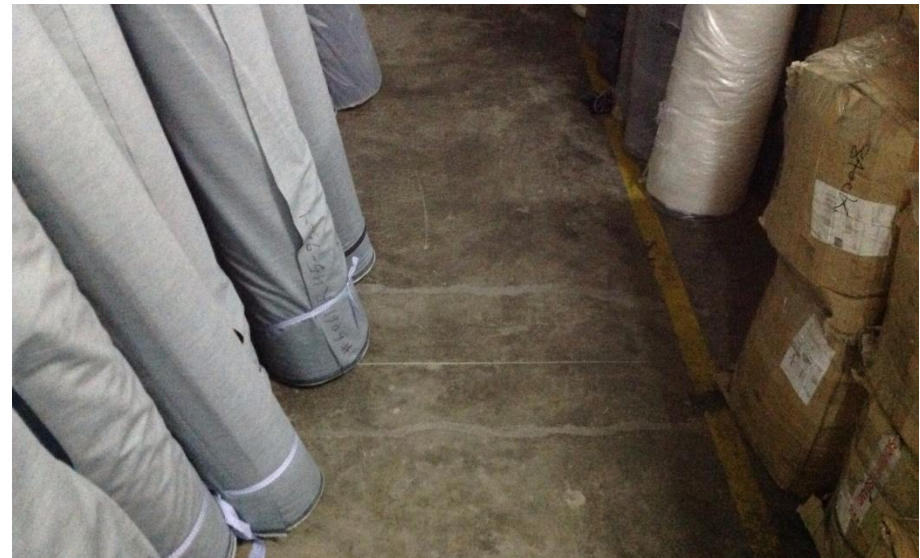
Building 2 – Cracking of slab along beam lines at 1<sup>st</sup> Floor

- Cracking was observed in a number of locations throughout the buildings.
- Extensive cracking was observed on the 1<sup>st</sup> Floor slab of Building 2 at the location of the support beams, and to areas of the façade where the walkways meet both the buildings as highlighted in Observations section above.
- Hairline cracking was observed to a number of beam soffits in both buildings at all floor levels. Cracking to areas of the façade and the stair-core walls of Building 2 was also observed.
- A number of cracks have been filled and / or painted over, particularly at Ground Floor level.
- Building Engineer to investigate the cause of the cracking and to carry out remedial works to the structure as required.

| Item No. | Observation | Recommended Action Plan | Recommended Timeline |
|---|---|---|---|
| 11 | Cracking | Monitor cracks to beams, slabs, columns and facades.<br>Building Engineer to investigate if cracking extends beyond the external render / internal plastering. | 6-months |
| 12 | Cracking | Building Engineer to advise on load reduction and repair and strengthening of the structure if required. | 6-months |

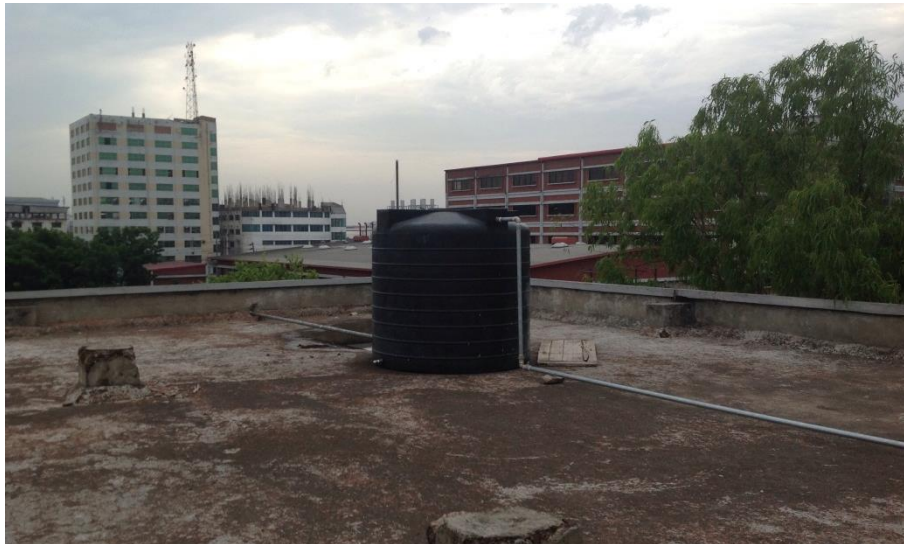
Building 1 – 5000 litre water tank at Roof Level

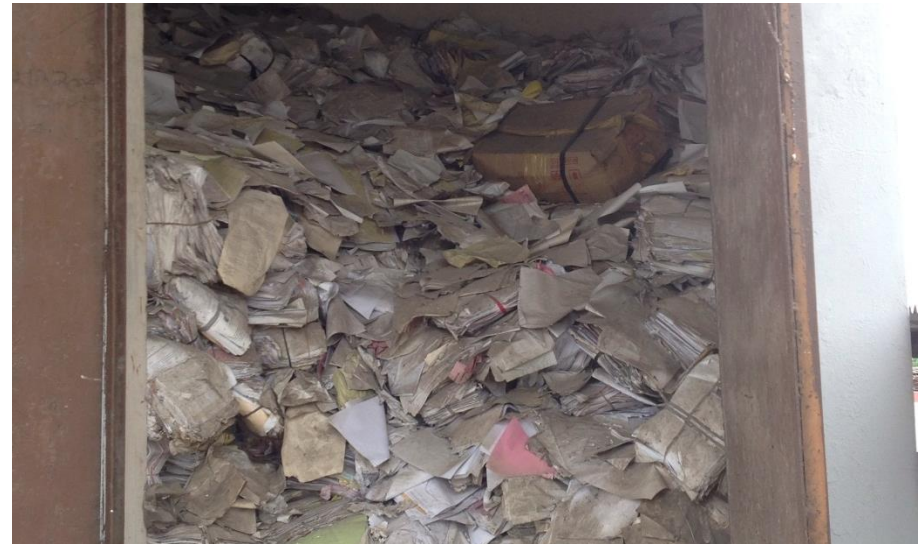
Building 1 - Storage room above lift-core at Roof level

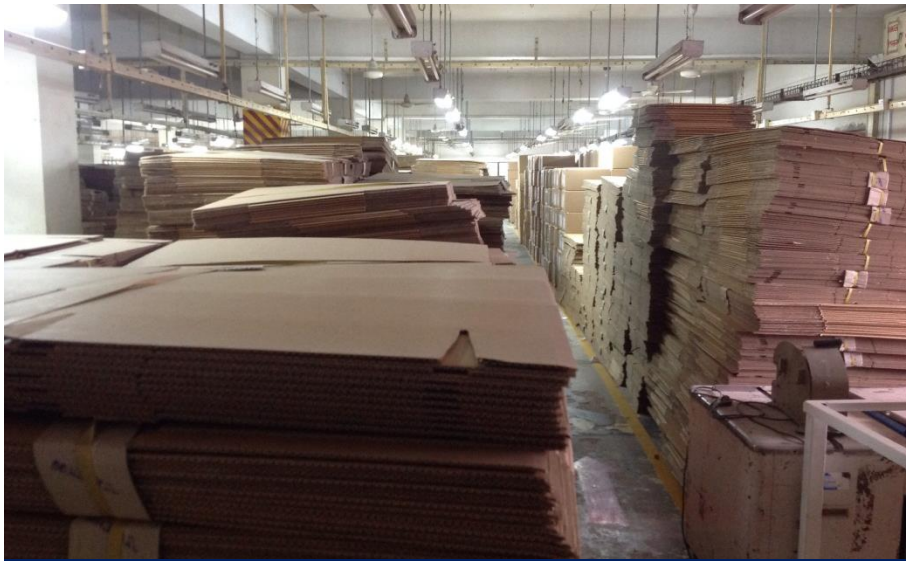
Building 1 – Cardboard/Boxed Goods Storage at 2<sup>nd</sup> Floor

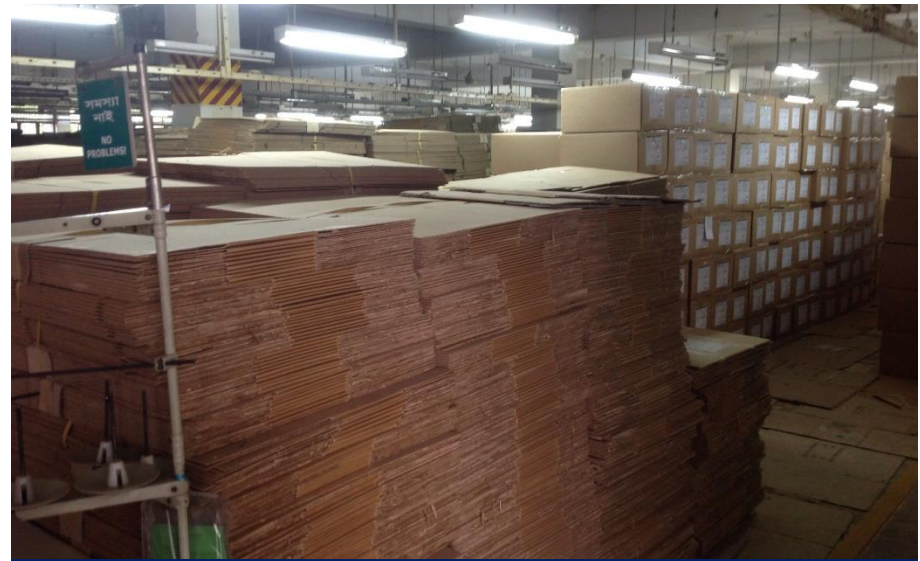
Building 1 – Cardboard/Boxed Goods Storage at 2<sup>nd</sup> Floor

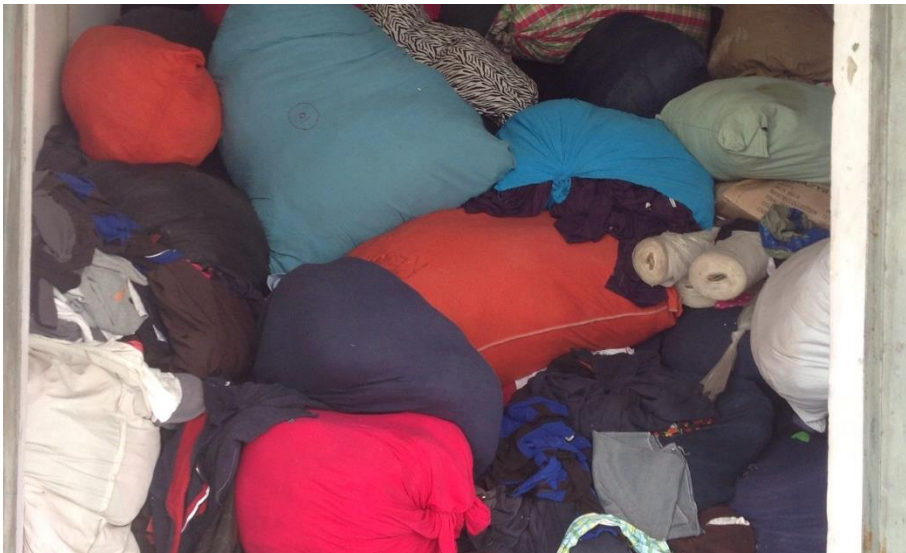
Building 2 - Storage room above lift-core at Roof level

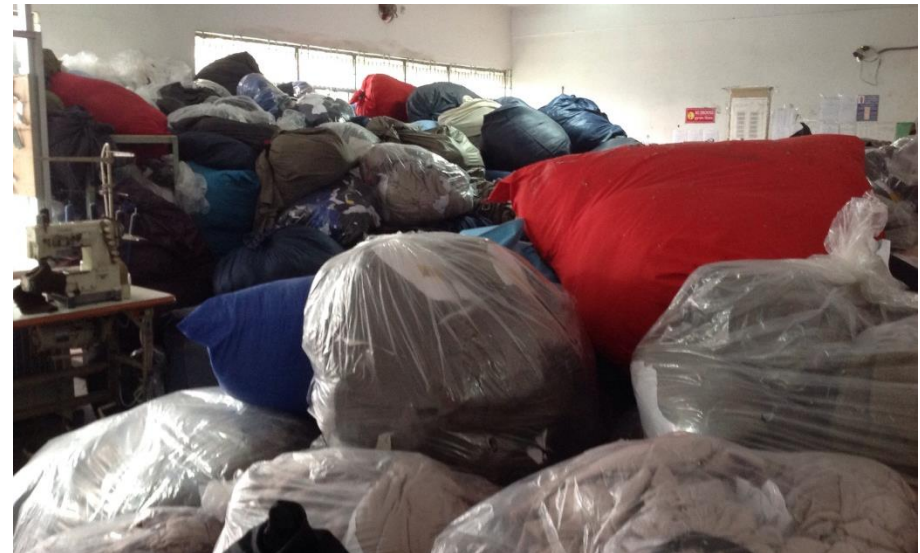
Building 2 - Storage room in 'Canteen' area at 1<sup>st</sup> Floor

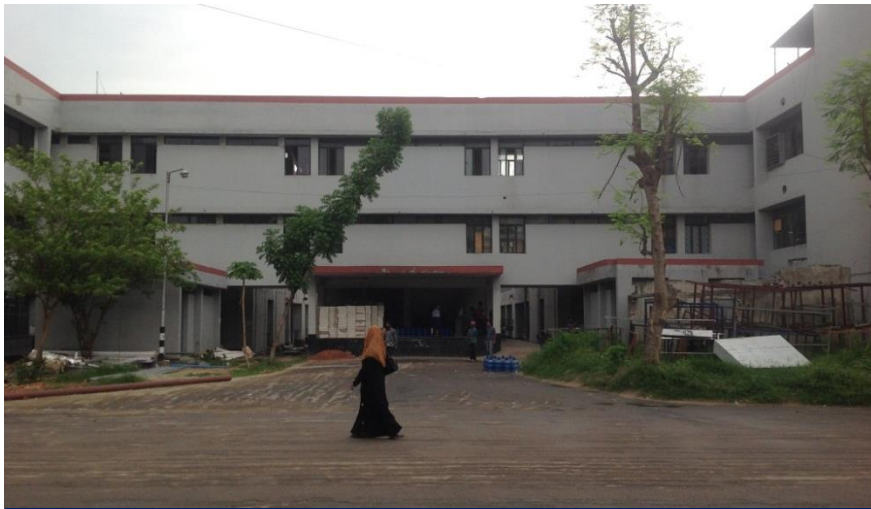
- The design of these structures, particularly the connection detail with the buildings, is not clear.
- Exposed slab and wall reinforcement in the structures was observed to run through, thereby providing connection with the building.

- Relative movement between the buildings and the structures does not appear to have been allowed for, and extensive cracking was observed.
- There were no drawings showing the structures.

Front elevation of link bridge connected to Building 1

- The link bridge appeared to be used as a storage area at 1<sup>st</sup> Floor level.
- Building Engineer to review the design of the ramp and bridge link structure, with special emphasis on the connection detail with the buildings, and to demonstrate that if any load is imparted to the building this has been adequately designed for.

- A full set of as-built drawings is to be provided detailing the buildings and the connecting structures.

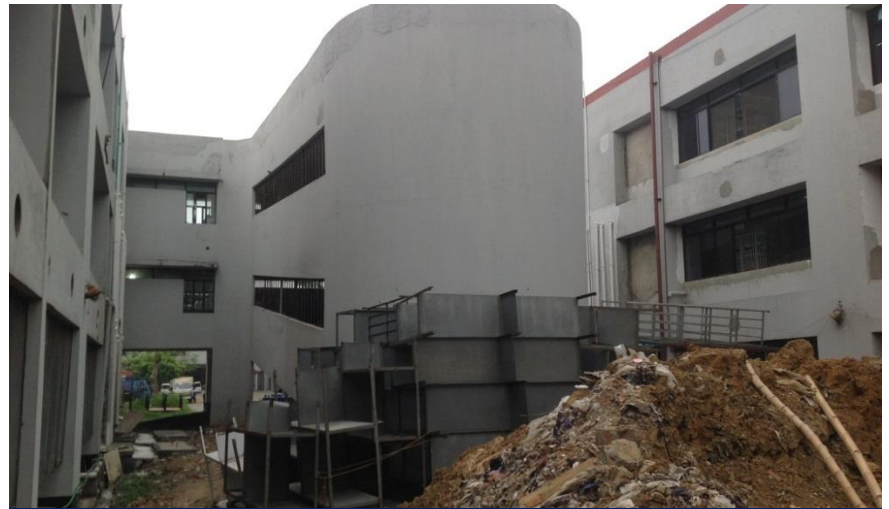
Back elevation of ramp and link bridge to Building 1

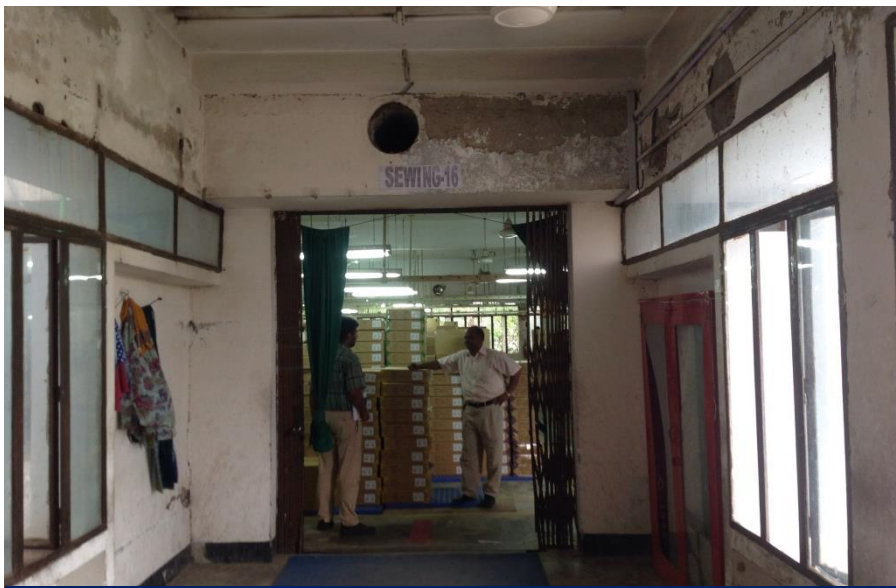
View from link bridge at connection with Building 1

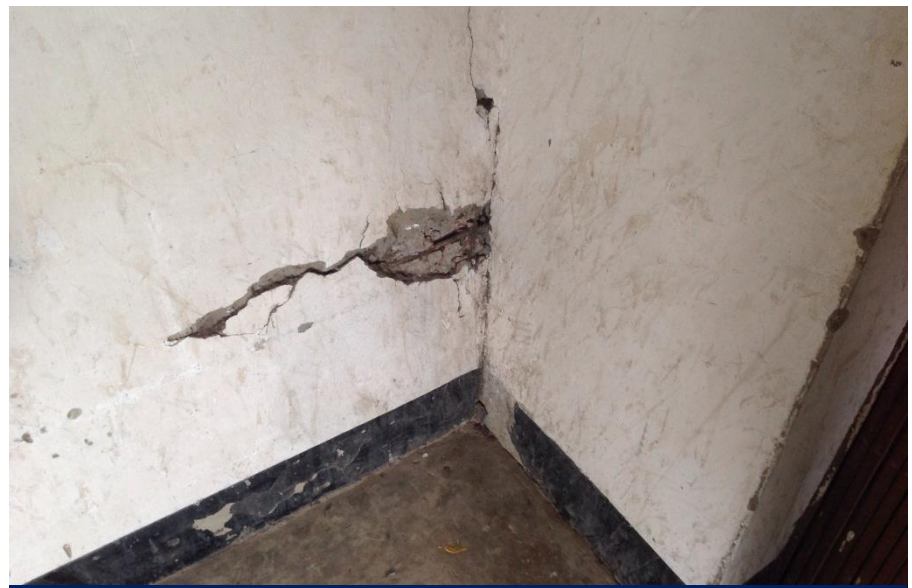
Apparent connection between link bridge and Building 1

| Item No. | Observation | Recommended Action Plan | Recommended Timeline |
|---|---|---|---|
| 7 | Pedestrian Walkways | Building Engineer to review the design of the walkways, with special emphasis on the connection detail with the buildings. | 6-weeks |
| 8 | Pedestrian Walkways | Building Engineer to carry out a design check of the concentrated loads imposed on the main factory buildings from the walkways and confirm that the existing structure has the capacity to accommodate these loads. | 6-weeks |

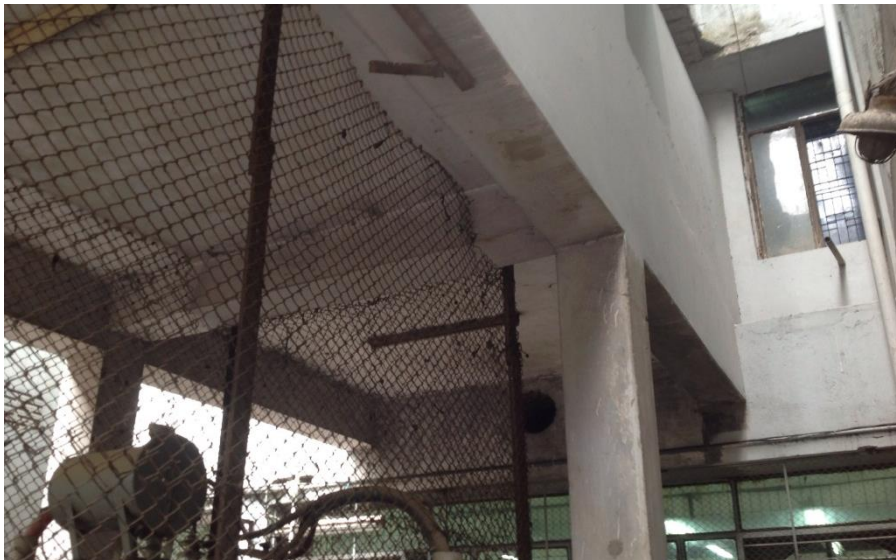
View of link bridge connection with Building 2

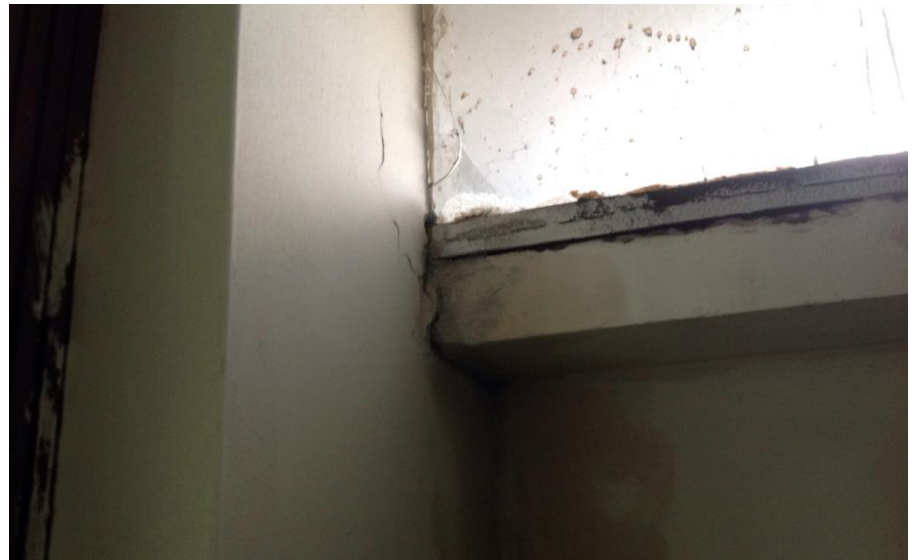
Cracking and evidence of remedial works to Building 2

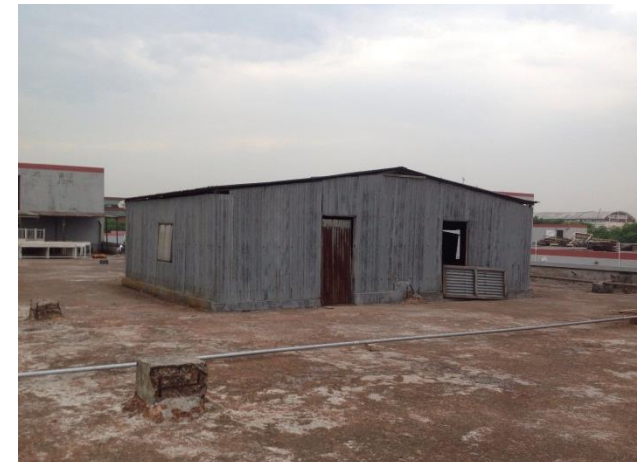
- Included in the factories are a number of lightweight structures located on the Roof of Building 1 and at Ground Floor level around Building 2.
- These structures appear to be non-engineered.
- Building Engineer to review the design of these lightweight structures to guard against uplift and lateral instability, with particular emphasis on connections and bracing, and to implement any remedial / upgrade works as required.

Building 1 – Lightweight Structure at Roof level

| Item No. | Observation | Recommended Action Plan | Recommended Timeline |
|---|---|---|---|
| 10 | Non-engineered lightweight steel structures | Building Engineer to check the design and capacity of the lightweight structures, with special emphasis on connections and bracing, and make any necessary alterations. | 6-weeks |

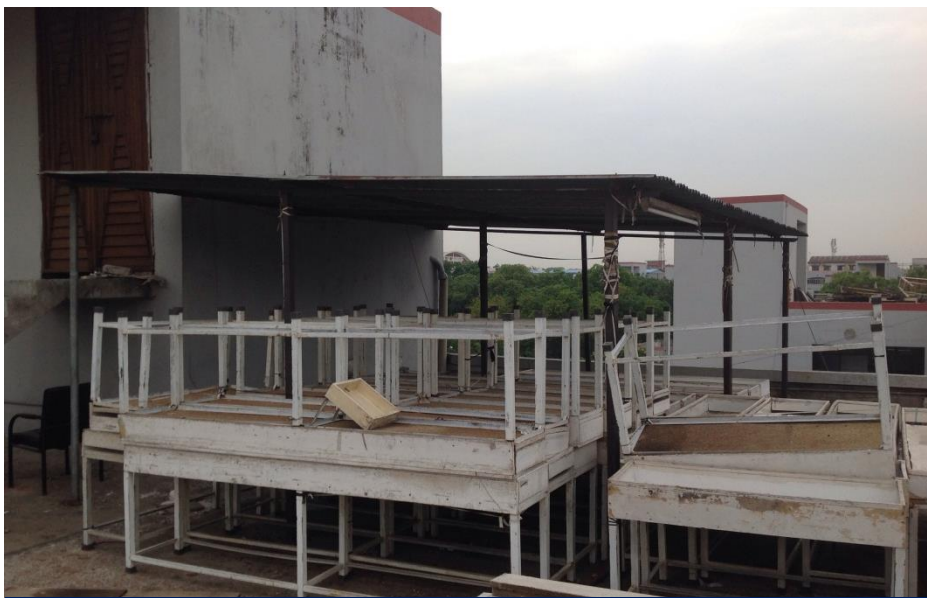
Building 1 – Lightweight structure at Roof level

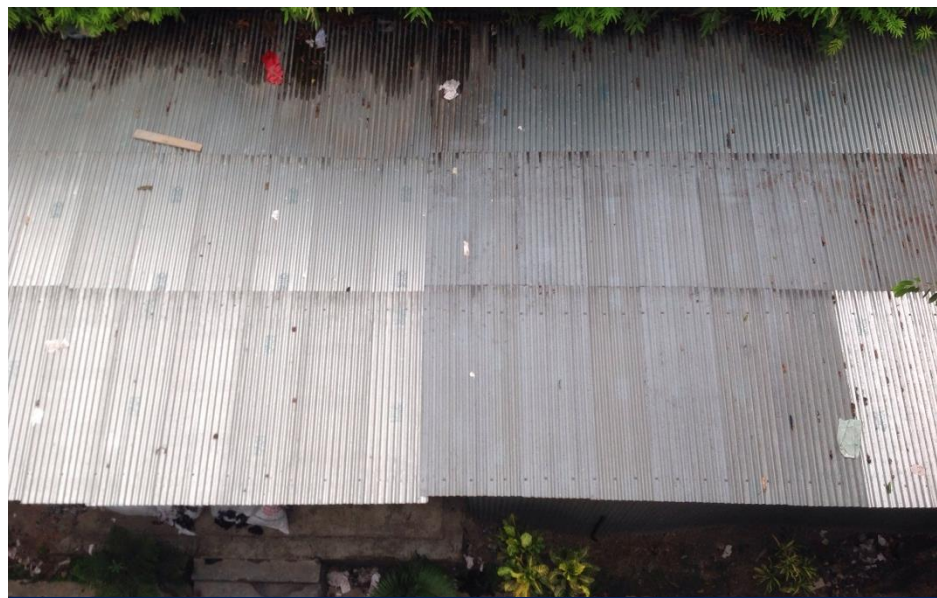
Building 2 – Lightweight structure at Ground level

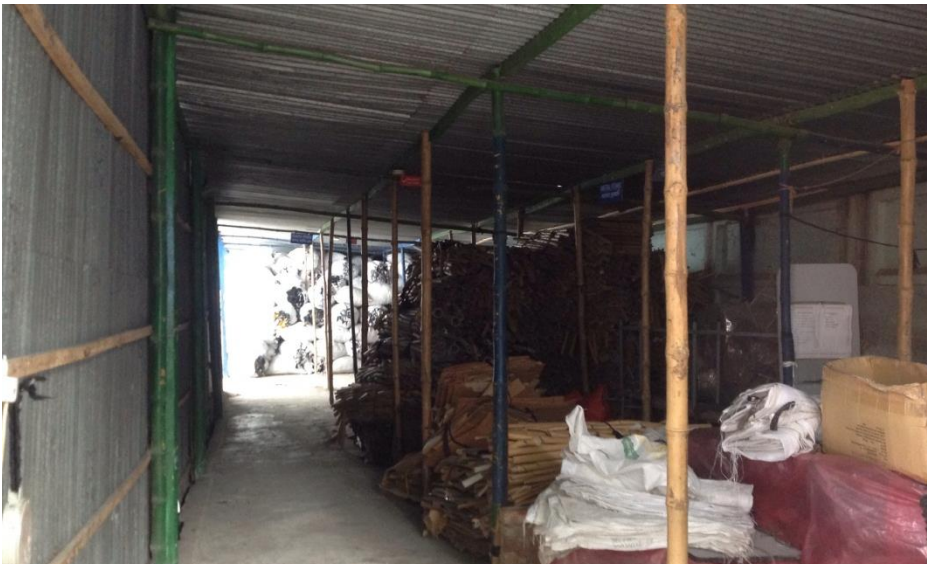
Building 2 – Lightweight structure at Ground level

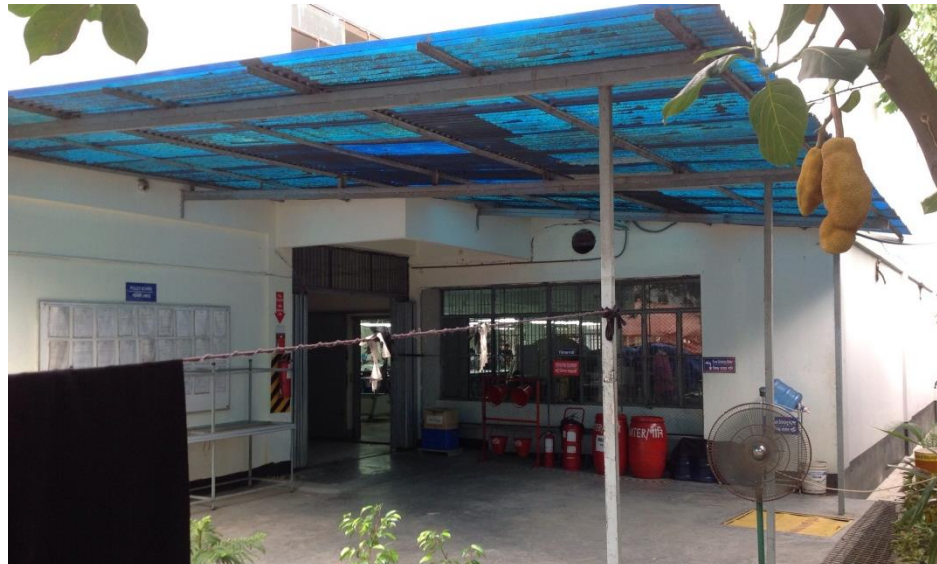
Building 2 – Lightweight structure at Ground level

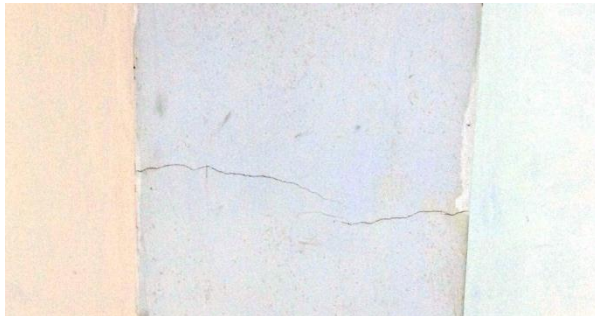
Building 1 - Cracking to beam soffit

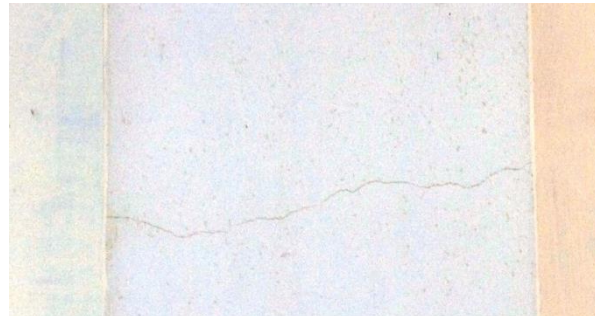
Building 1 - Cracking to beam soffit

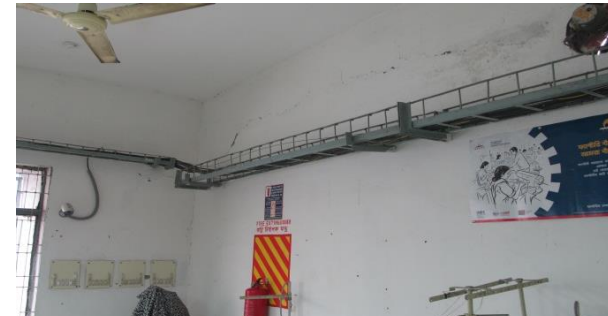
Building 2 - Cracking to NE corner

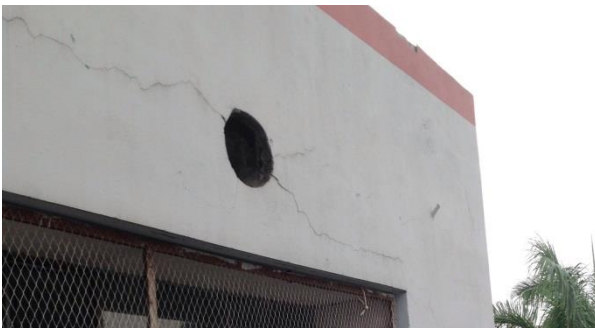
Building 2 - Cracking to SE corner

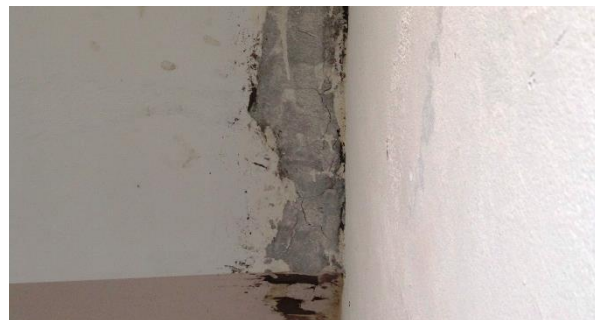
Building 2 – Cracking to SE stair slab

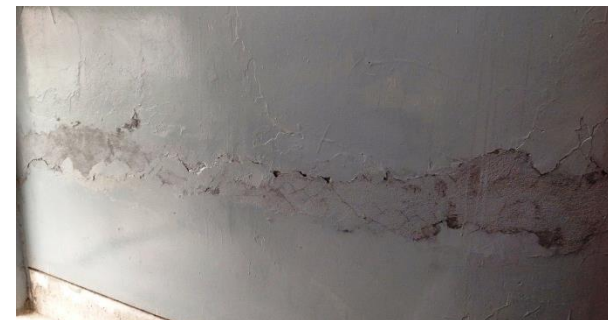
Building 2 – Cracking to SE stair wall
