FIRE SAFETY INSPECTION REPORT

LOADSTAR FASHIONS

PLOT # M-16/18/19

April 6, 2014

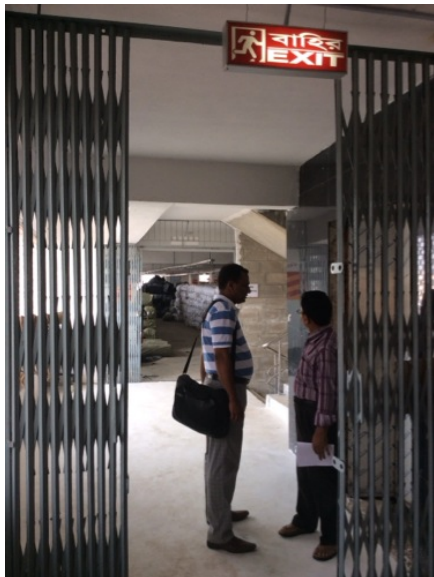
No.	Category	Finding	Recommendation	Remediation Timeframe
F-1	Fire Rated Construction	Central and East exit stairs are not separated from the factory floor.	<p>Provide minimum 1.5-hr fire rated doors and seal all unprotected openings to separate the exit stairs from work areas and other building spaces on all floor levels. Ensure that the fire doors are self-closing and positive latching and that they are provided with fire exit (panic) hardware where serving production floors.</p> <p>If fire doors are required to be held open for functional reasons, provide automatic-closing devices tied to the fire alarm system.</p>	Within 3 months

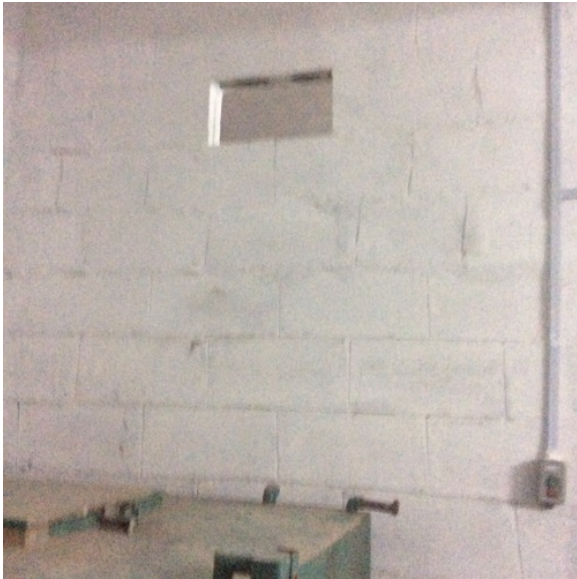
F-2	Fire Rated Construction	The two boiler rooms, two generator rooms, and transformer room are not separated by fire-rated construction.	Separate the service rooms by a minimum 2-hr fire-rated construction. Seal and/or protected all openings to maintain the required fire separations	Within 3 months
-----	-------------------------	---	--	-----------------

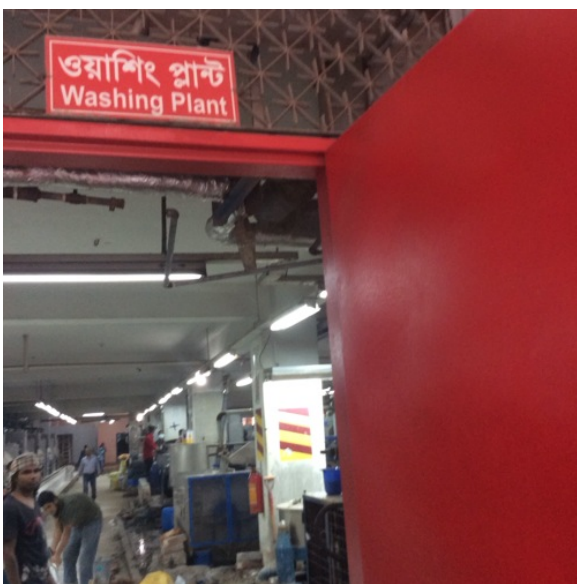
F-3	Fire Rated Construction	Unsealed penetrations and openings are located in West exit stair enclosures.	Seal all penetrations and openings in exit stair enclosure walls to maintain the fire separation.	Within 3 months
-----	-------------------------	---	---	-----------------

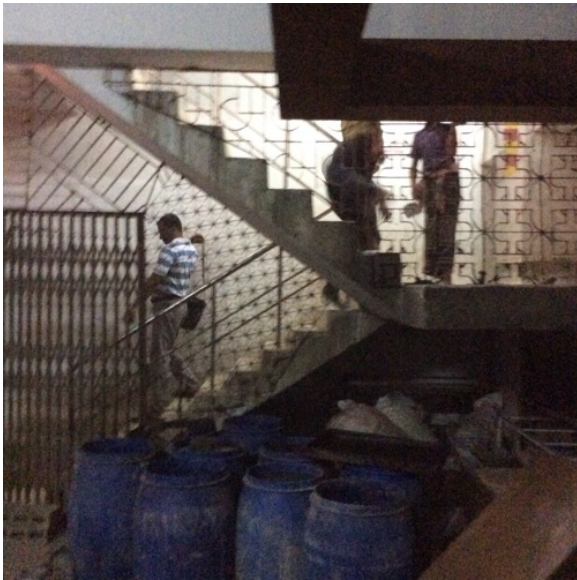
F-4	Egress	Storage was located in the East stair at the ground floor.	Remove all storage from exit stairs and egress paths.	Immediate
-----	--------	--	---	-----------

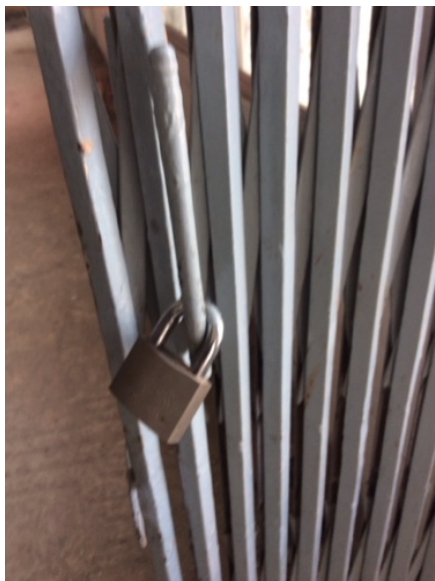
F-5	Egress	Egress doors and gates with locking features are provided at the discharge of both stairs.	Remove locking features from all egress doors and gates. If locks are required for security reasons, utilize special door locking features complying with NFPA 101.	Immediate
-----	--------	--	---	-----------

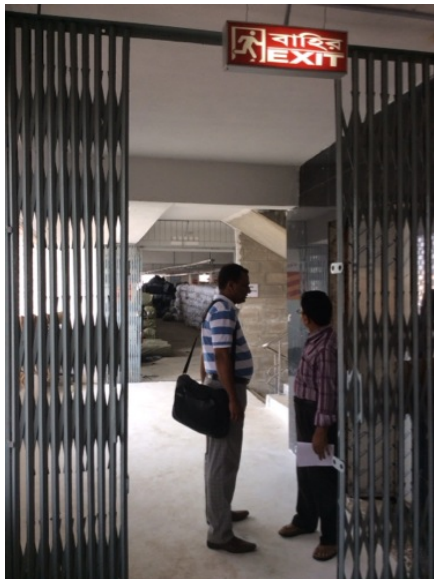
F-6	Egress	<p>Exit capacity from dining room on floor 7 is not adequate for the occupant load. Occupant load is 800, there are only two (2) doors from the room, and total exit capacity is 640 occupants.</p>	<p>Reduce occupant load to not more than available exit capacity immediately.</p> <p>In the future, if greater occupant load is desired, provide additional exits.</p>	Immediate
F-7	Egress	<p>Sliding doors are provided throughout all stairwells.</p>	<p>Replace all gates and sliding doors along the means of egress with side-hinged, swinging egress doors.</p> <p>If locks are required for security reasons, utilize special door locking features complying with NFPA 101.</p>	Within 1 month

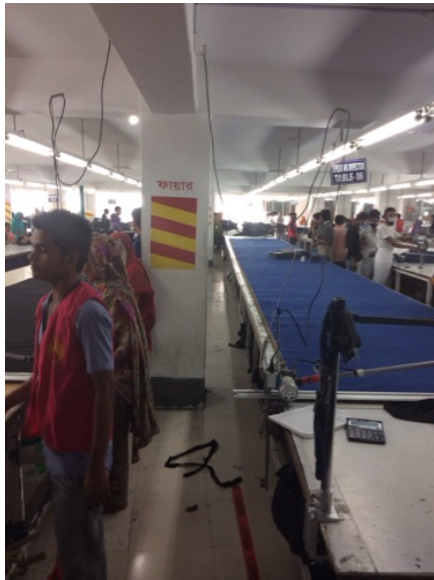
F-8	Egress	<p>The width of egress aisles on floors 9 and 10 are less than 36-in.</p>	<p>Provide minimum aisle widths of 36-in.</p>	Within 3 months
-----	--------	---	---	-----------------

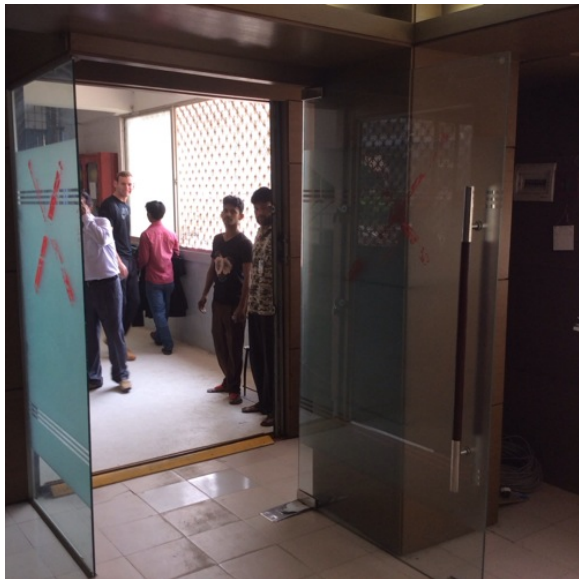
F-9	Egress	Egress door from office serving 50 or more occupants does not swing in the direction of egress travel.	Modify the egress door to swing in the direction of egress travel.	Within 3 months
-----	--------	--	--	-----------------

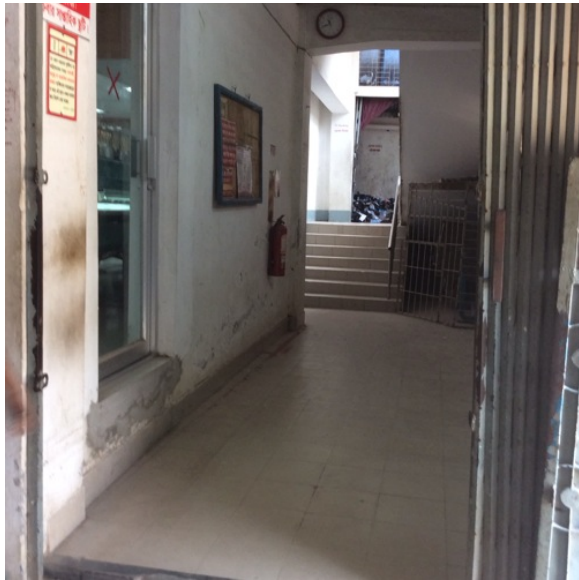
F-11	Egress	East exit stairs discharge inside the building.	Provide 2-hr fire-rated exit passageway leading directly outside	Within 6 months
------	--------	---	--	-----------------

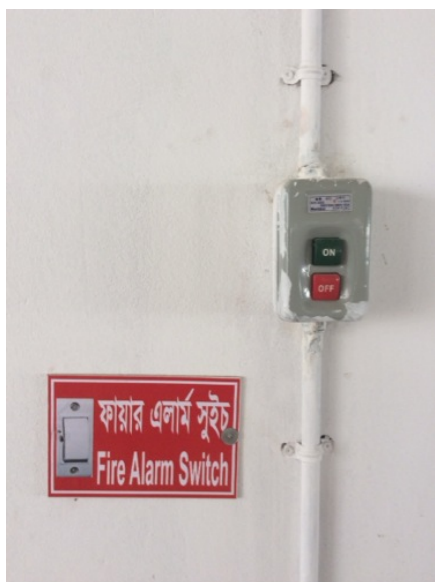
F-12	Fire Protection	The fire alarm system is antiquated, not a listed system, and does not provide alarm and notification features consistent with acceptable standards.	Replace the fire alarm system with a new, listed addressable fire alarm system in accordance with NFPA 72.	Design within 4 months, install within 9 months
------	-----------------	--	--	---

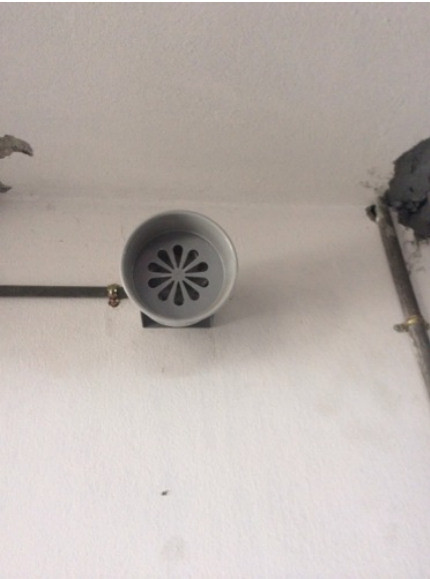
F-13	Fire Protection	The high-rise building has an occupied floor greater than 23m (75 ft) and is not provided with automatic sprinkler protection. The large occupant loads, heavy fuel loading, and anticipated extended egress times warrant sprinkler protection.	Provide automatic sprinkler protection throughout the building in accordance with NFPA 13.	Design within 6 months, install within 12 months
F-14	Fire Protection	Inspection, testing, and maintenance of the fire alarm system is not in accordance with NFPA 72.	Inspect, test and maintain the fire alarm system, and keep written records on-site, in accordance with NFPA 72.	Within 3 months

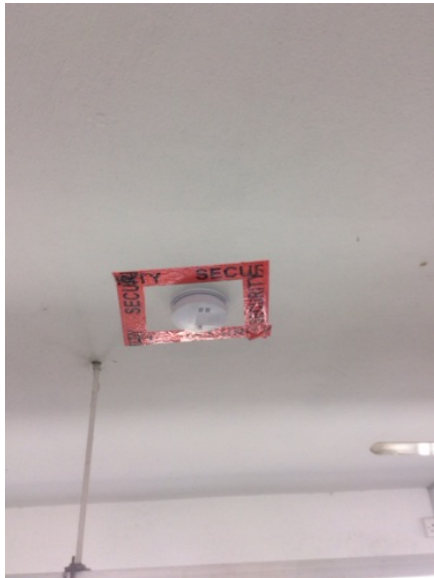
F-15	Fire Protection	The building is equipped with single-station smoke alarms. Smoke alarm activation sounds only a local alarm and does not provide automatic fire alarm notification of occupants.	Remove single-station smoke alarms. Provide automatic smoke detection throughout the building, tied into the fire alarm system, in accordance with NFPA 72.	Within 6 months
