# **FIRE SAFETY INSPECTION REPORT**

**CARLOS LEATHER FASHION LTD.  
TEKNOG PARA, JOYDEBPUR, GAZIPUR**

**ACCORD**  
on Fire and Building Safety in Bangladesh

August 27, 2014

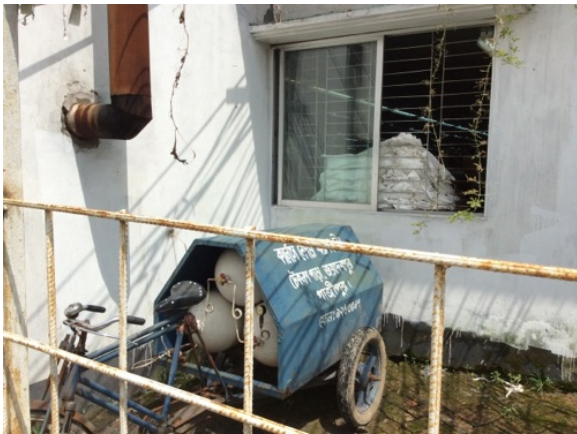
F-1	Fire Rated Construction	Hazardous materials storage area is not separated by fire-rated construction due to openings.	Separate the hazardous storage area by a minimum 2-hr fire-rated construction. Seal and protect all openings to maintain the required fire separations.	Within 3 months
-----	-------------------------	-----------------------------------------------------------------------------------------------	---------------------------------------------------------------------------------------------------------------------------------------------------------	-----------------

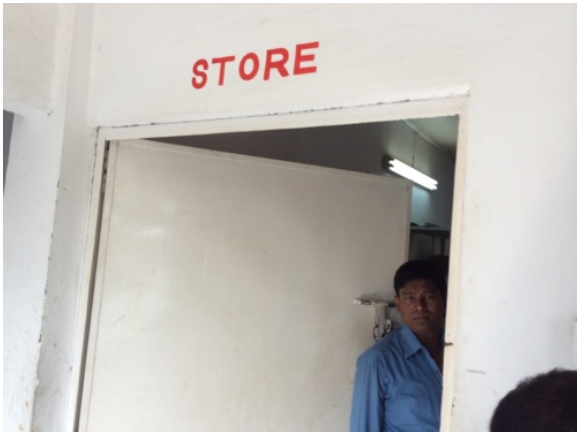
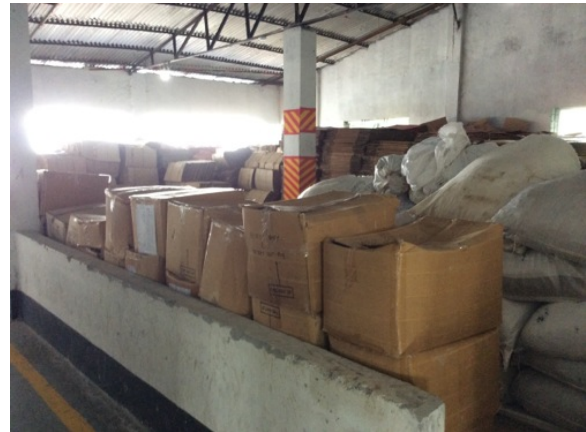
F-2	Fire Rated Construction	Storerooms used for combustible storages are not separated by fire-rated construction on the first floor.	Provide dedicated storage rooms separated by minimum 1-hr fire-rated construction.	Within 3 months
-----	-------------------------	-----------------------------------------------------------------------------------------------------------	------------------------------------------------------------------------------------	-----------------

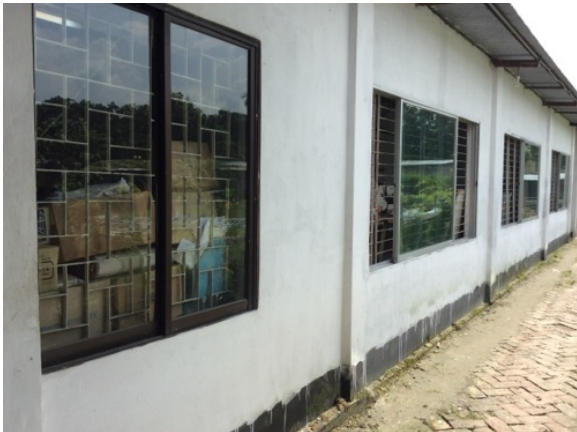
F-3	Fire Rated Construction	The exit discharge path serving South exit is less than 10 ft wide and is not separated from the building interior.	Seal all penetrations and openings to the interior of the building along the discharge path, up to a height of 10 ft., to provide a minimum 1-hr fire separation.	Within 6 months
-----	-------------------------	---------------------------------------------------------------------------------------------------------------------	-------------------------------------------------------------------------------------------------------------------------------------------------------------------	-----------------

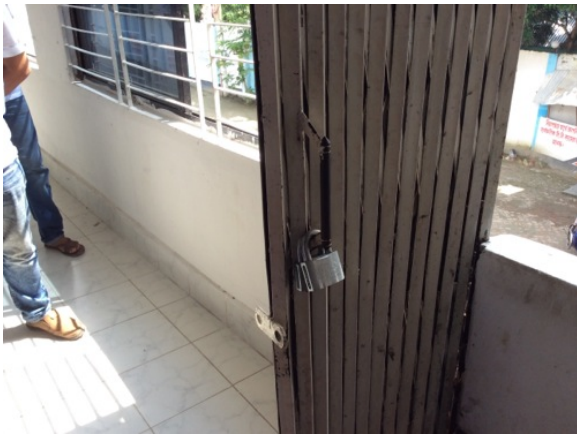
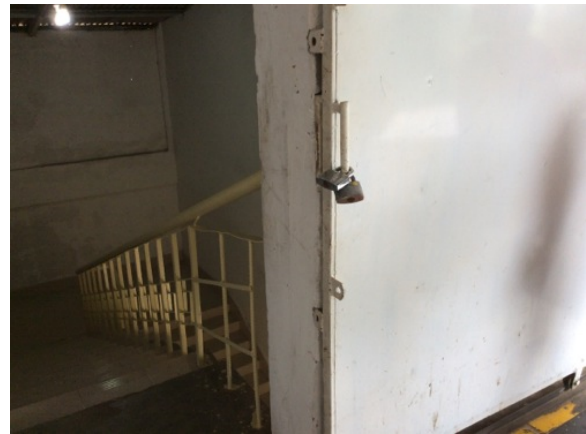
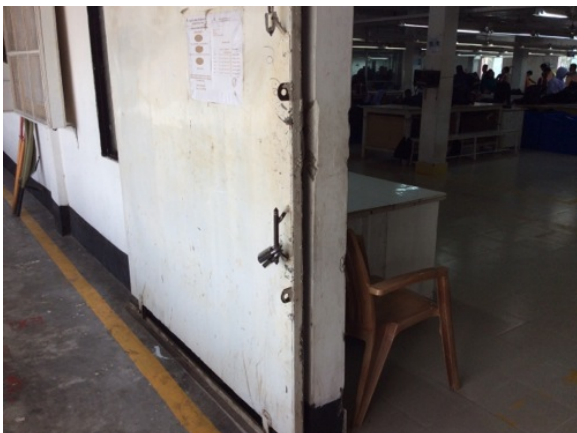
F-4	Egress	Egress doors and gates with locking features (padlocks) are provided at building exits, exit stairs and along egress routes. All gates and doors were not open and unlocked during the inspection.	Remove locking features from all egress doors and gates.  If locks are required for security reasons, utilize special door locking features complying with NFPA 101.	Immediate
-----	--------	----------------------------------------------------------------------------------------------------------------------------------------------------------------------------------------------------	----------------------------------------------------------------------------------------------------------------------------------------------------------------------------	-----------

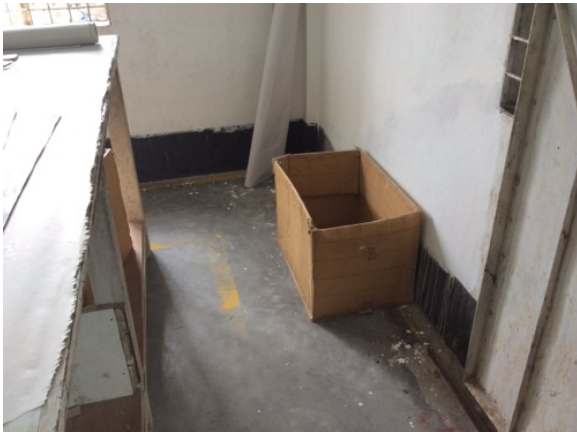
F-5	Egress	Storage was located in the egress path on the first floor.	Keep egress paths and stairs clear of storage.	Immediate
-----	--------	------------------------------------------------------------	------------------------------------------------	-----------

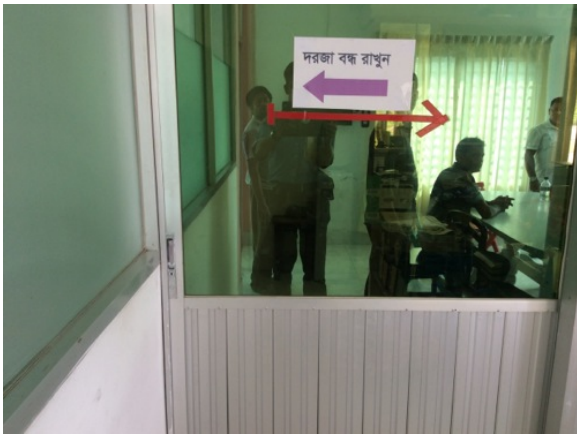
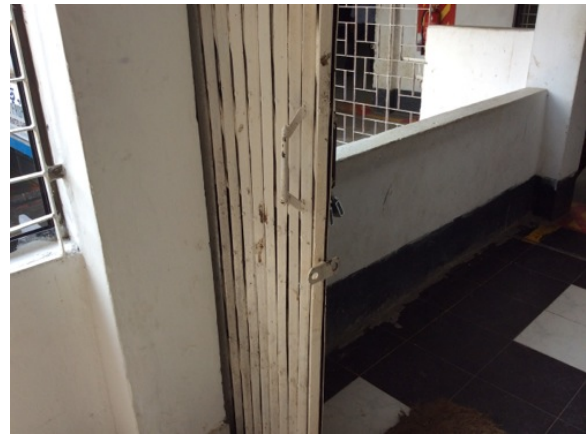
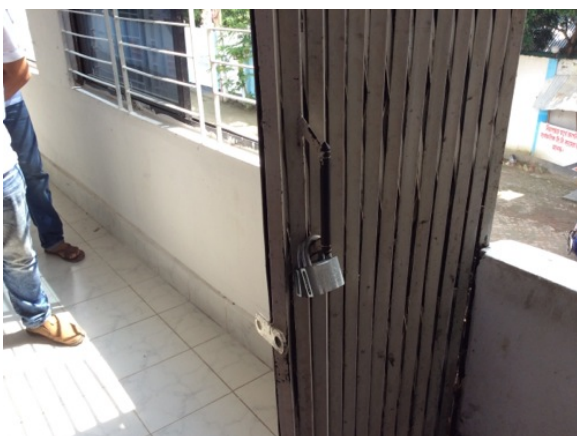
F-8	Egress	Collapsible gates and sliding doors are provided at building exits, exit stairs and along egress routes.	Replace all gates and sliding doors along the means of egress with side-hinged, swinging egress doors.  If locks are required for security reasons, utilize special door locking features complying with NFPA 101.	Within 1 month
-----	--------	----------------------------------------------------------------------------------------------------------	--------------------------------------------------------------------------------------------------------------------------------------------------------------------------------------------------------------------------	----------------

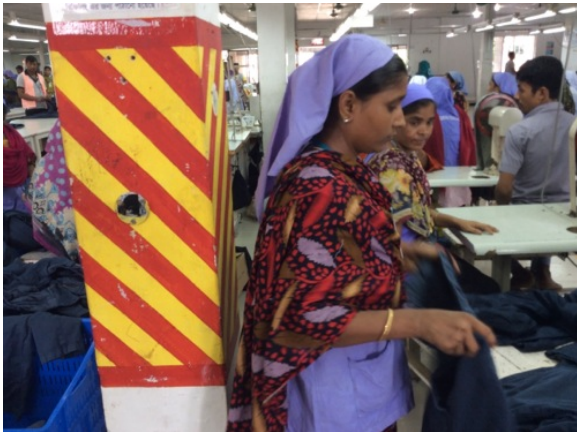
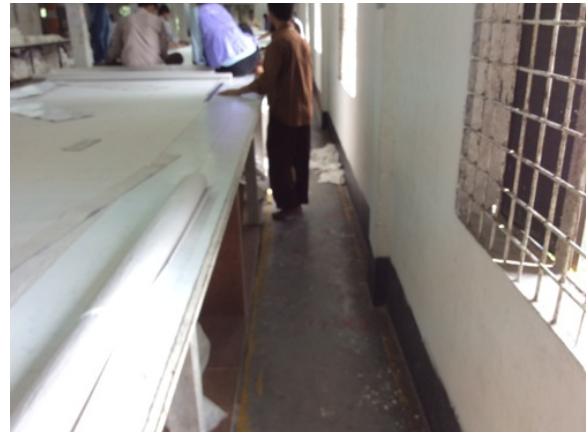
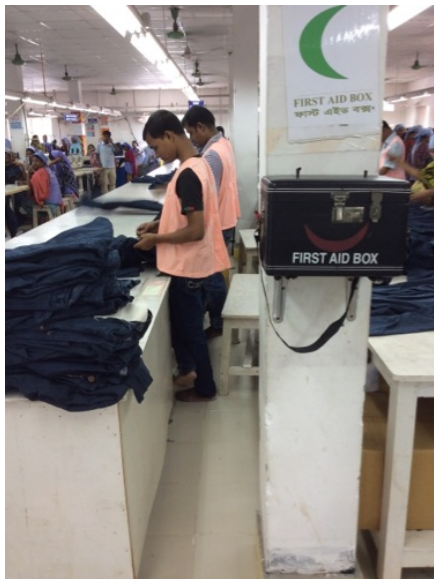
F-9	Egress	The width of egress aisles is less than 36-in. on the first floor.	Provide minimum aisle widths of 36-in.	Within 3 months
-----	--------	--------------------------------------------------------------------	----------------------------------------	-----------------

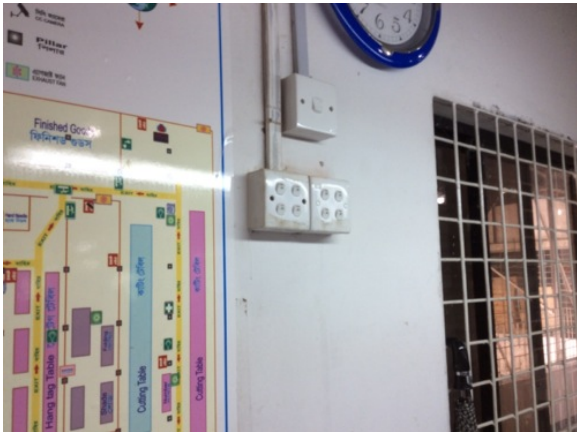
F-10	Fire Protection	The fire alarm system is antiquated, not a listed system, and does not provide alarm and notification features consistent with acceptable standards.	Replace the fire alarm system with a new, listed addressable fire alarm system in accordance with NFPA 72.	Design within 4 months, install within 9 months
------	-----------------	------------------------------------------------------------------------------------------------------------------------------------------------------	------------------------------------------------------------------------------------------------------------	-------------------------------------------------

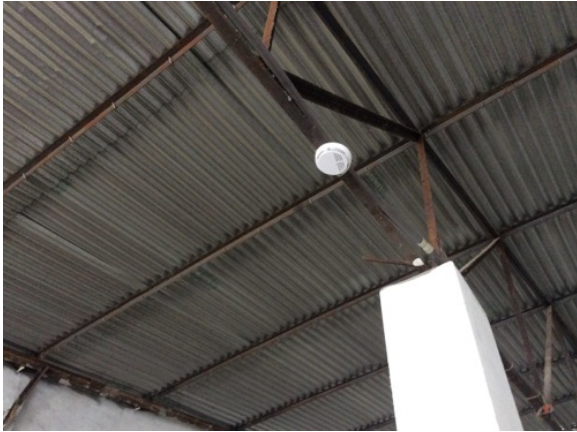
F-11	Fire Protection	Inspection, testing, and maintenance of the fire alarm system is not in accordance with NFPA 72.	Inspect, test and maintain the fire alarm system, and keep written records on-site, in accordance with NFPA 72.	Within 3 months
F-12	Fire Protection	The building is equipped with single-station smoke alarms. Smoke alarm activation sounds only a local alarm and does not provide automatic fire alarm notification of occupants.	Remove single-station smoke alarms. Provide automatic smoke detection throughout the building, tied into the fire alarm system, in accordance with NFPA 72.	Within 6 months

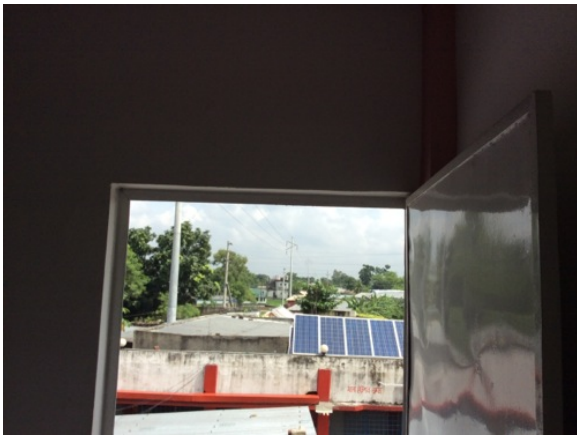
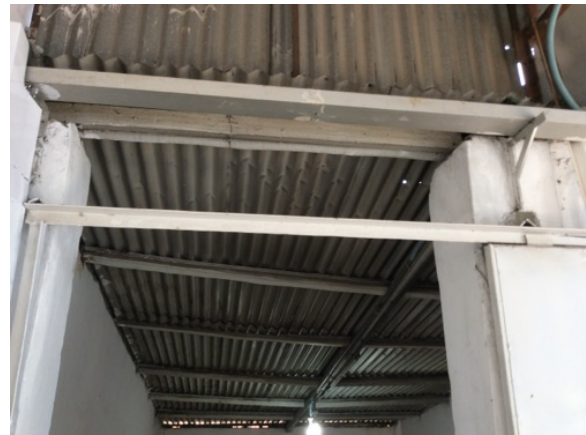
F-13	Egress Lighting	Exit sign not provided at North and West exit stairs.	Provide exit signs above all exits to the exterior and all doors to the exit stairs.	Within 1 month
------	-----------------	-------------------------------------------------------	--------------------------------------------------------------------------------------	----------------
