# **FIRE SAFETY INSPECTION REPORT**

**LIZ FASHION INDUSTRY LTD.  
ZAMIRDIA (STEEL STORE),P.S. -BHALUKA,  
MYMENSINGH.**

May 15, 2014

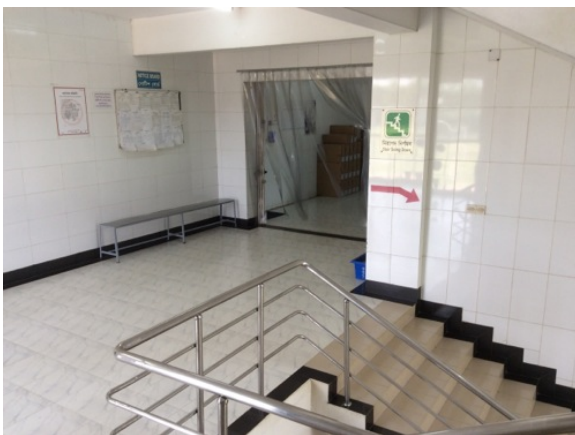
| No. | Category | Finding | Recommendation | Remediation Timeframe |
|---|---|---|---|---|
| F-1 | Fire Rated Construction | The exit stairs are not separated from work areas, and other spaces on each floor by fire-rated construction. This was reflected throughout the building on all floors. | <p>Provide minimum 1.5-hr fire rated doors and seal all unprotected openings to separate the exit stairs from work areas and other building spaces on all floor levels. Ensure that the fire doors are self-closing and positive latching and that they are provided with fire exit (panic) hardware where serving production floors.</p> <p>If fire doors are required to be held open for functional reasons, provide automatic-closing devices tied to the fire alarm system.</p> | Within 3 months |

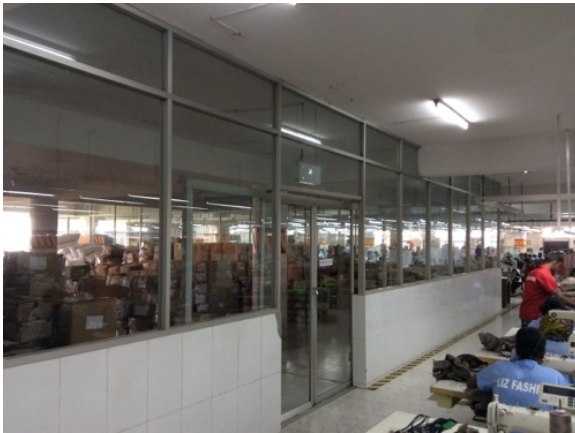
| F-2 | Fire Rated Construction | Storerooms used for combustible storage are not separated by fire-rated construction throughout the building on various floors. | Provide dedicated storage rooms separated by minimum 1-hr fire-rated construction. | Within 3 months |

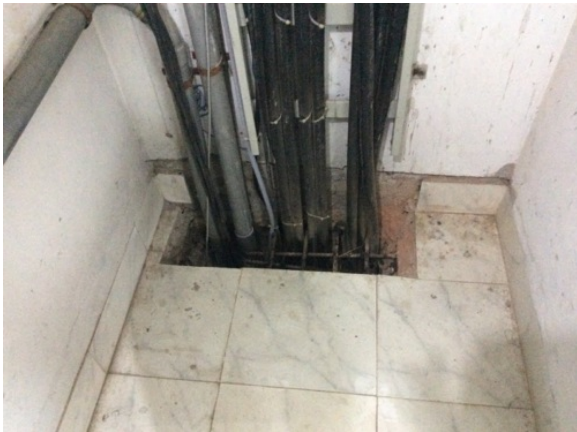
| F-3 | Fire Rated Construction | Unsealed penetrations and openings are located in the fire-rated floor/ceiling assemblies. Floor penetrations were found adjacent to the north stairwell inside an electrical room. Wiring from the electrical panels caused penetrations within the floor/ceiling. The rooms were not properly separated by fire rated construction from production floors. | <p>Provide a minimum 2-hr fire-rated shaft to separate the utility risers from each floor level.</p> <p>Seal all penetrations and openings in floor/ceiling assemblies to maintain the fire separation.</p> | Within 3 months |

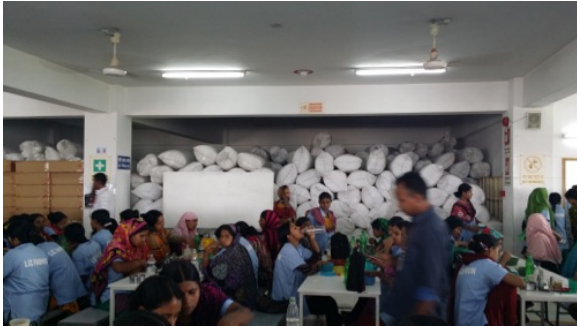
| F-4 | Fire Rated Construction | Areas used for combustible storage are open to factory floors throughout building on various floors. | <p>Provide dedicated storage rooms separated by minimum 1-hr fire-rated construction.</p> <p>Where separate storage rooms are not feasible, provide defined storage areas and limit the storage arrangement as follows:</p> <ul style="list-style-type: none"><li>- Maximum height of 2.4m and maximum area of 23m<sup>2</sup></li><li>- If sprinkler protected: maximum height of 3.66m and maximum area of 93m<sup>2</sup></li></ul> <p>Separate areas of unenclosed combustible storage by a minimum clear distance of 3m.</p> | Within 3 months |

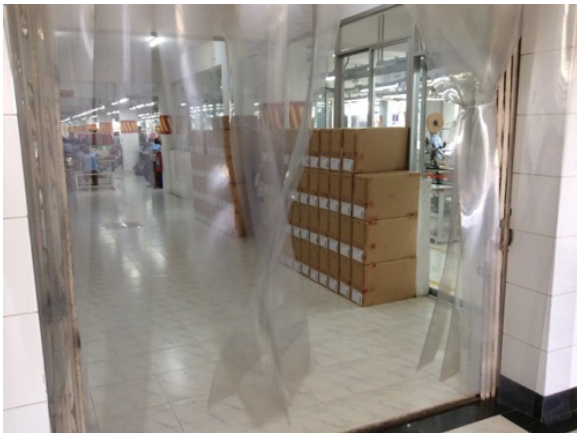
| F-5 | Egress | Egress doors / gates with locking features are provided at building exits, exit stairs, along egress routes, and exit discharge. This was reflected throughout the building on all floors. | Remove locking features from all egress doors / gates.<br><br>If locks are required for security reasons, utilize special door locking features complying with NFPA 101. | Immediate |

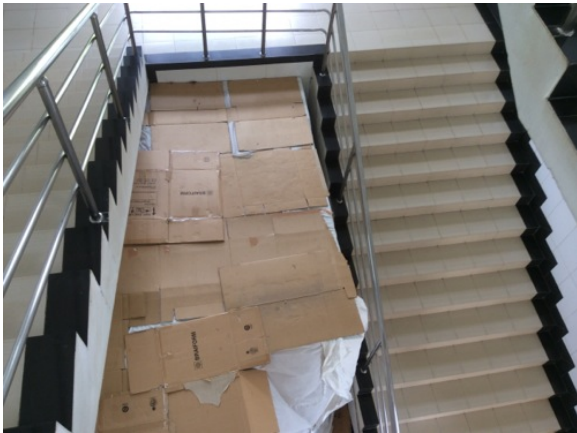
| F-6 | Egress | Storage areas were located in all exit stairwells on the ground floor, underneath the stairs. | Remove all storage from exit stairs and egress paths. | Immediate |

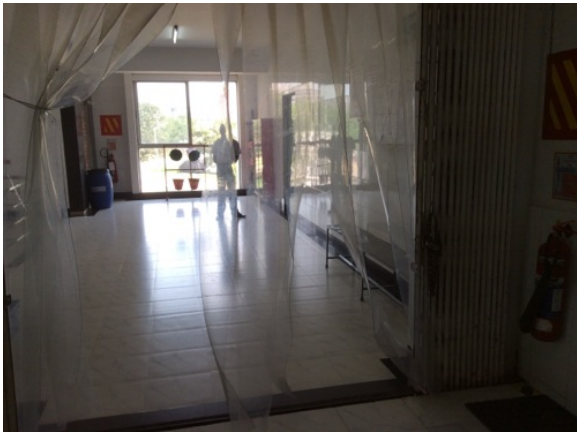
| F-7 | Egress | Collapsible gates / sliding doors are provided at building exits, exit stairs, along egress routes, and exit discharge. This was reflected throughout the building on all floors. | <p>Replace all gates / sliding doors along the means of egress with side-hinged, swinging egress doors.</p> <p>If locks are required for security reasons, utilize special door locking features complying with NFPA 101.</p> | Within 1 month |

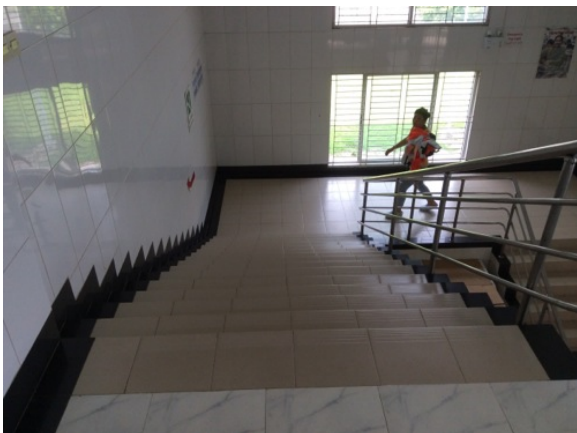
| F-8 | Egress | Handrails on both sides were not provided in each exit stairwell. | Provide handrails on at least one side of exit stair. | Within 3 months |

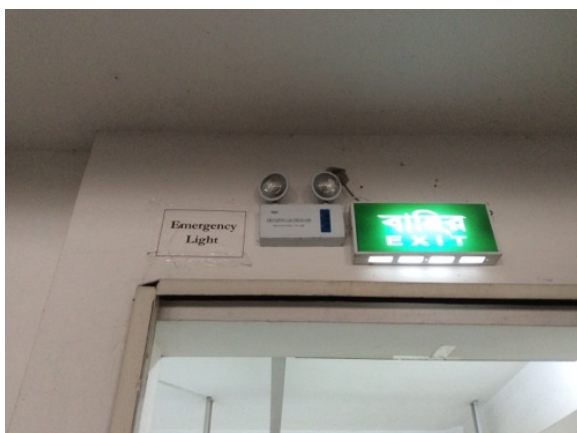
| F-11 | Egress Lighting | Manual on-off switch is provided for emergency lighting units. This was reflected throughout the building in various locations. | Remove manual on/off switches from emergency lighting units to prevent them from being switched off. | Within 1 month |
