# KDS Garment Industries Ltd. (11099)

255, Nasirabad I/A, Baizid Bostami Road, Chittagong-4211

20.APRIL.2014

## Identified Priority 1 Concerns

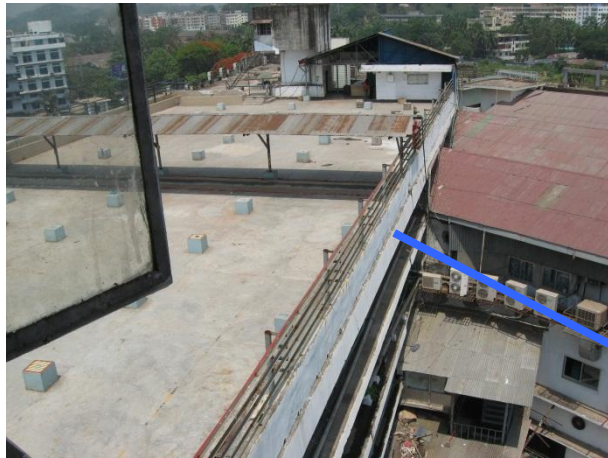
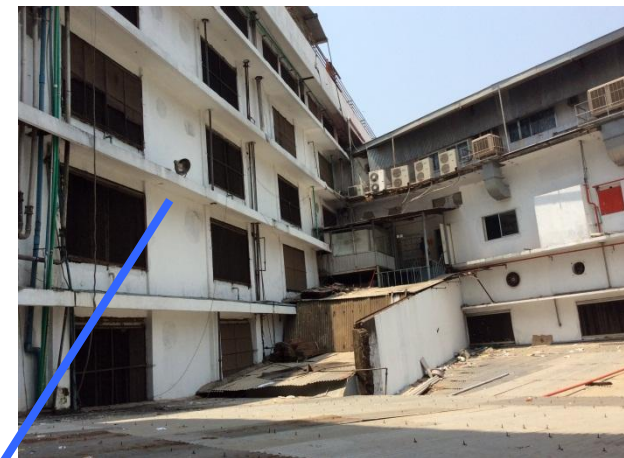
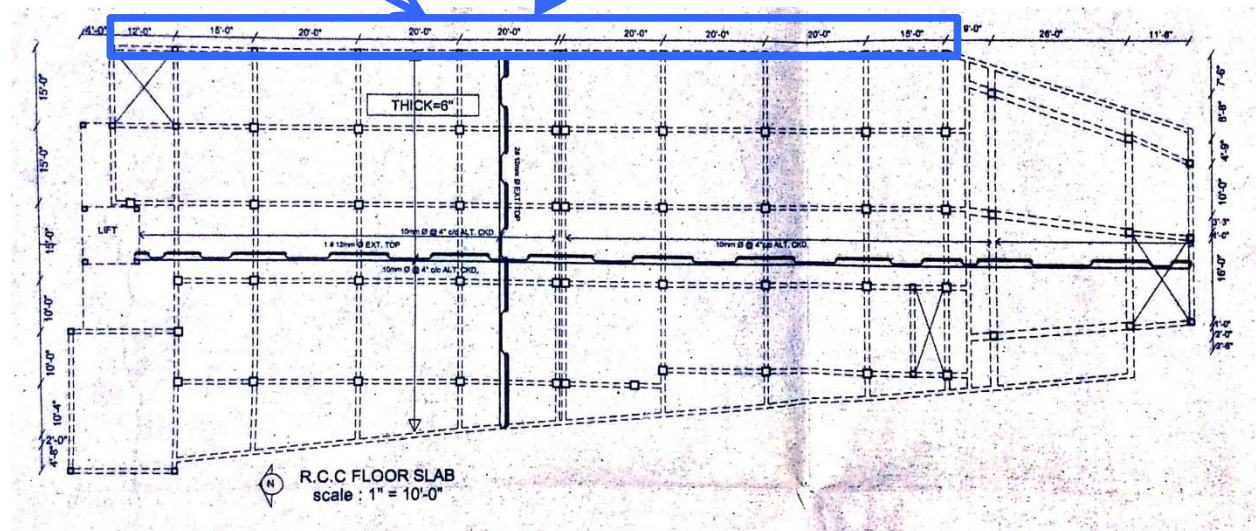
There are cantilevered slabs for rain protection that do not appear on the Building 1 drawings.

- Factory Engineer to survey the actual conditions and revise the drawings.
- Factory Engineer to review design, loads and columns stresses to confirm suitability for loads applied.

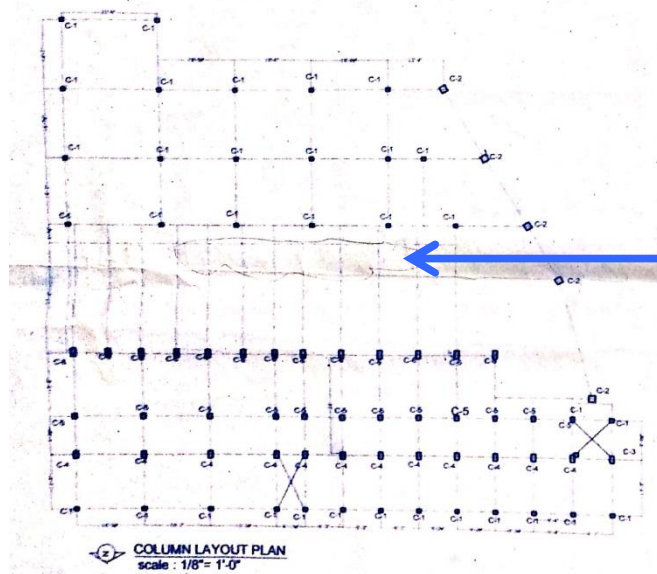
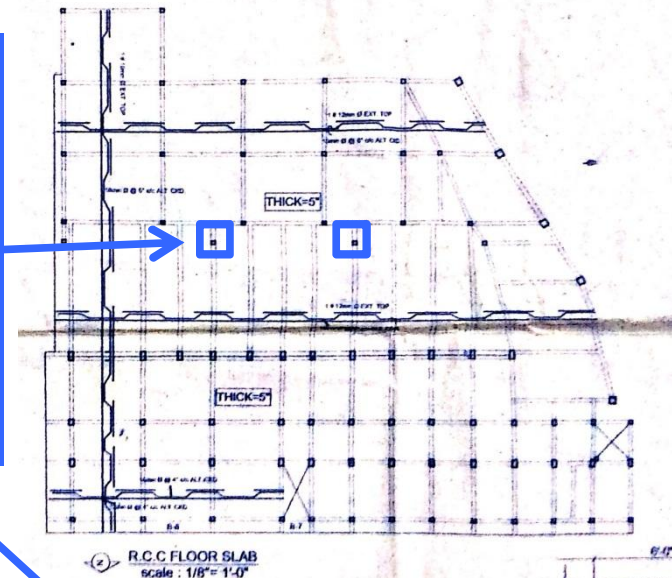
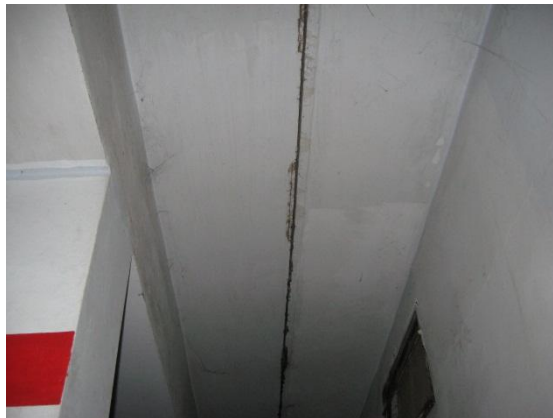
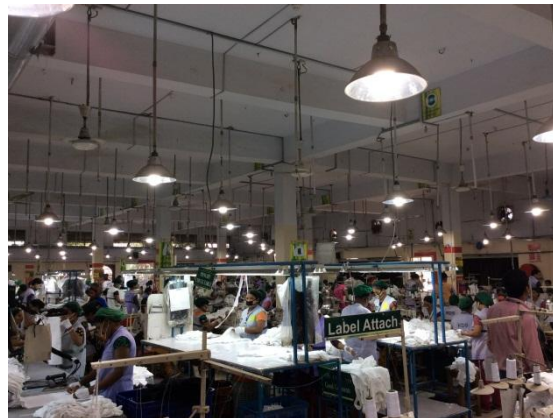
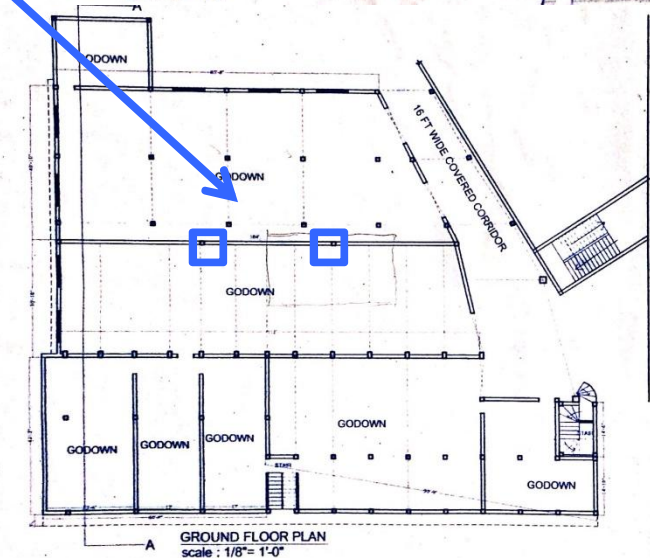
There are 2 columns that do not appear on Building 3 column layout or the foundation layout but they can be found on the slab layout and floor plan.

It is unclear whether the ground floor columns are in the line of wall. But columns were not found on 1<sup>st</sup> floor. Factory engineer should survey and revise the drawings.

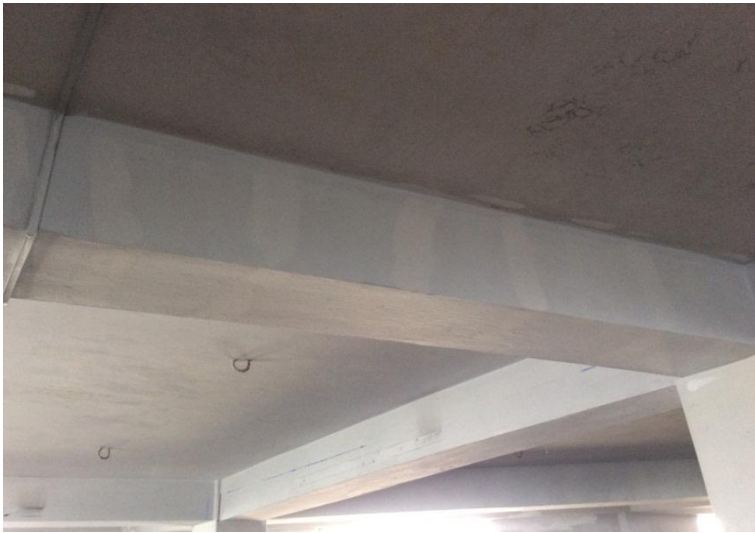
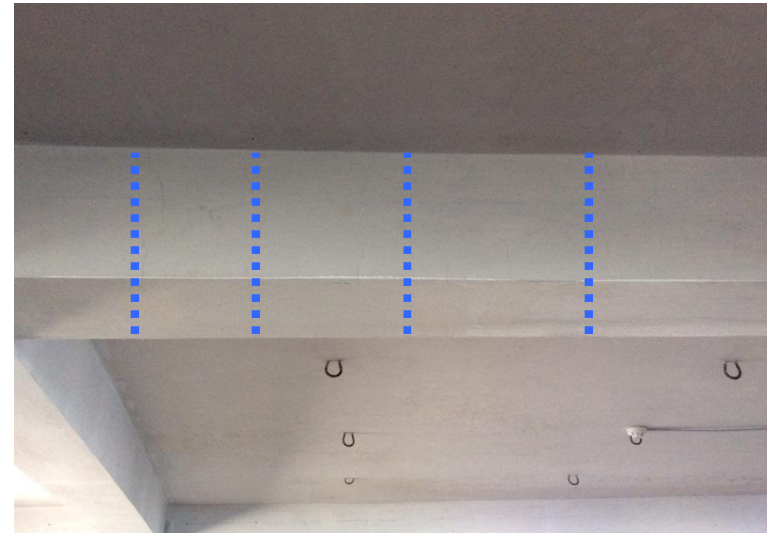
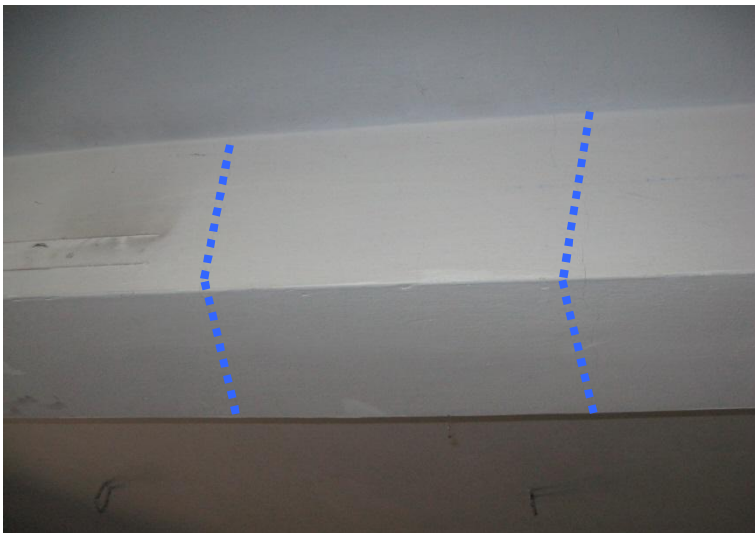
There are cracks found on the underside of beams in Building 1 and Building 2.

- A Detailed Engineering Assessment of this area is to be carried out.
- The distress found is to be suitably repaired and the cause rectified.

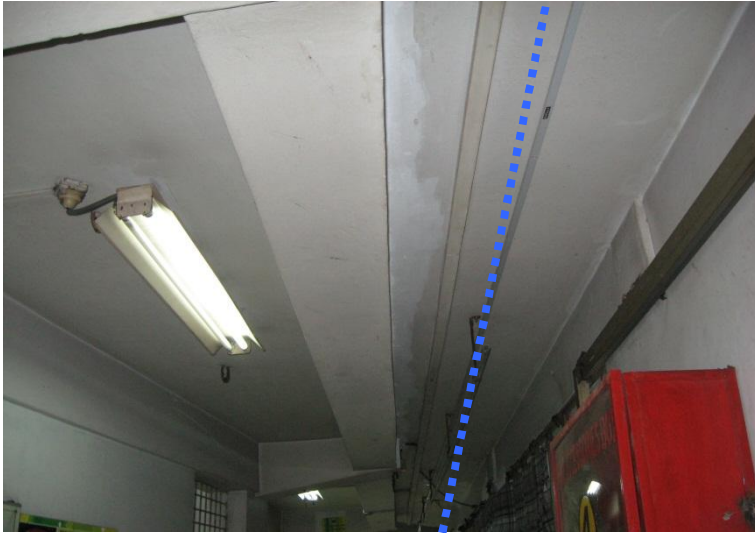
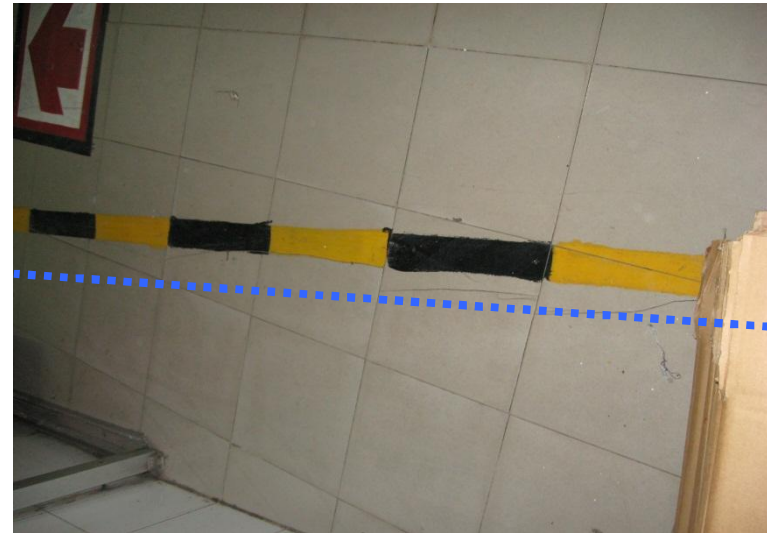
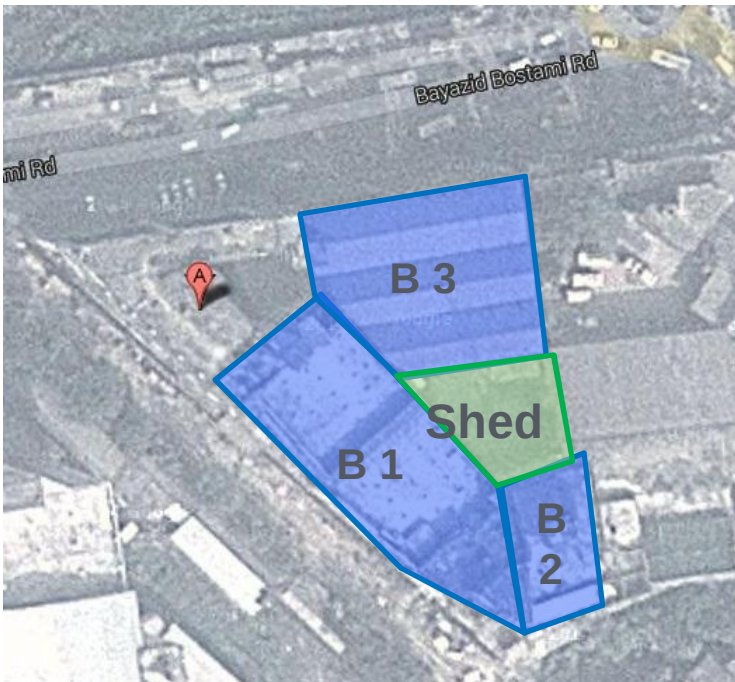
There are no movement joints between Building 1 and Building 2 or between Building 1 and Building 3. Cracks were found in the floor finishes between Building 1 and Building 2.

- The Factory's Building Structural Engineer should carry out a Detailed Engineering Assessment to prove the capacity of the building in its existing state. A further building approval should be gained for the building as it exists, as altered since the original approval. Alternatively, the existing buildings should be separated by a series of non-structural movement joints allowing each building to act independent ly.

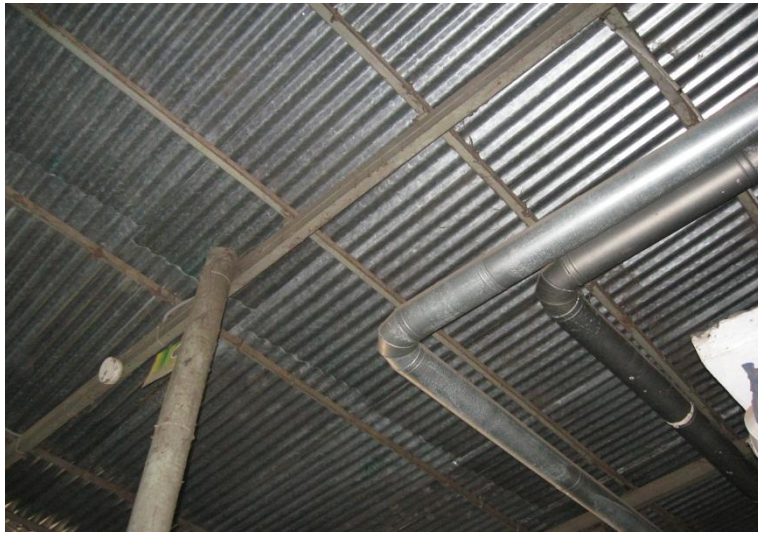
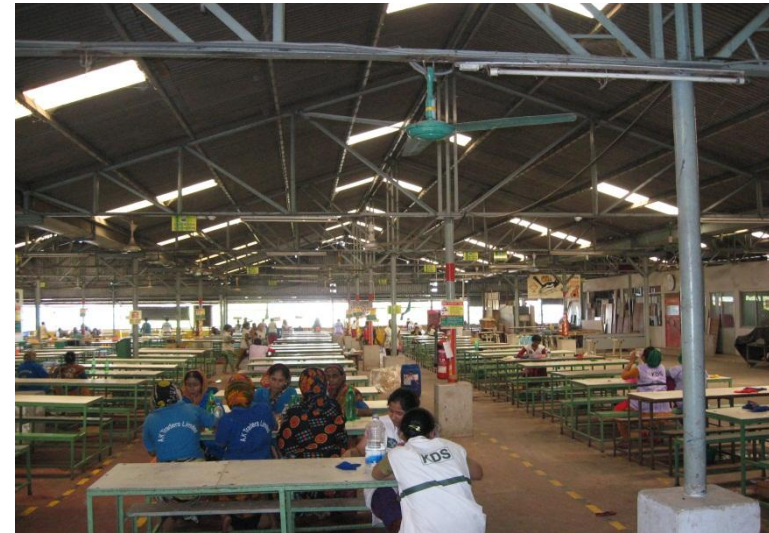
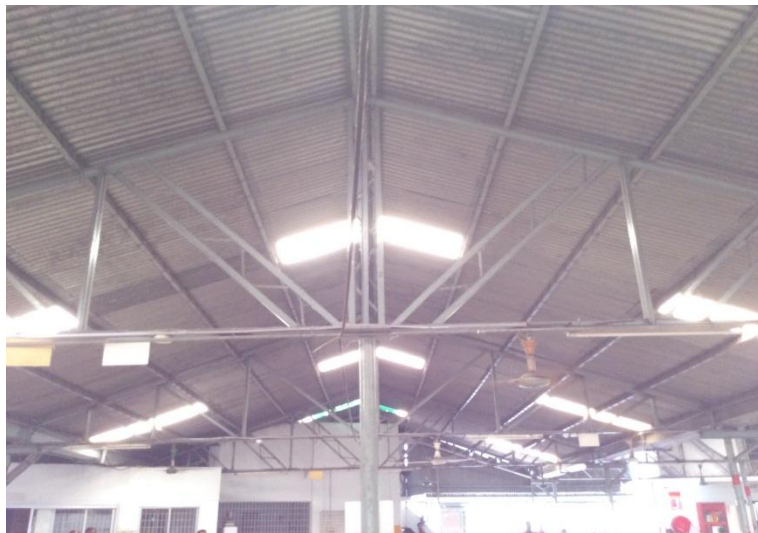
Structural steel elements of Building 3 and the Shed – it is not clear if fire proofing material is applied or is required.

- Fireproofing material for structural steel element is recommended based on Bangladeshi BNBC regulations.

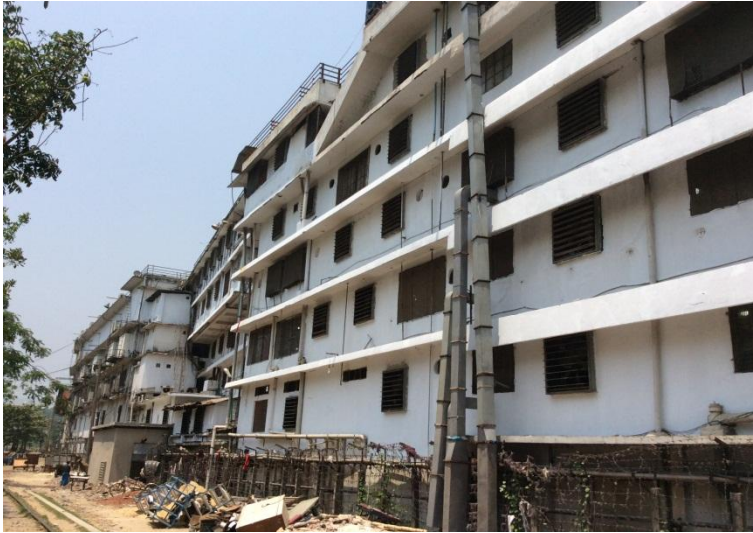
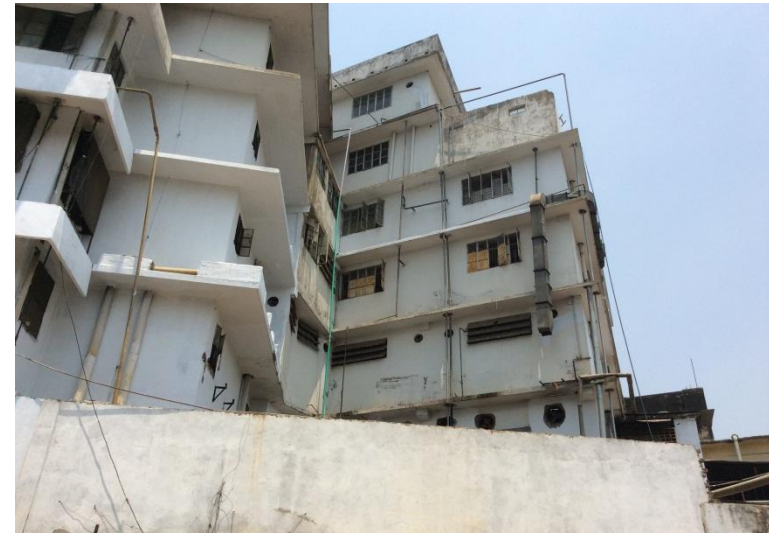
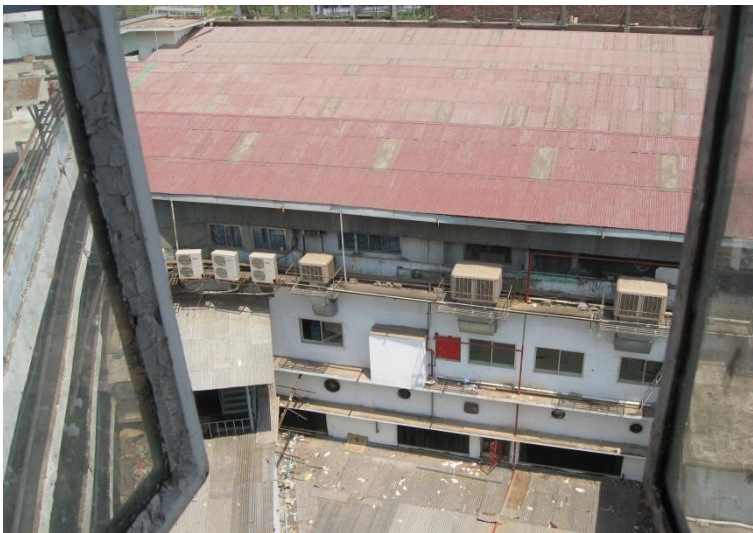
Concerns on the stability system for lateral loading and seismic loading. The façade brickwork walls lack moment capacity due to their lack of mechanical connection with the surrounding columns and beams.

We require that these items be investigated in a Detailed Engineering Assessment.

- Request that the Detailed Engineering Assessment of overall building to be carried out and in particular, stability and foundation aspects should be investigated in detail.

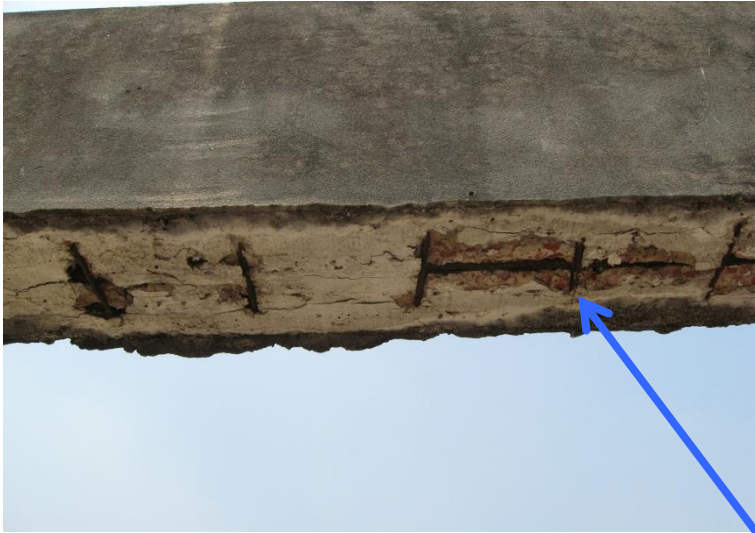
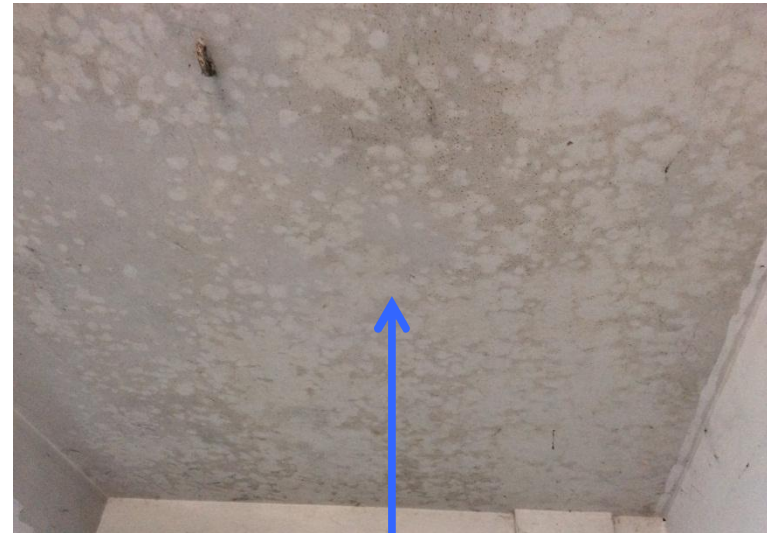
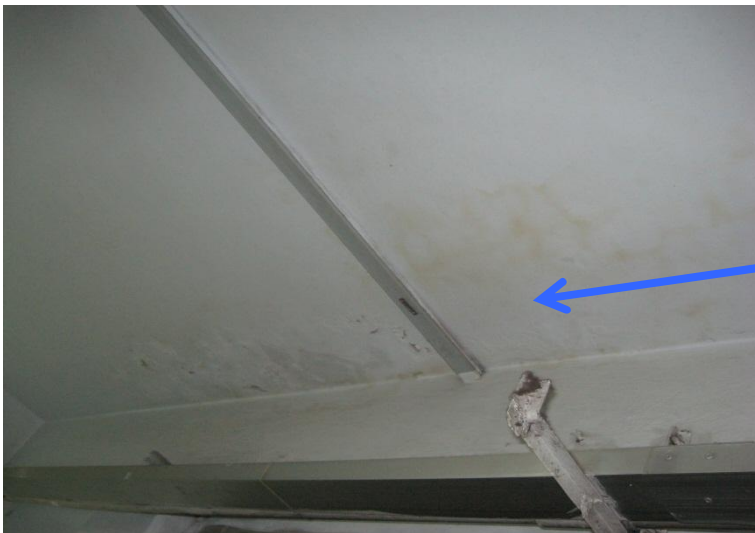
Damage due to water ingress was found on Building 1 and Building 2. Spalling of concrete and corroded rebar was found, especially on the upper levels of Building 2.

- For both serviceability and durability, it's recommended to repair the distress found with suitable permanent methods.
- After repairing, appropriate waterproofing materials should be applied.

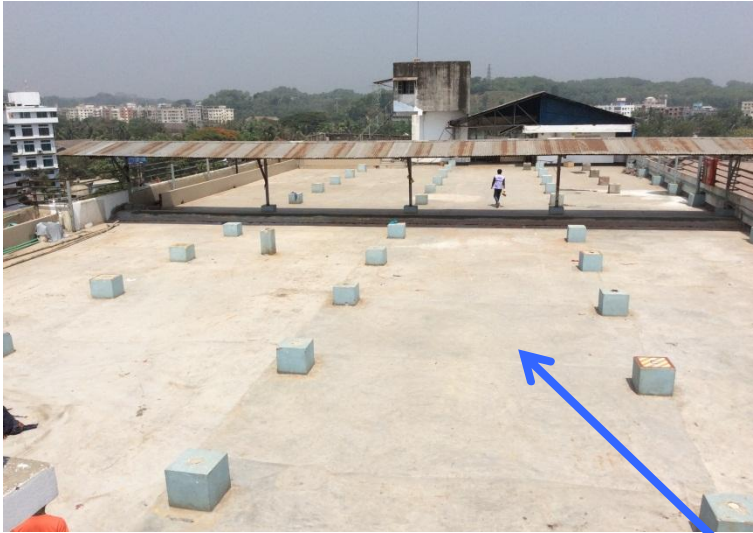
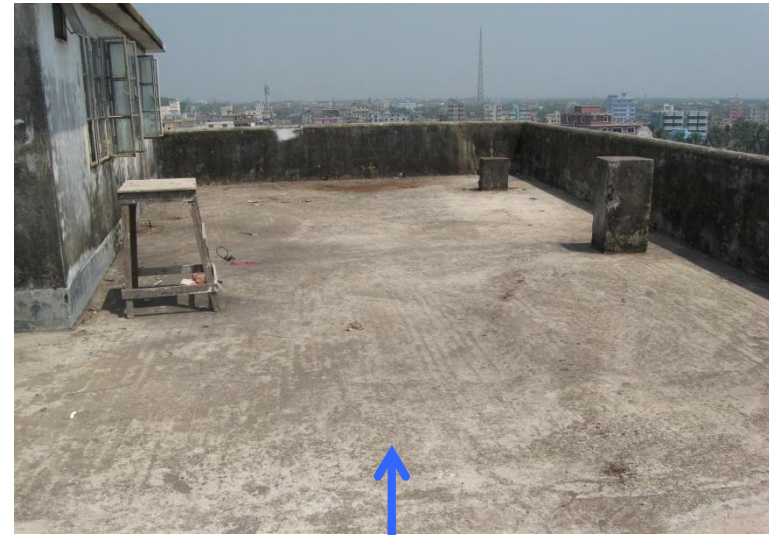
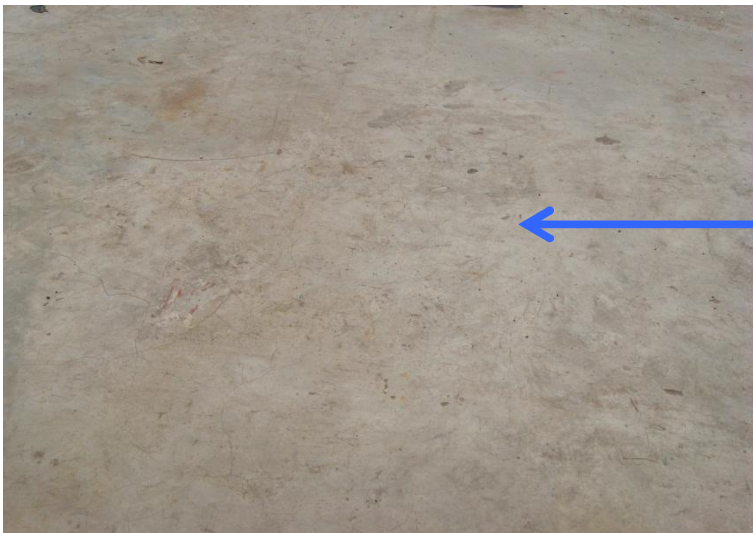
We were informed that the slab roofs had been treated with cementitious waterproofing. However, it is not clear if the system is still working.

- Engineer to inspect waterproofing material and its workability.
- Drainage system for the roof slab should be investigated and improved.
