Norban Comtex Ltd (10050)

Mouza-Sarabo, Chakroborty, Kasimpur Union, Gazipur
(+23.975960N, +90.265450E)

20.APRIL.2014

ACCORD
on Fire and Building Safety in Bangladesh

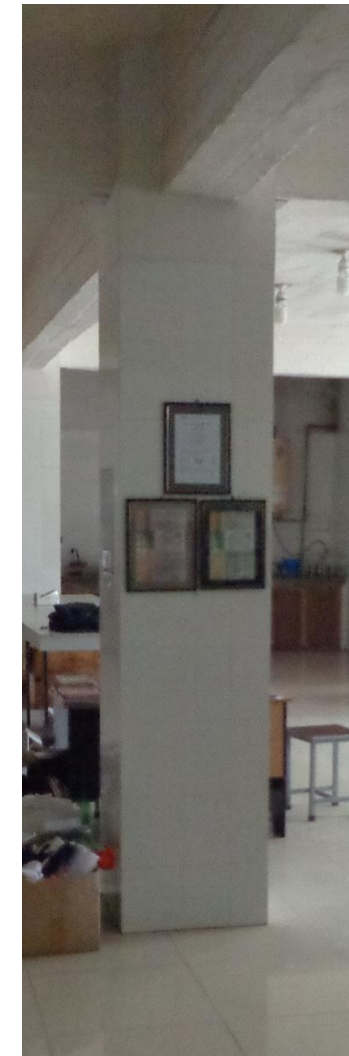
High Column Stresses

Within the Services Building and the Garment Pump house column load run-downs indicate higher than desirable levels of stress.

ITEM 1: (Priority 2) Column load run-downs for the Services Building and the Garment Pump house building indicate lower than desirable safety factors.

- Remove storage loads from all floors above basement level.

- Factory Engineer to review design loads and column stresses in both the Services Building and the Garment Pump house Building. Additionally, the Factory Engineer is to conduct a thorough review of the as-built Garment Pump house structure.

- Formulate, implement and actively monitor a slab loading plan for all floor plates within the factory.

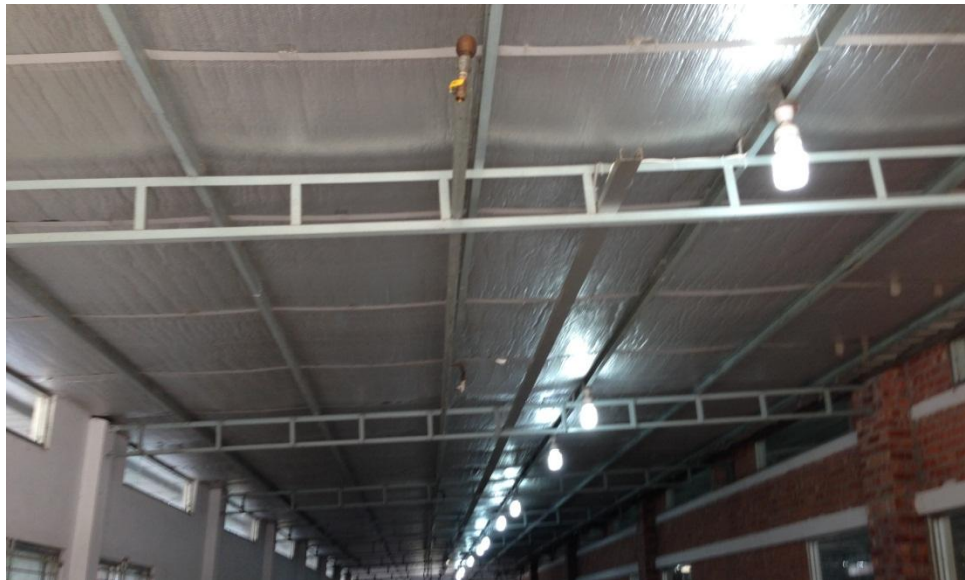
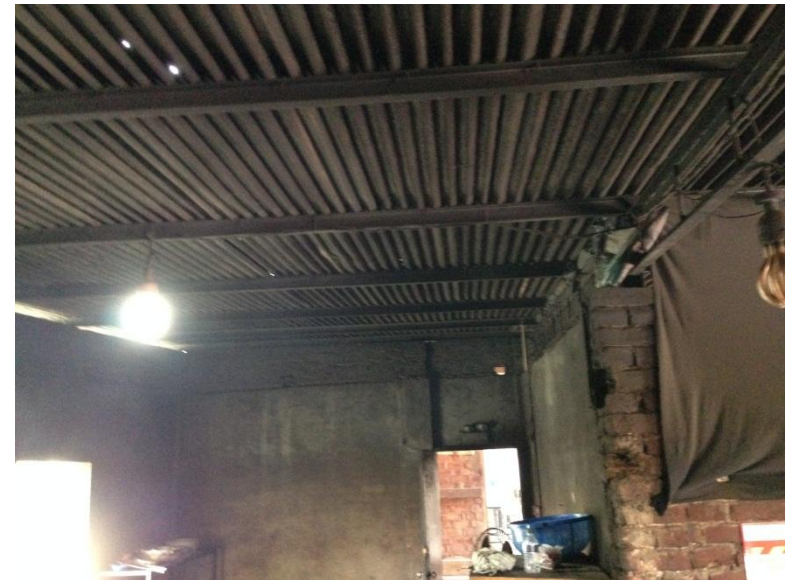
Poorly Framed Steel Shades

The factory complex contained an abundance of sheds, many of which were poorly framed and of very light steel sections.

ITEM 2: (Priority 2) Numerous steel sheds around the factory complex display poor framing practices and are composed of very light steel sections.

- Factory Engineer to conduct a review of all steel shade framing giving consideration to wind uplift loading.

- Implement any works found necessary by Engineer's review.

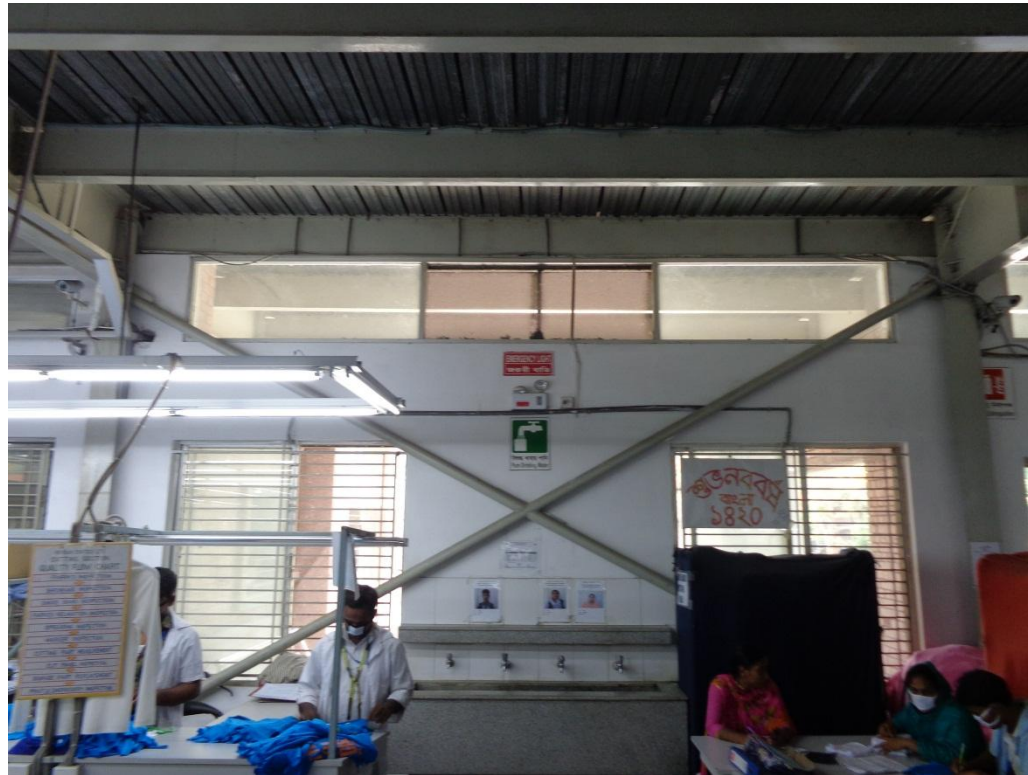
Lateral Restraint System

All R.C. buildings were constructed with beam/slab arrangements with no obvious means of lateral stability. Steel structures were noted to have at least a degree of steel cross-bracing.

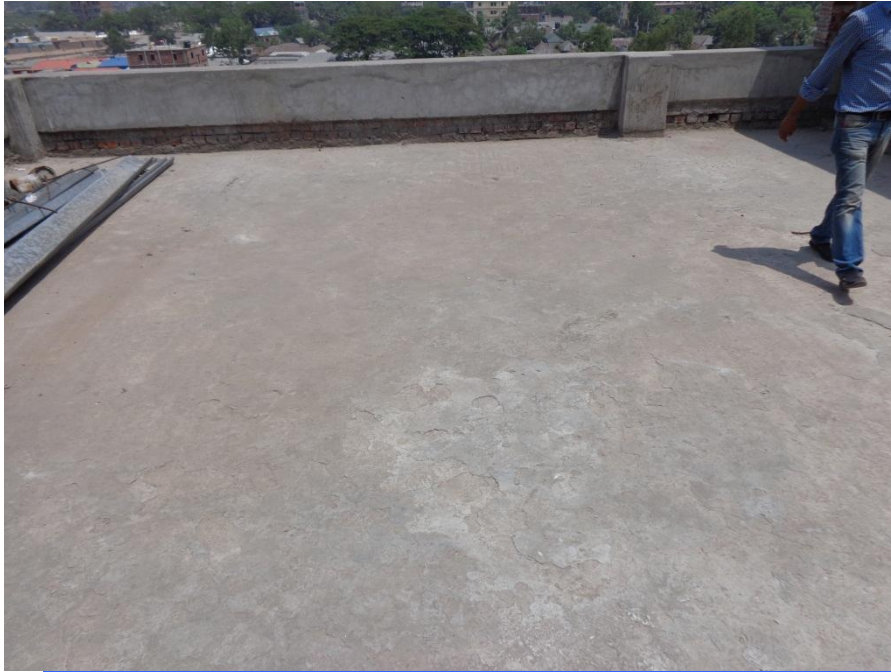
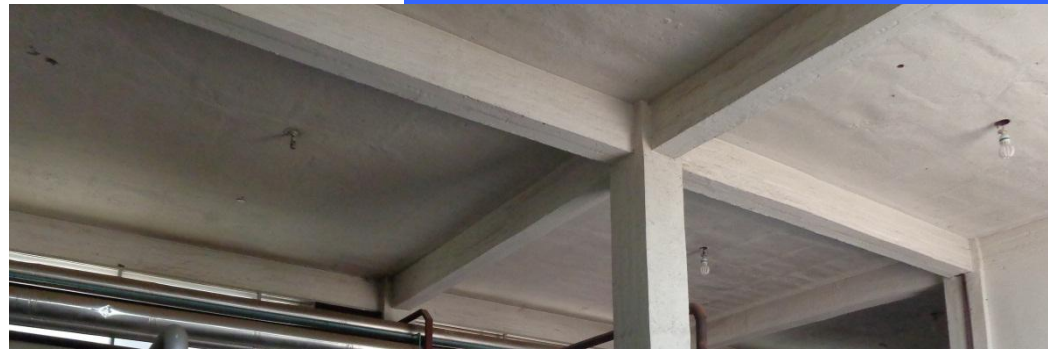
Roof Waterproofing System

There was no waterproofing observed at the rooftop levels of concrete topped buildings

There was no evidence of water infiltration at the underside of roof slabs
