# KDS Apparels Ltd. (9498)

251/252, Bayazid Bostami Rd, Nasirabad Industrial Area, Chittagong

20.April.2014

ACC RD  
on Fire and Building Safety in Bangladesh

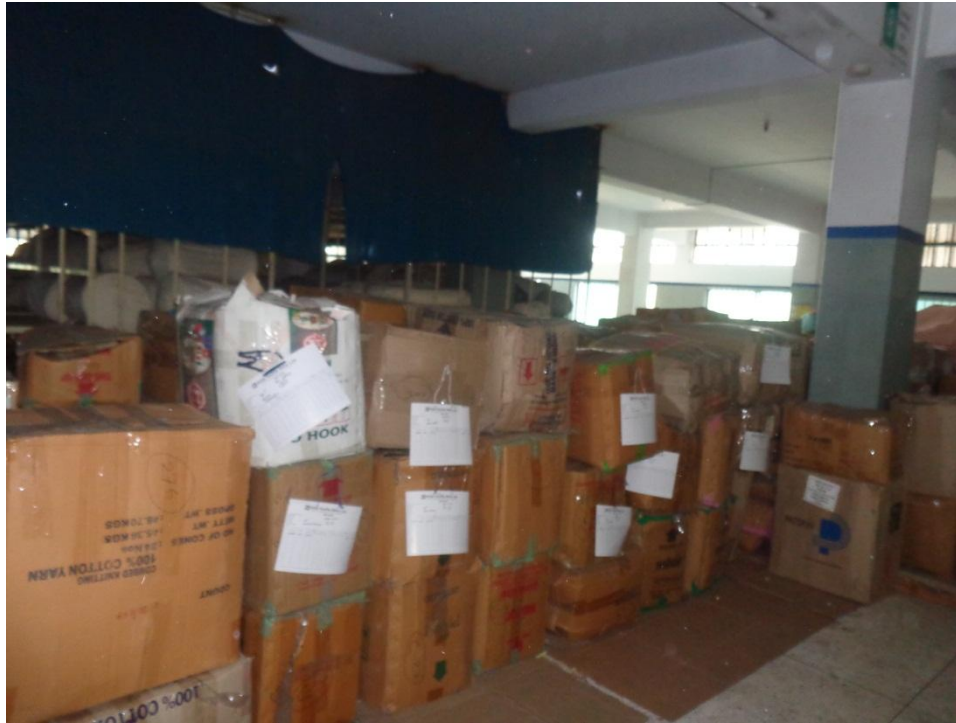
## 1<sup>st</sup> Priority 1 Concern

Block B building was built in 2005 with brick stone chip aggregate.

Columns reflect information provided on structural drawings which indicated 300mm x 450mm plan size with 14-20mm bars. one column was Ferro-scanned to confirm information.

Loading on typical floor was between approximately 4,8 kPa to 6 kPa.

The Managing Director was advised at the closing meeting to create and use loading plans immediately and remove all loading on the cantilevered section of Block B that is not recorded on any drawings.

Loading is to be reduced to acceptable stress levels. Limit loading to 3 kPa. We require a full Detailed Engineering Assessment of Block B.

- Verify in-situ stress and material properties by testing 100mm dia. Concrete cores of four columns.
- Commence a Detailed Engineering Assessment.

- Create and actively manage loading plans for all floors
- Induct workers on the use of the loading plans.

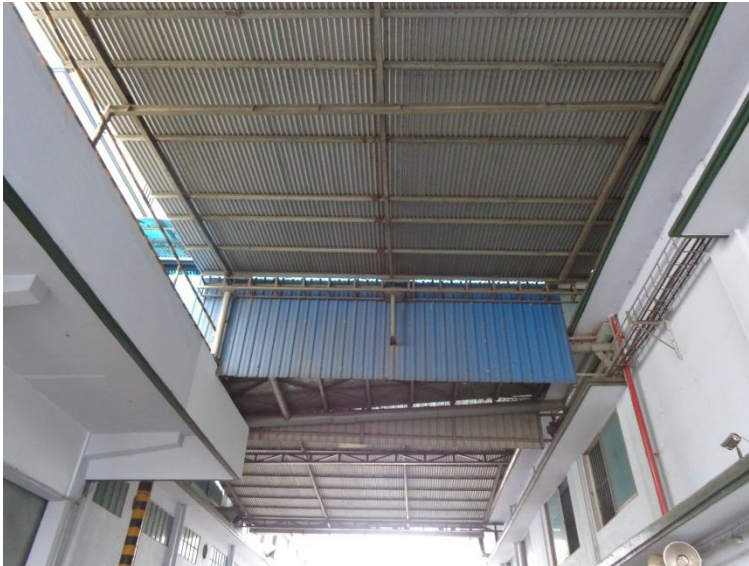
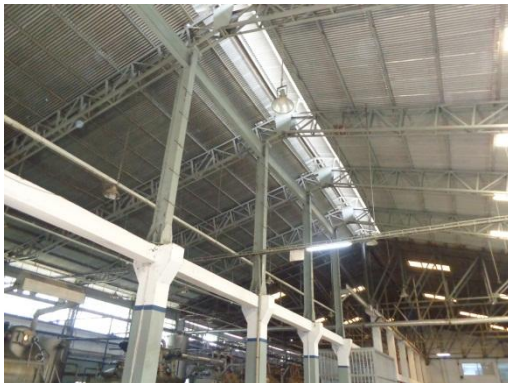
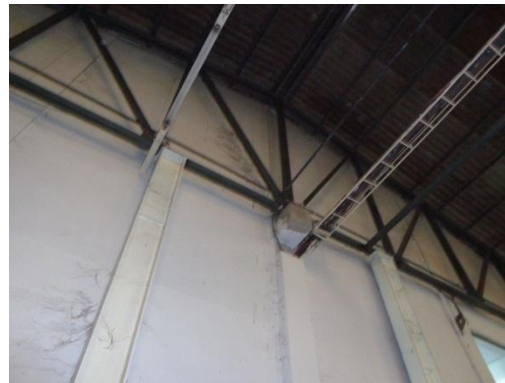
## 2<sup>nd</sup> Priority 1 Concern

During our survey, we found two steel structure buildings at the ground floor and a steel shed structure at the roof. We also found two bridges connecting both main buildings. Unorthodox details were noted in all parts.

As mentioned, no structural drawings were available for any of the steelwork structures.

Notable points:

1. Wind column in weak axis
2. Unrestrained bottom chords for uplift forces
3. Long spans for angles used for decking support
4. Improvised splices or bearing points

We require a full Detailed Engineering Assessment of the steelwork on this facility.

- Carry out a full Detailed Engineering Assessment of the steel structures evaluating capacities under gravity, lateral and uplift forces.

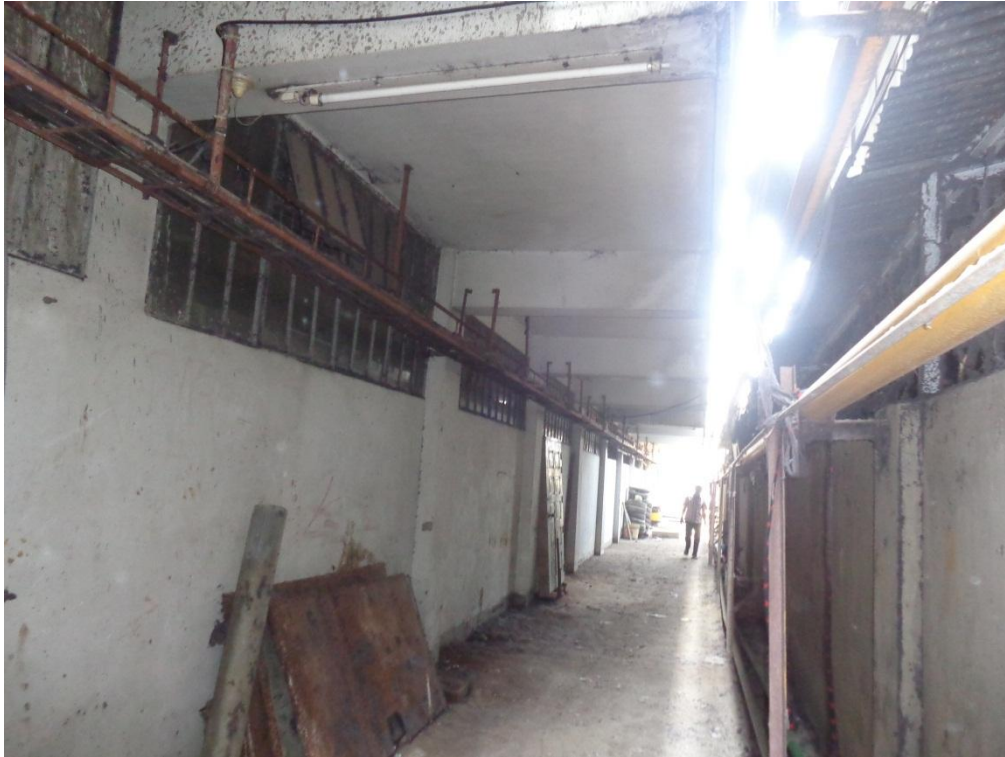
## 1<sup>st</sup> Priority 2 Concern

Our visit revealed a cantilevered section at the back of Block B. This was not shown on the structural drawings provided.

The capacity of the beams and slab as well as columns and foundations are to be included in the Detailed Engineering Assessment.

- Remove all loading on the cantilevered sections at all levels.

- Include an evaluation the ability of the beams and slabs as well as perimeter columns and foundations to take the surveyed loading in a full Detail Engineering Assessment.

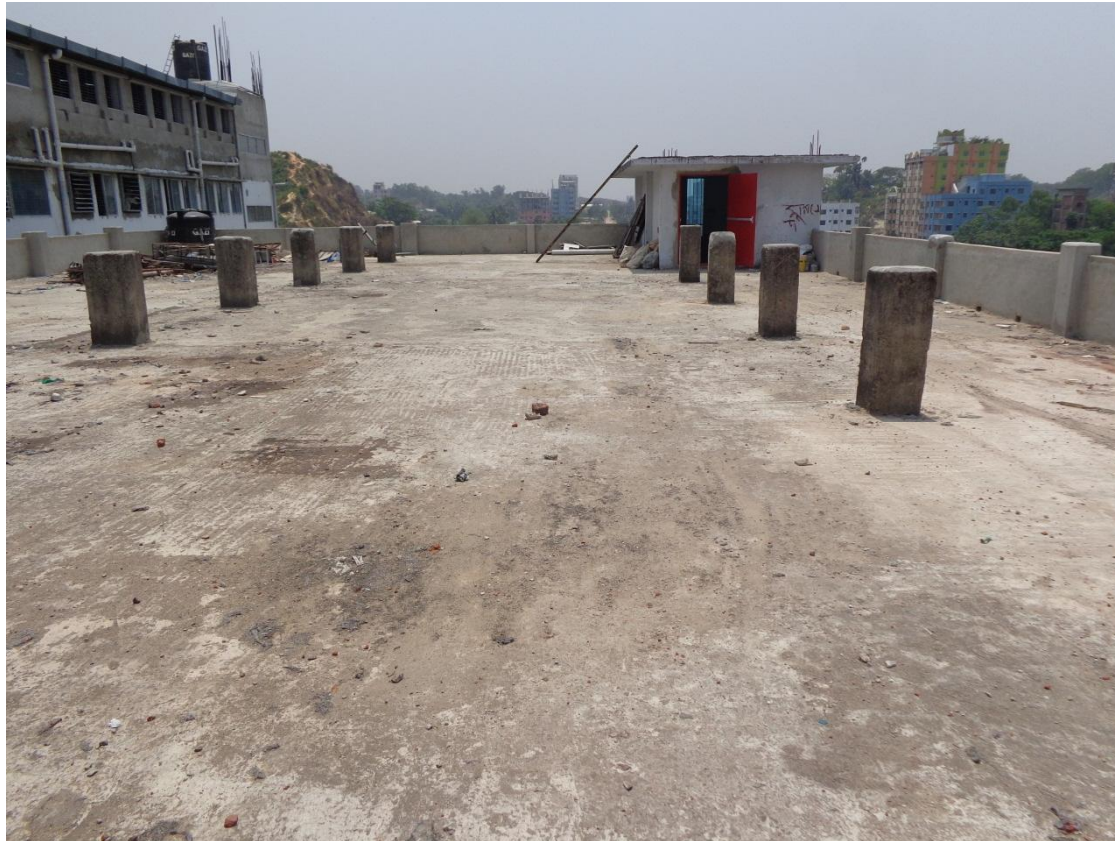
### 1<sup>st</sup> Priority 3 Concern

No waterproofing membrane was visible on the roof of the main buildings. This means that any cracks in the surface finishes on the roof will allow water to seep into the concrete slab beneath the finishes, and cause long-term soaking of the slab. The same applies to the water tanks at roof.

- Apply a new waterproofing membrane to all exposed roofs.

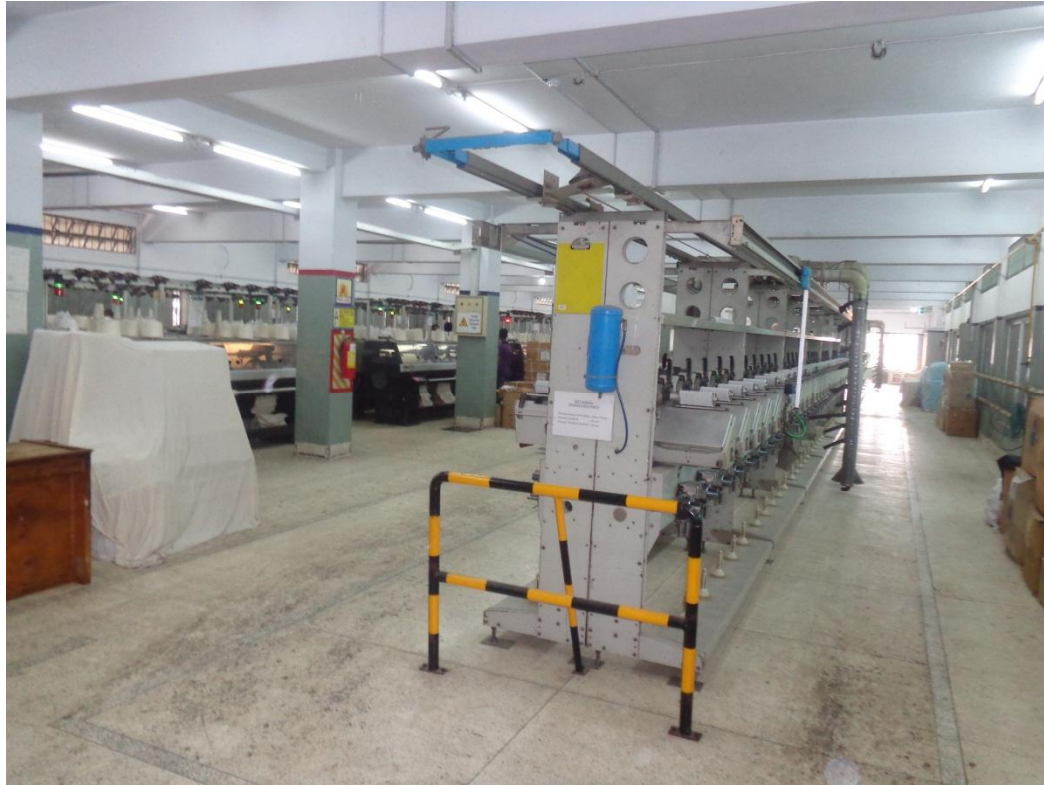
# Overall Stability System

Sway stability of building could probably be expected from rigid frame system (beam and column participation) although no ductile detailing is provided in structural plans.

Masonry infill is unrestrained and cannot be considered as any form of lateral restraint.

We require that these items be investigated as part of a Detailed Engineering Assessment.
