# Modele De Capital Ind. Ltd. (9671) Goumati Knitwear (9666)

20.APRIL.2014

ACCORD  
on Fire and Building Safety in Bangladesh

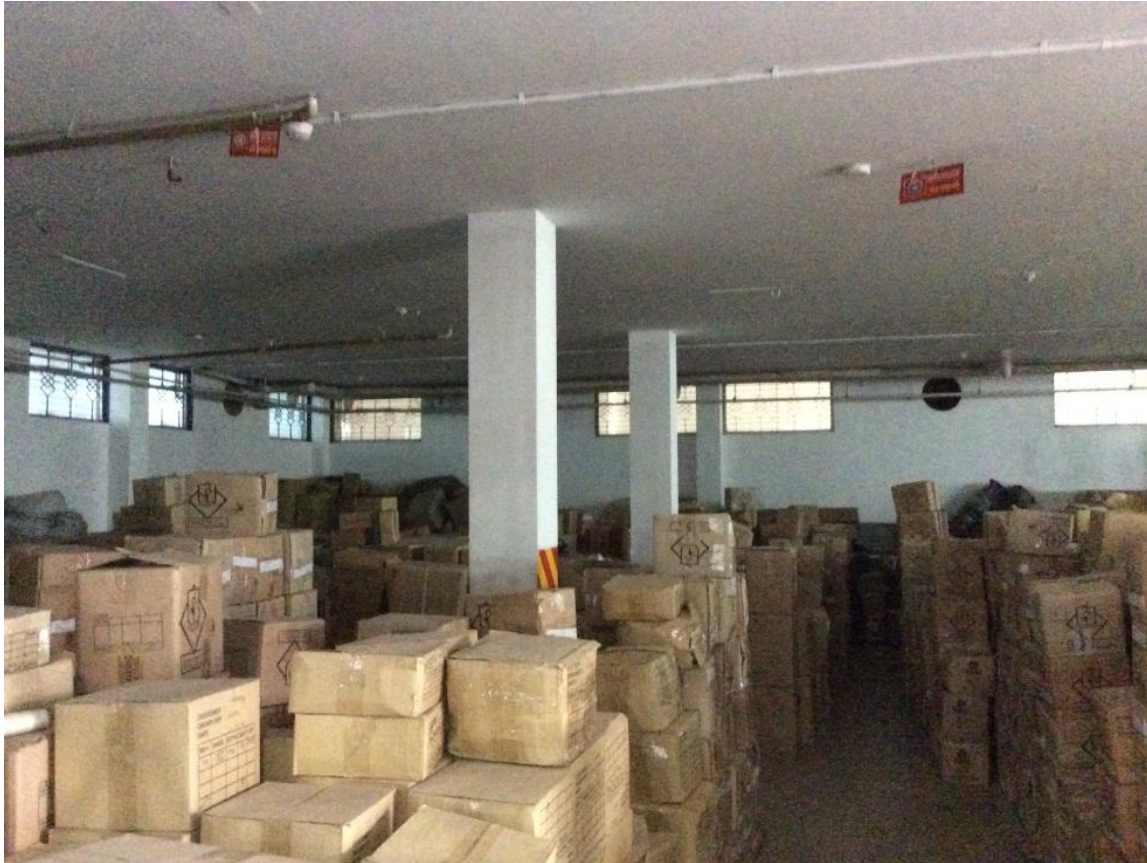
## Modele De Capital Factory

The columns in the Modele building were close to being overstressed. Storage was also observed at several levels.

High column stresses were calculated for the Modele building.

- Remove storage on levels 2 and 6 down to a maximum of 5.0kPa (125 psf).
- Do not increase loading on any of the floor slabs.

- Carry out a full Detailed Engineering Assessment to verify the structural capacity of the building.

- Carry out actions as required from the DEA.

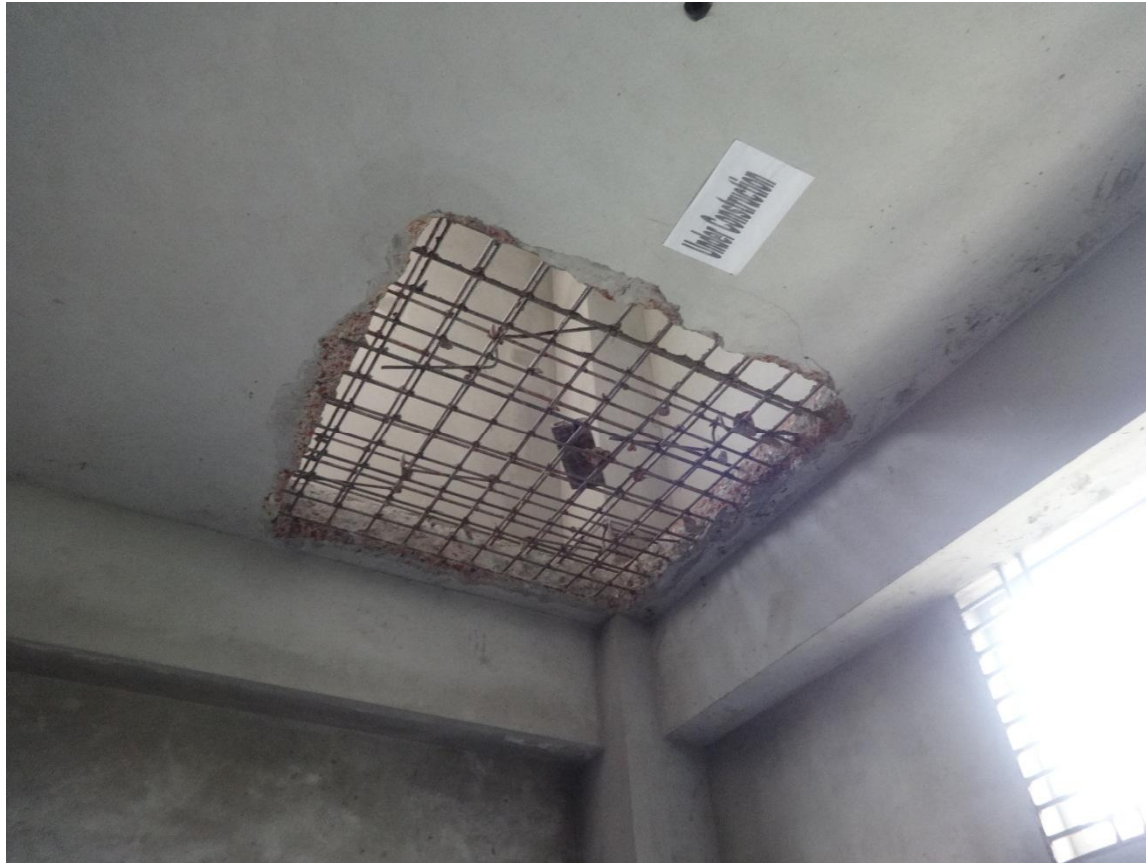
## Goumati Factory

Large unsupported slab opening in Goumati building.

- Temporarily support edge of slab.
- Do not load slab with construction materials.

- Either:
  - Keep opening and support free edges.
  - Infill slab opening and move staircase to a different location.

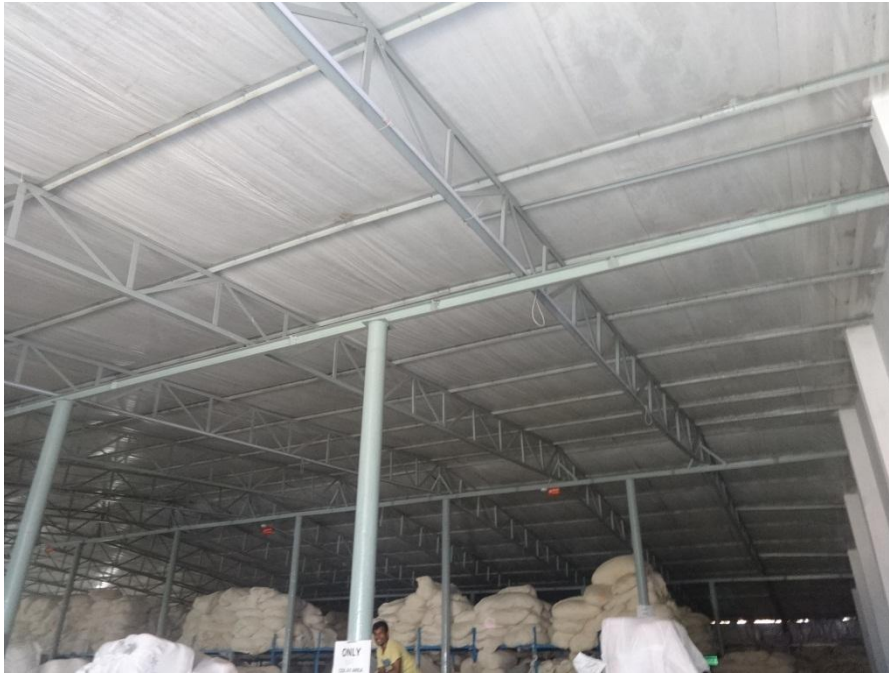
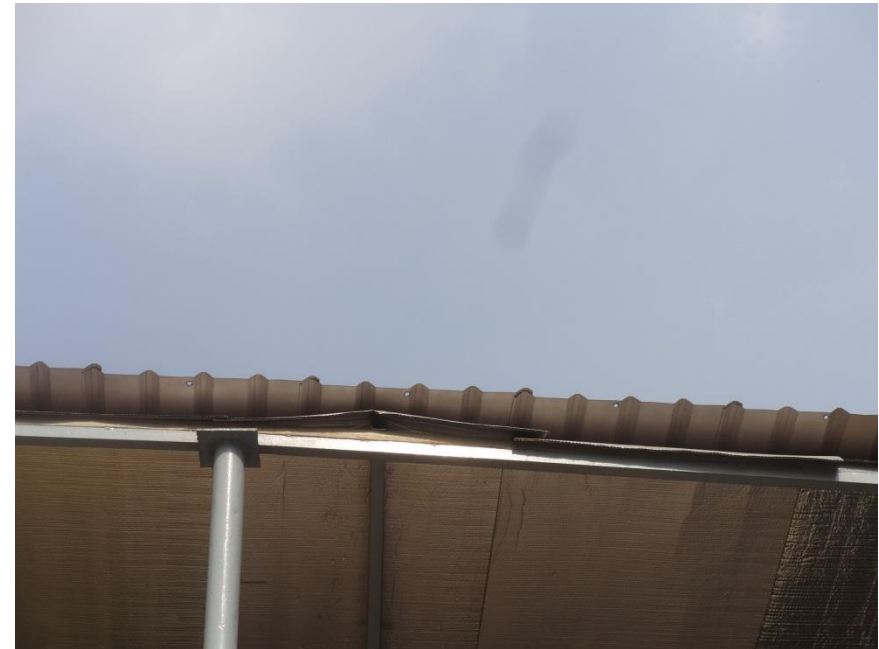
## Ancillary Buildings 4, 5, 6 & 7

Badly designed and detailed steel frames.

Badly designed and detailed ancillary buildings

- Carry out an engineering assessment on all of the ancillary buildings.

- Repair as required based on the engineering assessment.

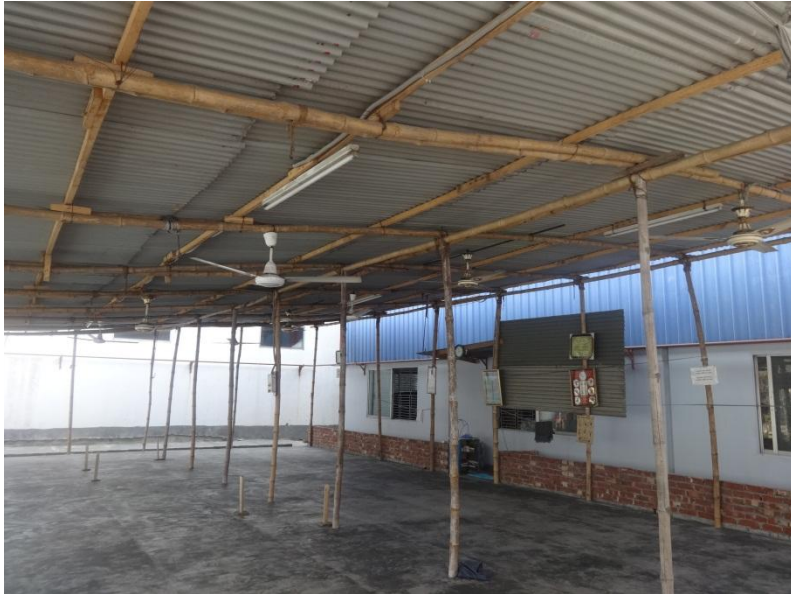
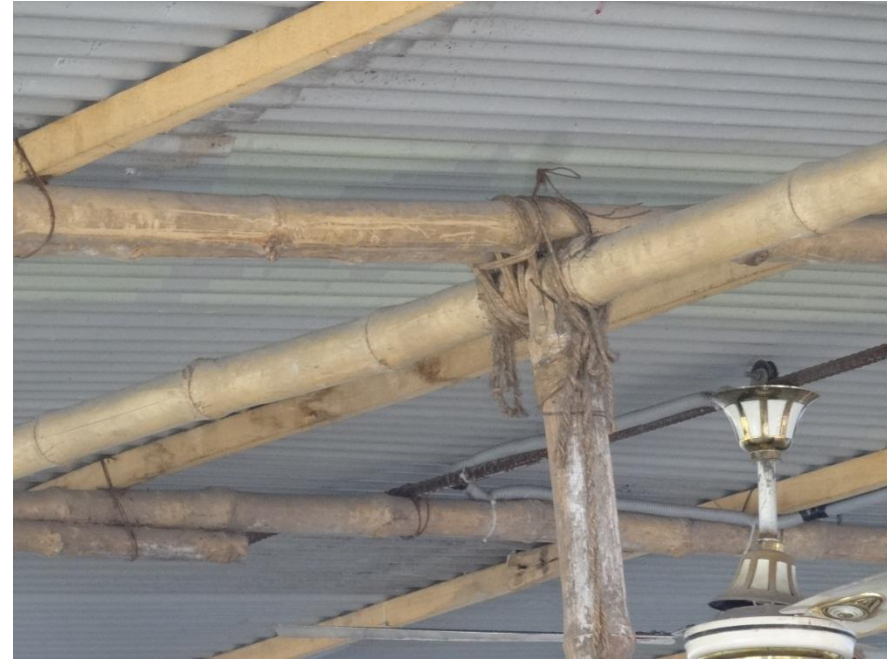
## Ancillary Buildings 1a & 1b

Structural condition of temporary buildings

Several “temporary” structures on site requiring strengthening or demolition

- Decide if building is permanent or temporary.

- Carry out engineering assessments if building are to remain.
- Or demolish buildings.

- Carry out recommendations of engineering assessment if building is going to remain.

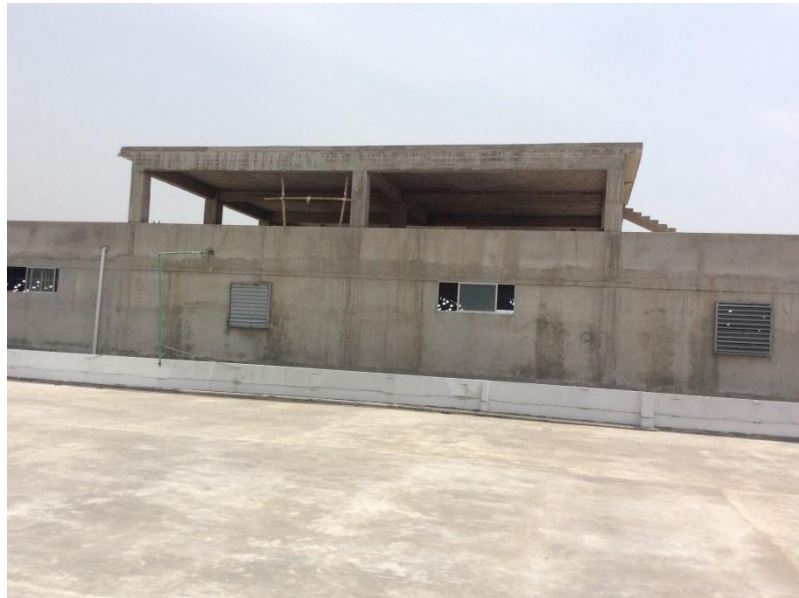
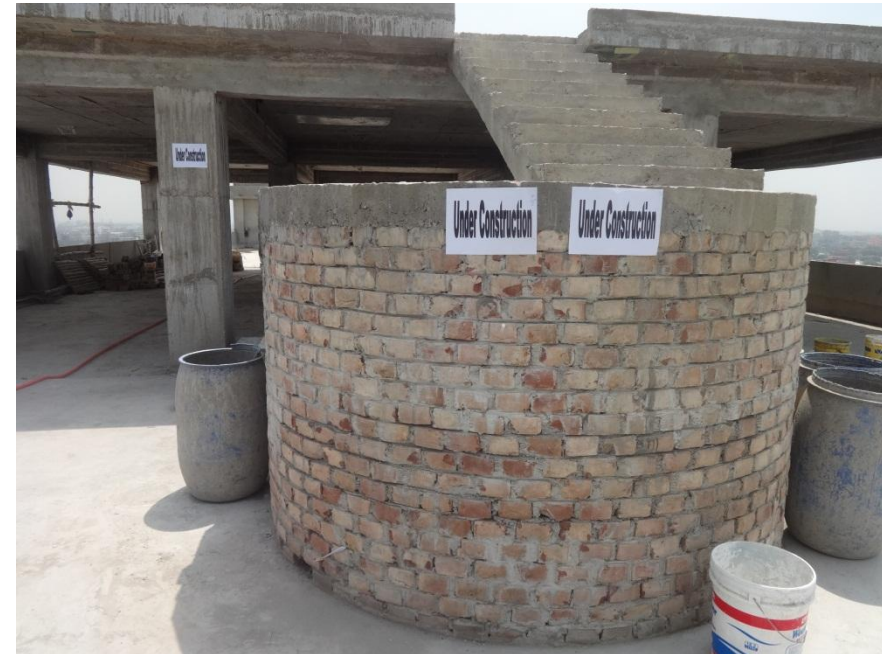
## Goumati Factory

A helipad is being constructed on the roof of the Goumati building however no loading information exists.

- Verify the capacity of the helipad to ensure proper use and operation according to local by-laws.

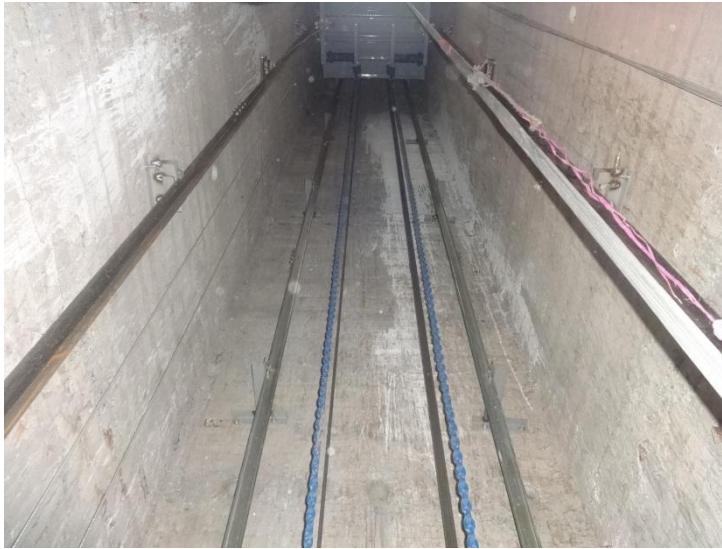
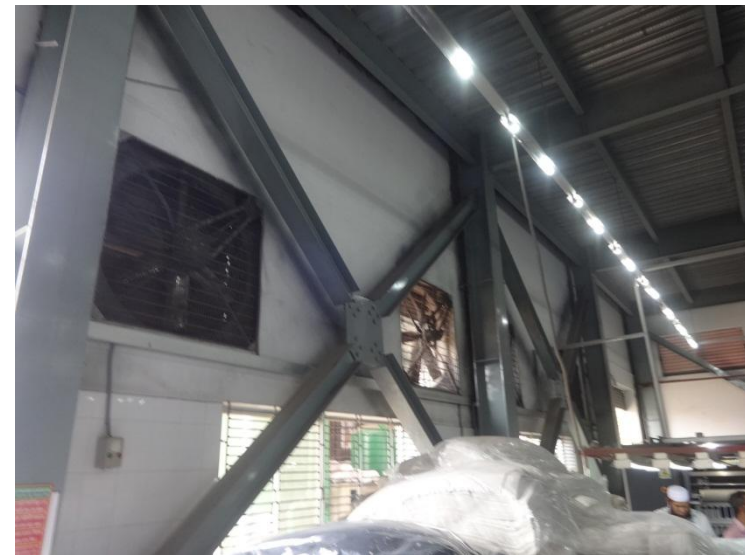
# Overall Stability System

The two factory buildings have core, lift shaft, walls for stability. Building 3 was a braced steel frame. The remaining buildings had no obvious stability systems.

We require that these items be investigated in a Detailed Engineering Assessment.

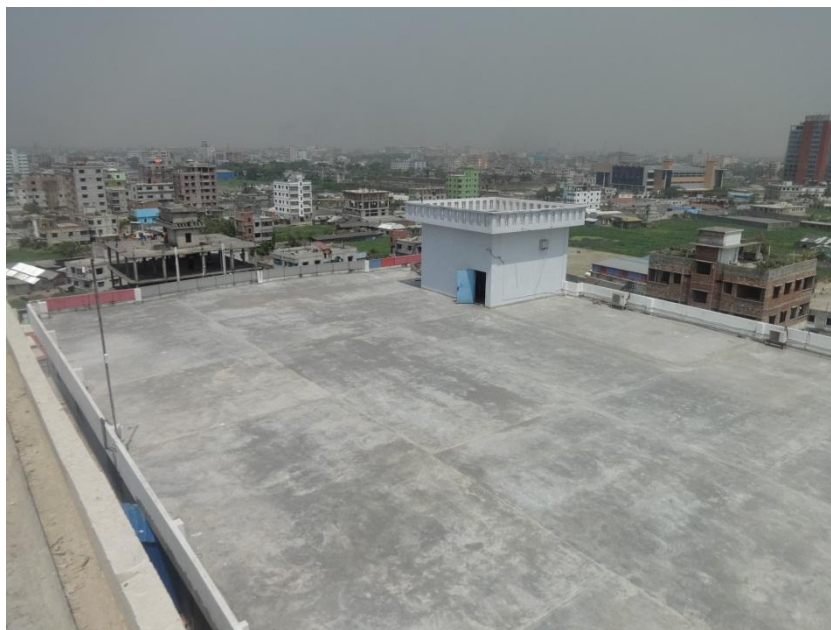
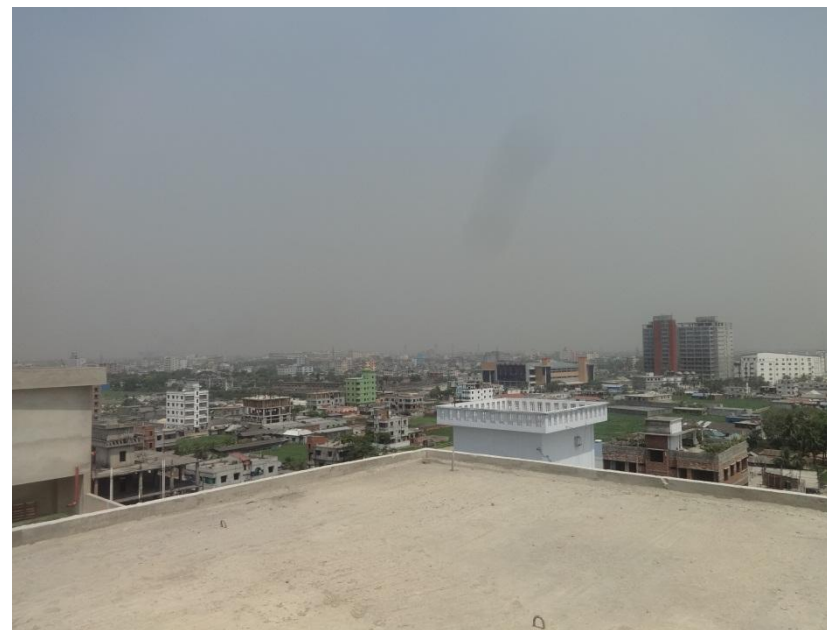
# Water Ingress at Roof Level

No waterproofing membrane was visible on the roof of either factory building. This means that any cracks in the surface finishes on the roof will allow water to seep into the concrete slab beneath the finishes, and cause long-term soaking of the slab.
