# Winter Dress Ltd (10907)

No.1 Kalma, Dairy Farm, Savar, Dhaka

30.APRIL.2014

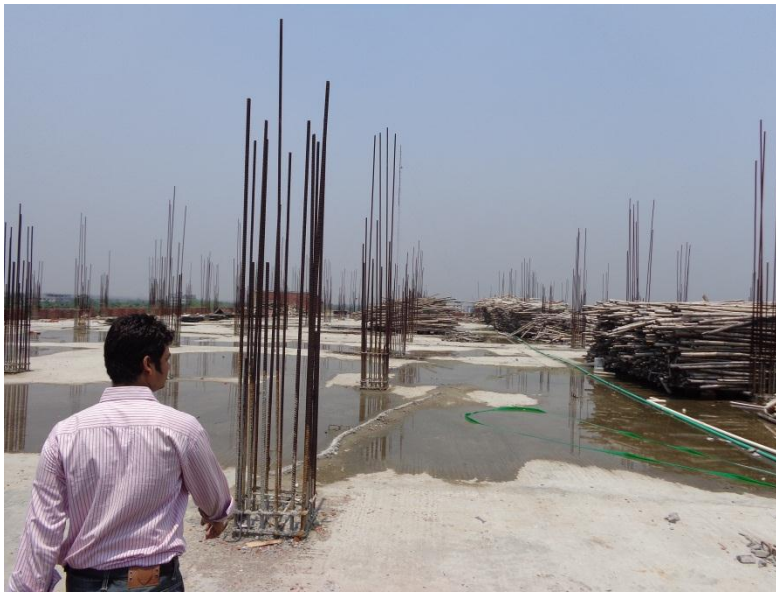
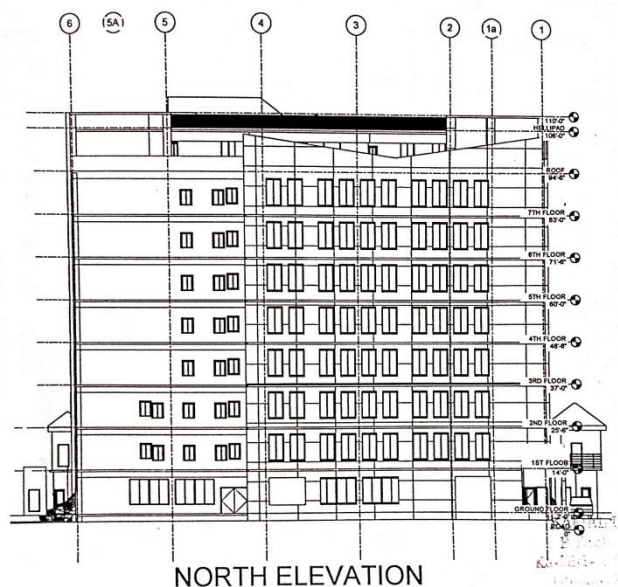
## Potential for Construction Above 6 Storeys

The building is currently constructed to the 5<sup>th</sup> Floor slab level. However, the Structural Drawings indicate potential for up to 8 Storeys above ground. Column checks indicate higher than desirable column stresses may be developed should the construction continue higher than 6 Storeys above ground.

Additionally, Permit Drawings are for a 10-Storey Building

**ITEM 1: (Priority 2)** Although the construction is currently at the 5<sup>th</sup> floor slab level, the Structural Drawings indicate potential for up to an 8-Storey building. Furthermore, a Permit has been provided for up to 10 Storeys. Column checks indicate higher than desirable stress levels should the building be constructed above the 6<sup>th</sup> Storey above Ground.

| Item No. | Observation | Recommended Action Plan | Recommended Timeline |
|---|---|---|---|
| 1 | Priority 2 - Continuation of the construction above the 5th Floor (6th Storey) level. | Should construction be considered above the 6th Storey, the Factory Engineer is to review design, loads and column stresses Under no circumstances can construction be continued higher than the original 8 Storeys considered by the structural design. | 6-weeks |
| 2 | Priority 2 - Continuation of the construction above the 5th Floor (6th Storey) level. | Conduct representative samples of concrete strength tests during future construction. | 6-months |

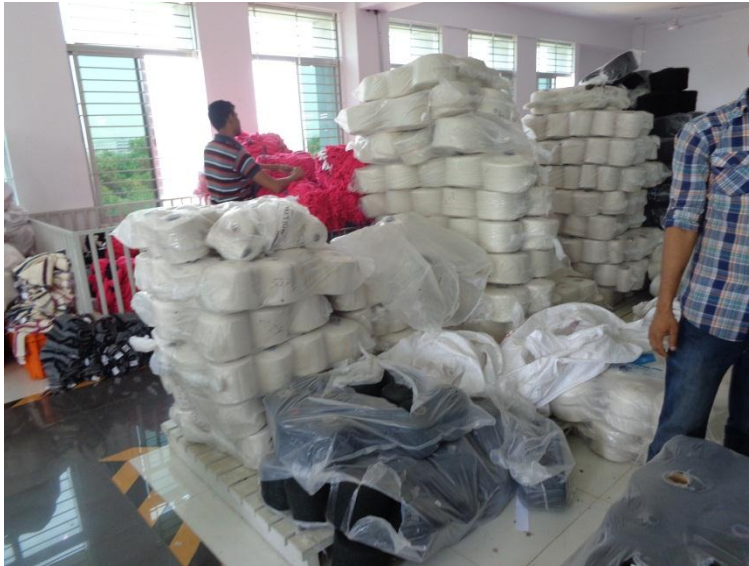
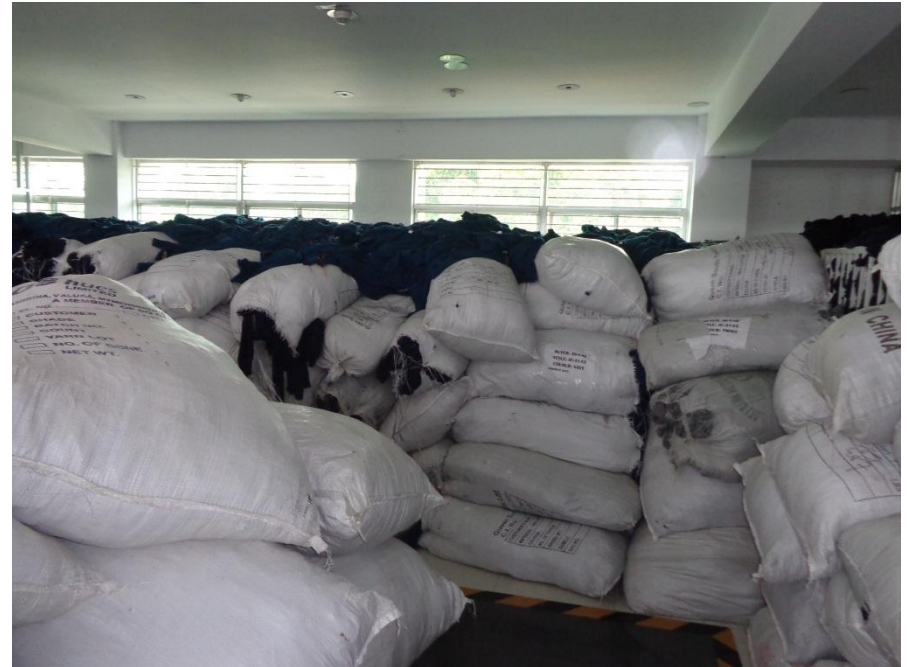
## High Local Storage & No Load Monitoring

An Engineer's letter was provided indicating a 3.0kPa maximum live load capacity for all floor slabs. However, there were localised areas of high storage. There was no evidence that load monitoring activities were taking place.

**ITEM 2: (Priority 3)** There were areas of higher than allowable live load storage observed, locally distributed throughout the factory. No slab load monitoring program seemed to be in effect.

| Item No. | Observation | Recommended Action Plan | Recommended Timeline |
|---|---|---|---|
| 3 | Priority 3 - High local storage levels | Reduce high local storage levels down to the allowable live load of 3.0kPa (60psf). | Immediate – Now |
| 4 | Priority 3 - High local storage levels | Develop and implement a loading plan for all floor plates within the factory giving consideration to slab, beam and column capacities. | 6-weeks |
| 5 | Priority 3 - High local storage levels | Actively monitor and enforce the loading plan. | 6-months |

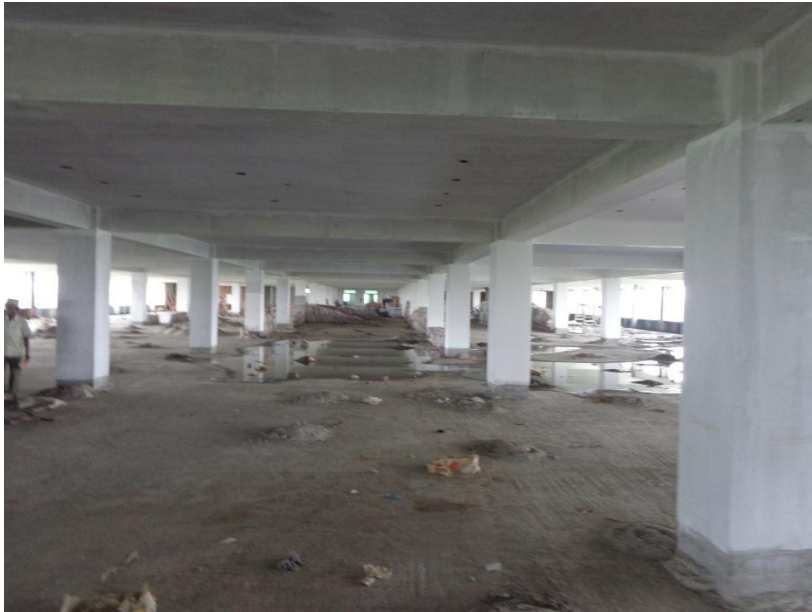
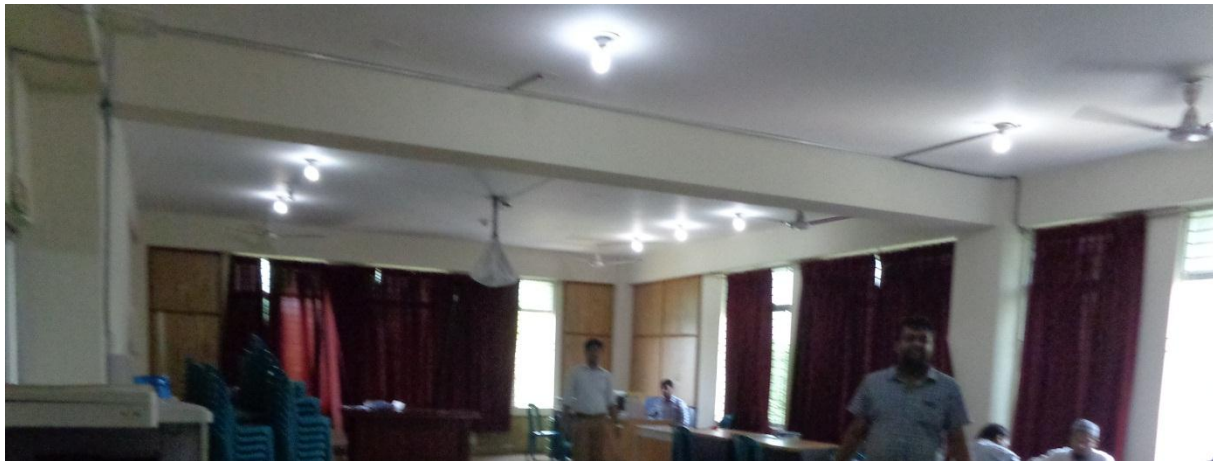
## Lateral Restraint System

The Winter Dress Ltd factory building was constructed using R.C. beam & column frames. This construction is considered to provide at least a measure of lateral stability. However, there are no shear walls or other form of robust lateral support system.

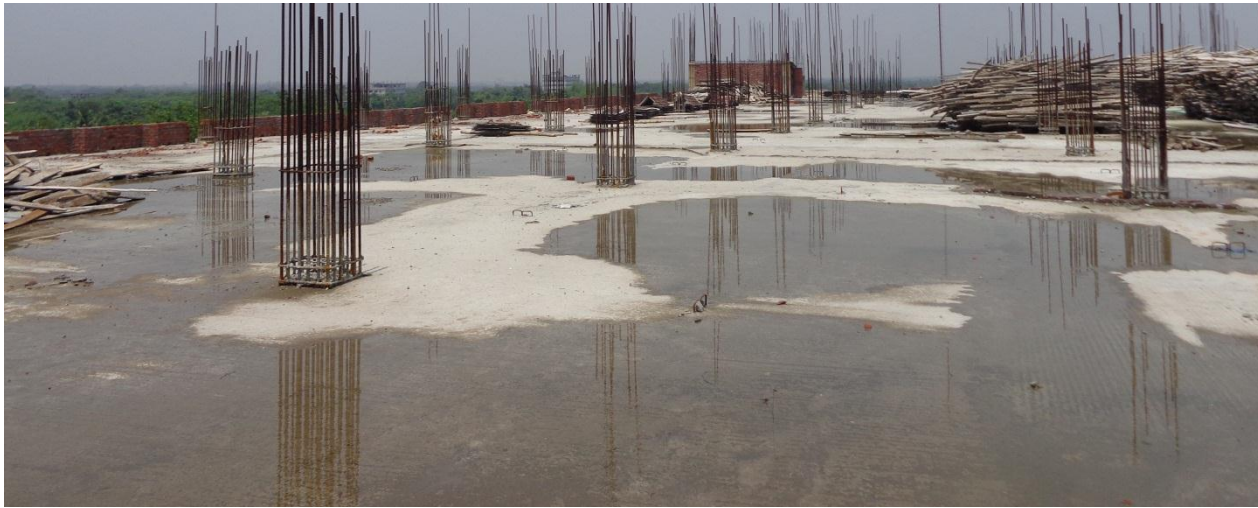
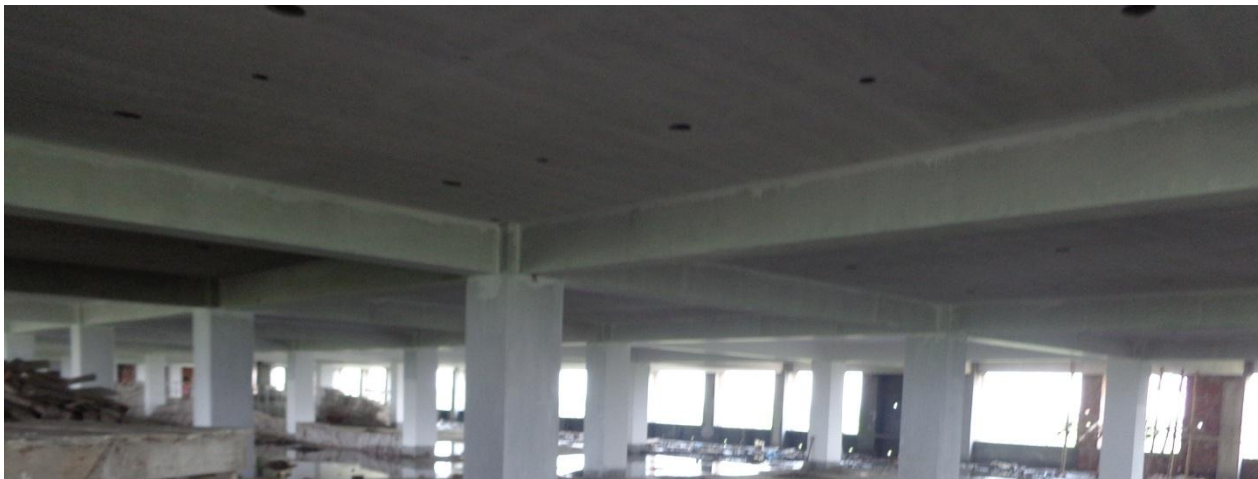
## Roof Waterproofing System

The 5<sup>th</sup> floor slab is currently serving as the roof slab. There is no water proofing provided and some ponding was evident at the time of inspection. However, there was no evidence of water ingress at the underside of the slab; likely due to its fairly recent construction.
