# Sung Kwang Apparels Ltd (10354)

Plot #1384-86, 1420-21, Vogra, Bason Sarak, Chandona, Gazipur

03.MAY.2014

## Identified Priority 1 Concerns

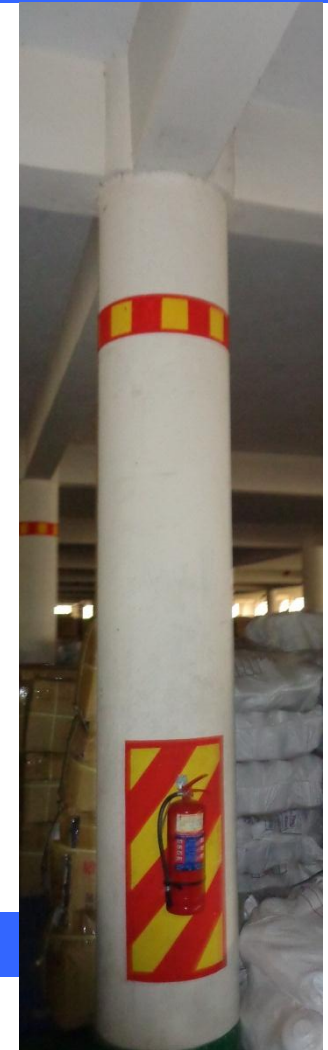
High Column Stresses

Under minimum allowable live loads the column stresses are higher than desirable.

**ITEM 1: (Priority 2) Under the minimum allowable live loads, column checks indicate that the columns at the Ground Floor level may have lower than desirable safety factors.**

| Item No. | Observation | Recommended Action Plan | Recommended Timeline |
|---|---|---|---|
| 1 | Under the minimum allowable live loads, column checks indicate that the columns at the Ground Floor level may have lower than desirable safety factors. | Reduce storage levels throughout the factory | Immediate – Now |
| 2 | Under the minimum allowable live loads, column checks indicate that the columns at the Ground Floor level may have lower than desirable safety factors. | Factory engineer to review design, loads and column stresses throughout factory. | 6-weeks |
| 3 | Under the minimum allowable live loads, column checks indicate that the columns at the Ground Floor level may have lower than desirable safety factors. | Complete implementation of any works deemed necessary by the factory engineer's review. | 6-months |

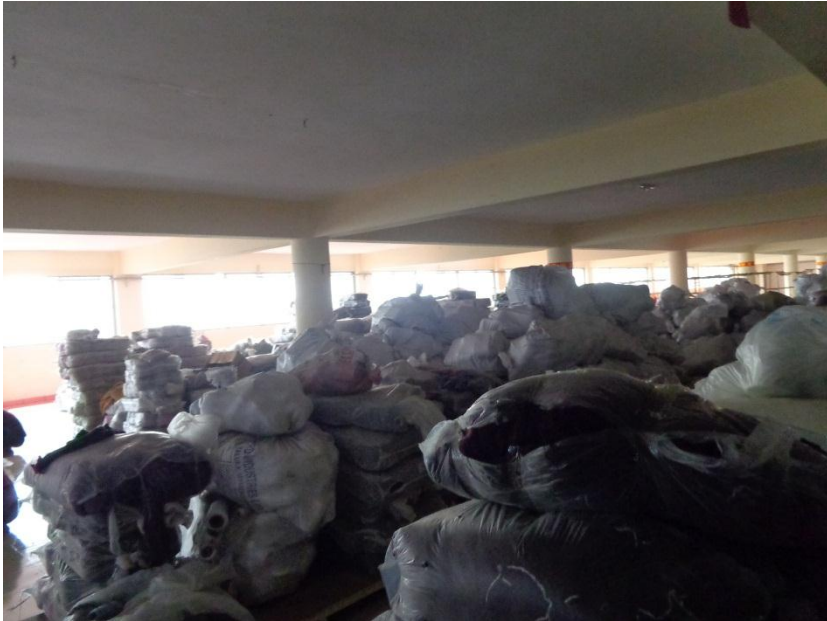
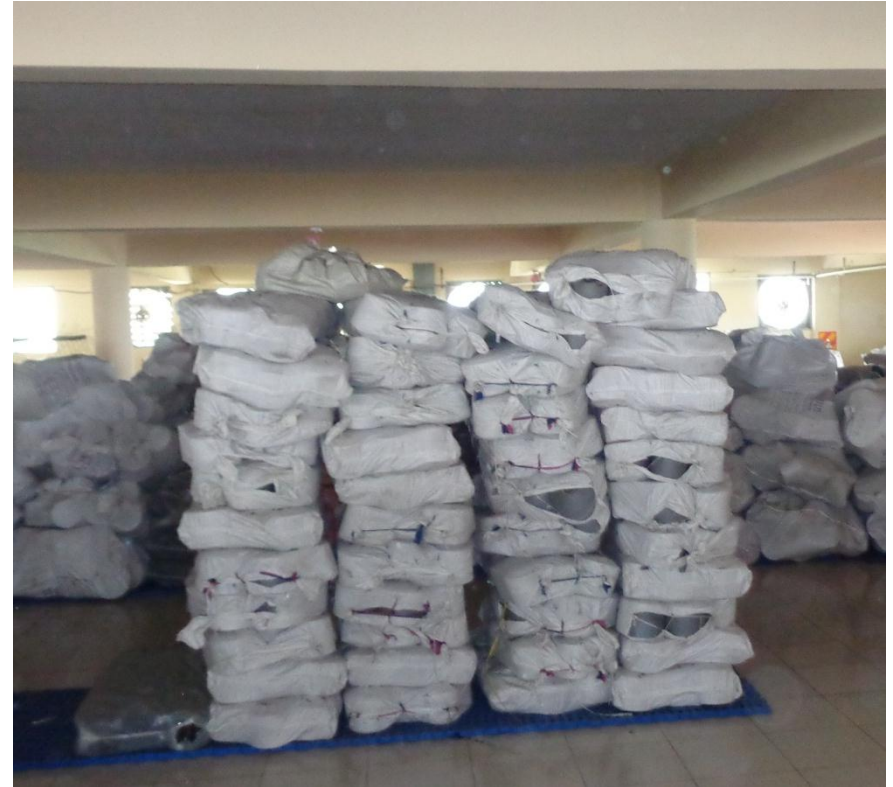
**No Loading Plan & High Storage**

No Loading Plan & High Storage

An Engineer's letter was provided indicating that an allowable live load of 100 psf for all floor slabs within the factory. However, during inspection there were high levels of storage observed sporadically throughout the building and no load monitoring appeared to be taking place.

**ITEM 2: (Priority 2) No explicit slab loading plans were available, nor was there any evidence of slab load monitoring. There was heavy storage observed sporadically throughout the factory building.**

| Item No. | Observation | Recommended Action Plan | Recommended Timeline |
|---|---|---|---|
| 4 | No explicit slab loading plans were available, nor was there any evidence of slab load monitoring. There was heavy storage observed sporadically throughout the factory building. | Reduce storage levels throughout the factory | Immediate – Now |
| 5 | No explicit slab loading plans were available, nor was there any evidence of slab load monitoring. There was heavy storage observed sporadically throughout the factory building. | Factory engineer to develop a loading plan for each floor within the factory complex, giving consideration to slab, beam and column capacity. | 6-weeks |
| 6 | No explicit slab loading plans were available, nor was there any evidence of slab load monitoring. There was heavy storage observed sporadically throughout the factory building. | Have implemented and actively monitor the loading plan | 6-months |

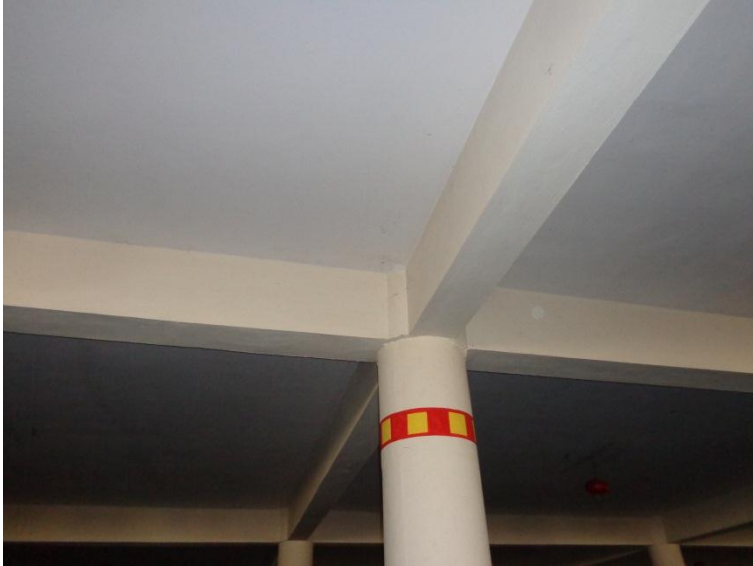
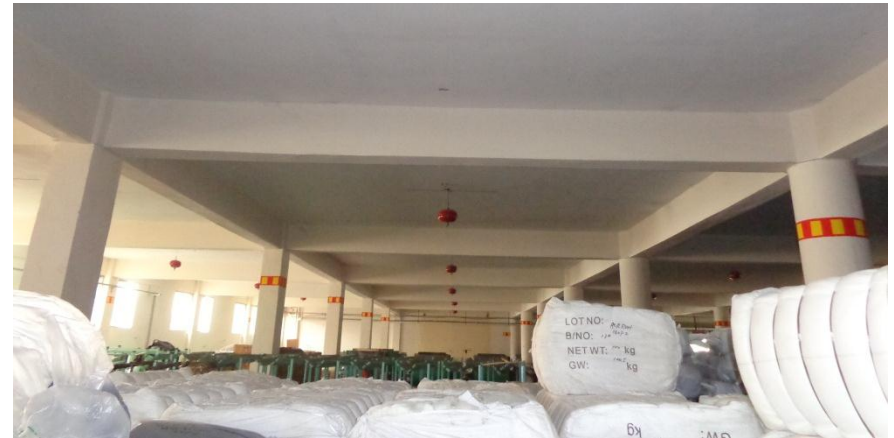
## Lateral Restraint System

All floors above the Ground Floor level were constructed of beam/slab configurations. This construction is assumed to provide at least partial moment frame action. However, no distinct and robust lateral restraint system was observed.

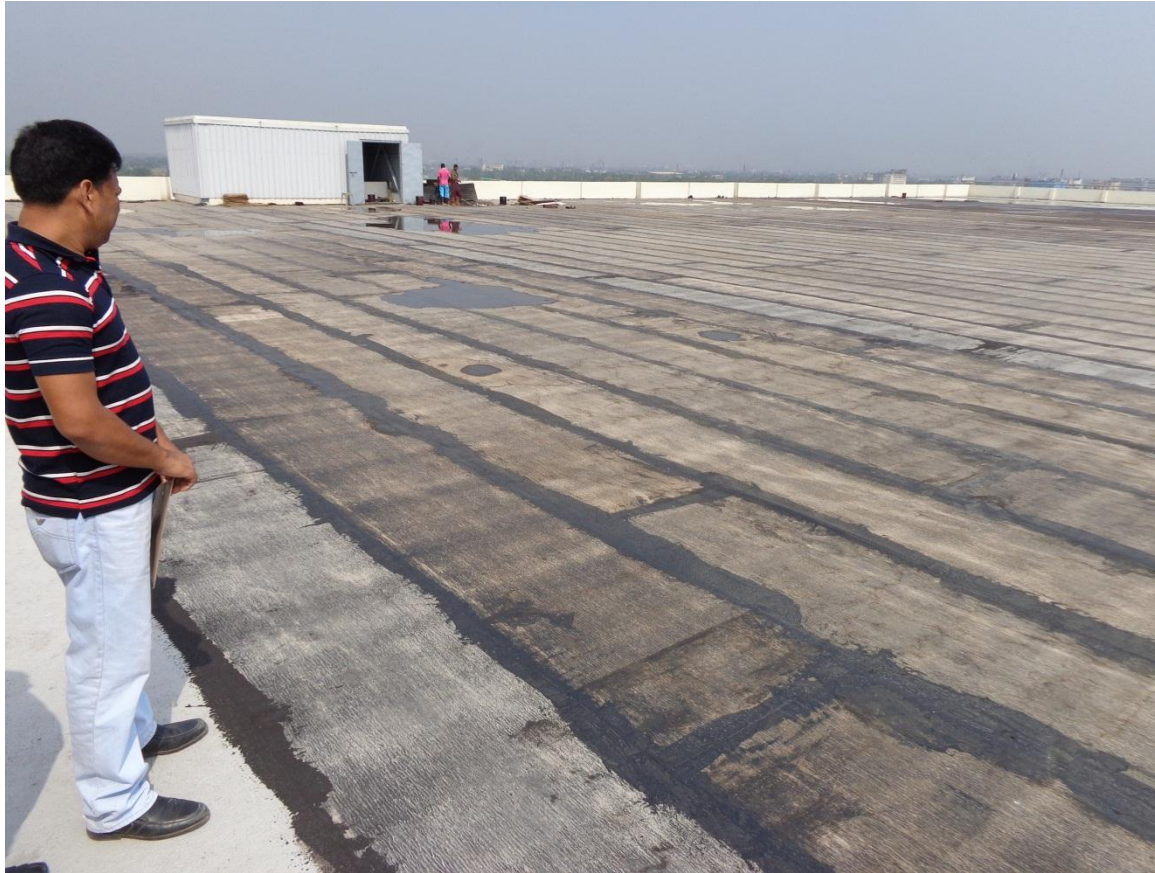
## Roof Waterproofing System

At the roof level we observed a waterproofing layer consisting of bitumen impregnated burlap fabric being applied to the top of the roof slab. There was no evidence of water ingress at the underside of the roof slab.
