Square Fashion Ltd. #10266

Chandra, Basan Union, Gazipur

03.MAY.2014

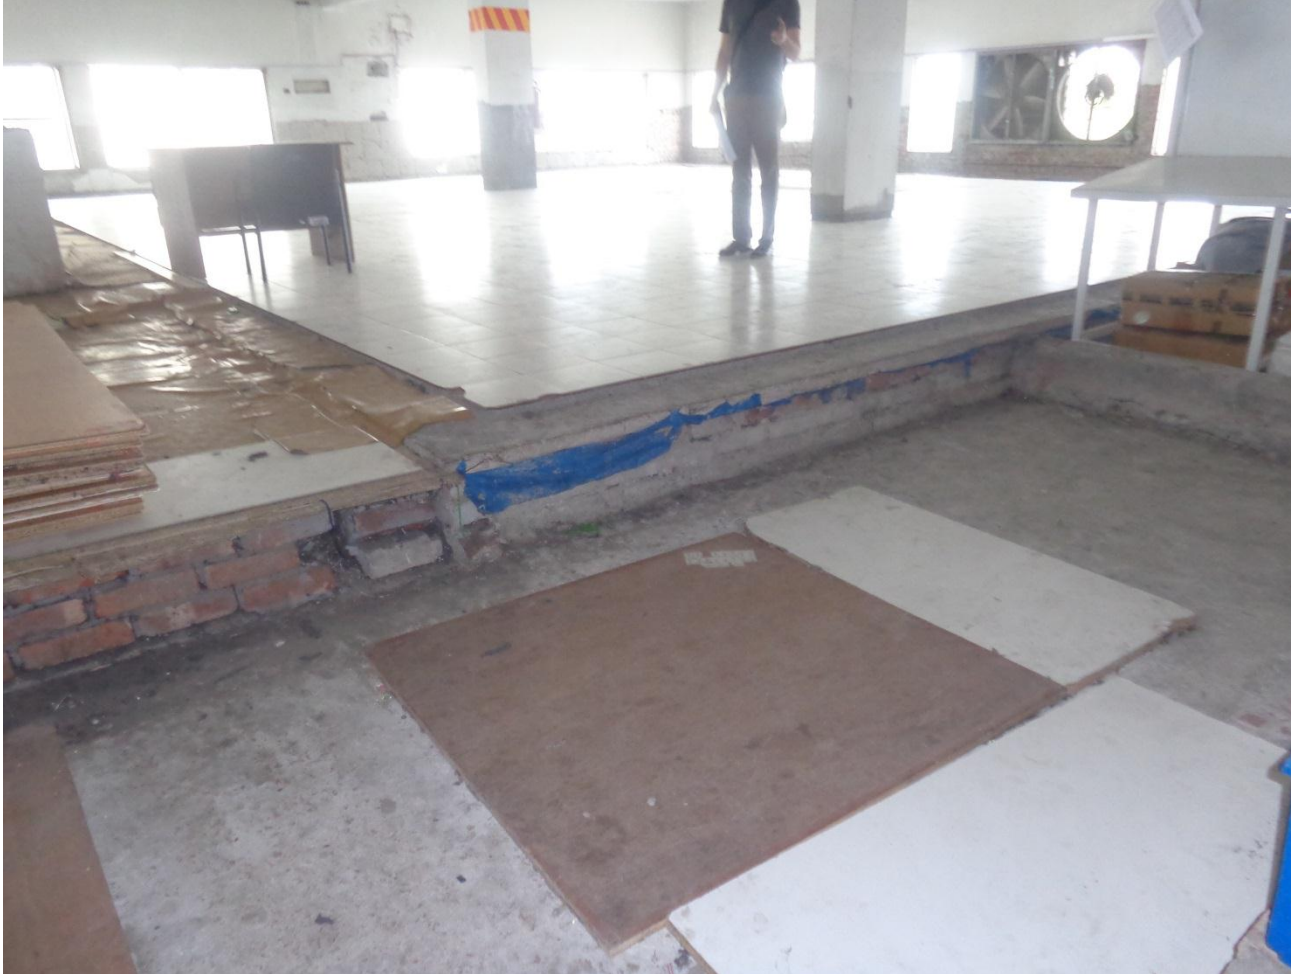
1st Priority 1 Concern

A 15" raised platform was discovered on the 1st floor, which is not shown on the structural drawings.

The raised platform is comprised of brick walls, sand infill, 4" concrete slab, screed and tile.

Item No.	Observation	Recommended Action Plan	Recommended Timeline
1	A 15” raised platform was discovered on the 1st floor, which is not shown on the structural drawings, nor is it accounted for in the loading plans provided.	Remove raised platform in its entirety.	Immediate – Now
2	A steel roof on the 6th floor slab is not shown on the structural drawings, nor is it accounted for in the loading plans provided.	Review as built conditions on roof slab and update structural drawings.	Immediate – Now
3	A steel roof on the 6th floor slab is not shown on the structural drawings, nor is it accounted for in the loading plans provided.	Review permissible loading with design and engineer and produce approved loading plans. Display & manage loading plans on all floors	6-weeks
4	No footing dimensions were found on structural drawings, and column reinforcing did not match structural drawings.	Review as built conditions on and update structural drawings.	Immediate – Now

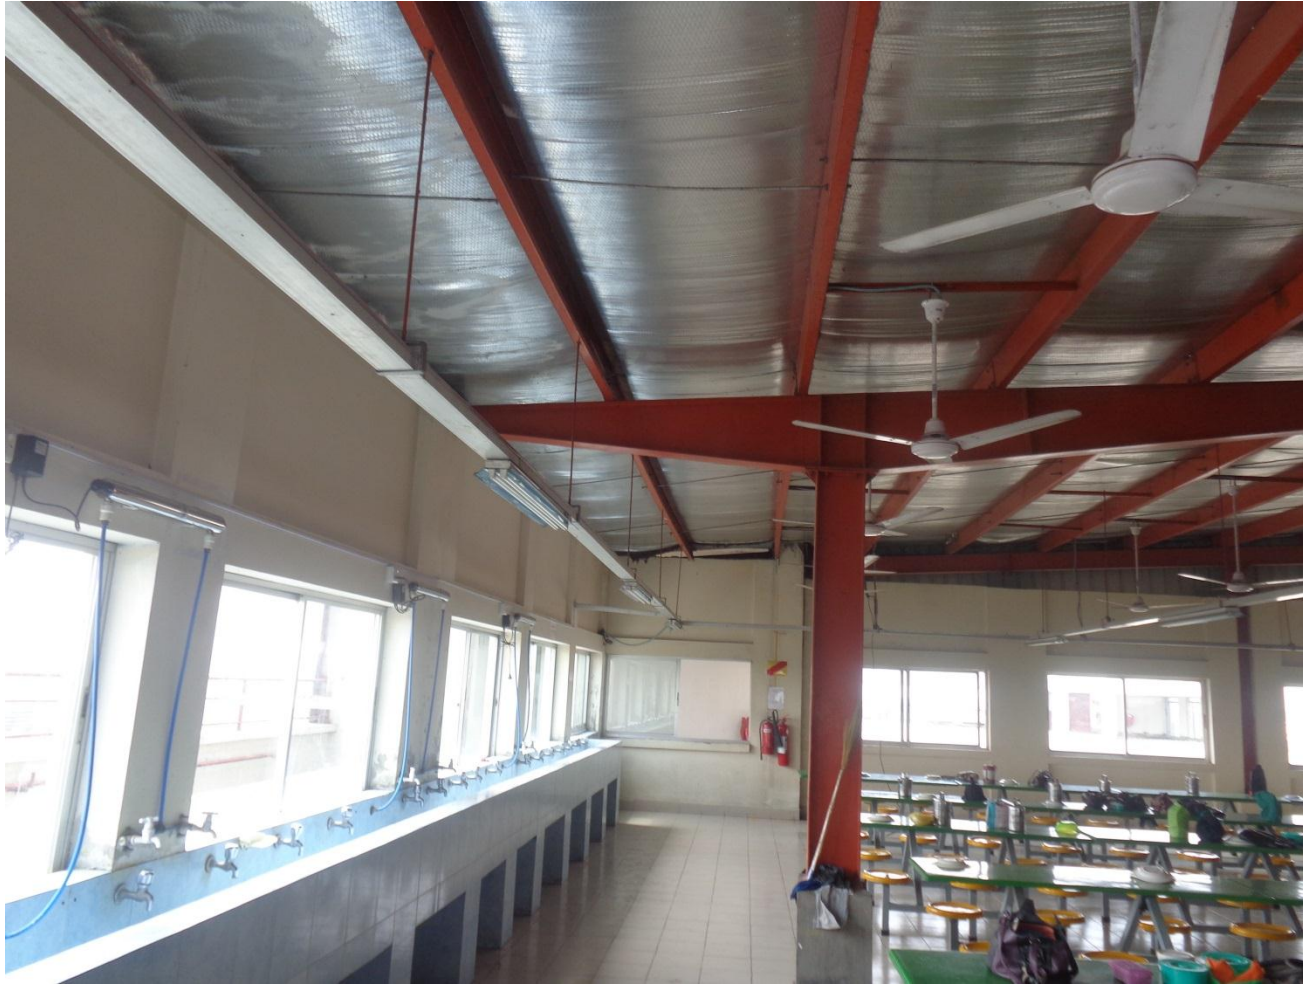
2nd Priority 1 Concern

A steel roof on the 6th floor slab is not shown on the structural drawings, nor is it accounted for in the loading plans provided

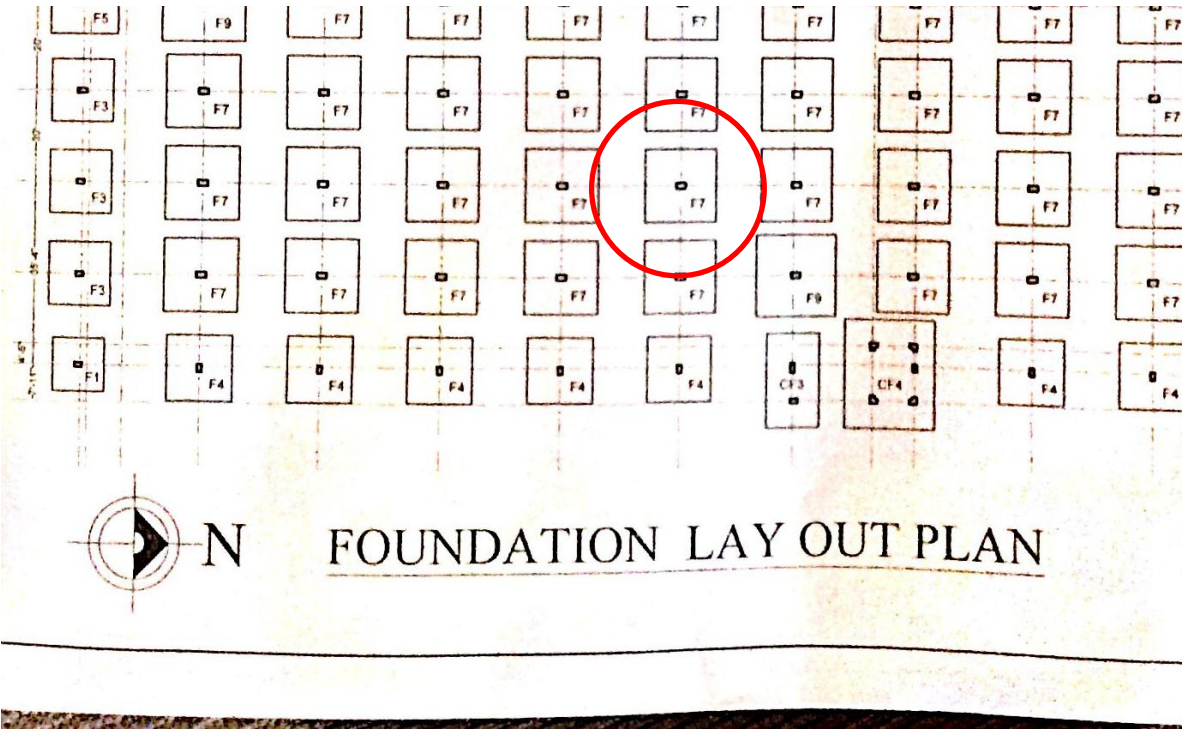
3rd Priority 1 Concern

No footing dimensions were found on structural drawings.

Scanned reinforcing steel in column did not match structural drawings.

C6	27"x17"	25"x15"	16-25 ϕ 	12-25 ϕ 	4-25 ϕ + 8-20 ϕ
C7	27"x17"	25"x15"	18-25 ϕ 3 	14-25 ϕ 	4-25 ϕ + 8-20 ϕ
C8	27"x17"	25"x15"	22-25 ϕ 	16-25 ϕ 	17-25 ϕ

5	No footing dimensions were found on structural drawings, and column reinforcing did not match structural drawings.	Review soils report recommendations to ensure footing size is adequate. Review column reinforcement to ensure adequate load bearing capacity.	6-weeks

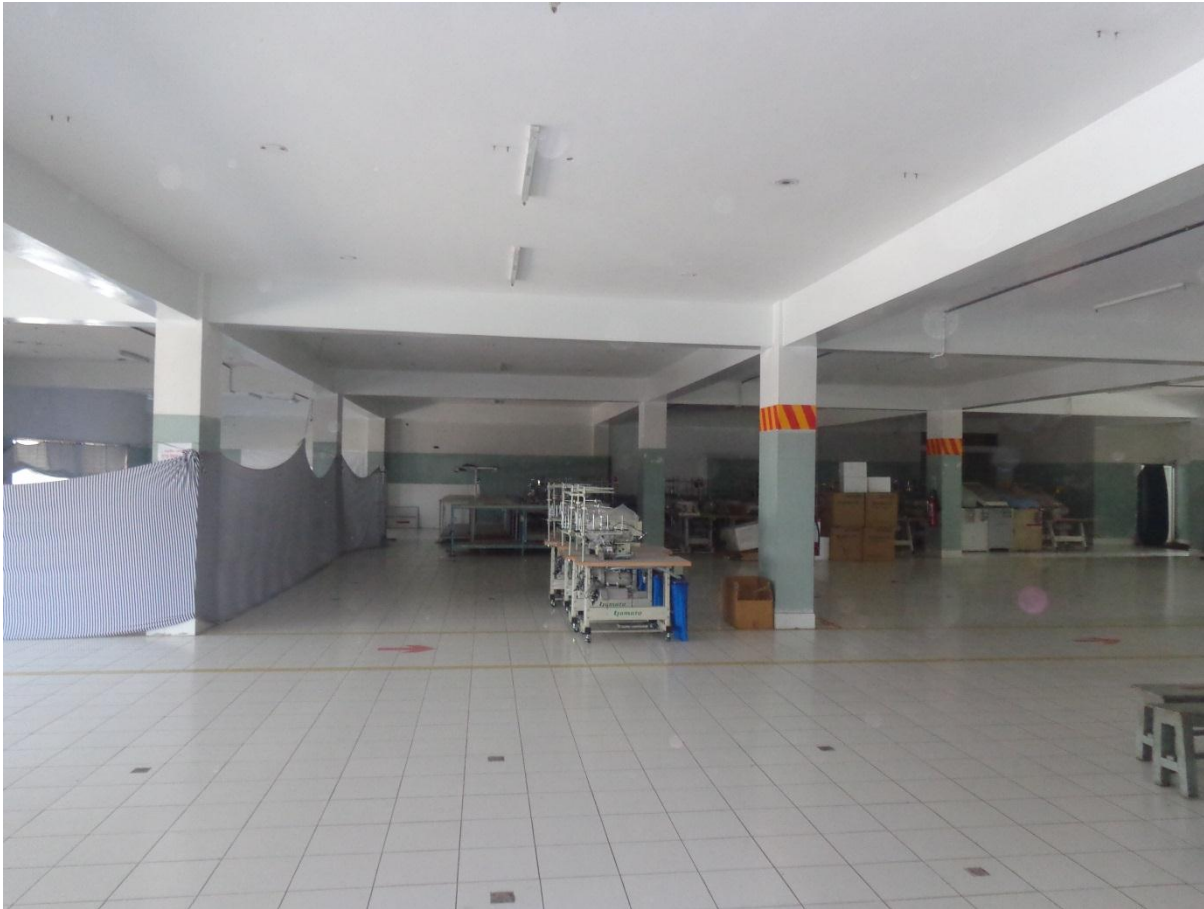
Overall Stability System

The building did not feature any core or shear walls. Stability was achieved through sway action between beams and columns and masonry infill walls.

We require that these items be investigated in a Detail Engineering Assessment

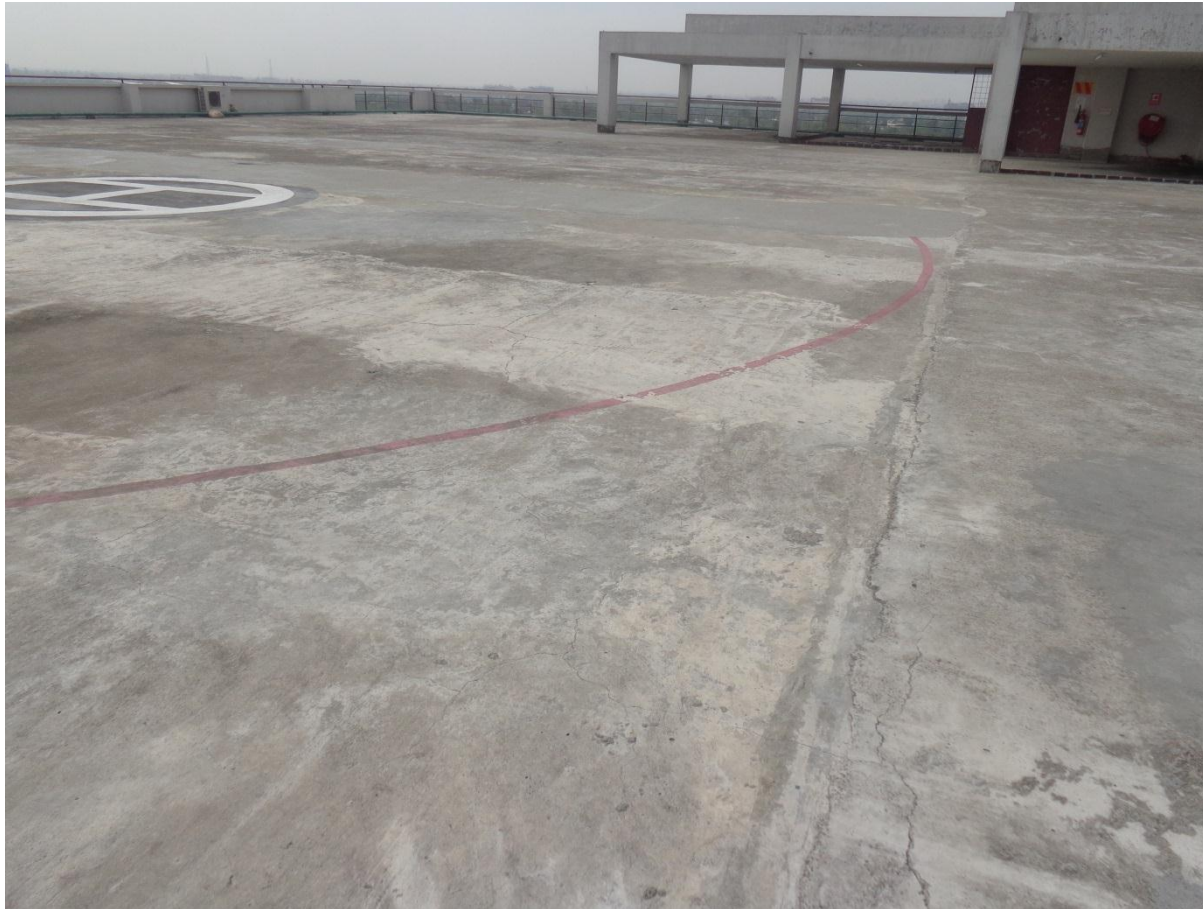
Water Ingress at Roof Level

No waterproofing membrane was visible on the roof of the building. This means that any cracks in the surface finishes on the roof will allow water to seep into the concrete slab beneath the finishes, and cause long-term soaking of the slab.
