# Vision Apparels (PVT) Ltd. #9633

Plot # M-1/3, Section-14, Mirpur  
(+23.803270N, 90.377548E)  
05.MAY.2014

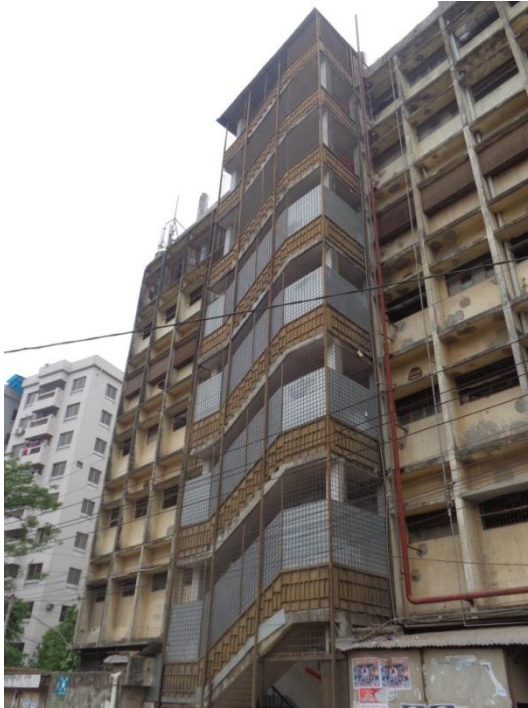
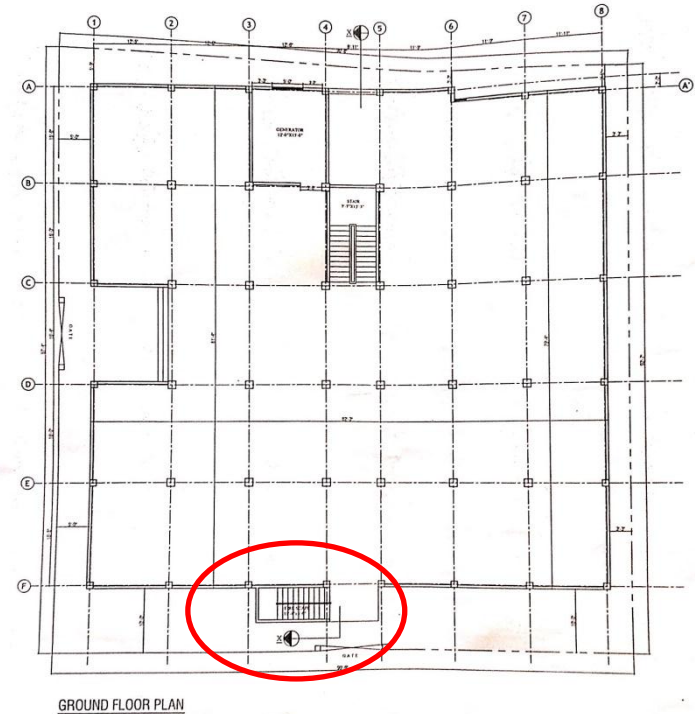
## 1<sup>st</sup> Priority 2 Concern

The emergency staircase on the side elevation of the 7 storey building is shown on the Architectural drawings, but is not shown on the structural drawings.

| Item No. | Observation | Recommended Action Plan | Recommended Timeline |
|---|---|---|---|
| 1 | The emergency staircase on the side elevation of the 7 storey building is shown on the Architectural drawings, but is not shown on the structural drawings. | Detail Engineering Assessment is required for the emergency staircase. | 6-weeks |
| 2 | The emergency staircase on the side elevation of the 7 storey building is shown on the Architectural drawings, but is not shown on the structural drawings. | Implement any works deemed necessary by the Detail Engineering Assessment. | 6-months |

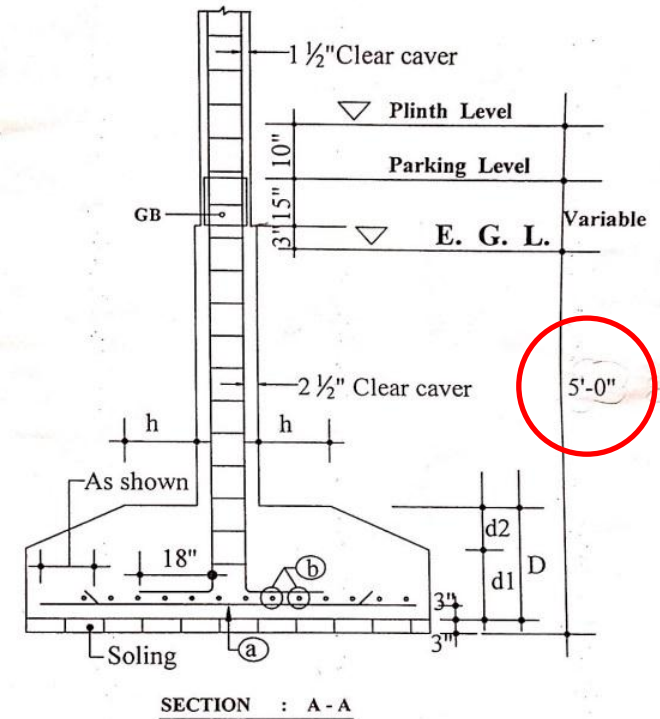
## 2<sup>nd</sup> Priority 2 Concern

Under the prevailing sub-soil condition it is found that the shallow depth spread (Square) footing foundation may be more suitable and economical for the proposed building. The foundation may be placed at 8' - 0" below from EGL. The allowable bearing capacity at those points may be considered as minimum 1.50 TSF with F. S. = 2.50 (Considering 1 Ton = 2000 Ibs, 1 TSF=0.97 kg/cm<sup>2</sup>).

The foundation depth shown on the structural drawings for the 7 storey building is shallower than specified in the geotechnical report.

| Item No. | Observation | Recommended Action Plan | Recommended Timeline |
|---|---|---|---|
| 3 | The foundation depth shown on the structural drawings for the 7 storey building is shallower than specified in the geotechnical report. | Detail Engineering Assessment is required for the foundations of the 7 storey building. | 6-weeks |
| 4 | The foundation depth shown on the structural drawings for the 7 storey building is shallower than specified in the geotechnical report. | Implement any works deemed necessary by the Detail Engineering Assessment. | 6-months |

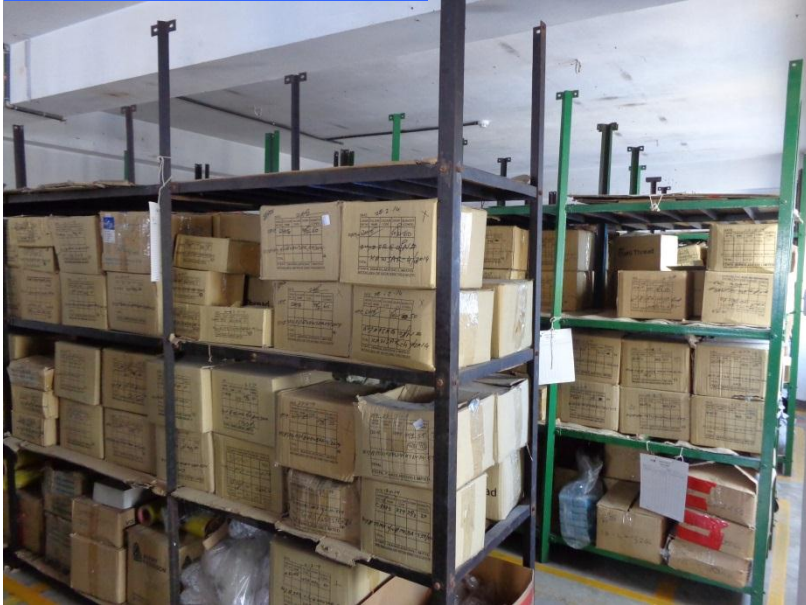
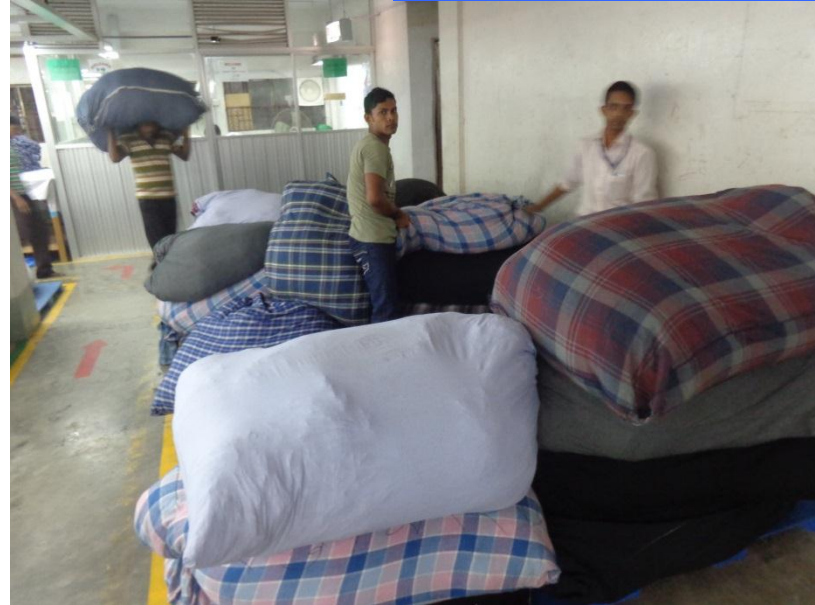
### 3<sup>rd</sup> Priority 2 Concern

No loading plans were provided for either building.

| Item No. | Observation | Recommended Action Plan | Recommended Timeline |
|---|---|---|---|
| 5 | No loading plans were provided for either building. | Factory Engineer to develop a loading plan for each floor within the factory complex, giving consideration to slab, beam and column capacity. | 6-weeks |
| 6 | No loading plans were provided for either building. | Implement and actively manage the loading plan. | 6-months |

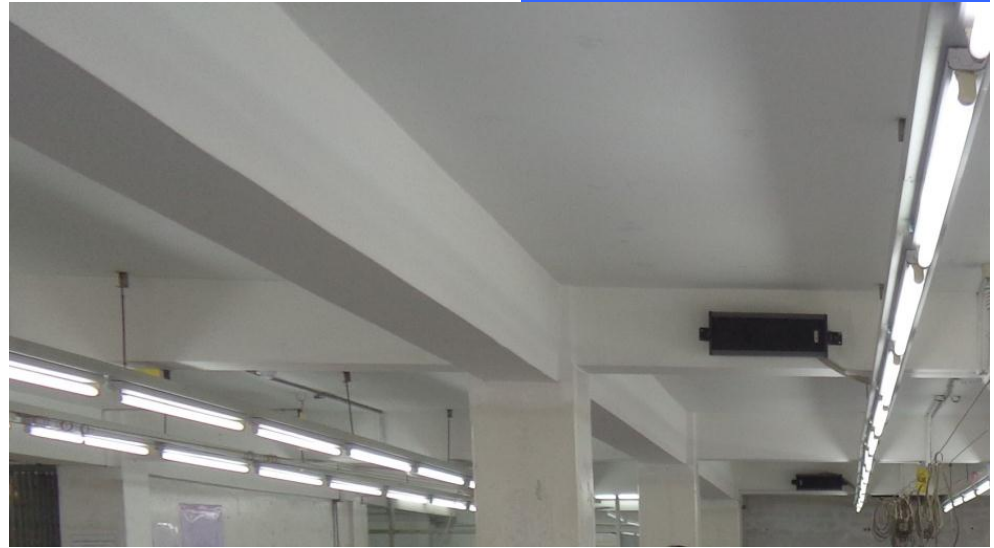
7 Storey Building

The building did not feature any core or shear walls. Stability was achieved through sway action between beams and columns and masonry infill walls.

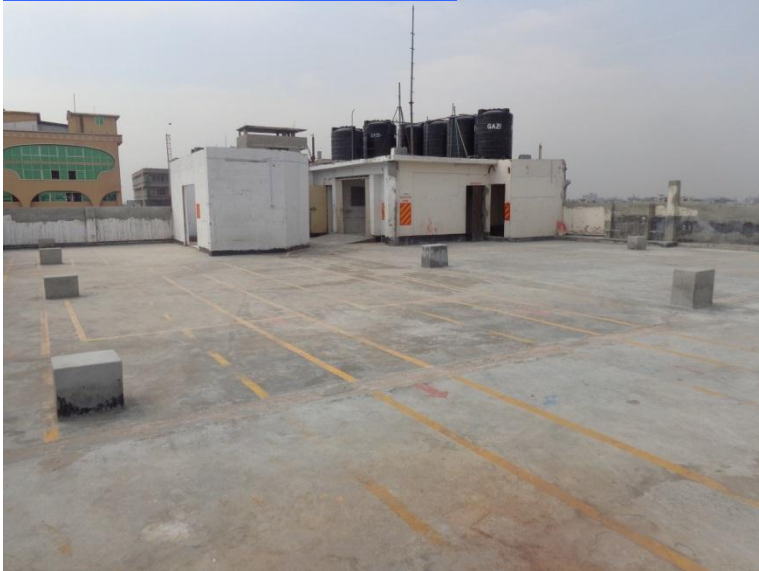
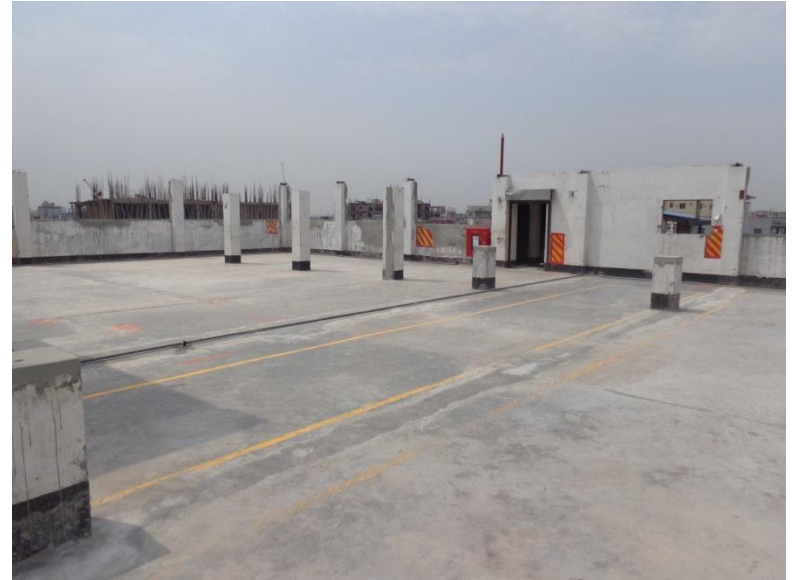
No waterproofing membrane was visible on the roof of the buildings. This means that any cracks in the surface finishes on the roof will allow water to seep into the concrete slab beneath the finishes, and cause corrosion of the reinforcing steel.
