# Y.K Knitwear Ltd. #10331

Plot S-7 & S-8, Estate Kanabari, Gazipur Sadar

05.May.2014

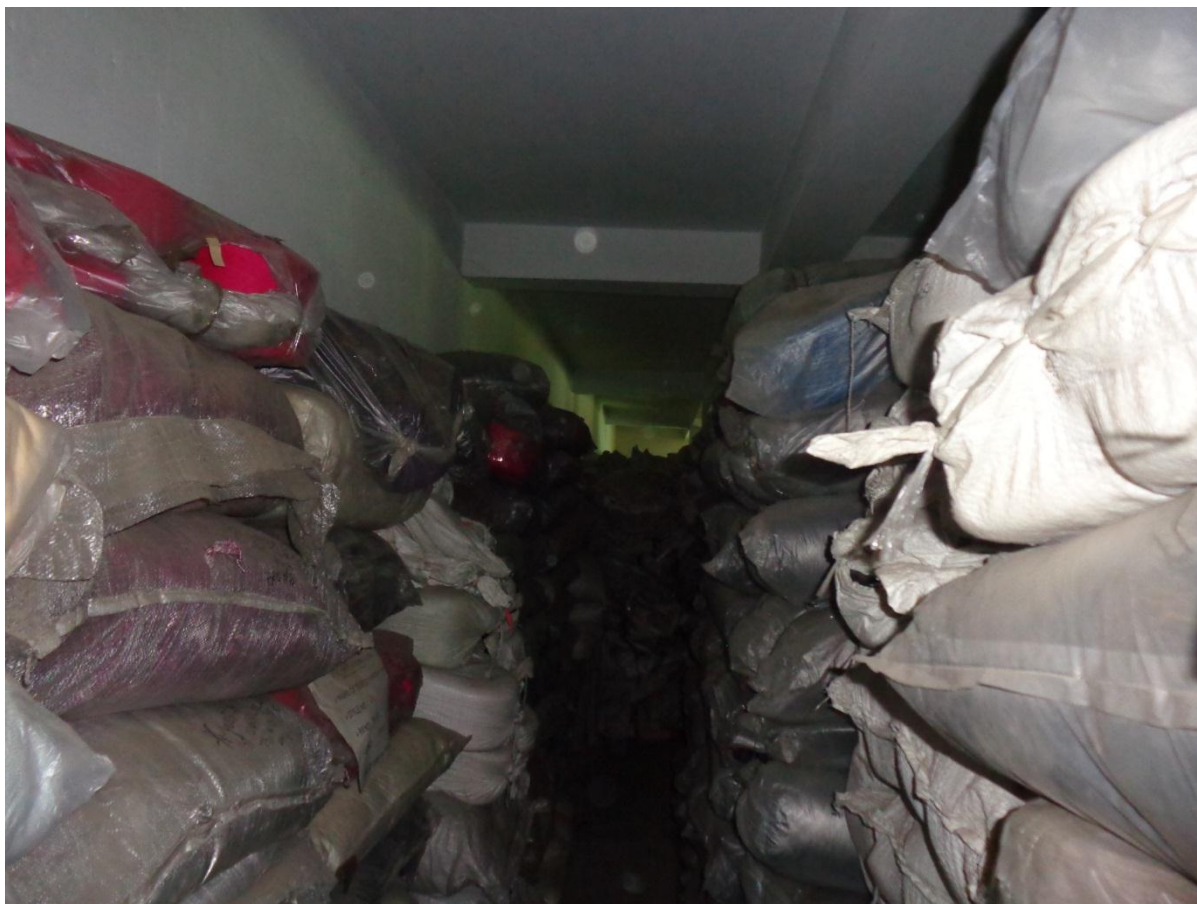
No adequate loading plan is in place – loading to be reduced

The current loading plan evaluates the total load on the total floor area. A proper loading plan is required for every floor which splits the loading into tributary areas associated columns.

Furthermore, heavy loading was found on the cantilever section at the joint on the storage floor. Managing Director and Factory Engineer were advised to reduce loading on cantilevered section

Reduce loading to 3 kPa until capacity assessment is made.

| Item No. | Observation | Recommended Action Plan | Recommended Timeline |
|---|---|---|---|
| 1 | No adequate loading plan is in effect. | Lower storage loads to 3 kPa on the upper floors<br>Factory engineer to confirm allowable design floor loadings.<br>Verify in situ concrete stresses with 100mm concrete cores | immediate – now |
| 2 | No adequate loading plan is in effect. | Factory engineer to produce and actively manage a loading plan for all floor plates within the factory giving consideration to slab beam, column and foundation capacity | 6-weeks |

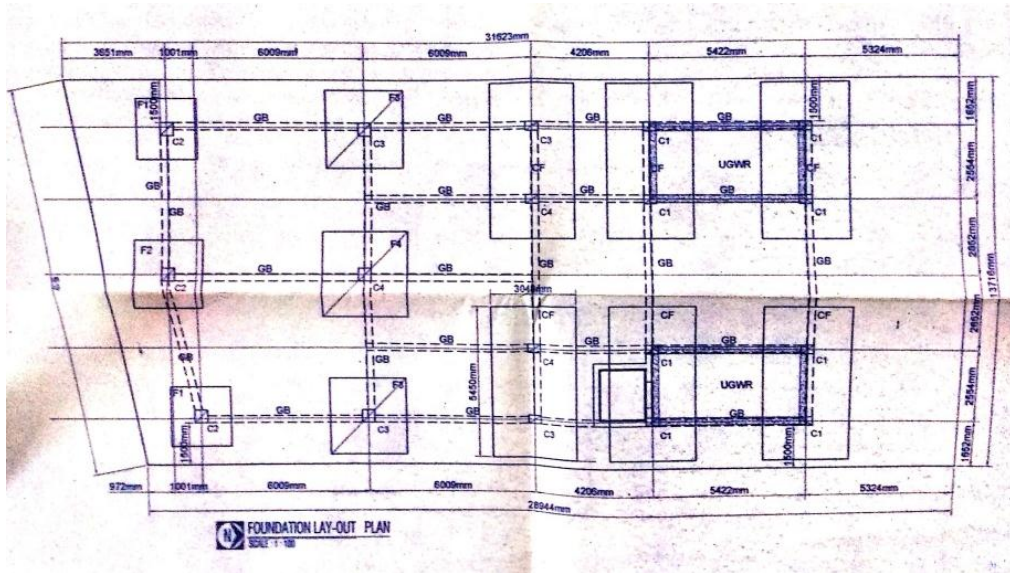
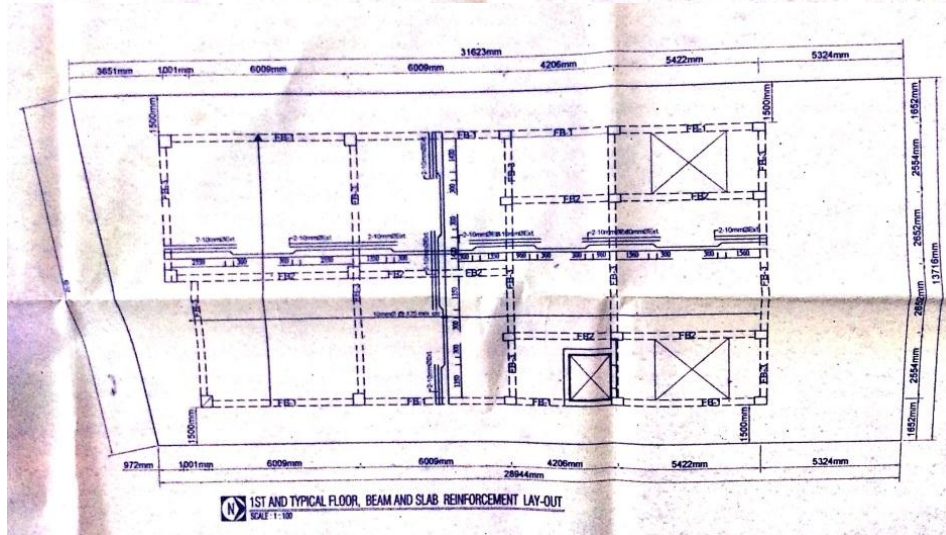
For the 7 storey building, we found some differences between the structural drawings and the actual site conditions. For example, we were confirmed by the Factory Engineer, that the column layout was modified just before construction

| Item No. | Observation | Recommended Action Plan | Recommended Timeline |
|---|---|---|---|
| 4 | Engineering document do not match actual site conditions for 7 storey building. | Produce a Detailed Engineering Assessment including verification of the whole part of the 7 storey section in regard the structure on the site.<br>Produce As build drawings of the 7 storey section. | 6-weeks |

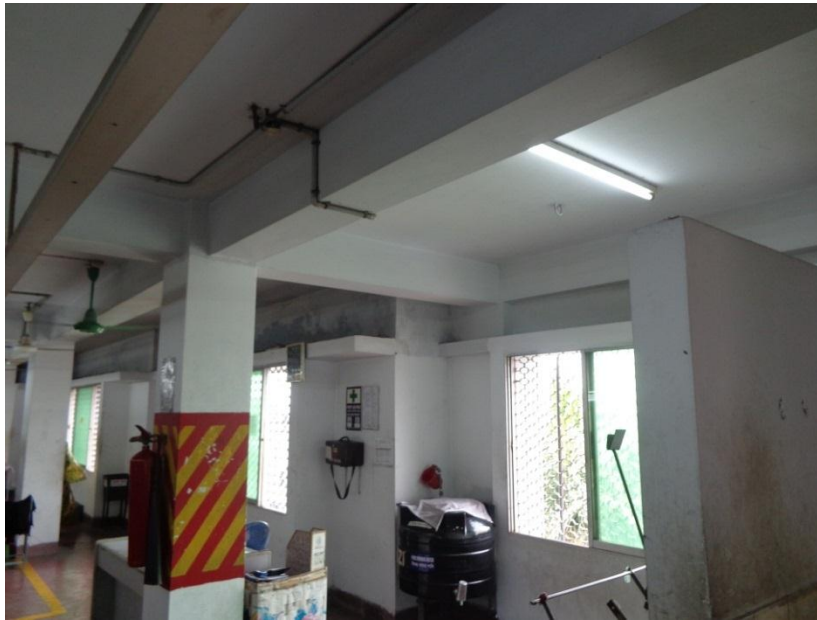
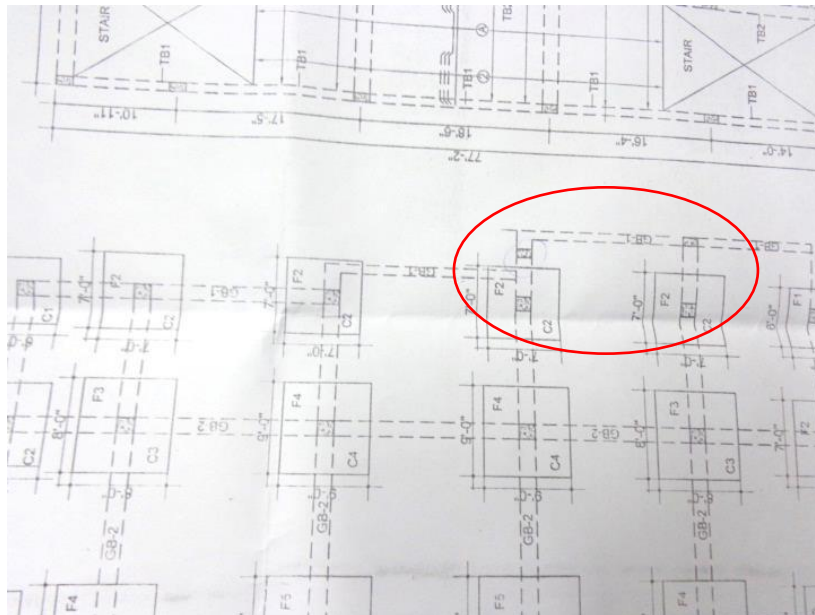
Partial plan view - column layout

In the 6 storey section, there is small section at the back where there is a small column that runs down to a cantilevered grade beam. The column is not in the schedule and the rebar for the grade beam seems low as it shows only 5 top bars.

This area needs to be verified in a Detailed Engineering Assessment

| Item No. | Observation | Recommended Action Plan | Recommended Timeline |
|---|---|---|---|
| 6 | Cantilevered grade beam supporting a column | Include in the Detailed Engineering Assessment the verification of column not in the schedule as well as the cantilevered grade beam in the 6 storey building section | 6-weeks |

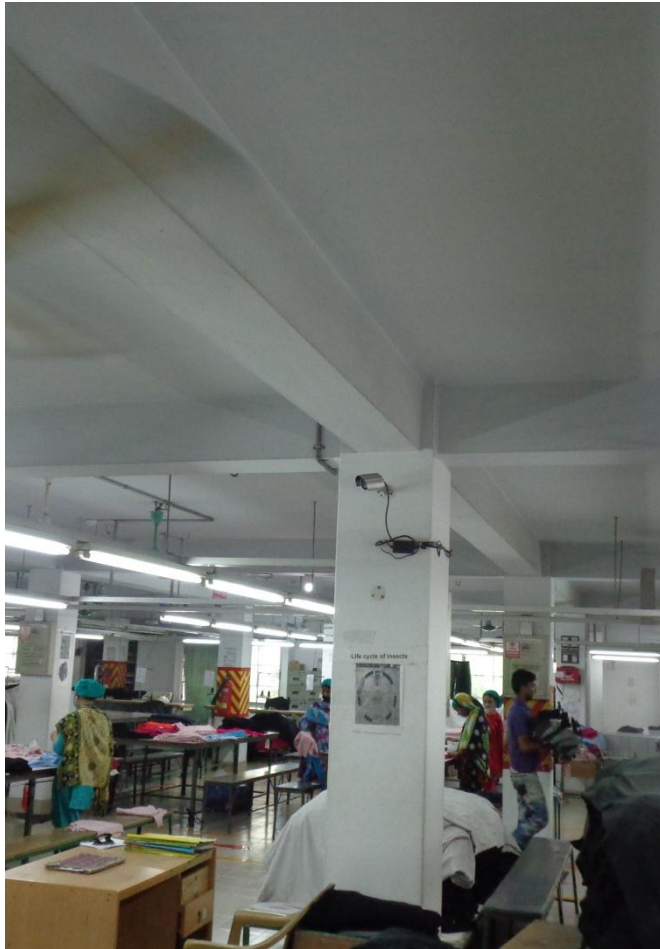
During our visit, we found the 7 storey building had only 2 bays wide, for a total width of roughly 10m. We believe this building section to have minimal overturning resistance and lateral stability.

Like the 6 storey section, sway stability of building could probably be expected from rigid frame system (beam and column participation) although no ductile detailing is provided in structural plans. Masonry infill is unrestrained and cannot be considered.

We require the lateral stability of these buildings be investigated in a Detail Engineering Assessment immediately

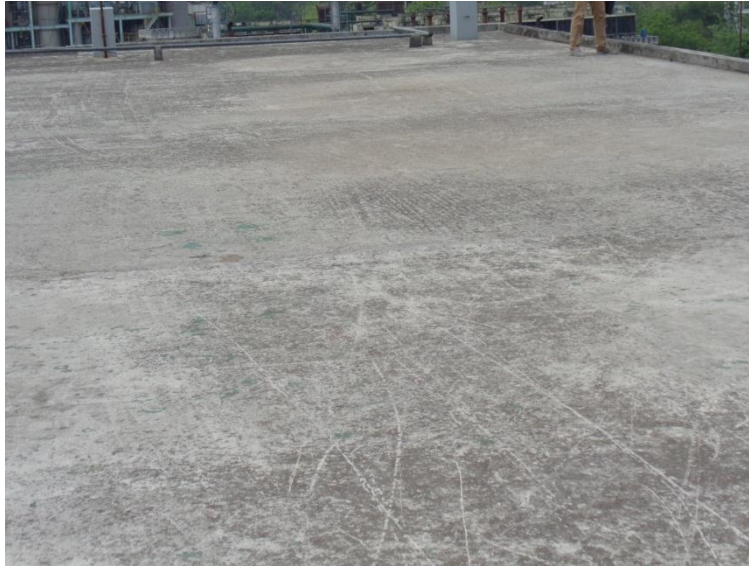
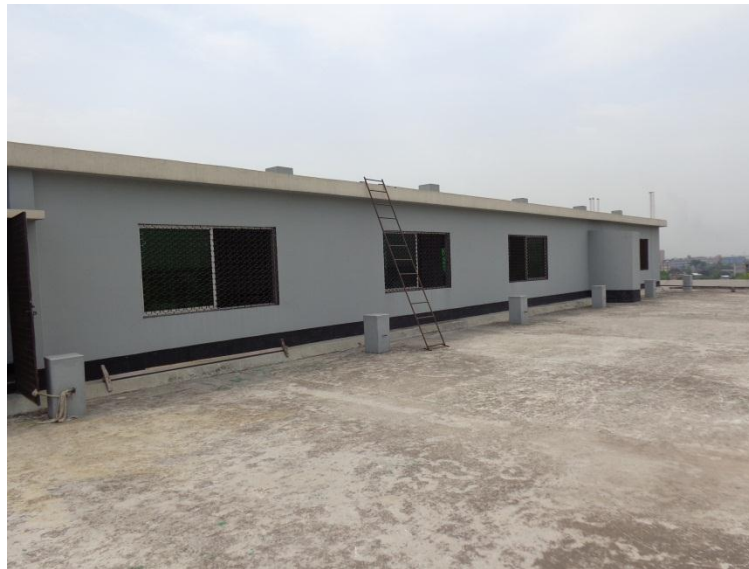
No waterproofing membrane was visible on these roofs. This means that any cracks in the surface finishes on the roof will allow water to seep into the concrete slab and cause long-term soaking of the slab.
