# Interstoff Cloathing Ltd. #9494

06.May.2014

ACC RD  
on Fire and Building Safety in Bangladesh

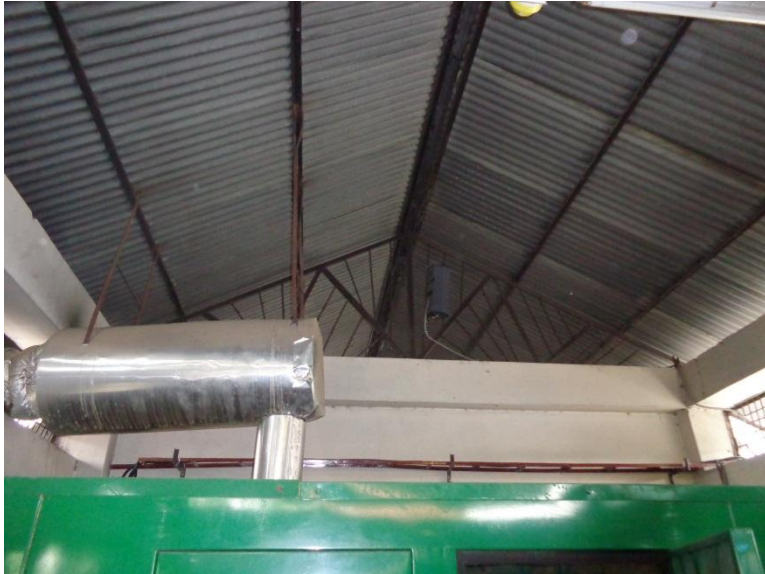
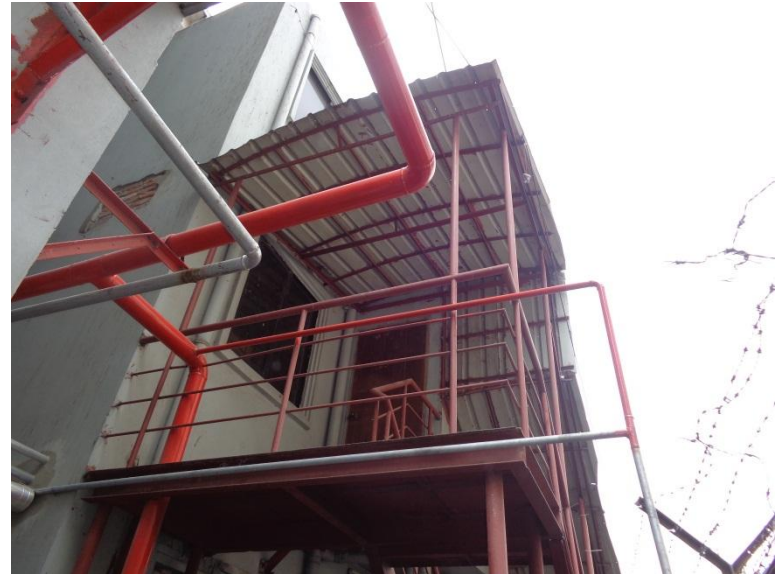
## 2<sup>nd</sup> Priority 2 - Concern

For all the structural steel roofs and canopy located at the shades and the utility buildings, no documents were available concerning the construction of these. All these structural steel must be checked by the factory engineer. Furthermore, technical documents should be produced for reference purposes.

| Item No. | Observation | Recommended Action Plan | Recommended Timeline |
|---|---|---|---|
| 4 | No construction documents were available for the structural steel elements | Factory engineer to assess the capacity of the steel roof and canopy construction. | 6-weeks |
| 5 | No construction documents were available for the structural steel elements | Carry out any remedial works deemed necessary by the factory engineer. | 6-months |

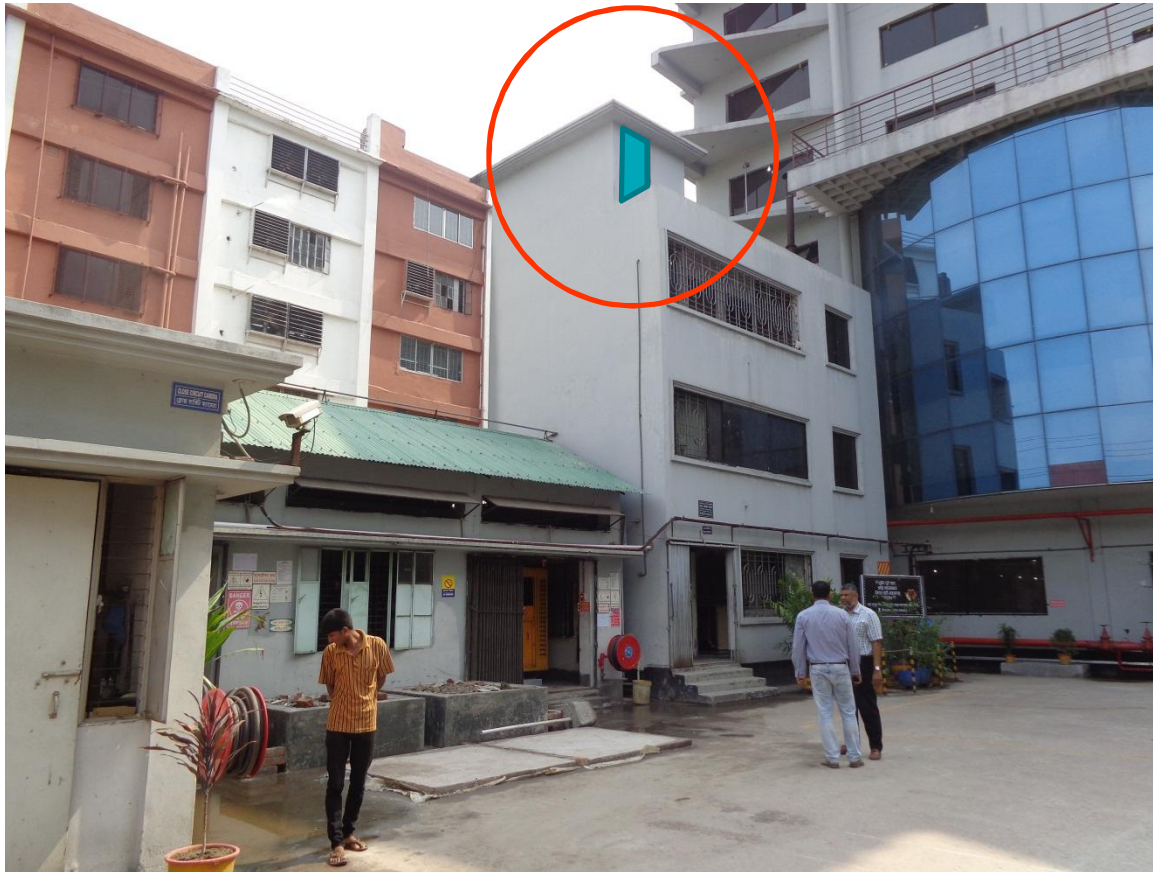
No guard rail was found at the roof of the utility building close to exit.

The utility building has no hand rail or security element in place close to the access door at the roof. A security element could prevent the fall of a worker.

Distance between ledge and door is roughly 1220 mm

| Item No. | Observation | Recommended Action Plan | Recommended Timeline |
|---|---|---|---|
| 6 | No guard rail was found at the roof of the utility building close to exit. | Factory engineer has to design according to BBC a railing around the exit at the utility building roof. | 6-weeks |
| 7 | No guard rail was found at the roof of the utility building close to exit. | Complete all necessary works. | 6-months |

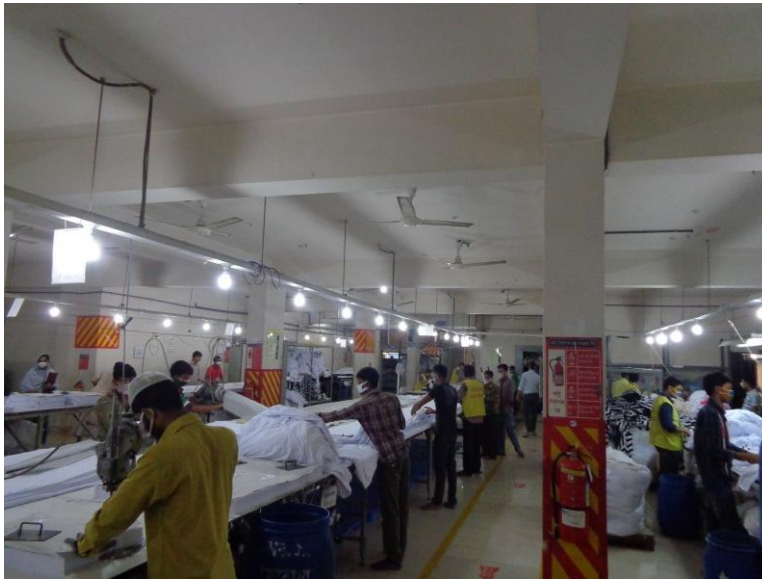
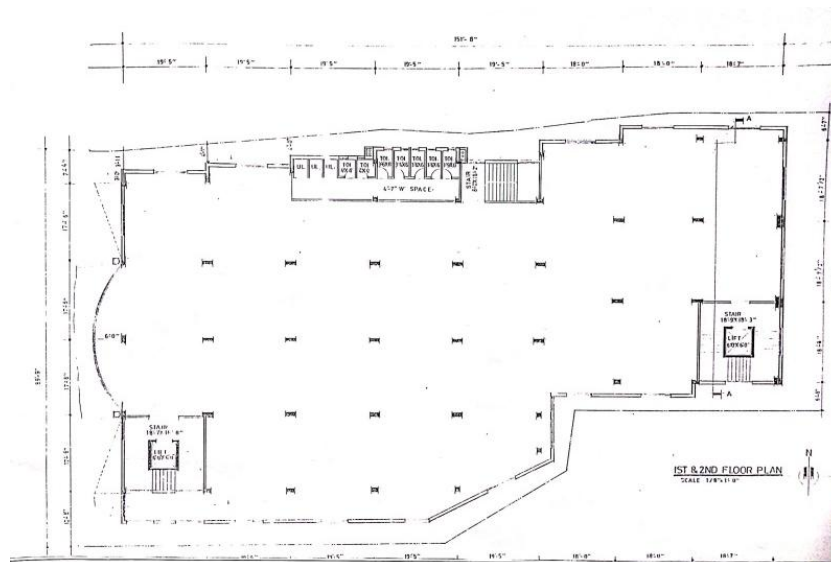
Sway stability of building could probably be expected from rigid frame system (beam and column participation) although no ductile detailing is provided in structural plans. Masonry infill is unrestrained and cannot be considered. Furthermore, as we can see on the drawings, the weak axis of the columns are all in the same direction.

We require that these items be investigated in a Detail Engineering Assessment immediately

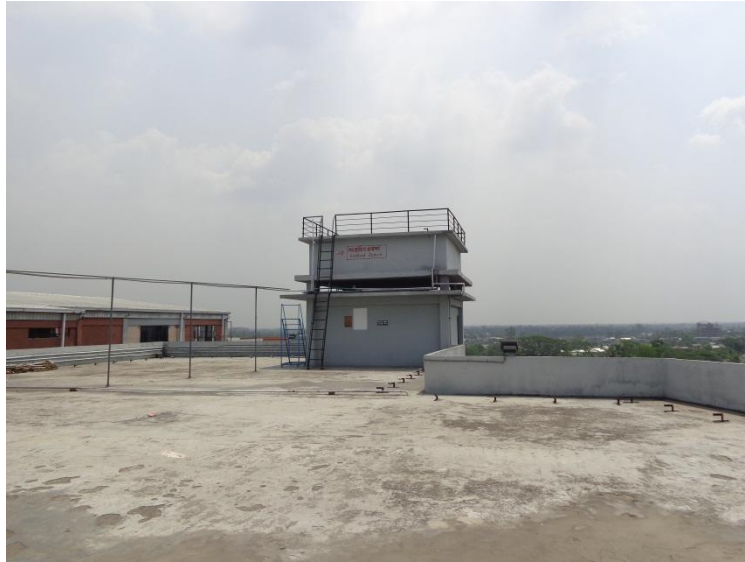
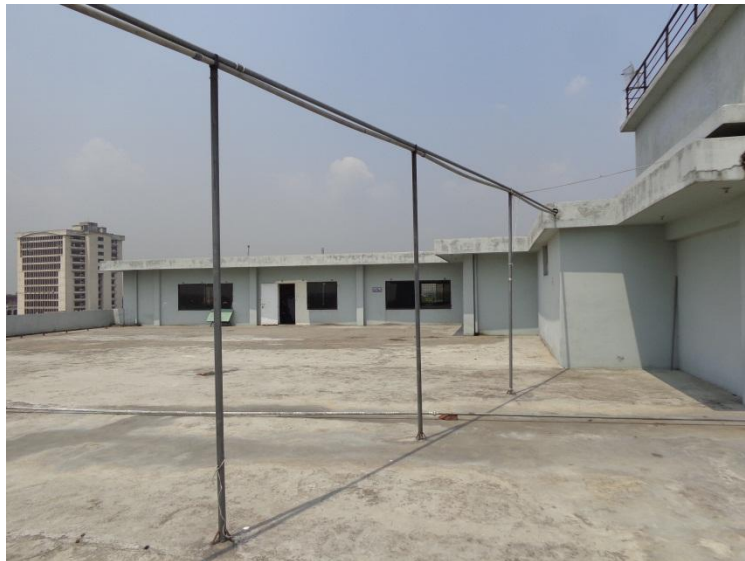
No waterproofing membrane was visible on these roofs. This means that any cracks in the surface finishes on the roof will allow water to seep into the concrete slab and cause long-term soaking of the slab.
