FIRE SAFETY INSPECTION REPORT

**PEAK APPARELS LTD.
VOGRA, JAYDEVPUR, GAZIPUR, DHAKA**

ACCORD
on Fire and Building Safety in Bangladesh

August 31, 2014

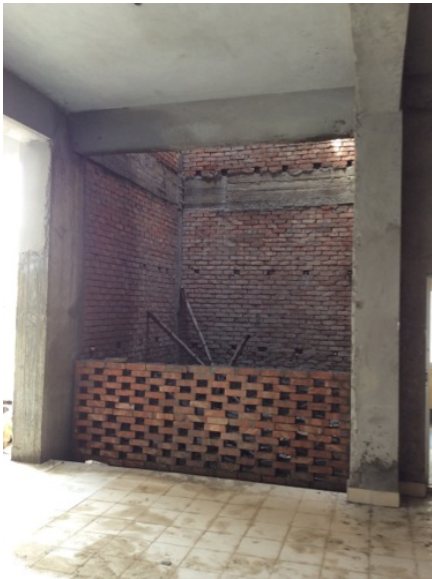
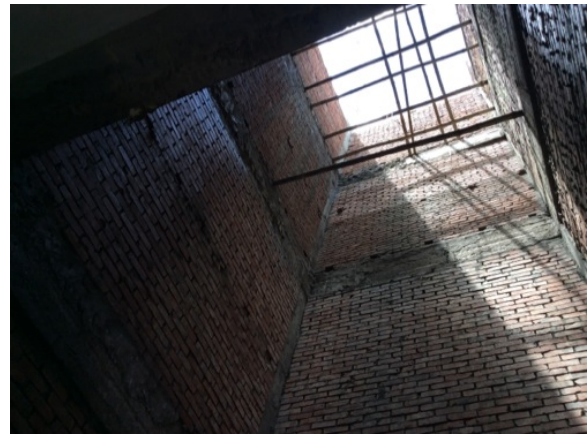
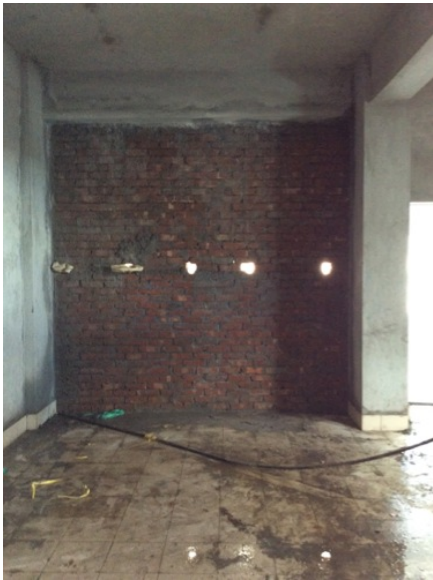
No.	Category	Finding	Recommendation	Remediation Timeframe
F-1	Fire Rated Construction	The elevator shaft adjacent to the northwest exit stair had unprotected openings on all floors. Reportedly an elevator is to be installed within the shaft before the building is utilized for factory operations.	Install an elevator in the shaft before before occupying the building with factory operations. If no elevator is installed within the shaft when factory operations begin, seal the shaft on all floors.	Immediate

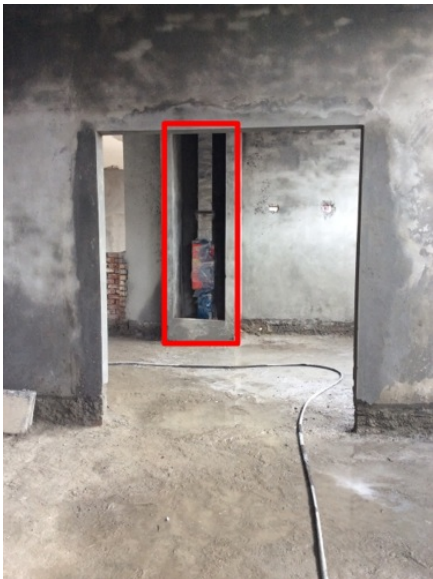
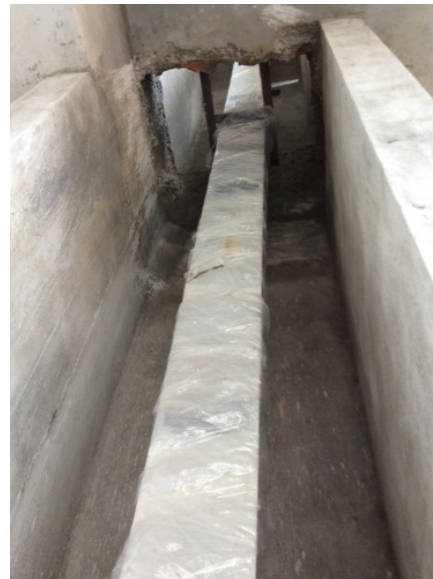
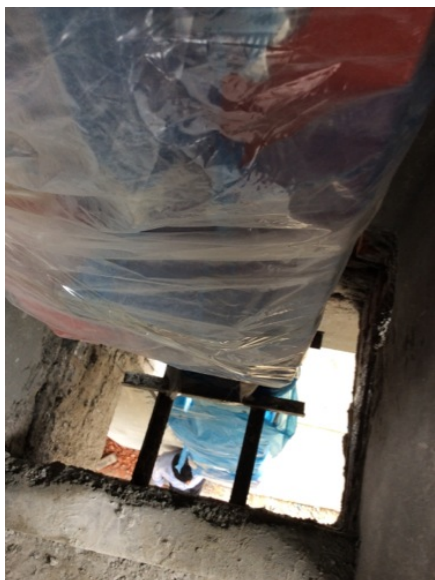
F-2	Fire Rated Construction	The electrical riser adjacent to the southwest exit stair had unprotected openings on all floors.	Seal the electrical riser on all floors before occupying the building with factory operations.	Immediate
-----	-------------------------	---	--	-----------

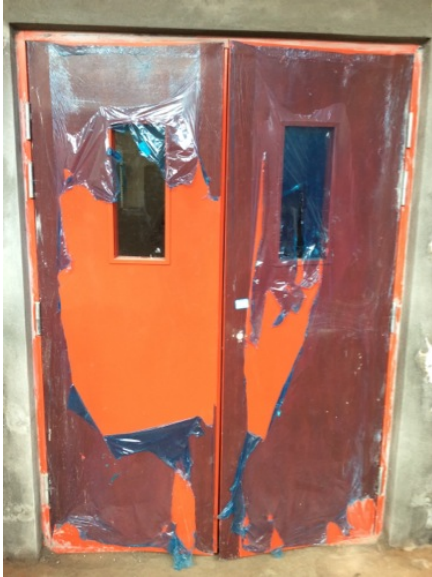
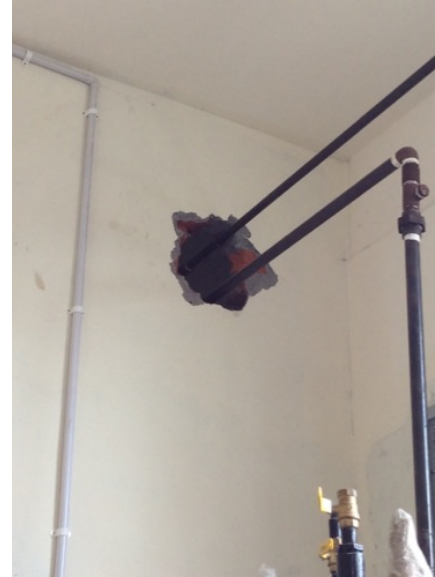
F-3	Fire Rated Construction	The ground floor boiler room is not separated by fire-rated construction due to a penetration and possible non-rated doors. The room was provided with a reported fire door, however no rating label from the manufacturer was present on the door. Though not completely installed, the door was also not provided with panic hardware or self closing hardware.	Separate the boiler room by a minimum 2-hr fire-rated construction. Seal and/or protected all openings to maintain the required fire separations	Within 3 months
-----	-------------------------	---	--	-----------------

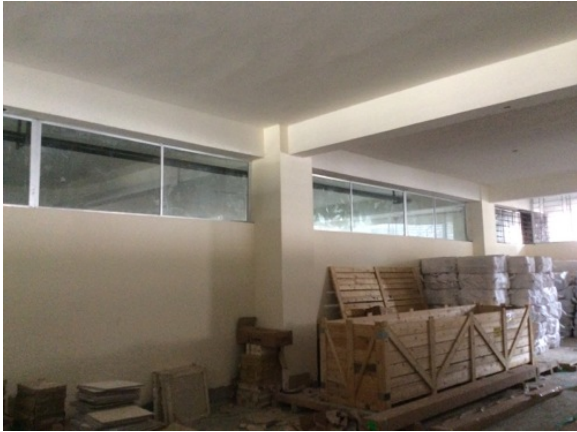
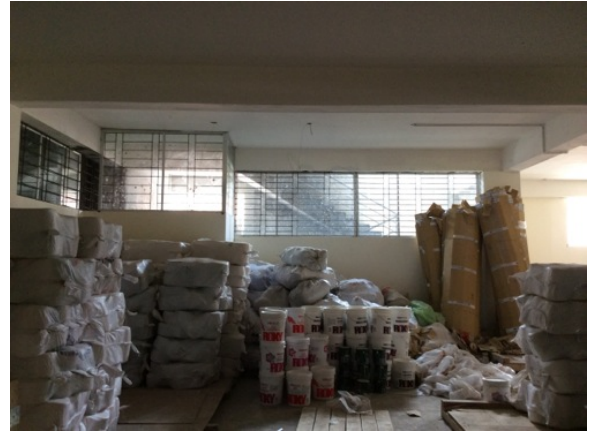
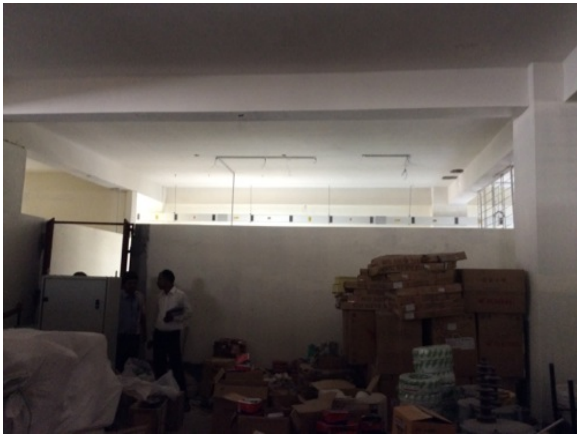
F-4	Fire Rated Construction	Rooms used for combustible storage are not separated by fire-rated construction. Specifically, the building has three (3) dedicated storage rooms on the ground floor (accessory store, yarn store, finish fabric store).	Provide dedicated storage rooms separated by minimum 1-hr fire-rated construction. All three (3) storage rooms were located adjacent to each other. Unprotected openings from one storage room to another are acceptable however, all openings to factory floors, egress routes and exit stairs must be provided with fire-rated separation.	Within 3 months
-----	-------------------------	---	--	-----------------

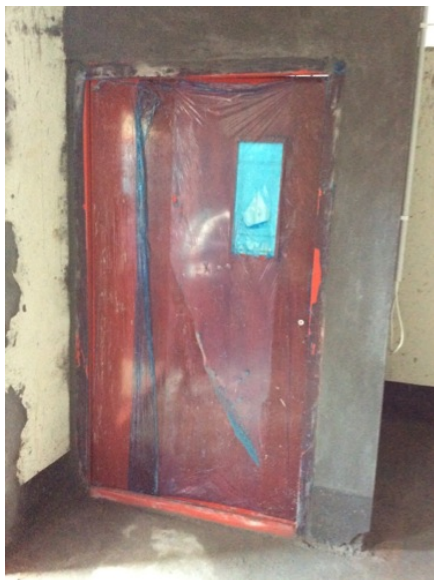
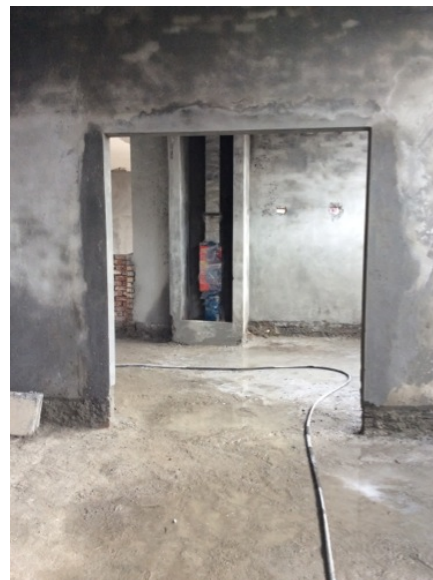
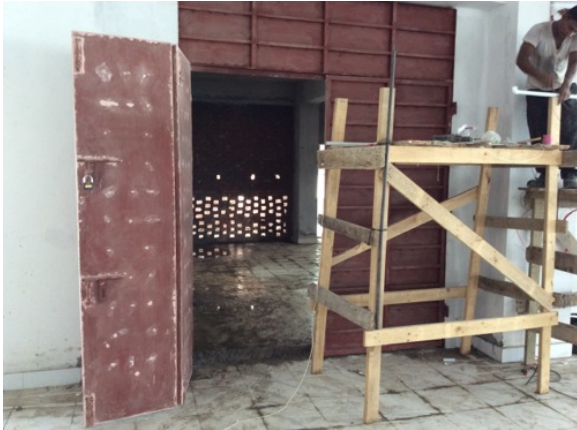
F-5	Fire Rated Construction	<p>All exit stairs are not separated from work areas and other spaces on each floor by fire-rated construction. Both the southwest exit stair (second and third floor) and the east exit stair (all floors) were provided with reported fire doors, however no rating label from the manufacturer was present on the doors. Though not completely installed, the doors were also not provided with panic hardware or self closing hardware.</p> <p>The northwest exit stair also had a wash room that discharged to the exit enclosure no the first, second and third floor.</p>	<p>Provide minimum 1.5-hr fire rated doors and seal all unprotected openings to separate the exit stairs from work areas and other building spaces on all floor levels. Ensure that the fire doors are self-closing and positive latching and that they are provided with fire exit (panic) hardware where serving production floors.</p> <p>If fire doors are required to be held open for functional reasons, provide automatic-closing devices tied to the fire alarm system.</p> <p>Provide the wash rooms discharging to the northwest exit stair with fire-rated separation on all floors. Alternately, relocate access to the washroom by means of the factory floor and seal the existing access doors.</p>	Within 3 months

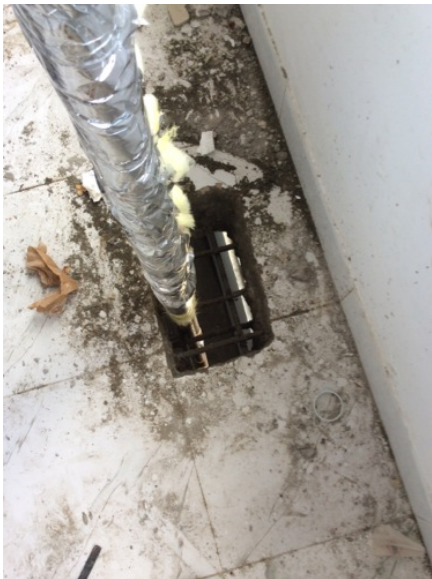
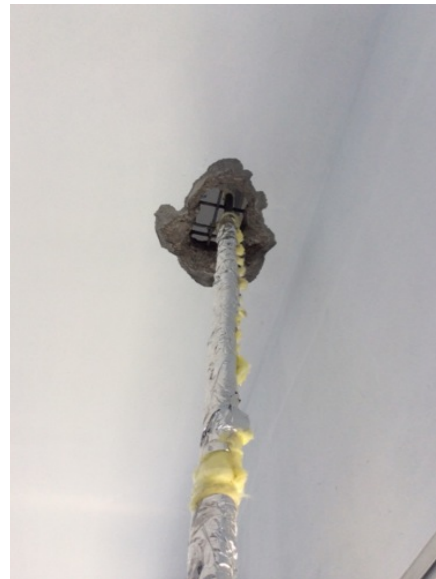
F-6	Fire Rated Construction	Unsealed penetrations (boiler piping) are located in the fire-rated floor/ceiling assemblies of the ground, first and second floors.	Seal all penetrations and openings in floor/ceiling assemblies to maintain the fire separation.	Within 3 months
-----	-------------------------	--	---	-----------------

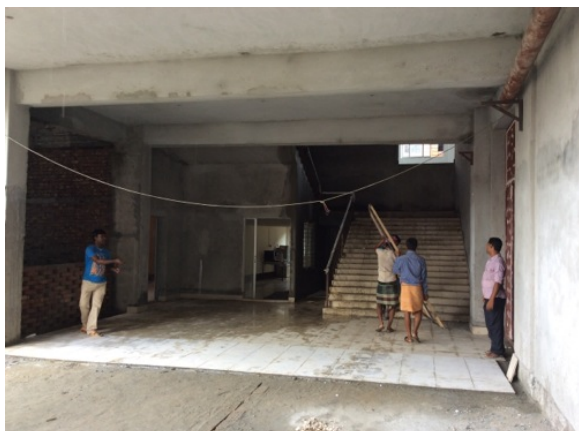
F-7	Fire Rated Construction	The northwest exit stair was unenclosed in fire-rated construction on the ground floor.	Enclose all exit stairs in 2-hr fire-rated construction on all floors.	Within 3 months
-----	-------------------------	---	--	-----------------

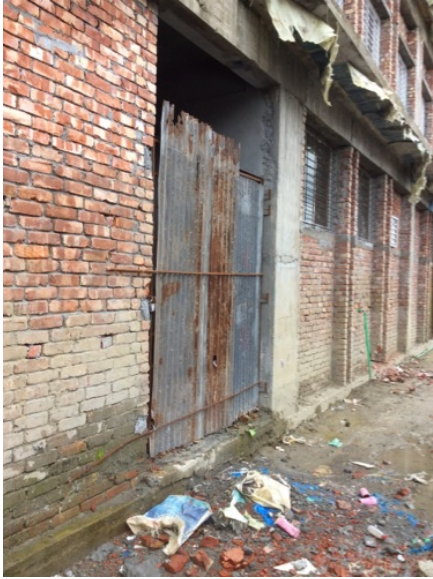
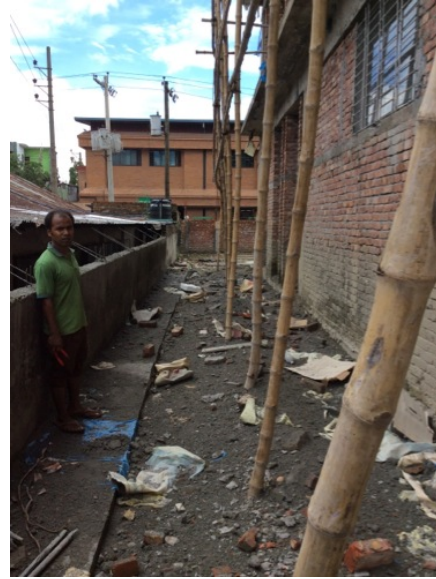
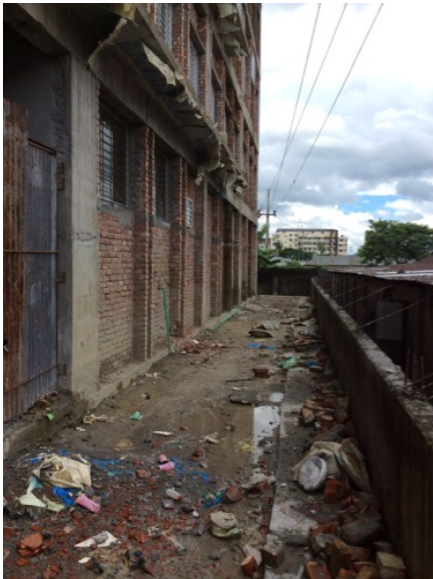
F-8	Fire Rated Construction	The discharge path serving the east exit stair is less than 10 ft wide and is not separated from the building interior.	Seal all penetrations and openings to the interior of the building along the discharge path, up to a height of 10 ft., to provide a minimum 1-hr fire separation.	Within 6 months
			Alternatively, provide a second remote discharge path to the public way. Ensure the common path of travel along the second path is less than 100 ft. and that the path is kept unobstructed and even along the means of egress.

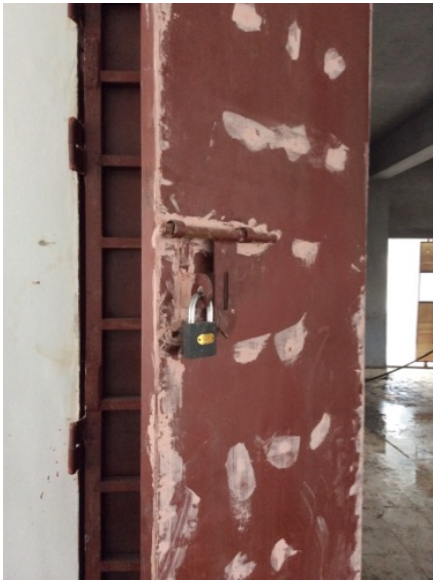
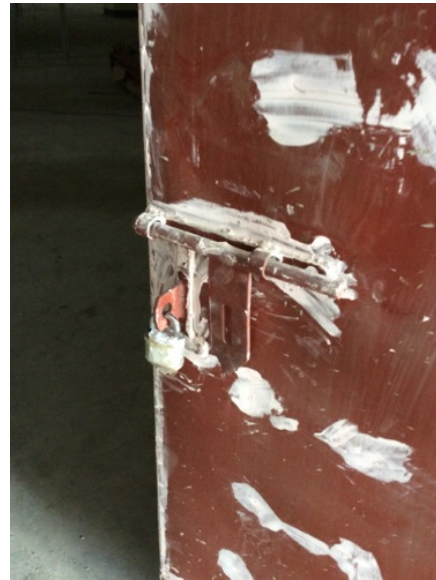
F-9	Egress	Egress doors with locking features are provided at building exits and exit stairs. All doors were open and unlocked during the inspection.	Remove locking features from all egress doors before occupying the building with factory operations. If locks are required for security reasons, utilize special door locking features complying with NFPA 101.	Immediate
-----	--------	--	--	-----------

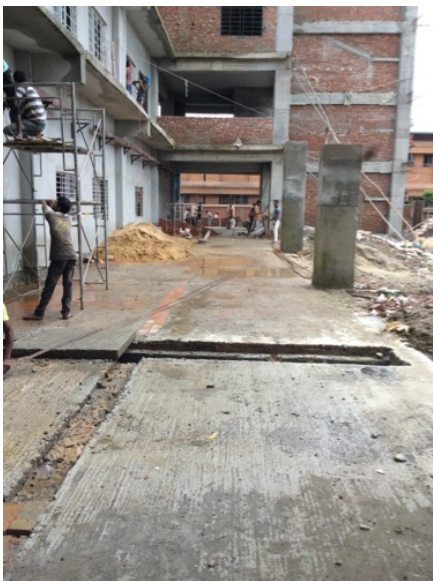
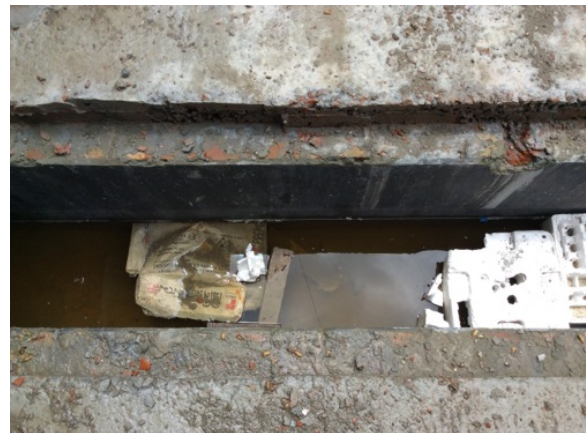
F-11	Egress	An uneven walking surface is present after discharge from the northwest exit star.	Before occupying the factory with normal operations, provide a clear and even discharge path along all egress routes.	Immediate
------	--------	--	---	-----------

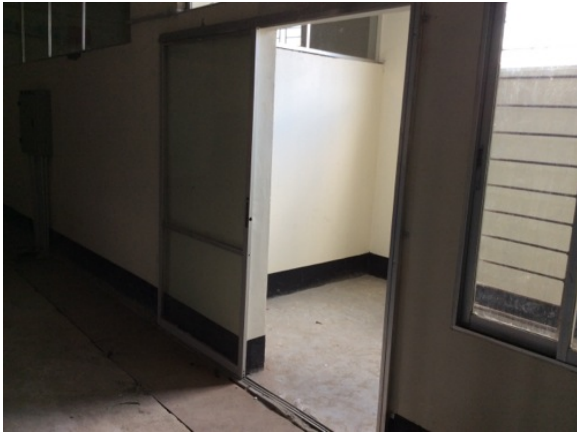
F-12	Egress	Sliding doors are provided along egress routes.	Replace all sliding doors along the means of egress with side-hinged, swinging egress doors.	Within 1 month
			If locks are required for security reasons, utilize special door locking features complying with NFPA 101.

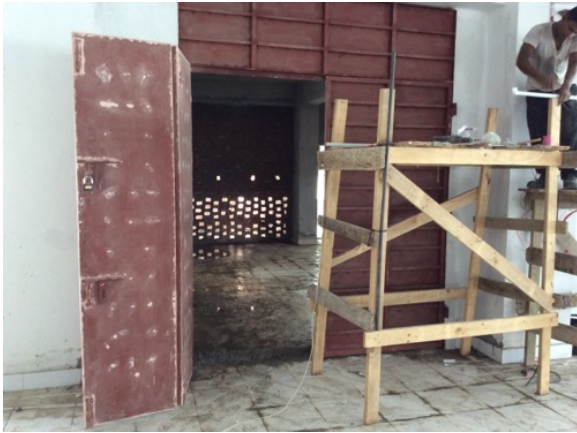
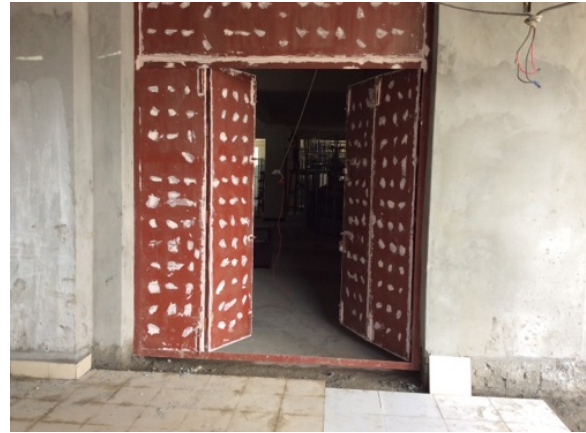
F-13	Egress	<p>The egress doors to the northwest exit stair did not swing in the direction of egress travel on all floors. These doors are required to be fire-rated doors, ensure that once installed the new doors swing in the direction of egress travel.</p> <p>Also, the west egress door from the ground floor knitting section did not swing in the direction of egress travel.</p>	<p>Modify the egress door to swing in the direction of egress travel.</p>	<p>Within 3 months</p>
------	--------	---	---	------------------------

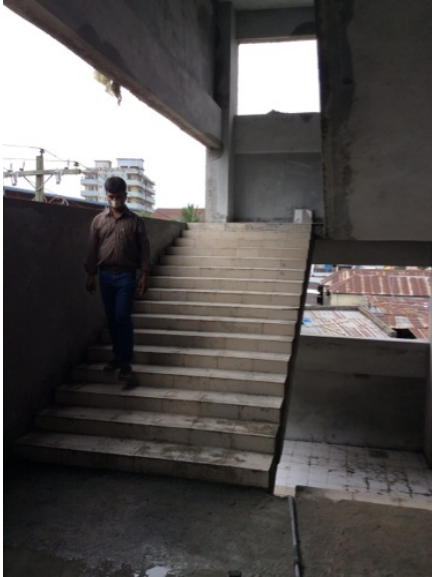
F-14	Egress	<p>Handrails are not provided throughout the southwest exit stair.</p>	<p>Provide handrails on at least one side of exit stair.</p>	<p>Within 3 months</p>
------	--------	--	--	------------------------
