# Vintage Denim Studio Ltd. #9208

Plot #99 & 102-128, Ishwardi EPZ, Ishwardi, Pabna

07.May.2014

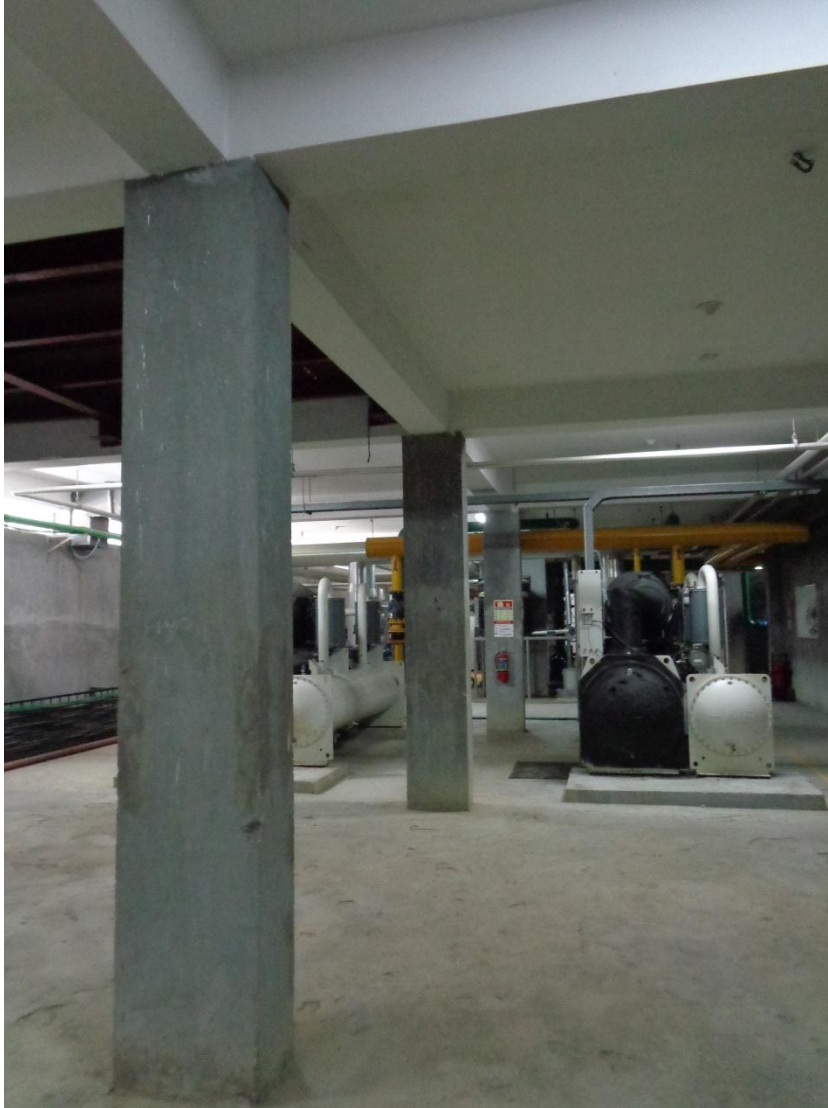
### 1<sup>st</sup> Priority 3 Concern

During our survey, we found that most dimensions in the construction documents of the concrete buildings were a little bit off. Because the buildings are no more than 2 storeys, this concern is not critical.

| Item No. | Observation | Recommended Action Plan | Recommended Timeline |
|---|---|--|---|
| 1 | Construction documents for concrete buildings do not reflect actual site conditions | Update documents with actual site conditions | 6-months |

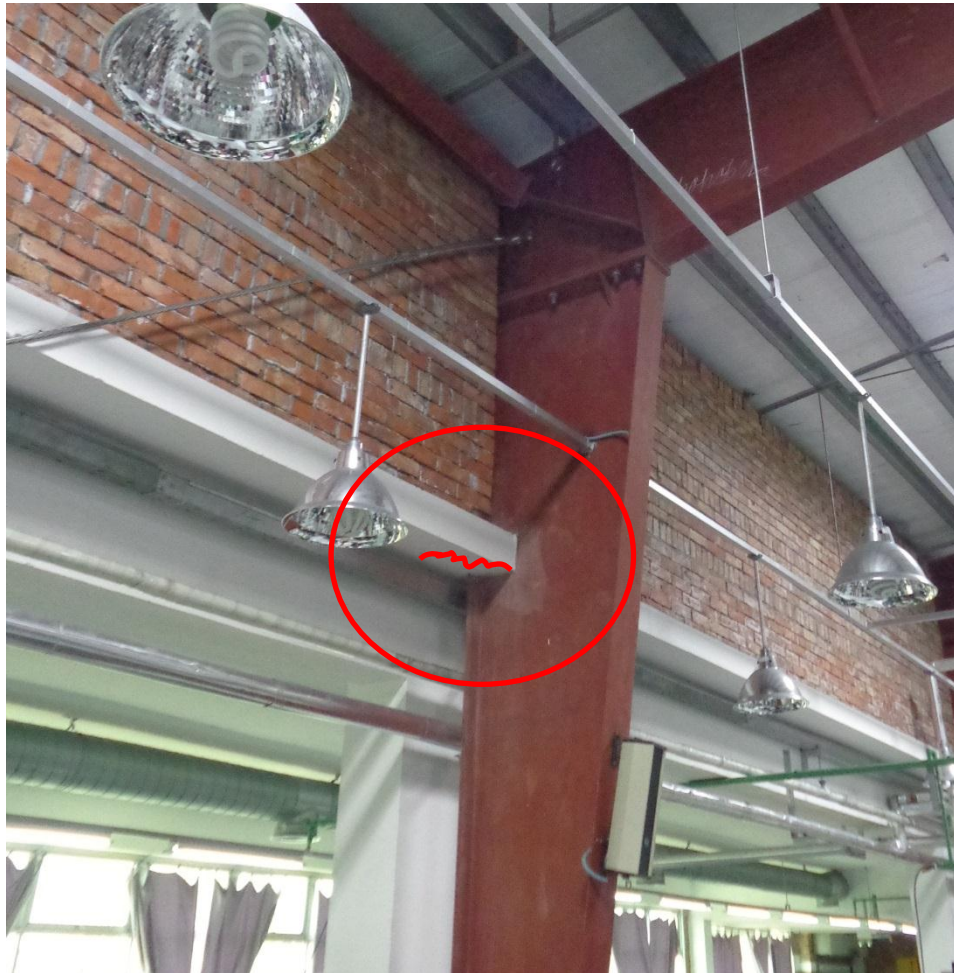
## 2<sup>nd</sup> Priority 3 Concern

On the picture, we can see that the concrete slabs overlaps the flange of the column. We have found cracking and loose debris that could fall on the workers.

| Item No. | Observation | Recommended Action Plan | Recommended Timeline |
|---|---|--|---|
| 2 | Concrete slab at Main Production Shed should be dissociated from steel columns. | Clear all loose material that could potential fall on the workers. | Immediate – Now |
| 3 | Concrete slab at Main Production Shed should be dissociated from steel columns. | Demolish the concrete around the column to allow the steel structure to move freely. | 6-months |

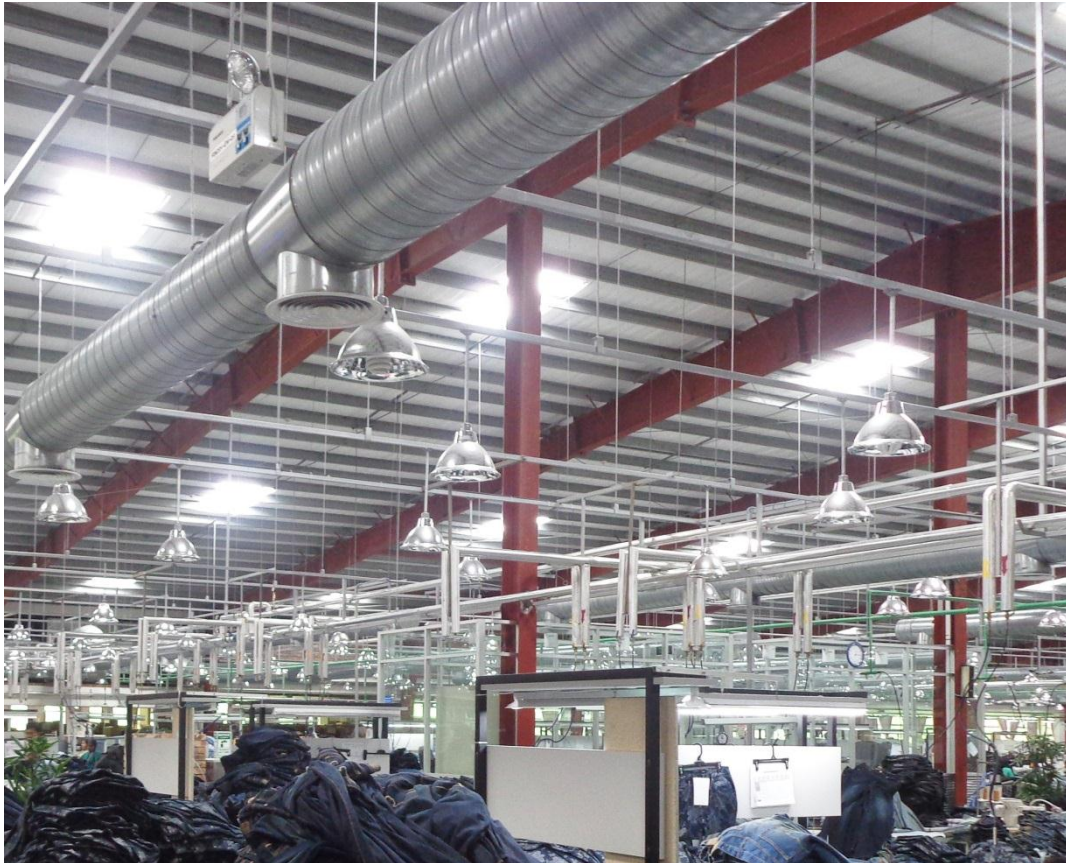
### 3<sup>rd</sup> Priority 3 Concern

Calculations have shown the columns to be satisfactory to support gravity loads (taking slenderness into account).

We would like the design engineer to confirm that the column has sufficient capacity under lateral loads which might induce moments into the column.

| Item No. | Observation | Recommended Action Plan | Recommended Timeline |
|---|---|--|---|
| 4 | Central columns of main production shed should be checked compression/flexure interaction | design engineer to confirm that the column has sufficient capacity under lateral loads which might induce moments into the column. | 6-months |

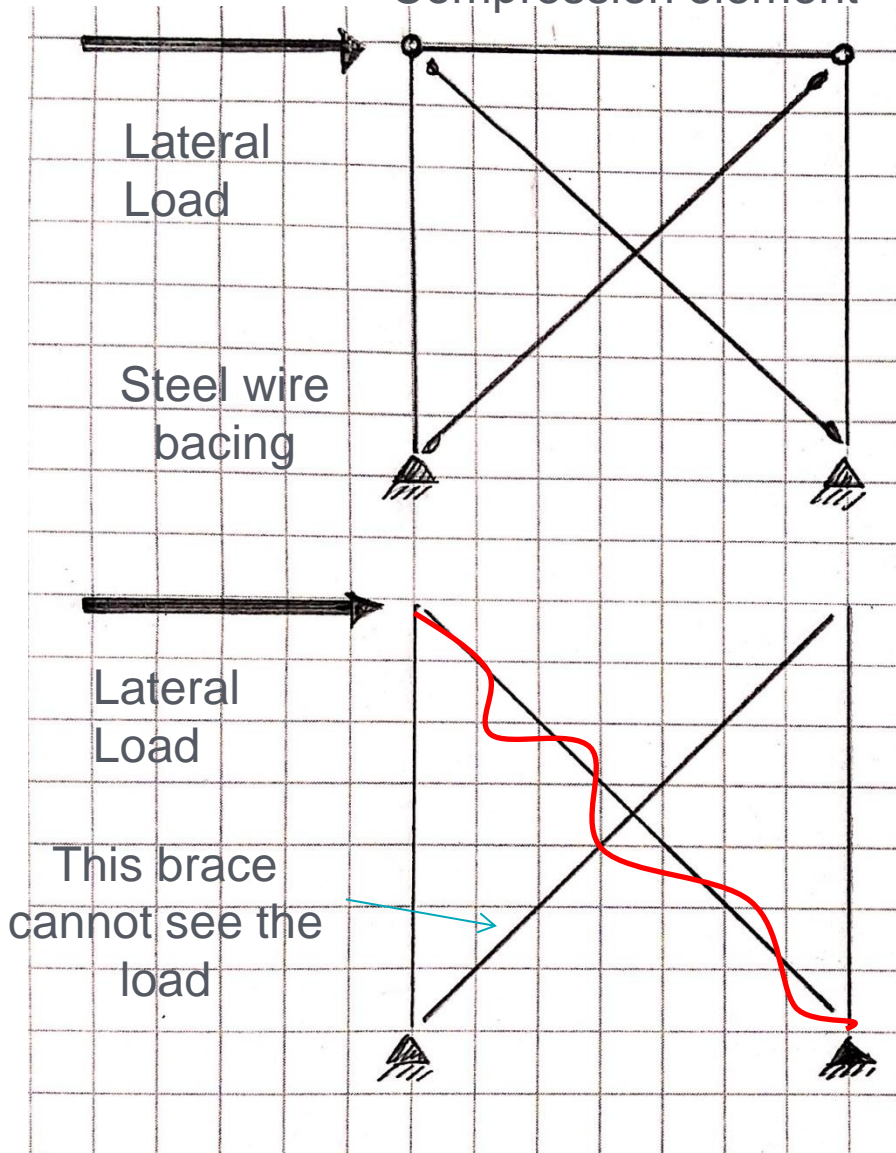
The structure should detailing for adequate lateral restraints for beams and purlins. The building also had horizontal steel wire bracing for the roof diaphragm.

Where we have a concern is that at the end of the horizontal bracing, the vertical bracing is not aligned and does not always have the collecting element at the top.

We require that this item be investigated in a Detail Engineering Assessment

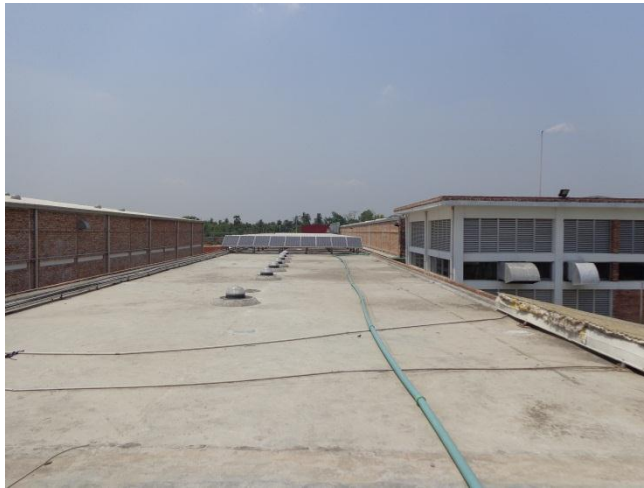
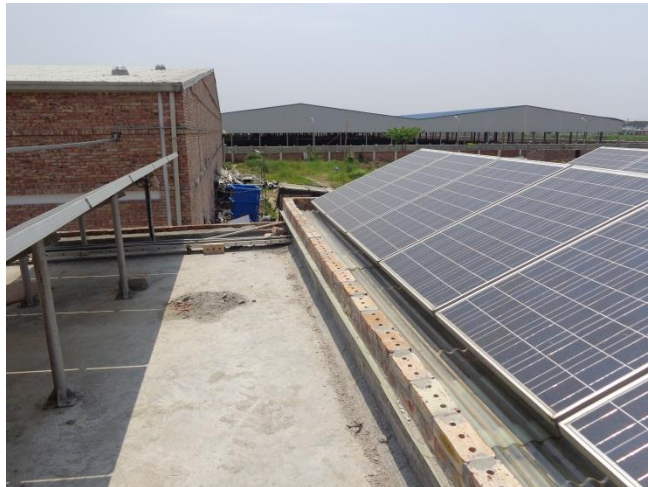
## Roof Waterproofing System at Office and Utility Building

No waterproofing membrane was visible on the roofs of the office building and utilities building. This means that any cracks in the surface finishes on the roof will allow water to seep into the concrete slab and cause long-term soaking of the slab, and potential deterioration of the brick chip concrete.
