# Liberty Knitwear (Unit-2) Ltd #11570

10.May.2014

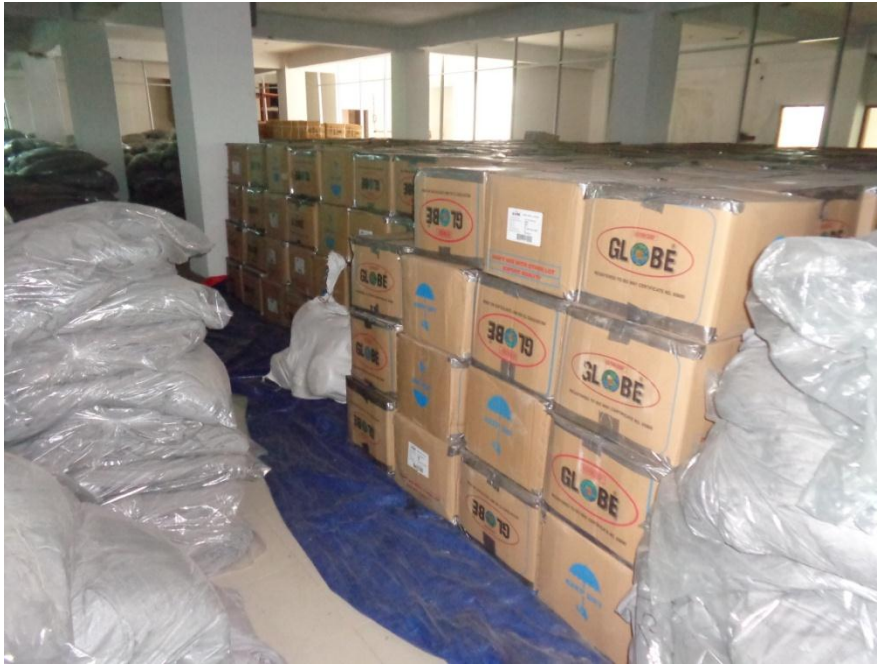
Storage Area at East side of main building –  
Design load exceeded: loading to be reduced

Construction debris was piled up in stairs, greatly  
exceeding design loading for stairs.

| Item No. | Observation | Recommended Action Plan | Recommended Timeline |
|---|---|---|---|
| 1 | Main building – Design load exceeded, loading to be reduced. | Redistribute material in storage areas to respect design load of 3 kPa (60 psf).<br>Evacuate construction debris from stairs and add supervision to prevent future occurrence. | Immediate – Now |

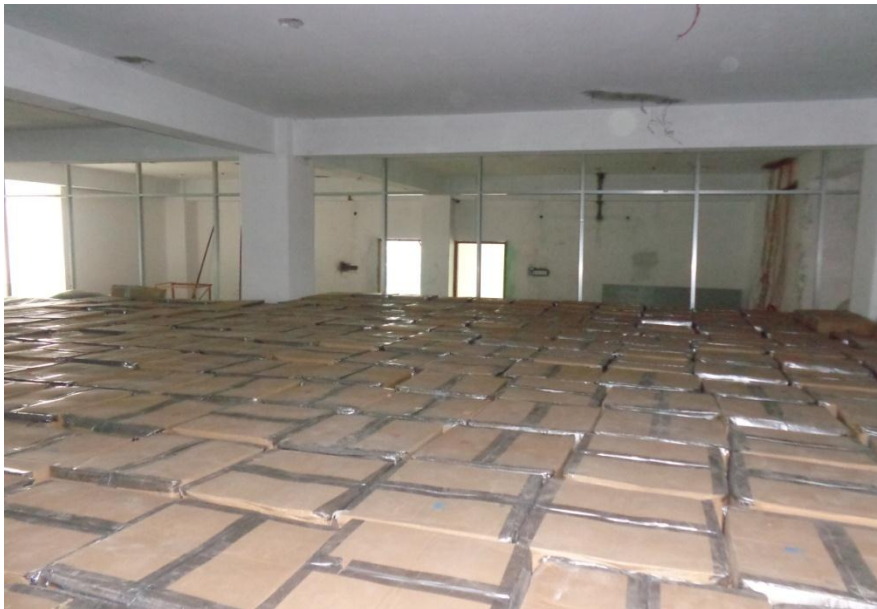
For Main building, on 1<sup>st</sup> and 2<sup>nd</sup> floor heavy storage is seen over a large area. In some places loading exceeds design loading plan for these floors (up to 100 psf versus 60 psf design).

Construction debris was also piled up at stair landings of the floor under construction.

| Item No. | Observation | Recommended Action Plan | Recommended Timeline |
|---|---|---|---|
| 2 | Main building – Design load exceeded, loading to be reduced. | Implement better control to prevent overload of floors by construction materials.<br>Implement better supervision of floor loadings in storage areas. | 6-weeks |

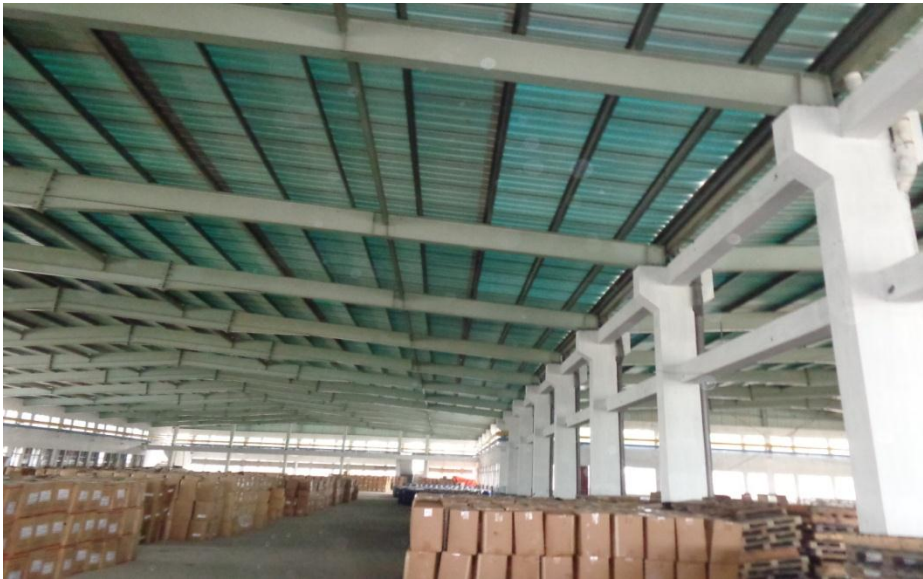
Detailed structural drawings are not available for “pre-engineered” roof structure of dyeing and finishing buildings.

| Item No. | Observation | Recommended Action Plan | Recommended Timeline |
|---|---|---|---|
| 3 | Detailed structural drawings are not available for “pre-engineered” roof structure of dyeing and finishing buildings. | Detailed structural drawings to be sent to owner of building | 6-months |

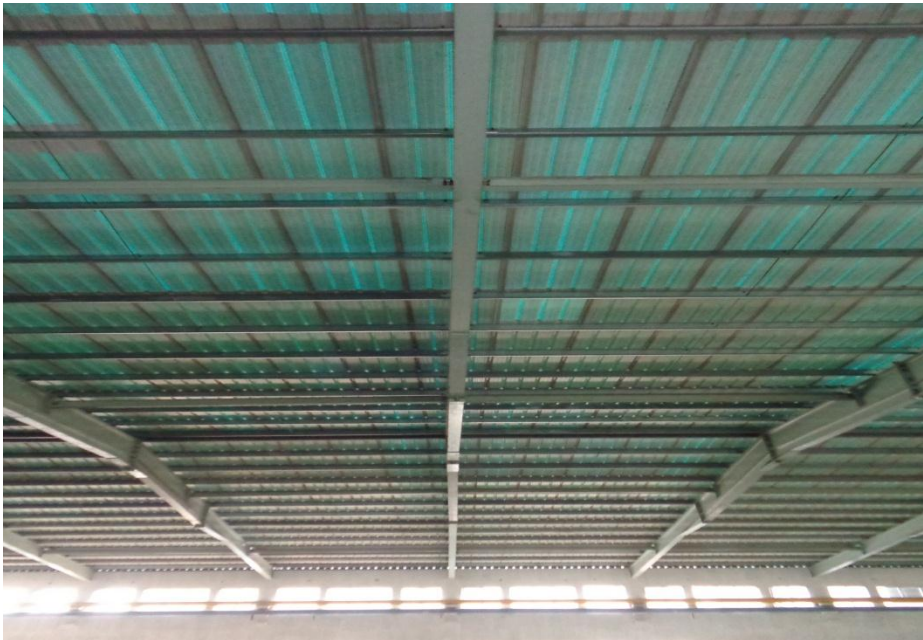
Factory owner does not have detail drawing for steel structure. Detail drawing should be compiled for future reference.

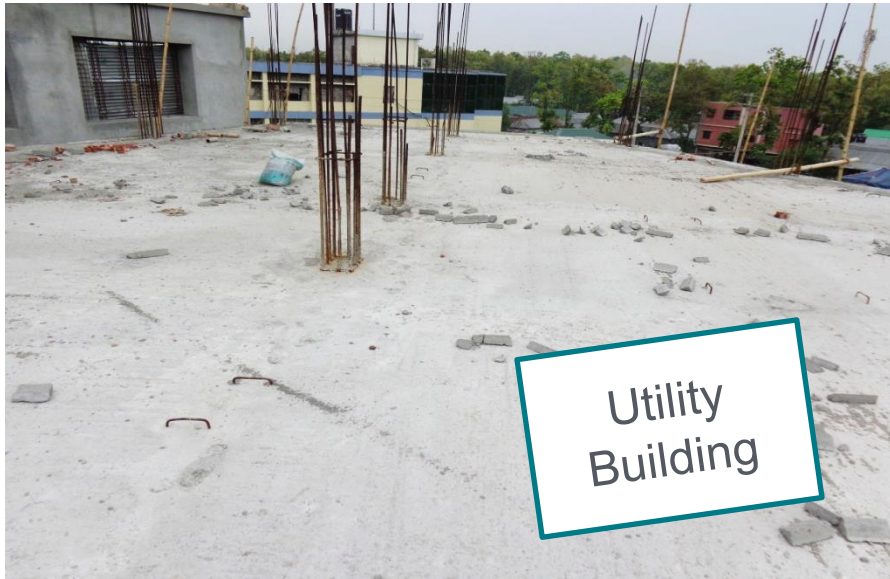
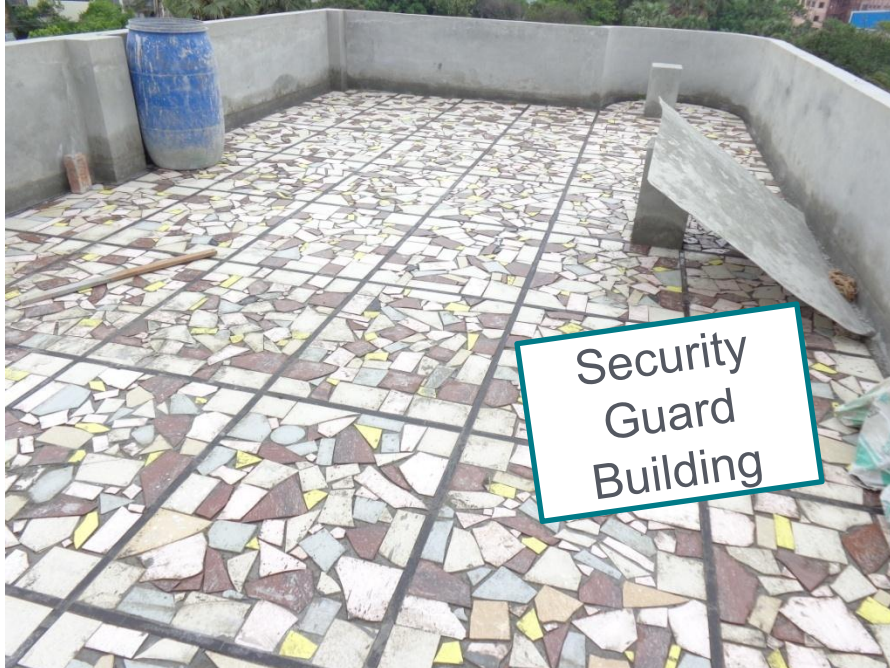
Most of the buildings of the factory are still in construction. When construction will be completed, applying waterproofing should be considered
