Vertex Innovative Apparels Ltd. (10524)

Forkan Tower, 360/A, Bitak Bazar, Sagorika, Pahartoli Thana, Chittagong

15.MARCH.2014

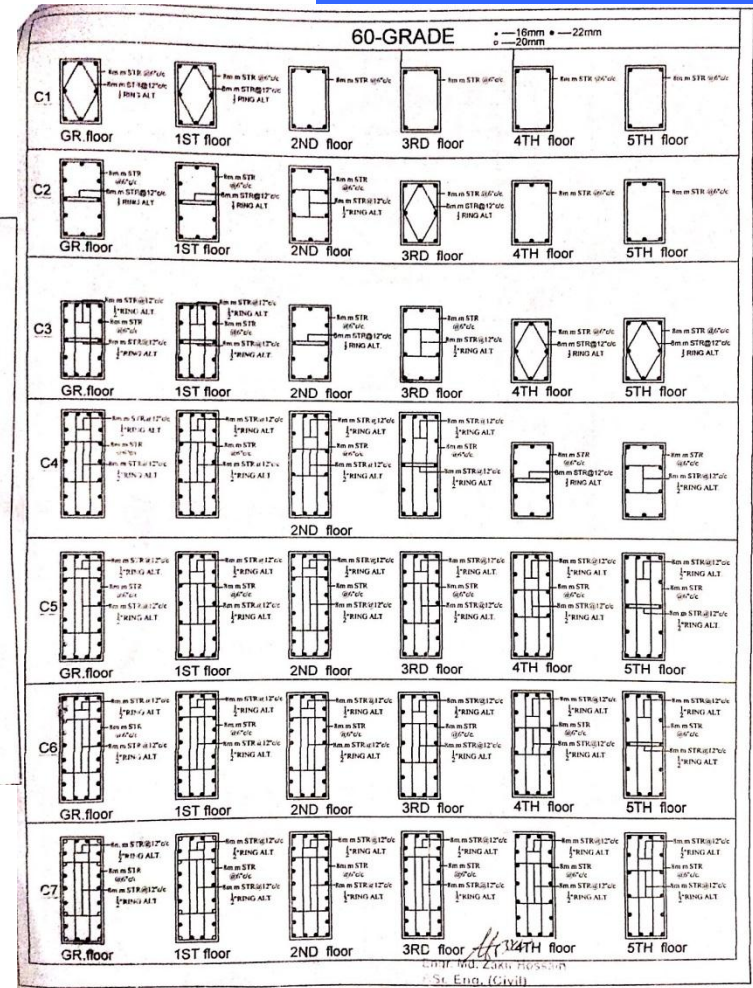
Low Column Safety Factors

Column load run-downs indicate lower than desirable column safety factors.

ITEM 1: (Priority 1) Column load run-downs indicate a low column safety factor for the completed building. It is notable that the building is currently under construction at the 5th floor slab level.

Item No.	Observation	Recommended Action Plan	Recommended Timeline
1	Column load run-downs indicate a low column safety factor for the completed building. It is notable that the building is currently under construction at the 5th floor slab level.	Do not continue construction past the 5th floor slab level. It is recommended that the 5th floor slab be used as the roof level.	Immediate – Now
2	Column load run-downs indicate a low column safety factor for the completed building. It is notable that the building is currently under construction at the 5th floor slab level.	Factory engineer to review design, loads and column stresses.	6-weeks
3	Column load run-downs indicate a low column safety factor for the completed building. It is notable that the building is currently under construction at the 5th floor slab level.	Produce and actively manage a loading plan for all floor plates giving consideration to slab and column capacity.	6-months

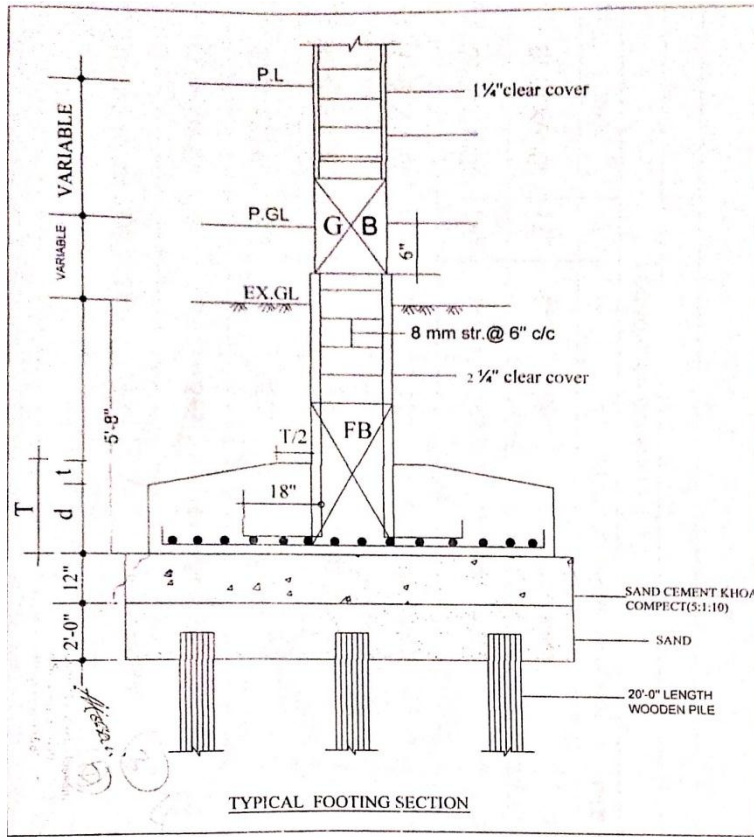
Soil Capacity/Footing Design & Incomplete Structural Drawings

Foundations are built in a manner other than that recommended by the geotechnical report. General foundation capacity checks were performed. Based upon Geotechnical findings, the soil bearing capacity does not appear adequate to support the foundation shown on the structural drawings.

ITEM 2: (Priority 2) It was noted that the foundations shown on structural drawings do not match the recommendations made by the Geotechnical report. After examination of Geotechnical findings and various foundation checks based upon the foundations indicated by the structural drawings. It is doubtful that the soil bearing capacity is adequate to support the loads applied to the footings presented. Notably, bamboo piles were used beneath pad footings. However, they commence approximately 2 feet beneath the underside of footing and only extend to a depth of 28'-8" below grade where soil is of very poor capacity.

4	It was noted that the foundations shown on structural drawings do not match the recommendations made by the Geotechnical report. After examination of Geotechnical findings and various foundation checks based upon the foundations indicated by the structural drawings. It is doubtful that the soil bearing capacity is adequate to support the loads applied to the footings presented. Notably, bamboo piles were used beneath pad footings. However, they commence approximately 2 feet beneath the underside of footing and only extend to a depth of 28'-8" below grade where soil is of very poor capacity.	A Detailed Engineering Assessment to be conducted in order to determine the adequacy of the as-built foundation for existing soil properties.	6-weeks
5	It was noted that the foundations shown on structural drawings do not match the recommendations made by the Geotechnical report. After examination of Geotechnical findings and various foundation checks based upon the foundations indicated by the structural drawings. It is doubtful that the soil bearing capacity is adequate to support the loads applied to the footings presented. Notably, bamboo piles were used beneath pad footings. However, they commence approximately 2 feet beneath the underside of footing and only extend to a depth of 28'-8" below grade where soil is of very poor capacity.	Carry out any remedial measures recommended by above mentioned detailed engineering assessment.	6-months

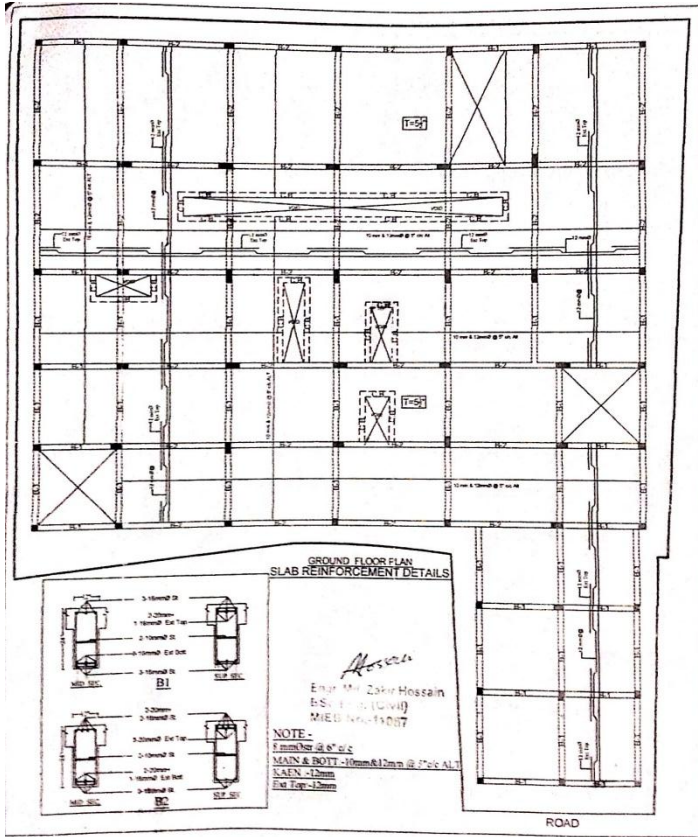
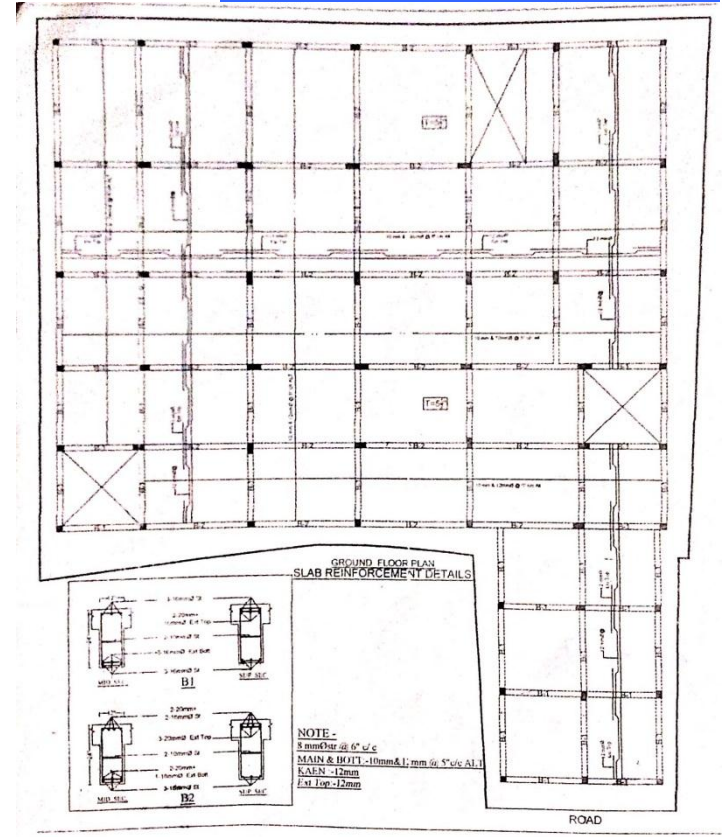
Incomplete Structural Drawings

Structural drawings are incomplete. Typical slab reinforcing and roof slab reinforcing plans are missing. Two differing ground floor slab plans are presented. Plans are generally of very poor quality.

ITEM 3: (Priority 2) Structural drawings were found to be inconsistent and of low quality. It is questionable how the full structure has been built while lacking clear concise structural drawings. As an example, there is no typical floor slab reinforcing plan provided. However, the structure is currently under construction at the 5th storey level.

6	Structural drawings were found to be inconsistent and of low quality. It is questionable how the full structure has been built while lacking clear concise structural drawings. As an example, there is no typical floor slab reinforcing plan provided. However, the structure is currently under construction at the 5th storey level.	A Detailed Engineering Assessment to be carried out in order to adequately formulate structural plans and assess the suitability of as-built structural elements.	6-weeks
7	Structural drawings were found to be inconsistent and of low quality. It is questionable how the full structure has been built while lacking clear concise structural drawings. As an example, there is no typical floor slab reinforcing plan provided. However, the structure is currently under construction at the 5th storey level.	Address findings and recommendations of the above mentioned detailed engineering assessment.	6-months
