Hop Lun Apparels Ltd. (9670)

S.T. Tower, Mouza-Gazipura, Gazipura, Tongi, Gazipur

22.MARCH.2014

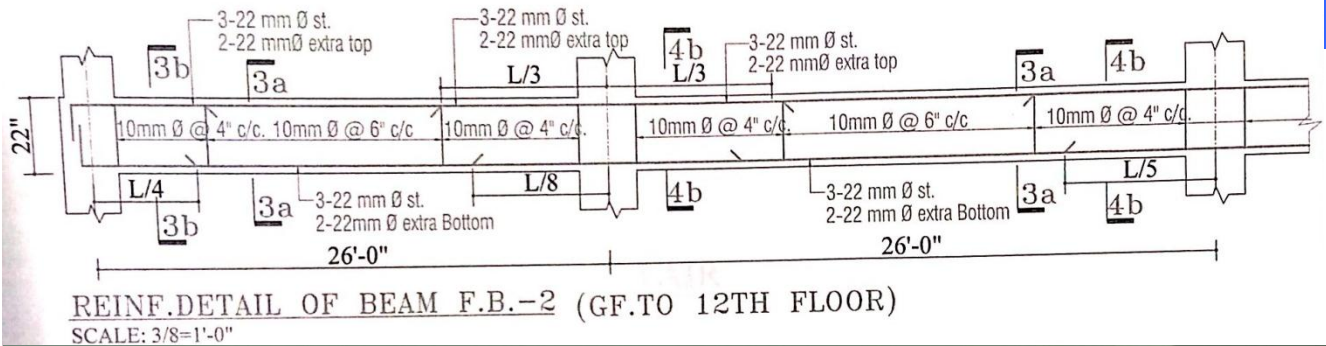
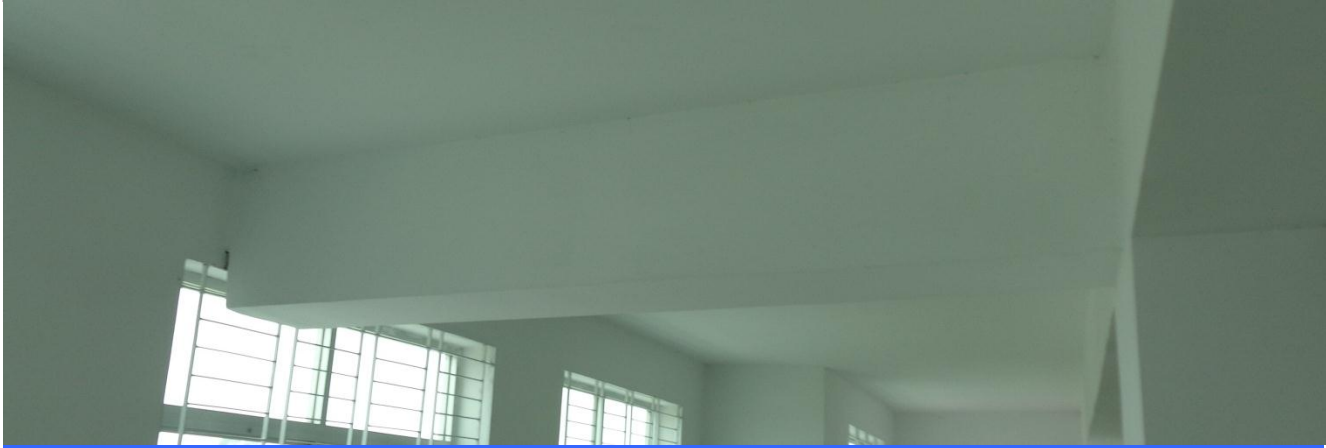
Structural Drawings do not Detail Beam Cantilevers

Structural drawings were, relatively speaking, very well done. However, portions of the slab were observed to be cantilevered past the column grid while no cantilever beam reinforcing details were shown. It was indicated by the factory engineer that negative moment reinforcement over the outer most column was simply extended to the end of the cantilever.

Structural drawings do not show beam cantilever reinforcement

ITEM 1: (Priority 2) Typical floor beams cantilever outside of the column grid at various slab jog locations shown on the slab plans. However, floor beam plans do not indicate reinforcement that should be provided in the cantilevered portions of the beam. The factory engineer has indicated that negative moment reinforcement specified over beam supports has been placed continuously to the end of the cantilevers.

Item No.	Observation	Recommended Action Plan	Recommended Timeline
1	Typical floor beams cantilever outside of the column grid at various slab jog locations shown on the slab plans. However, floor beam plans do not indicate reinforcement that should be provided in the cantilevered portions of the beam. The factory engineer has indicated that negative moment reinforcement specified over beam supports has been placed continuously to the end of the cantilevers.	Remove any storage from cantilevered portions of floor slabs	Immediate – Now
2	Typical floor beams cantilever outside of the column grid at various slab jog locations shown on the slab plans. However, floor beam plans do not indicate reinforcement that should be provided in the cantilevered portions of the beam. The factory engineer has indicated that negative moment reinforcement specified over beam supports has been placed continuously to the end of the cantilevers.	Udayan Consultants to verify as built cantilever adequacy and amend structural drawings with cantilever reinforcing details.	6-weeks

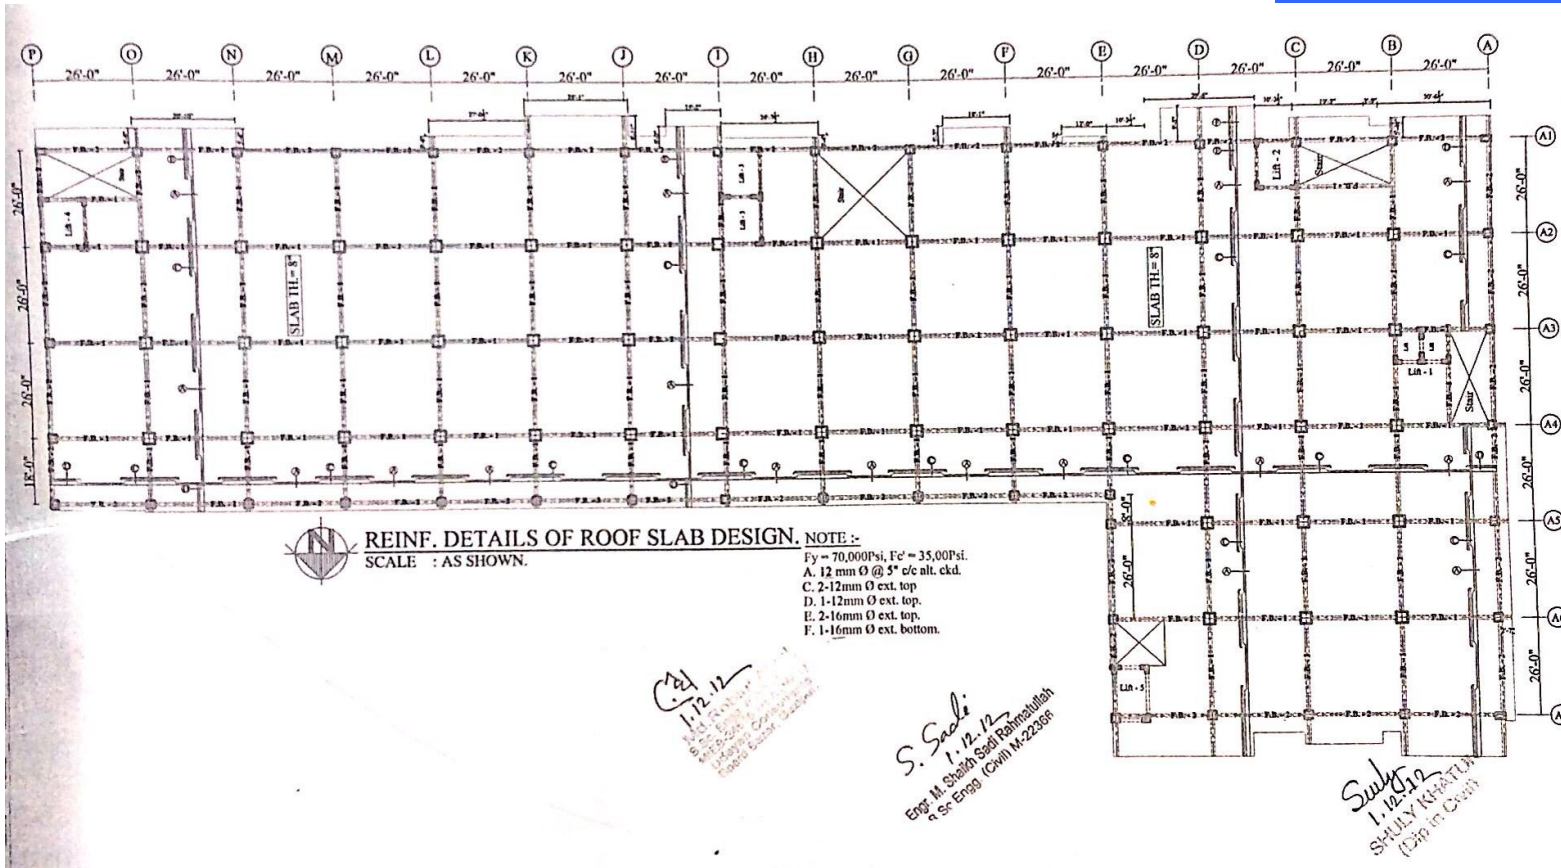
**Structural Drawings do not Contain Labelled Typical
Floor Slab Reinforcing Plan**

Floor slab reinforcing plan is labelled as a Roof Slab plan. No other slab reinforcing plan was contained within the drawings. It was indicated by the factory engineer that the slab reinforcing shown was used in all floor slabs.

ITEM 2: (Priority 2) Structural drawings contain only one slab reinforcing plan labelled “Reinf. Details of Roof Slab Design”. It is unclear whether these details are intended for typical floor slab reinforcing or only the roof slab reinforcing.

3	Typical floor beams cantilever outside of the column grid at various slab jog locations shown on the slab plans. However, floor beam plans do not indicate reinforcement that should be provided in the cantilevered portions of the beam. The factory engineer has indicated that negative moment reinforcement specified over beam supports has been placed continuously to the end of the cantilevers.	Implement any works deemed necessary during review.	6-months
4	Structural drawings contain only one slab reinforcing plan labelled “Reinf. Details of Roof Slab Design”. It is unclear whether these details are intended for typical floor slab reinforcing or only the roof slab reinforcing.	Have Udayan Consultants verify adequacy of Reinf. Details of Roof Slab Design plan for use as a typical floor slab. Udayan Consultants to amend drawings with a Typical Slab Reinforcement Plan.	6-weeks
5	Structural drawings contain only one slab reinforcing plan labelled “Reinf. Details of Roof Slab Design”. It is unclear whether these details are intended for typical floor slab reinforcing or only the roof slab reinforcing.	Implement any works deemed necessary during review.	6-months
