Knittex Industries Ltd. (10837)

21.APRIL.2014

ACCORD
on Fire and Building Safety in Bangladesh

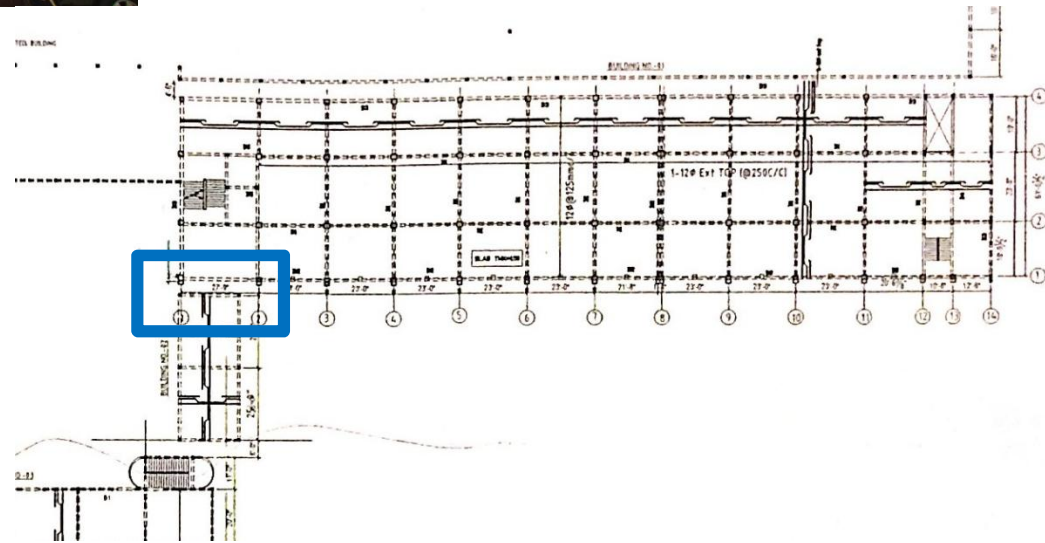
1st Priority 1 Concern

Structural and permit drawings do not reflect all existing site conditions.

The structural and permit drawings do not reflect all the existing site conditions. Discrepancies included, but are not limited to, additional concrete room above machine room on roof of building #1, steel roof above 5th floor of building #1, cantilevered roof slab of building #1, the link between buildings #1 and #2, column layout for building #2, the staircase between buildings #2 and #3, and structural drawings for building #4.

- Review actual existing site conditions and update structural and permit drawings as required.

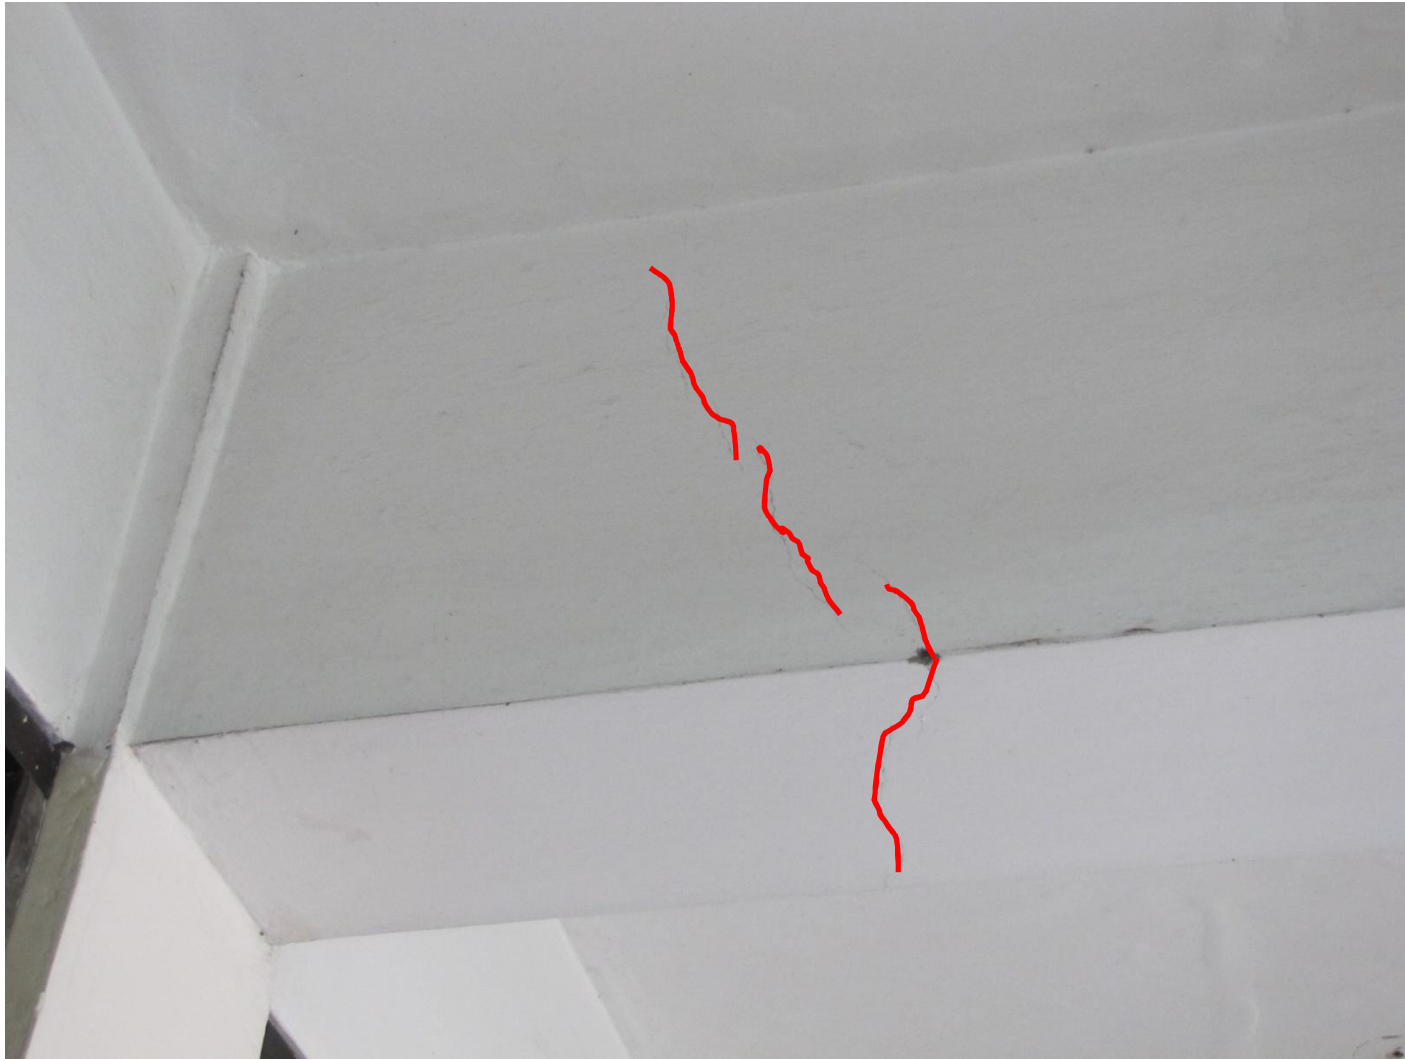
2nd Priority 1
Concern

Evidence of
overstressing in
Building #3 due
to overloaded
slab.

At building #3, shear cracks were observed in the beams under the roof slab. We were informed an additional 100mm waterproofing slab was added to the existing 150mm roof slab. We were not able to confirm this on site, and this was not shown on the structural drawings. As a result of this additional dead weight, the column appears to be overstressed.

- Remove all storage loading at the 1st and 2nd floors down to 2.0kPa (40 psf) until a Detailed Engineering Assessment can be carried out to determine the load carrying capacity of the columns.
- No persons to access roof slab (0kPa) until the DEA can be carried out.

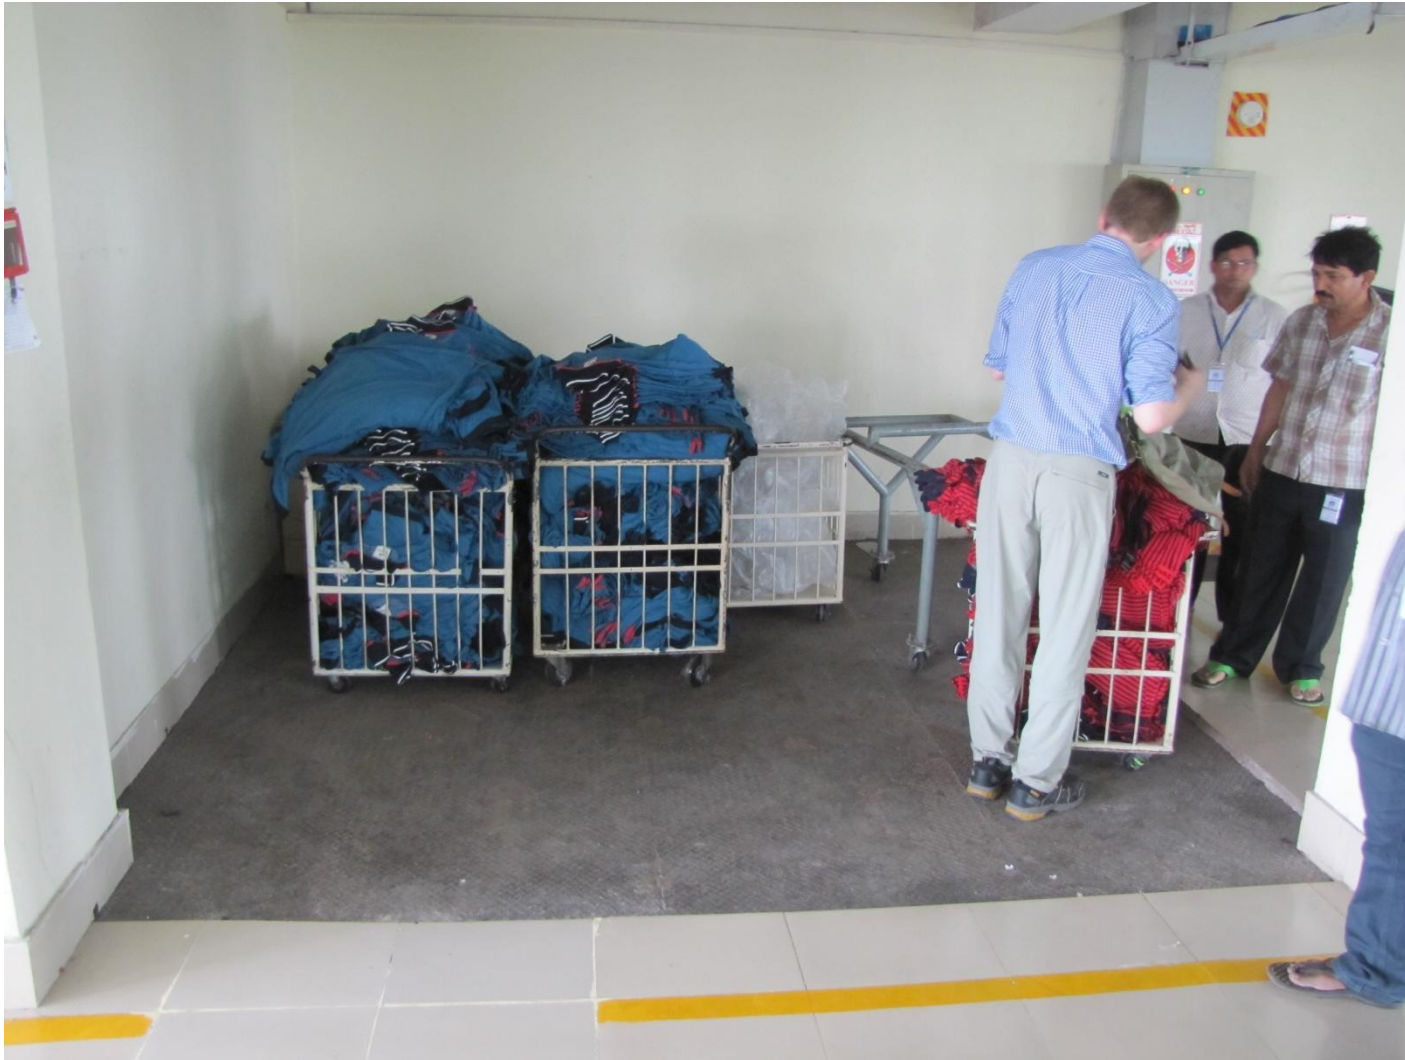
3rd Priority 1
Concern

Steel plate infill
at lift shaft in
Building #1
appears
inadequate for
applied loading.

At building #1, the steel checkered plate infill in the lift shaft at the 1st, 2nd, and 3rd floors appears inadequate for the applied loading. Excessive deflection was noted, as well as poor steel detailing. At the time of the inspection, storage loading was applied to the steel checkered plate.

- Remove all loading (persons and storage) down to 0kPa until an engineering assessment can be carried out on the load carrying capacity of the steel checkered plate.

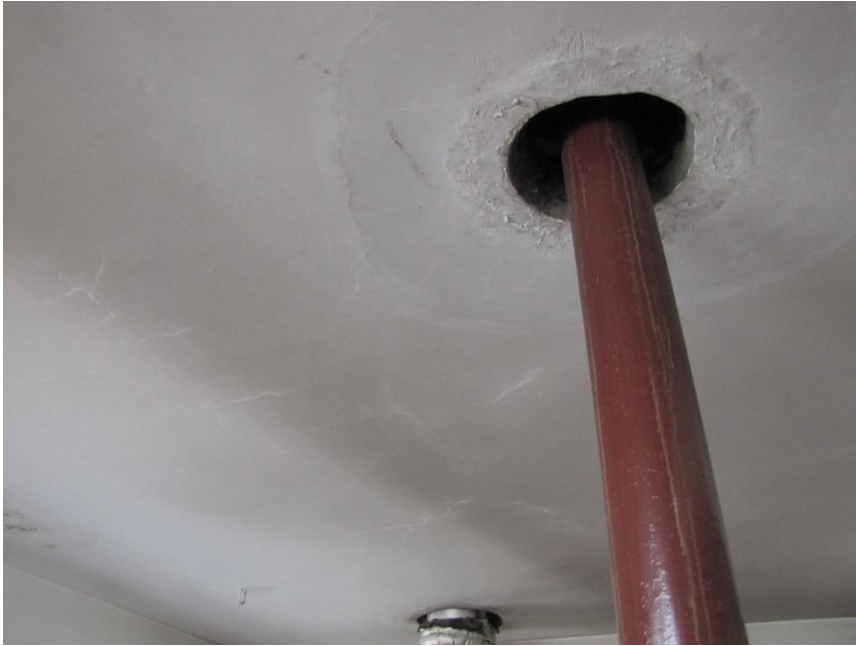
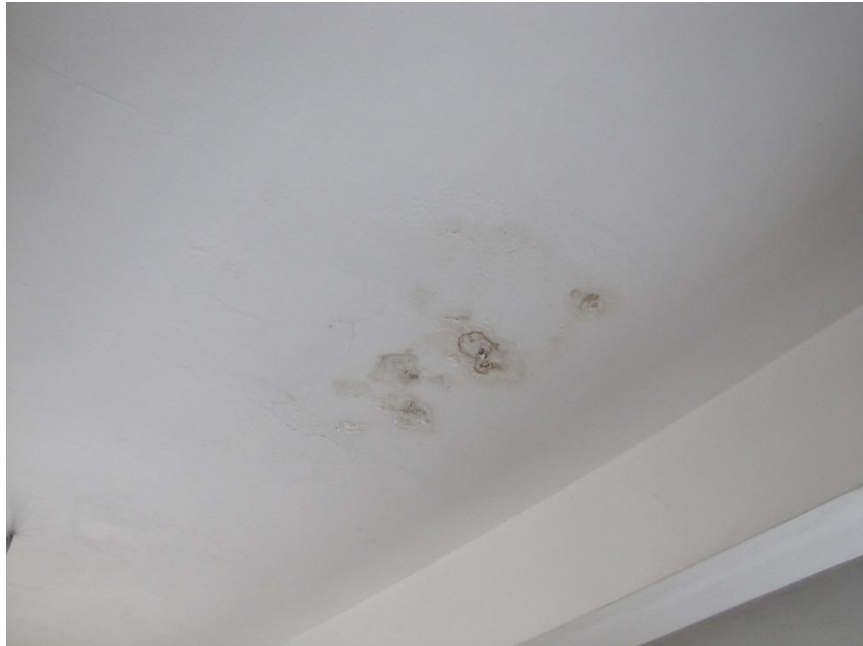
Priority 2 Concern

Water staining (right) and cracking (above) at roof slab of Building #5 due to water seepage from tank above.

At building #5, water staining and cracking was observed in the roof slab. The water cooling equipment on the roof appears to be leaking and accumulating at a low point against the parapet. This water is percolating through the slab.

- Repair leak at water cooling unit and properly drain roof with adequately sloping surface and weeping holes.

- Repair roof slab.

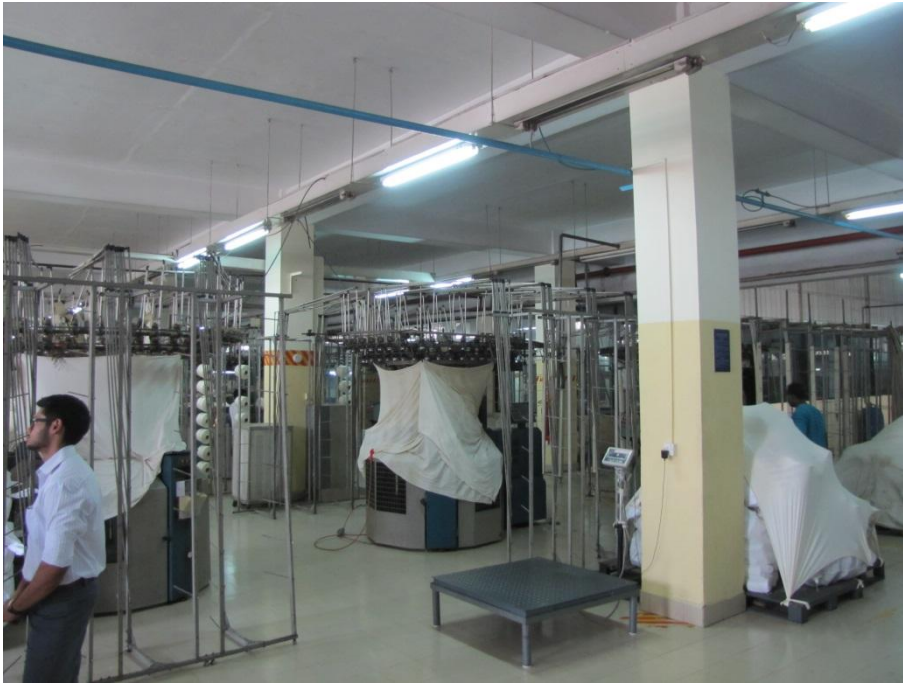
Overall Stability System

The buildings did not feature any core or shear walls. Stability was achieved through sway action between beams and columns and masonry infill walls.

We require that these items be investigated in a Detailed Engineering Assessment.

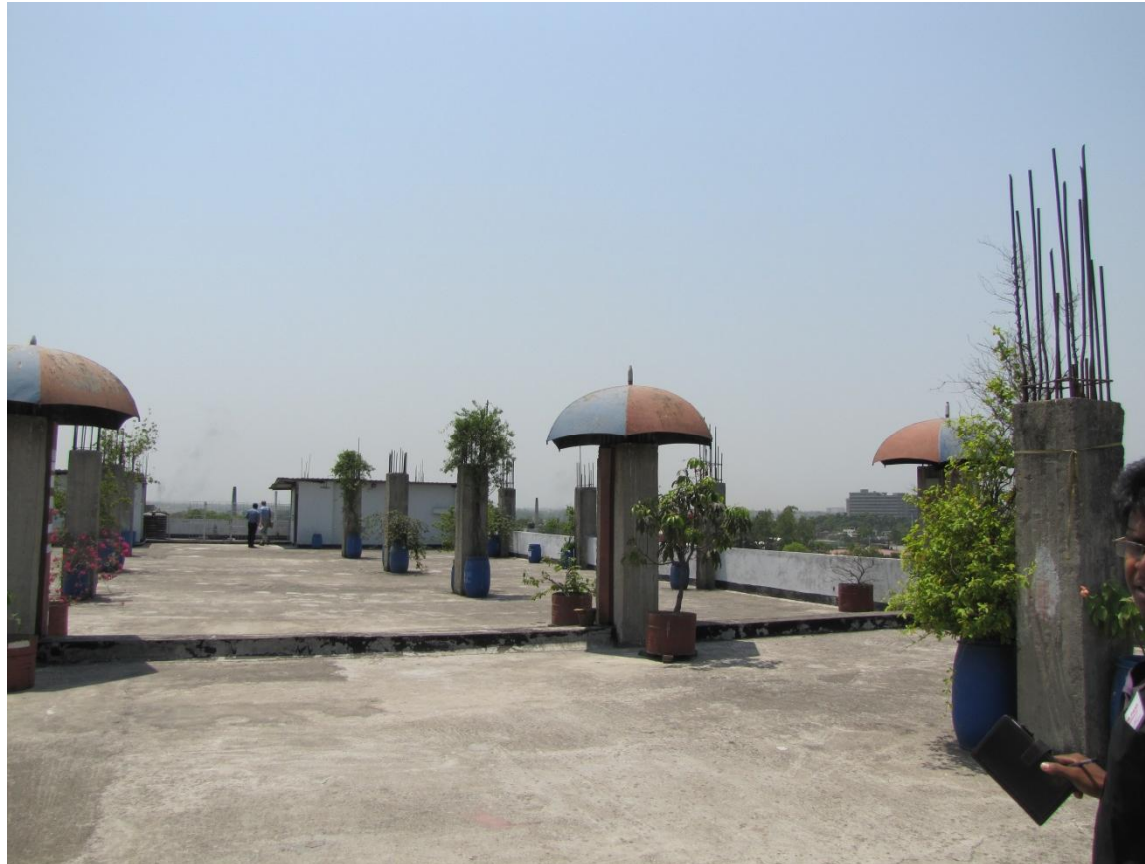
Water Ingress at Roof Level

No waterproofing membrane was visible on the roof of the building. This means that any cracks in the surface finishes on the roof will allow water to seep into the concrete slab beneath the finishes, and cause long-term soaking of the slab.
