FIRE SAFETY INSPECTION REPORT

KNIT ASIA LTD
EAST NARSHINGAPUR, BURIPARA, EARPUR,
ASHULIA, DHAKA

ACC   **RD**
on Fire and Building Safety in Bangladesh

June 8, 2014

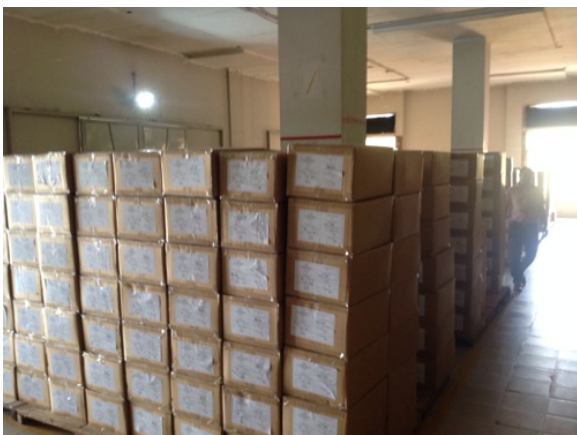
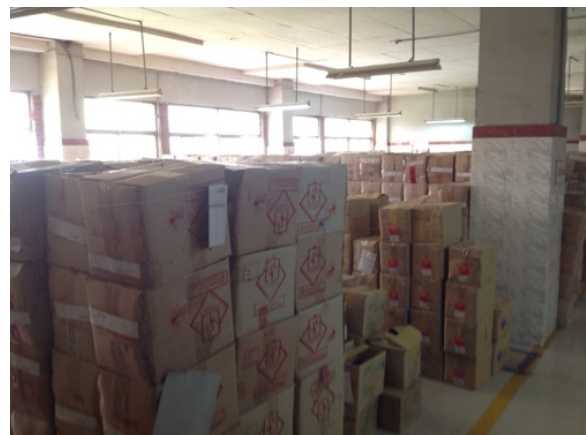
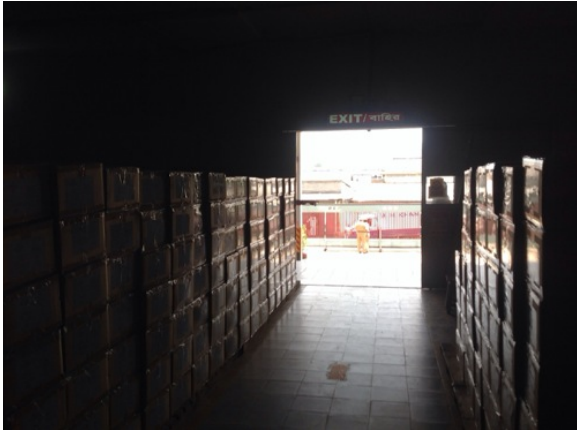
No.	Category	Finding	Recommendation	Remediation Timeframe
F-1	Fire Rated Construction	Areas used for storage on the ground floors warehouse is not separated by fire rated construction. These areas were found i the basement, ground floor, 4, and 5 floors.	<p>Provide dedicated storage rooms separated by minimum 1-hr fire-rated construction.</p> <p>Where separate storage rooms are not feasible, provide defined storage areas and limit the storage arrangement as follows:</p> <ul style="list-style-type: none"> - Maximum height of 2.4m and maximum area of 23m² - If sprinkler protected: maximum height of 3.66m and maximum area of 93m² <p>Separate areas of unenclosed combustible storage by a minimum clear distance of 3m.</p>	Within 3 months

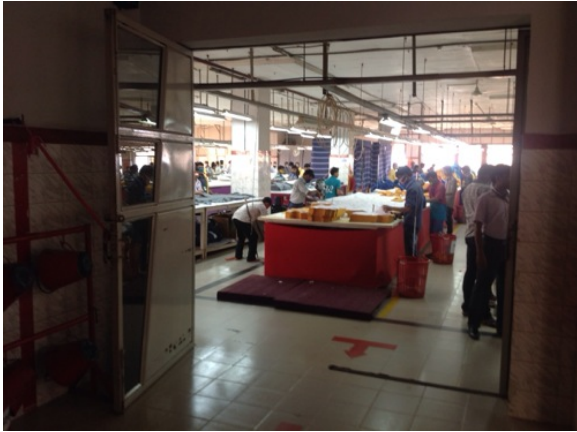
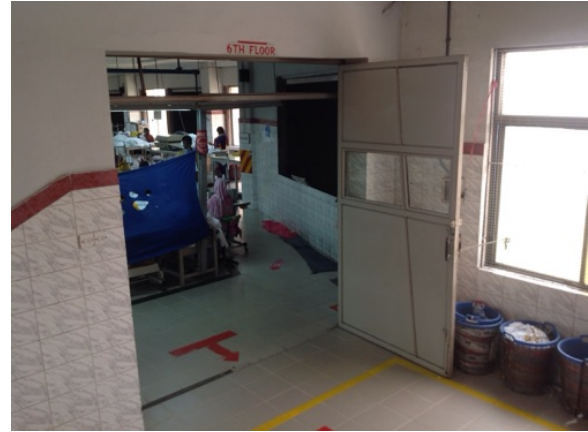
F-2	Fire Rated Construction	Exit stairs is not separated from work areas, other spaces on each floor by fire-rated construction.	Provide minimum 1.5-hr fire rated doors and seal all unprotected openings to separate the exit stairs from work areas and other building spaces on all floor levels. Ensure that the fire doors are self-closing and positive latching and that they are provided with fire exit (panic) hardware where serving production floors.	Within 3 months
			If fire doors are required to be held open for functional reasons, provide automatic-closing devices tied to the fire alarm system.

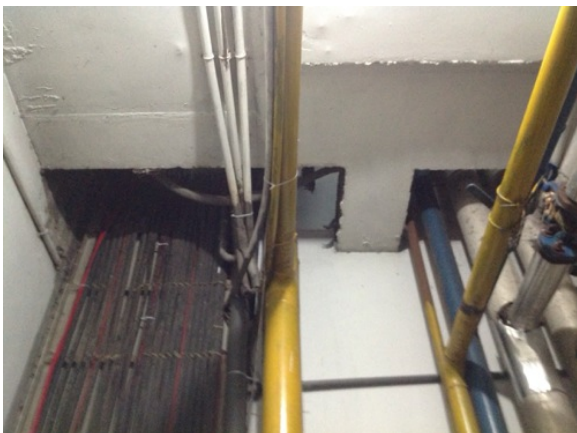
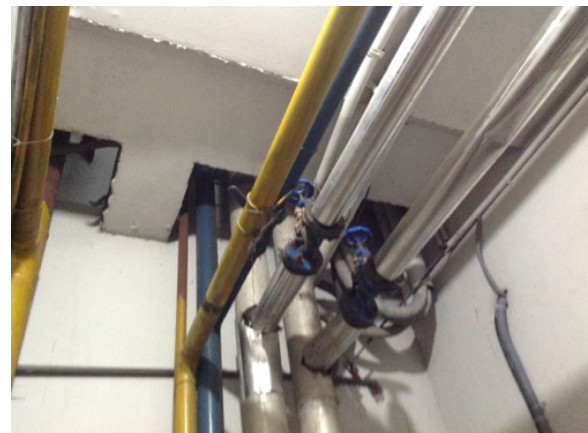
F-3	Fire Rated Construction	Unsealed penetrations and openings are located in the fire-rated floor/ceiling assemblies of the IPS room.	Provide a minimum 2-hr fire-rated shaft to separate the utility risers from each floor level.	Within 3 months
			Seal all penetrations and openings in floor/ceiling assemblies to maintain the fire separation.

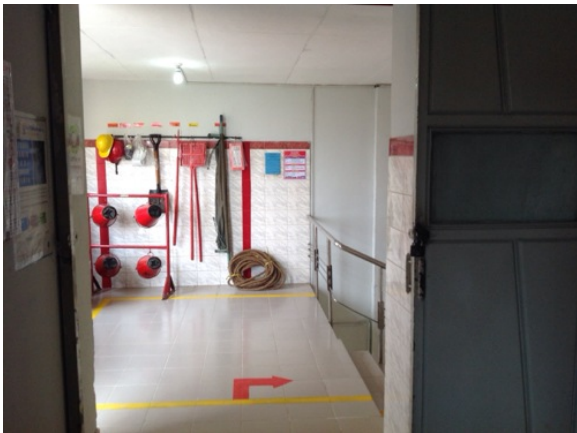
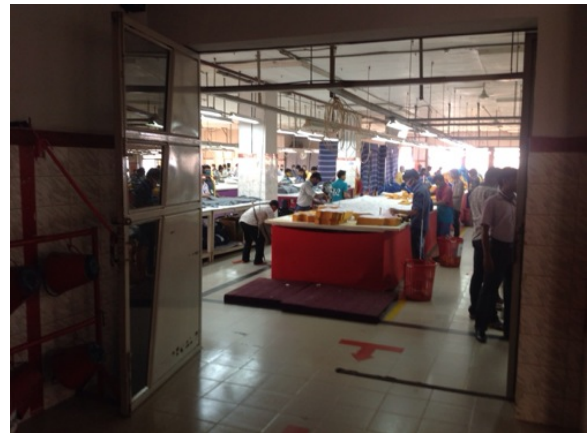
F-4	Egress	Egress doors and gates with locking features are provided at building exits, exit stairs, along egress routes, exit discharge. These locking features can be found on all exits.	Remove locking features from all egress doors / gates. If locks are required for security reasons, utilize special door locking features complying with NFPA 101.	Immediate
-----	--------	--	--	-----------

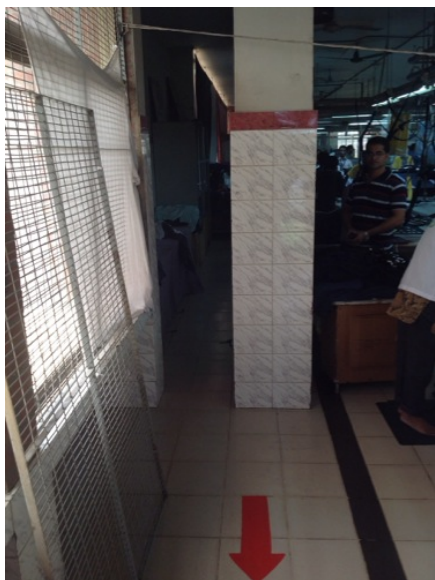
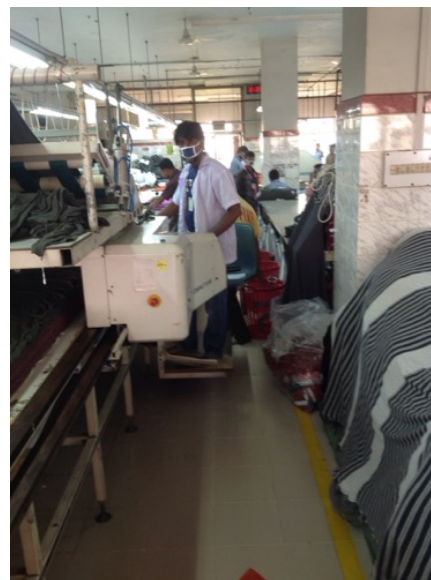
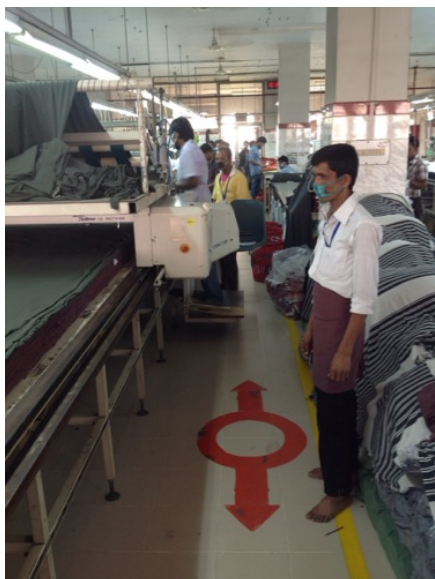
F-5	Egress	Storage was located in the egress path on floors 7 and 3 along the north and northwest and center egress paths.	Keep egress paths and stairs clear of storage.	Immediate
-----	--------	---	--	-----------

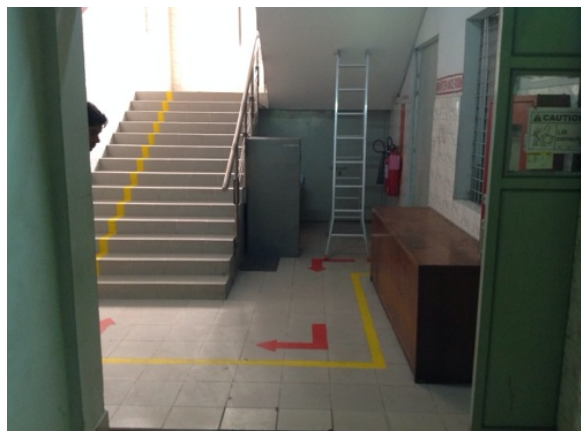
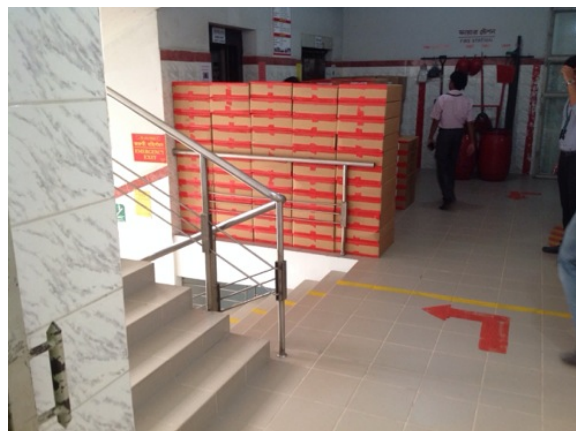
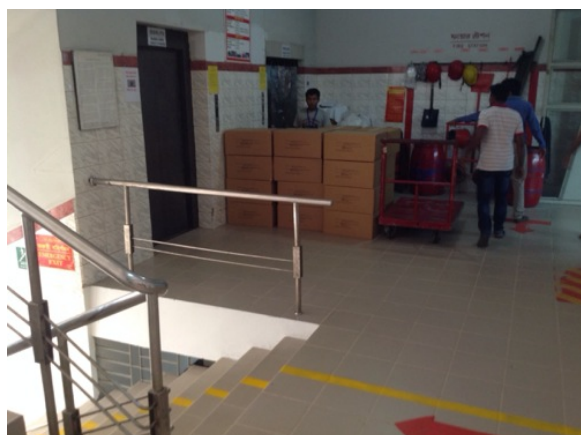
F-6 Egress

Storage was located in the exit stair of the north exit stairwell on floors 2,3,4,and th basement.

Remove all storage from exit stairs and egress paths.

Immediate

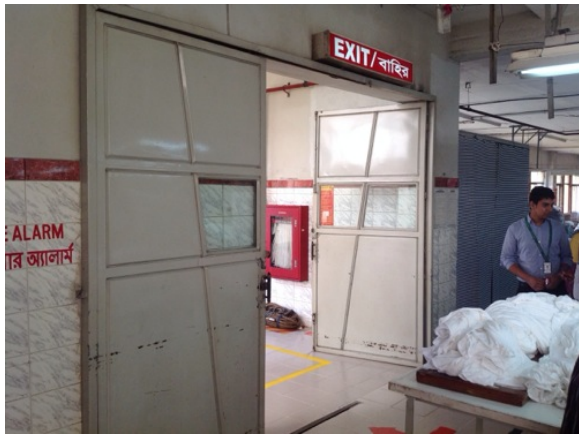
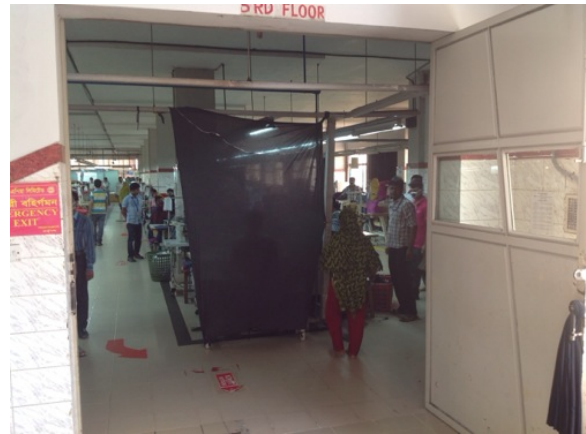
F-8	Egress	Collapsible gates are provided at building exit discharge on all discharges on the ground floor.	<p>Replace all gates and sliding doors along the means of egress with side-hinged, swinging egress doors.</p> <p>If locks are required for security reasons, utilize special door locking features complying with NFPA 101.</p>	Within 1 month
-----	--------	--	---	----------------

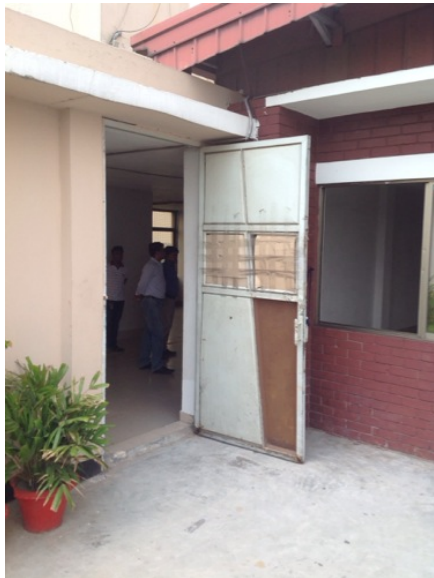
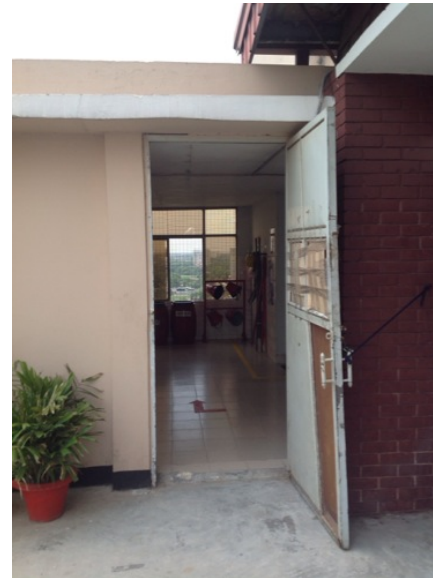
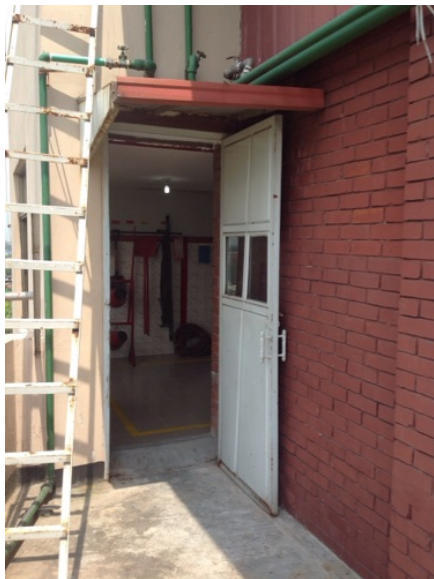
F-9	Egress	Exit stair door serving 50 or more occupants does not swing in the direction of egress travel on floor 8 east and west exit stairwells.	Modify the egress door to swing in the direction of egress travel.	Within 3 months
-----	--------	---	--	-----------------

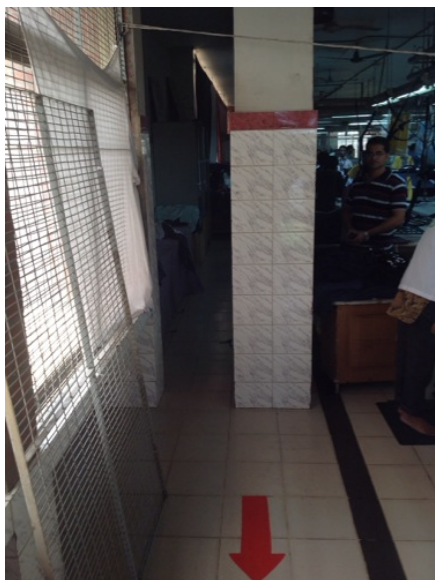
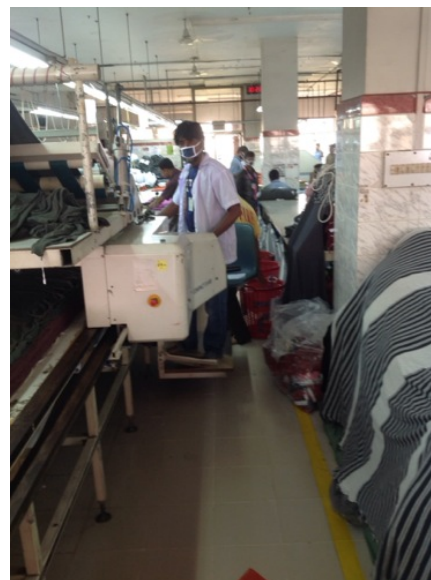
F-10	Egress	The width of egress aisles is less than 36-in. on floor 7 and 3 along the northwest and center egress paths.	Provide minimum aisle widths of 36-in.	Within 3 months
------	--------	--	--	-----------------
