# Green Life Knit Composite Ltd. (11061)

Tongabari, Ashulia, Savar, Dhaka

31.MARCH.2014

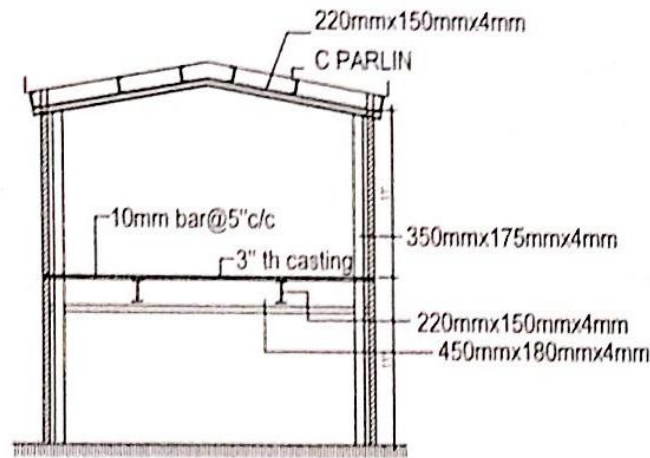
**SECTION (X-X)**

There is uncertainty as to whether the 2-storied Warehouse/Medical Clinic/Dining Hall building was intended to have a basement. Building sections show no basement and piles are shown starting 2'-6" below the existing grade level. However, there is a basement floor plan presented and there appears to be a beam and slab reinforcing plan for a suspended slab Ground Floor

**ITEM 1: (Priority 2)** There appears to be discrepancy in the both the Architectural and Structural drawings as to whether the 2-storied Warehouse/Medical Clinic/Dining Hall building is intended to have a basement.

| Item No. | Observation | Recommended Action Plan | Recommended Timeline |
|---|---|---|---|
| 1 | There appears to be discrepancy in the both the Architectural and Structural drawings as to whether the 2-storied Warehouse/Medical Clinic/Dining Hall building is intended to have a basement. | Design engineer to comment as to the acceptability of the as-built structure. | 6-weeks |
| 2 | There appears to be discrepancy in the both the Architectural and Structural drawings as to whether the 2-storied Warehouse/Medical Clinic/Dining Hall building is intended to have a basement. | Implement any recommendations of the design engineer. | 6-months |

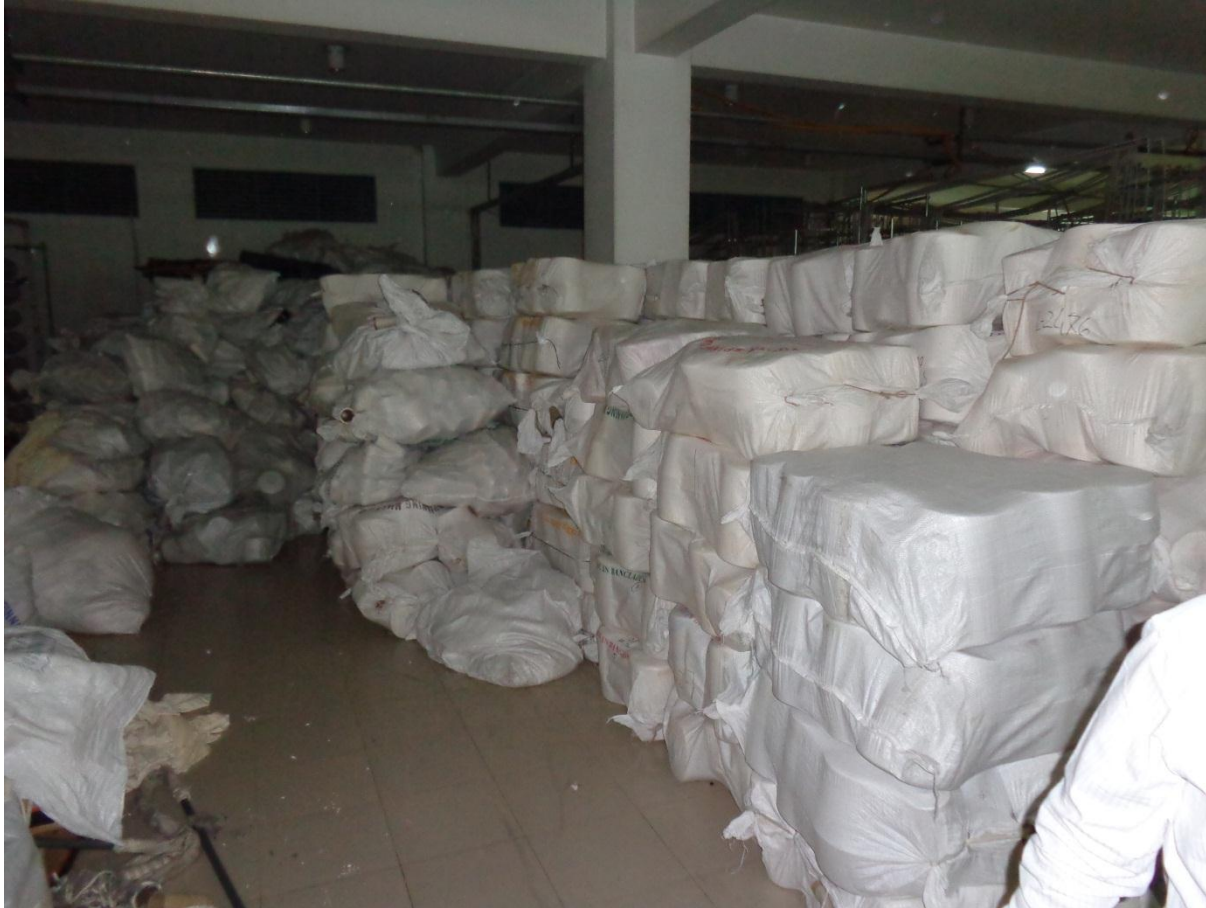
Building drawings display allowable floor loads. However, the allowable loadings do not appear to be under active monitoring and management. There was notably very few areas which exceeded the allowable live loads and storage for the most part seemed reasonable.

## Allowable Floor Loads Locally Exceeded

**ITEM 2: (Priority 3)** Although storage loads were for the most part very reasonable, there was no apparent management of allowable floor loadings and some localized areas of higher than desirable loading were observed.

| Item No. | Observation | Recommended Action Plan | Recommended Timeline |
|---|---|---|---|
| 3 | Although storage loads were for the most part very reasonable, there was no apparent management of allowable floor loadings and some localized areas of higher than desirable loading were observed. | Develop and implement a formal loading plan for all floor plates within the factory giving consideration to slab, beam and column capacities. | 6-weeks |
| 4 | Although storage loads were for the most part very reasonable, there was no apparent management of allowable floor loadings and some localized areas of higher than desirable loading were observed. | Actively monitor slab loadings throughout the factory complex. | 6-months |
