Lodestar Fashion Ltd. #10229

Mid Asia Fashions Ltd. #10257

Industrial plot # M-16, Section – 14, Mirpur, Dhaka.

05.April.2014

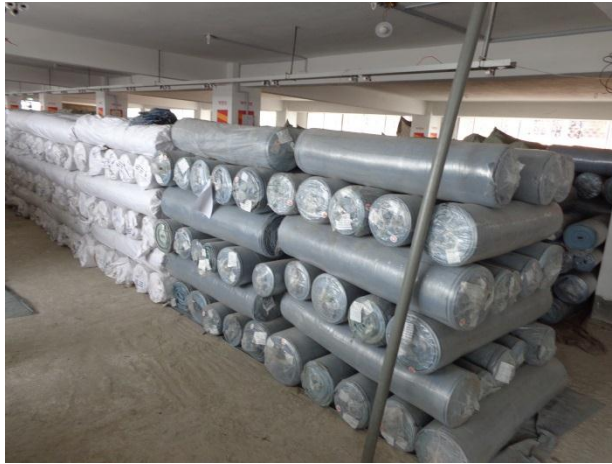
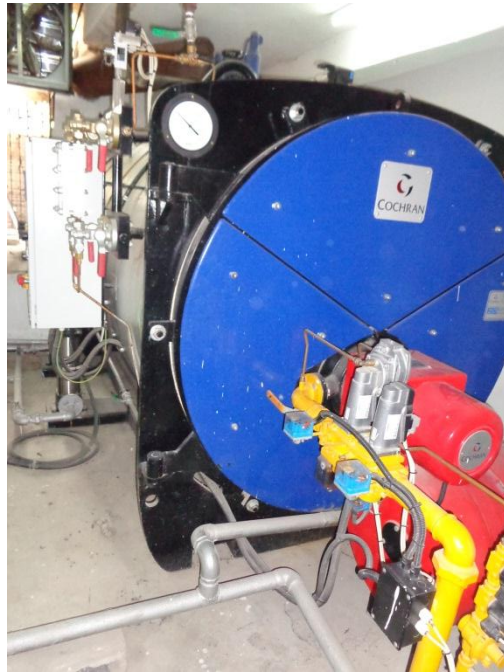
1st Priority 1 Concern

Ground floor with basement is heavily loaded with equipment

Fabric stores are found on 2 levels. Loading is approximately 1.52m to 1.83m.

The combination of these 2 elements create a potential overstressing of the columns

ITEM 1: (Priority 1) Column overstressing due to storage

Item No.	Observation	Recommended Action Plan	Recommended Timeline
1	Column overstressing due to storage.	Verify insitu concrete stresses either by 100mm dia. cores or existing cylinder strength data from 4 columns. Detail Engineering Assessment of Factory to be commenced, see attached scope	Immediate – Now
2	Column overstressing due to storage.	Factory engineer to produce and actively monitor a loading plan for all floor plates within the factory complex, with consideration given to slab, column and foundation capacity	6-weeks
3	Capacity assessment of slab and material proprieties below roof water tanks.	Include in Detailed Engineering Assessment of Factory, see attached scope Evaluation of material properties of the slab and beams by coring samples Keep water level to a minimum until assessment is completed.	Immediate – Now
4	Engineer assessment of masonry (brick) column at roof.	Include in Detailed Engineering Assessment of Factory, see attached scope.	Immediate – Now

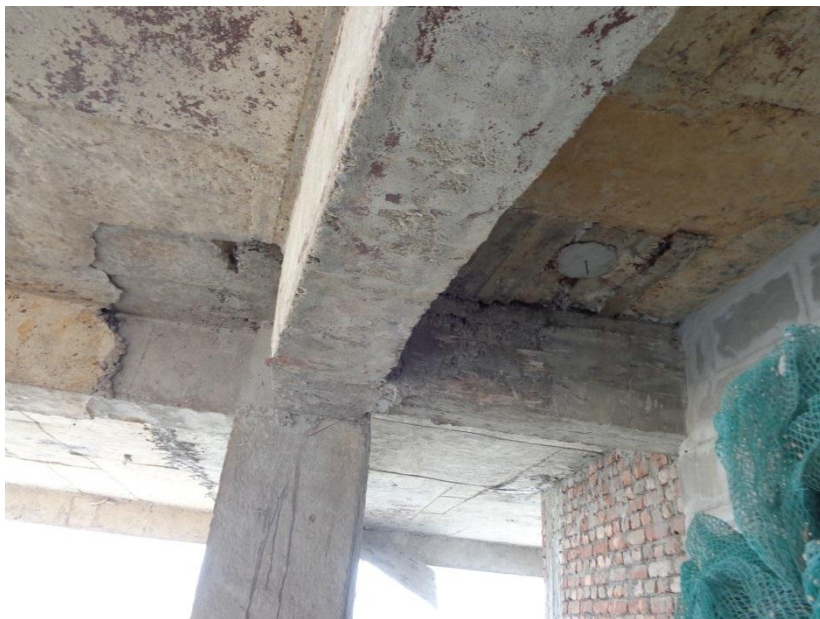
2nd Priority 1 Concern

Slabs and beams are in bad shape. Apparent rebar and bad pouring – structural integrity to be checked by engineer

ITEM 2: (Priority 1) Capacity assessment of slab and material proprieties below roof water tanks

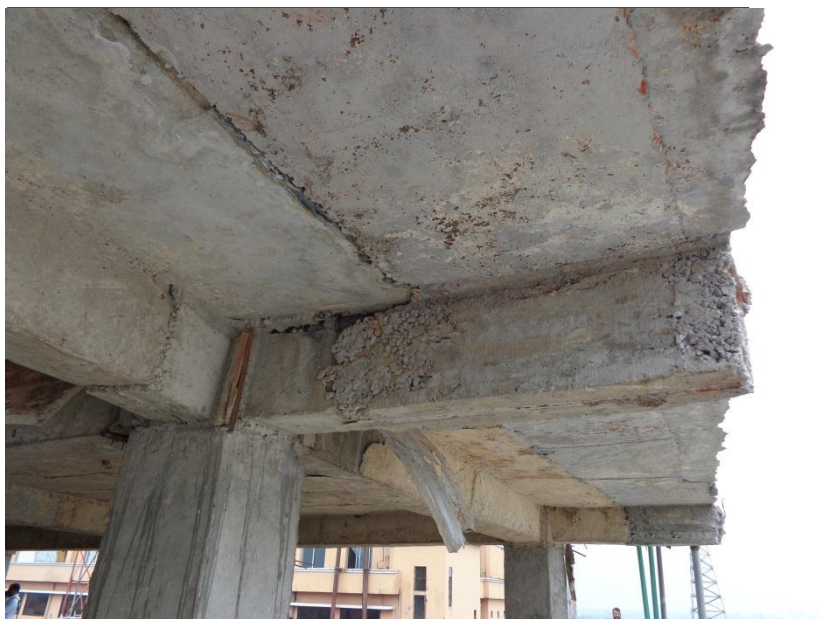
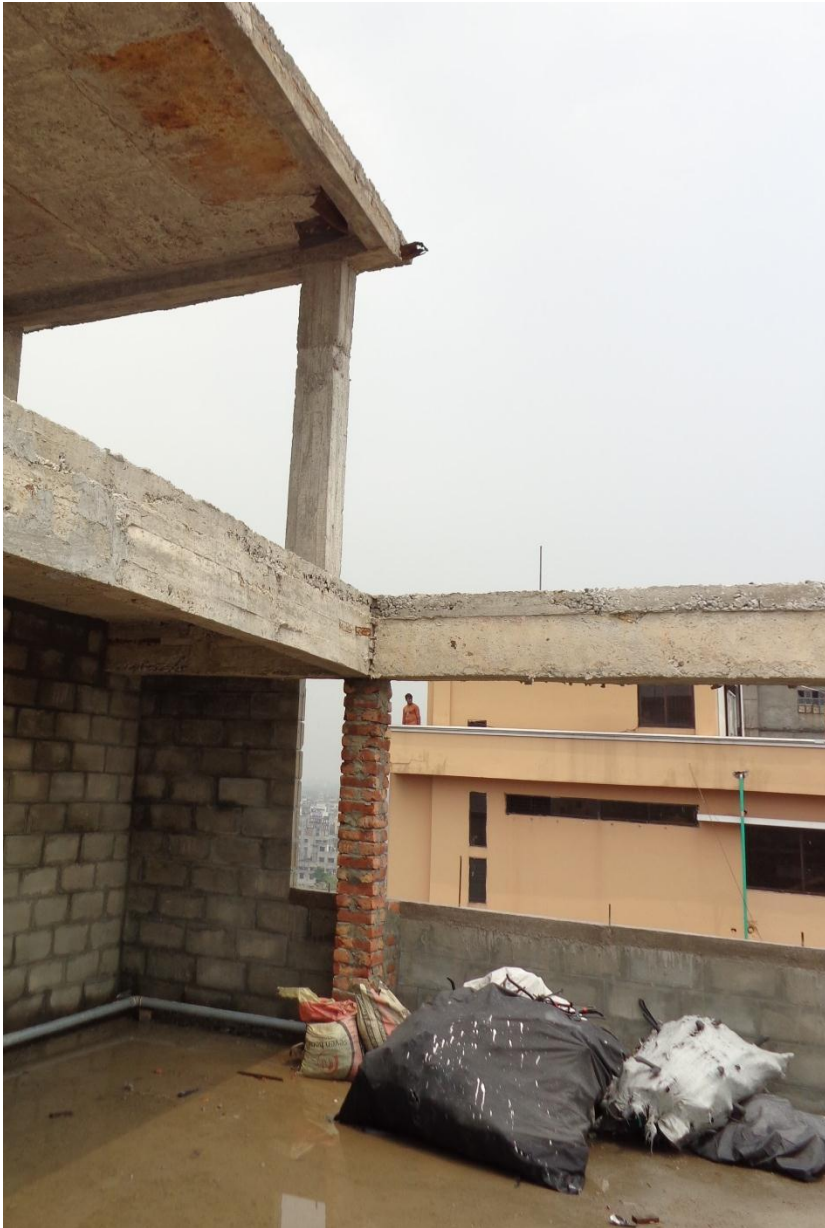
3rd Priority 1 Concern

Masonry column supporting concrete beam at roof to be evaluated by engineer. Loading on upper floor should be restricted and all existing material should be taken off

ITEM 3: (Priority 1) Engineer assessment of masonry (brick) column at roof

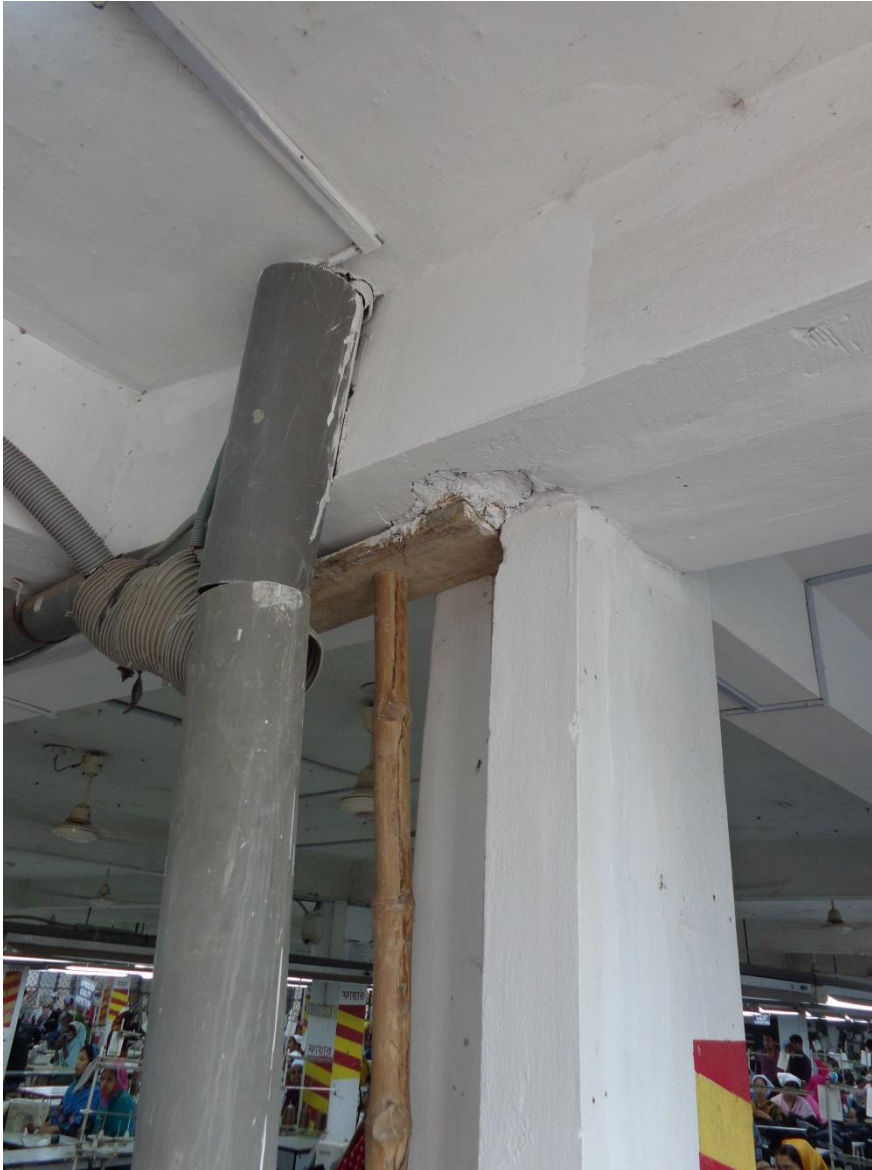
4th Priority 1 Concern

Investigation of structural integrity of beam to column connection by engineer is required.

ITEM 4: (Priority 1) Structural integrity of beam to column connection

5	Structural integrity of beam to column connection.	Include in Detailed Engineering Assessment of Factory, see attached scope.	Immediate – Now
6	Cantilevered sections at joint, at each floor.	Include in Detailed Engineering Assessment of Factory, see attached scope.	Immediate – Now
7	Steel detailing of sheds on roof.	Include in Detailed Engineering Assessment of Factory, see attached scope. Assess capacity of shed to resist wind forces (down force & uplift)	6-weeks
8	Roof appears not to have any waterproofing system applied.	Consider applying a new waterproofing membrane.	6-months

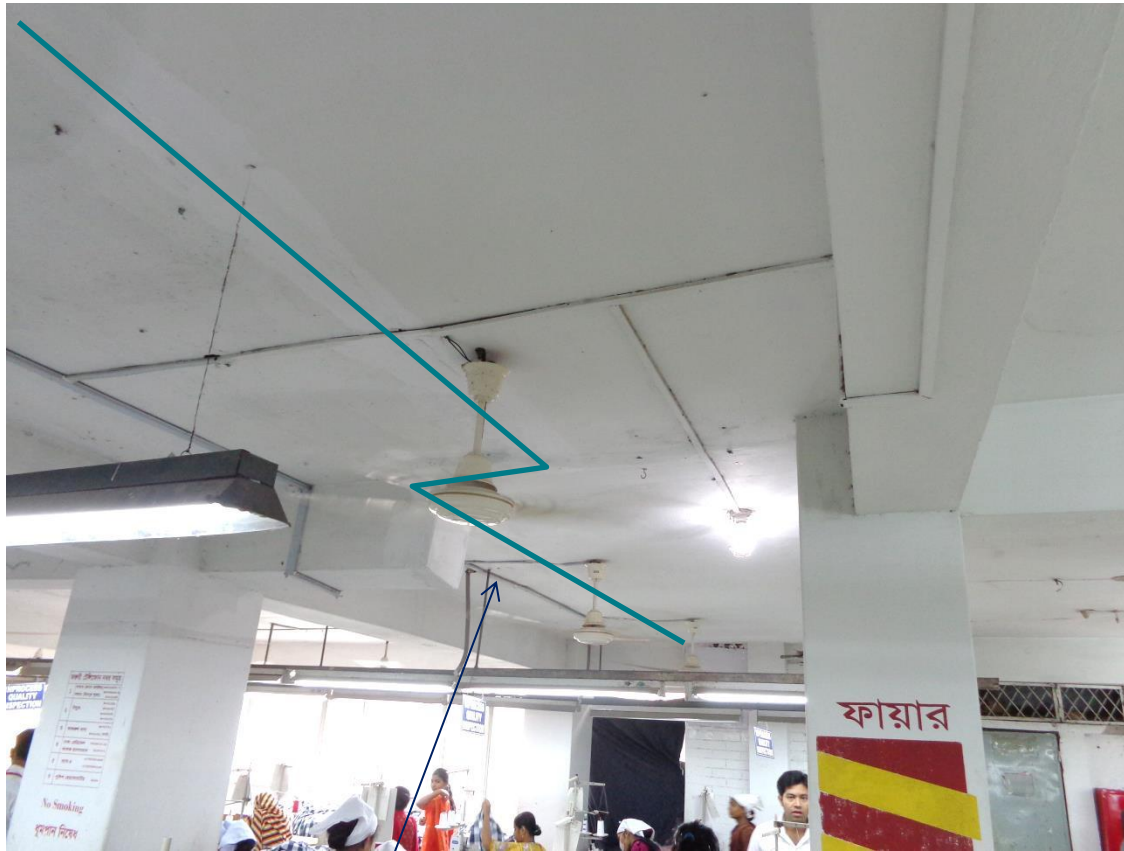
5th Priority 1 Concern

Movement Joint

Apparent cracking in floor finish and deflection of cantilevered section was seen on site. Details vary from gridline to gridline. Engineer to evaluate capacity of cantilevered sections

ITEM 5: (Priority 1) Cantilevered sections at joint, at each floor

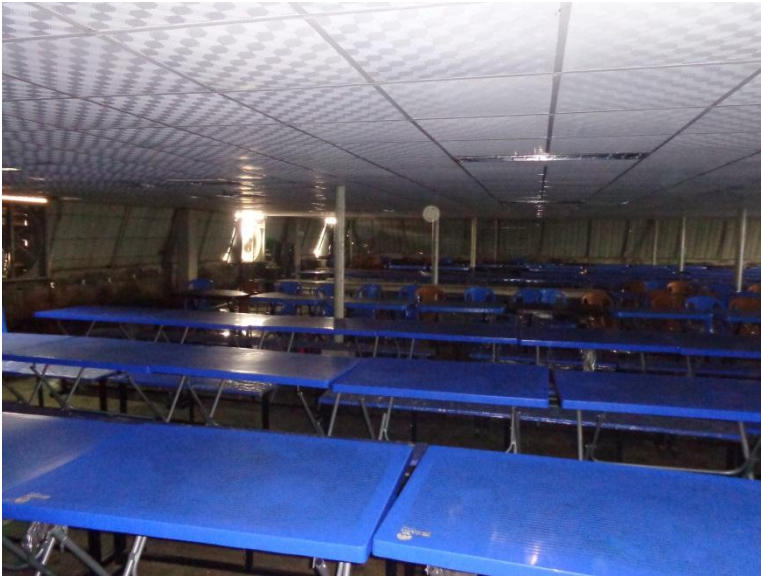
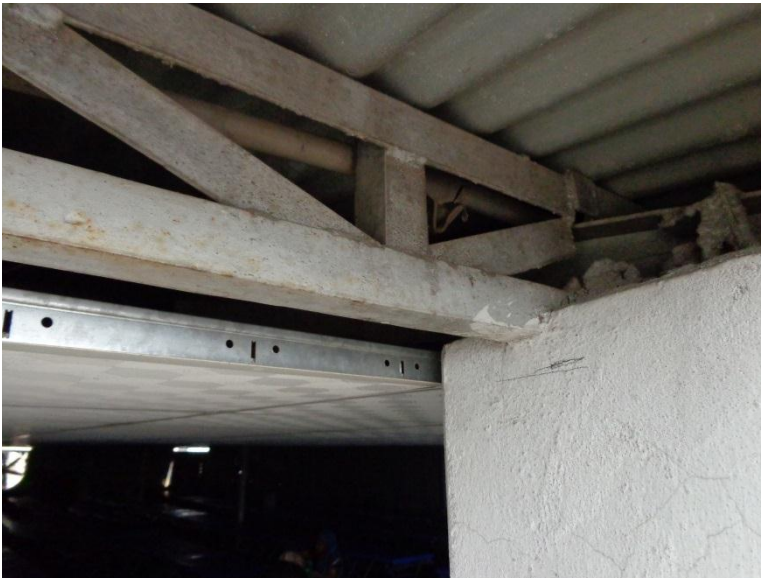
1st Priority 2 Concern

Steel shed at roof of 8th story section was not apparent, but we were able to see that steel elements were not tied down to concrete elements. Furthermore, lateral stability of the trusses of these sheds is commonly insufficient.

ITEM 6: (Priority 2) Steel detailing of sheds on roof

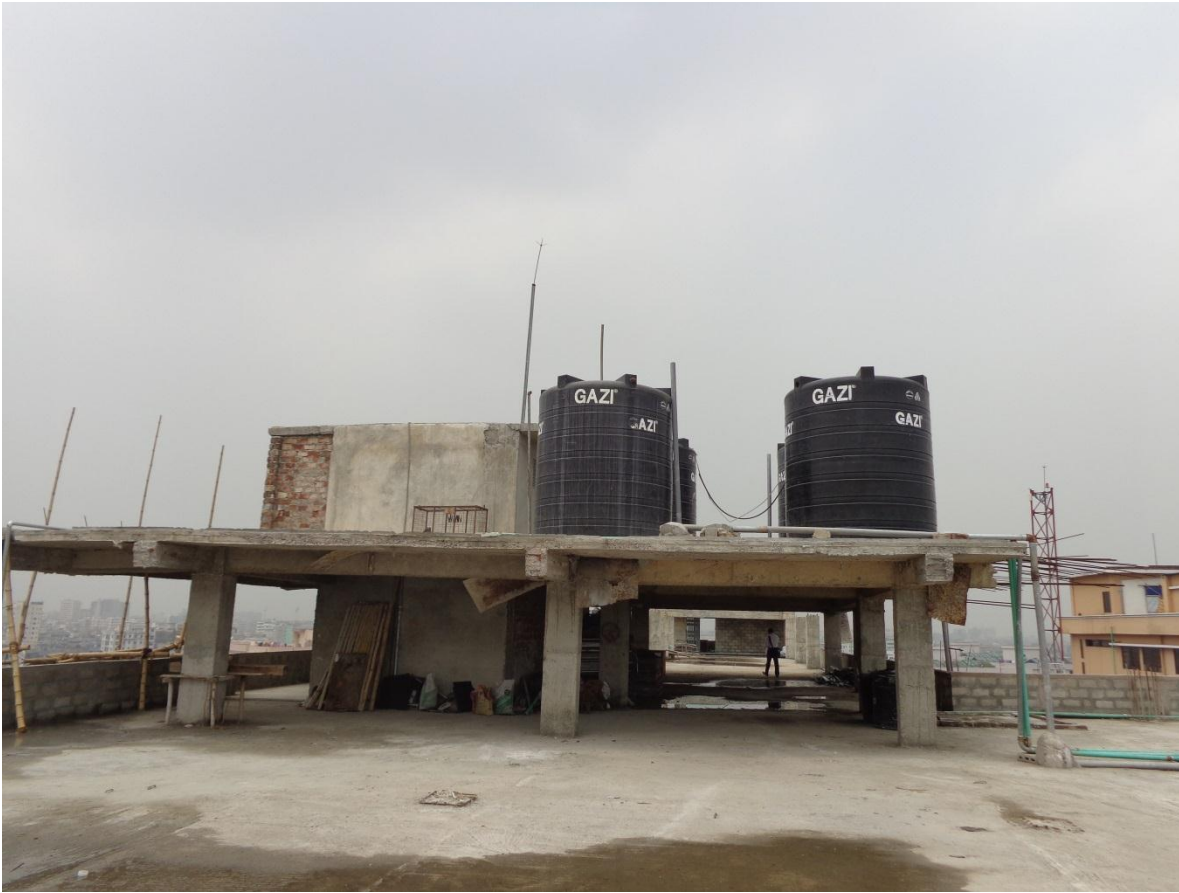
1st Priority 3 Concern

No waterproofing membrane was visible on the roof of the building. This means that any cracks in the surface finishes on the roof will allow water to seep into the concrete slab and cause long-term soaking of the slab and alter the concrete characteristics.

Roof Floor does not appear to have any waterproof membrane to protect lower floor from water damage

ITEM 7: (Priority 3) Roof appears not to have any waterproofing system applied.

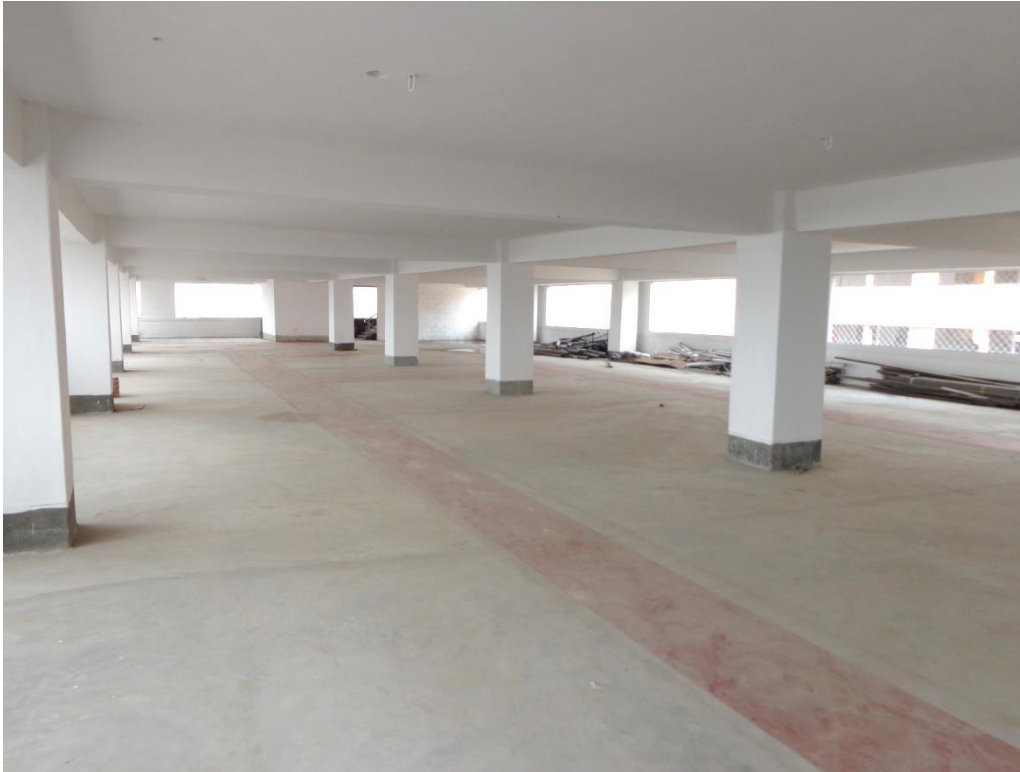
Overall Stability System

Brick wall infills cannot be considered in the lateral load resisting system as they are not restrained.

Sway stability is therefore partially provided by rigid frame action between beams and columns.

We require that these items be investigated in a Detail Engineering Assessment
