# MG Knit Flair Ltd. (9200)

# MG Shirtex Ltd. (9594)

31/1, Laxmipura, Chandura, Joydebpur

05.APRIL.2014

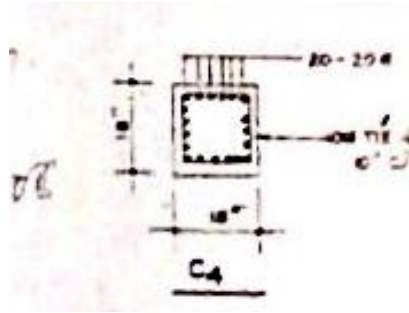
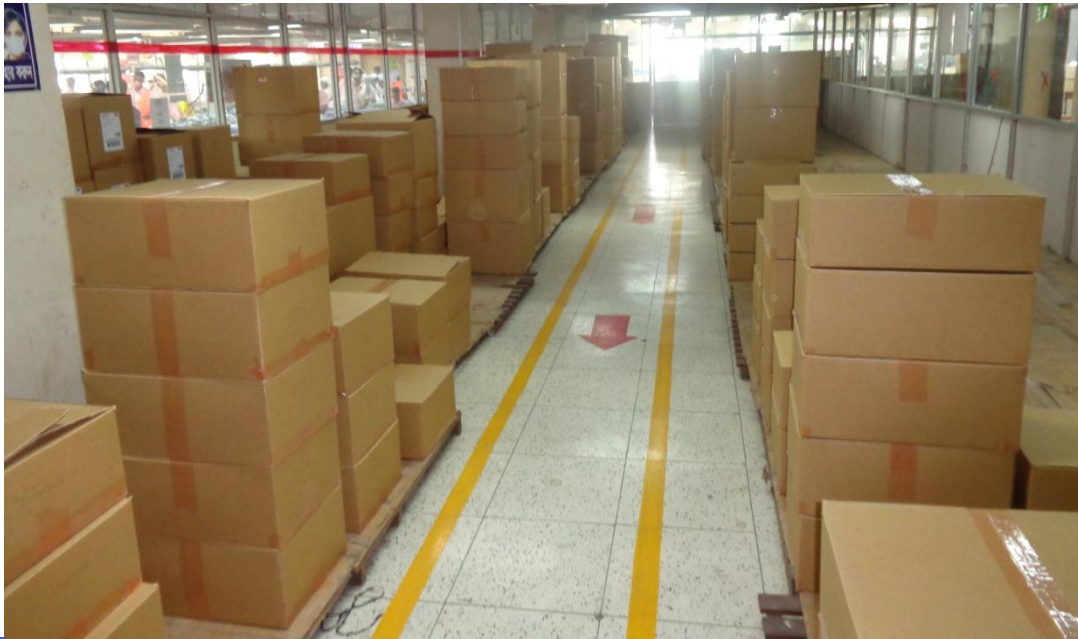
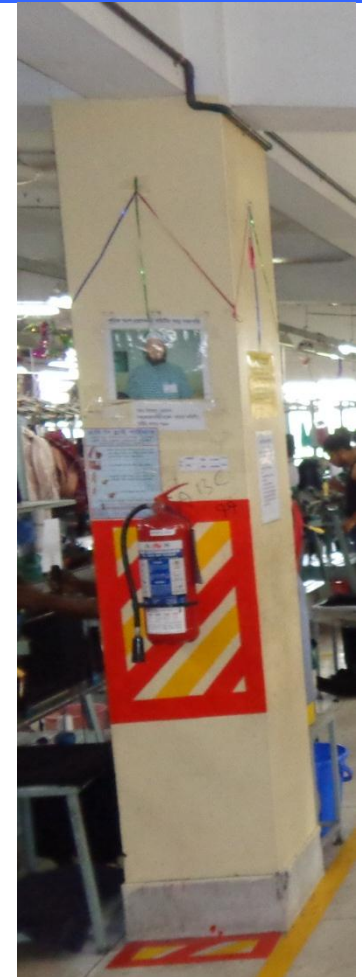
## Low Column Safety Factors

Although, storage levels were very low. Under minimum allowable live loading, column load run-downs yield lower than desirable safety factors.

**ITEM 1: (Priority 1)** Based upon minimum allowable live loads the column load run-down indicates low safety factors (1.25 to 1.5).

| Item No. | Observation | Recommended Action Plan | Recommended Timeline |
|---|---|---|---|
| 1 | Based upon minimum allowable live loads the column load run-down indicates low safety factors (1.25 to 1.5). | Remove workers and equipment from one factory floor and transfer storage at all floor levels to new storage warehouse as discussed on site.<br>Factory engineer to review design, loads and column stresses. | Immediate – Now |
| 2 | Based upon minimum allowable live loads the column load run-down indicates low safety factors (1.25 to 1.5). | Conduct a detailed engineering assessment.<br>Produce and actively manage a loading plan for all floors within the factory giving consideration to slab, beam and column capacity. | 6-weeks |
| 3 | Based upon minimum allowable live loads the column load run-down indicates low safety factors (1.25 to 1.5). | Carry out any recommendations put forth by the detailed engineering assessment. | 6-months |

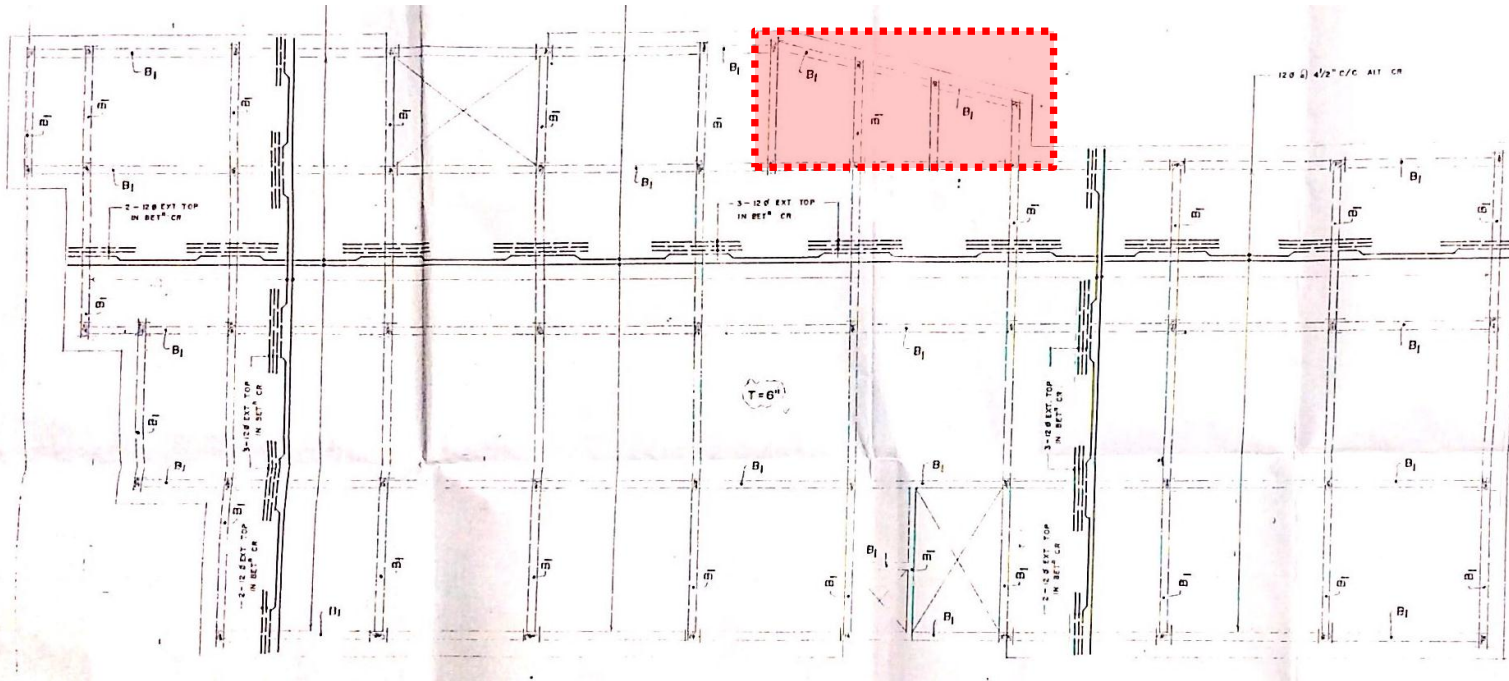
Un-identified Beams

There were several short span beams at each floor that are not identified on the beam layout plan. Additionally no beam reinforcing detail is shown for the size of beam observed in this area.

**ITEM 2: (Priority 2)** Several beams present at each typical floor are not identified on the Structural drawings nor are there details shown for these beams.

| Item No. | Observation | Recommended Action Plan | Recommended Timeline |
|---|---|---|---|
| 4 | Several beams present at each typical floor are not identified on the Structural drawings nor are there details shown for these beams. | As part of Detailed Engineering Assessment, verify adequacy of beams identified as the first priority 2 concern. | 6-weeks |
| 5 | Several beams present at each typical floor are not identified on the Structural drawings nor are there details shown for these beams. | Carry out any recommendations put forth by the detailed engineering assessment. | 6-months |

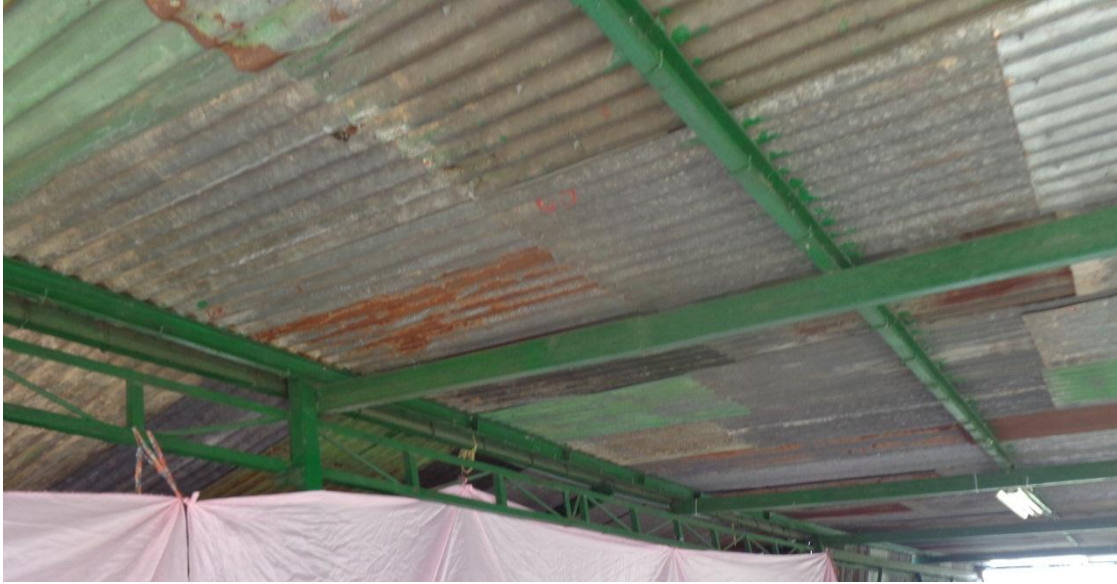
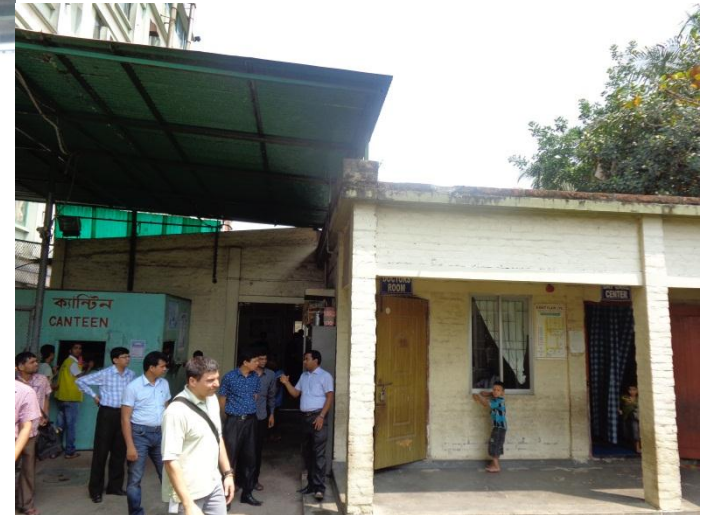
## Poorly Framed Steel Roofs

The steel roof framing above the Day Care/Dining & Rooftop Prayer areas appears to be poorly constructed and in poor repair.

**ITEM 3: (Priority 2)** Steel framing above the Day Care/Dining Hall and the Rooftop Prayer area is of poor quality and composed of exceedingly light sections.

| Item No. | Observation | Recommended Action Plan | Recommended Timeline |
|---|---|---|---|
| 6 | Steel framing above the Day Care/Dining Hall and the Rooftop Prayer area is of poor quality and composed of exceedingly light sections. | Verify the adequacy of the steel roof structures identified as the 2nd priority 2 concern | 6-weeks |
| 7 | Steel framing above the Day Care/Dining Hall and the Rooftop Prayer area is of poor quality and composed of exceedingly light sections. | Either remove the steel roofs or carry out works as recommended by the detailed engineering assessment. | 6-months |
