Mark Sweater Ltd.

1st March 2015

Structural Inspection Report

Observations & Actions

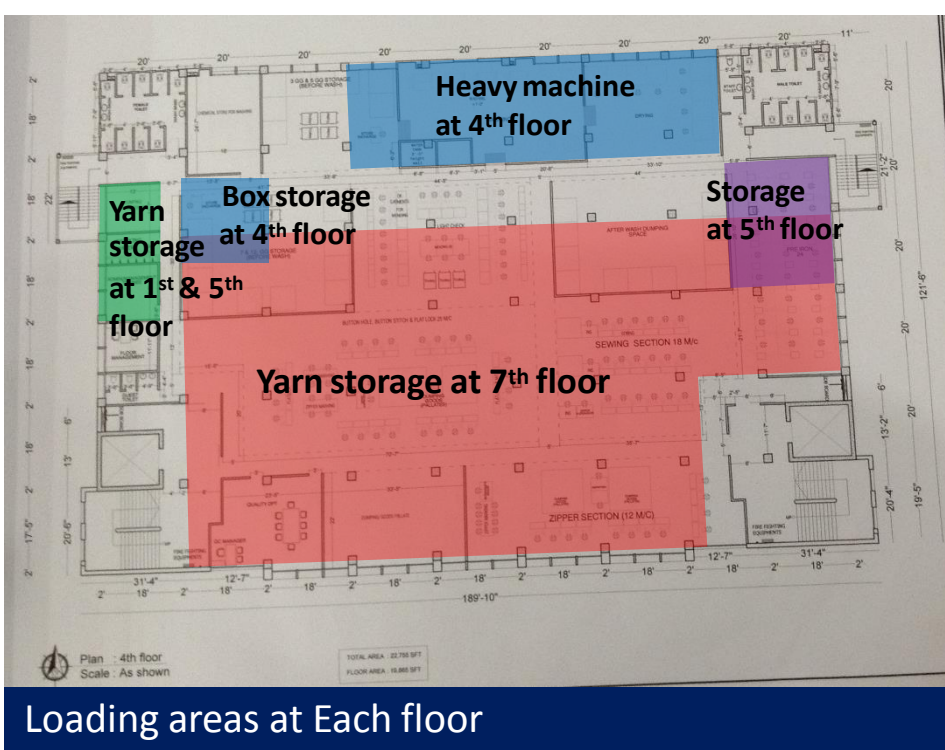
**Building 1:
Locally heavy floor loading in some storage
areas**

Loading areas at Each floor

- Factory Engineer to investigate if the applied loading can be safely carried by the slabs, beams and by the columns.
- Produce and actively manage a loading plan for all floor plates within the factory giving consideration to floor capacity and column capacity.

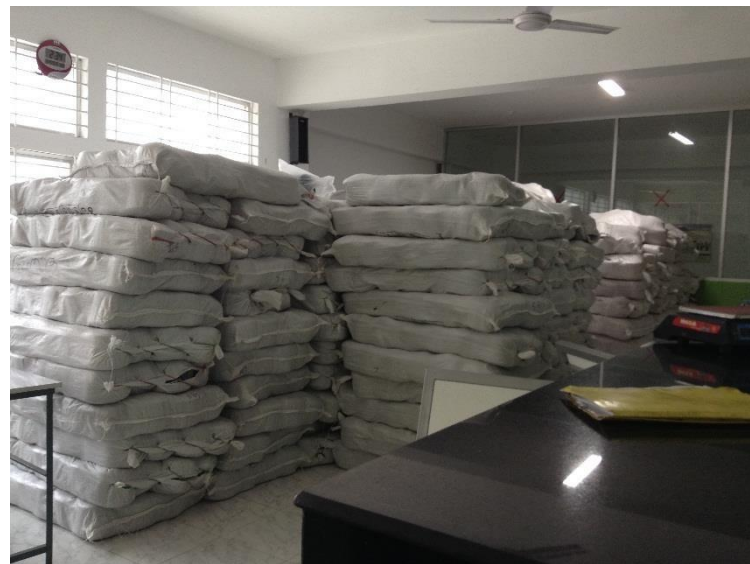
1st Floor – Yarn storage

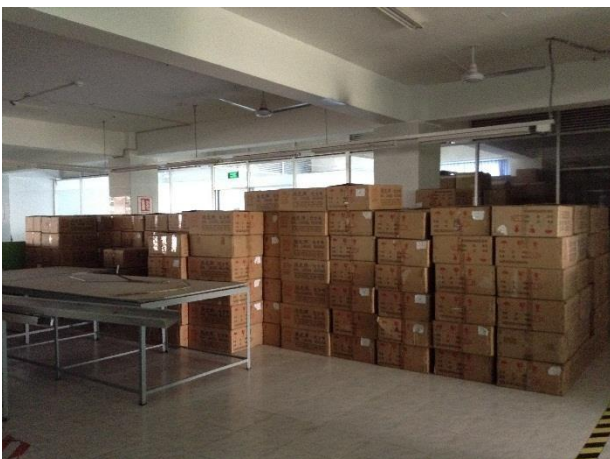
4th Floor – Box storage

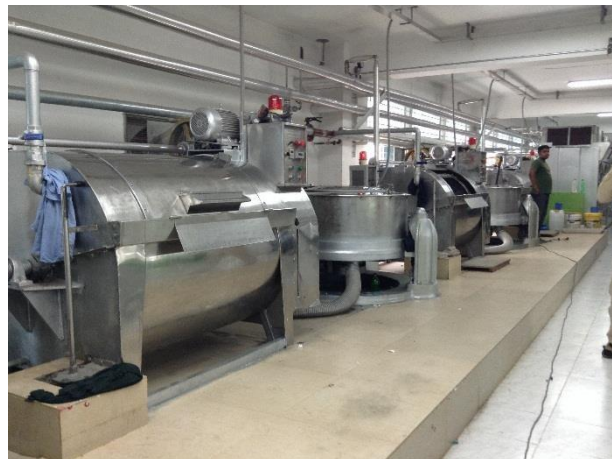
4th Floor – Heavily loaded machine

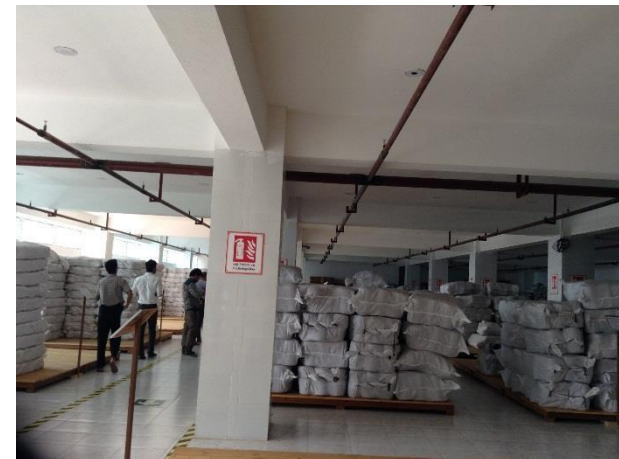
7th Floor – Yarn storage

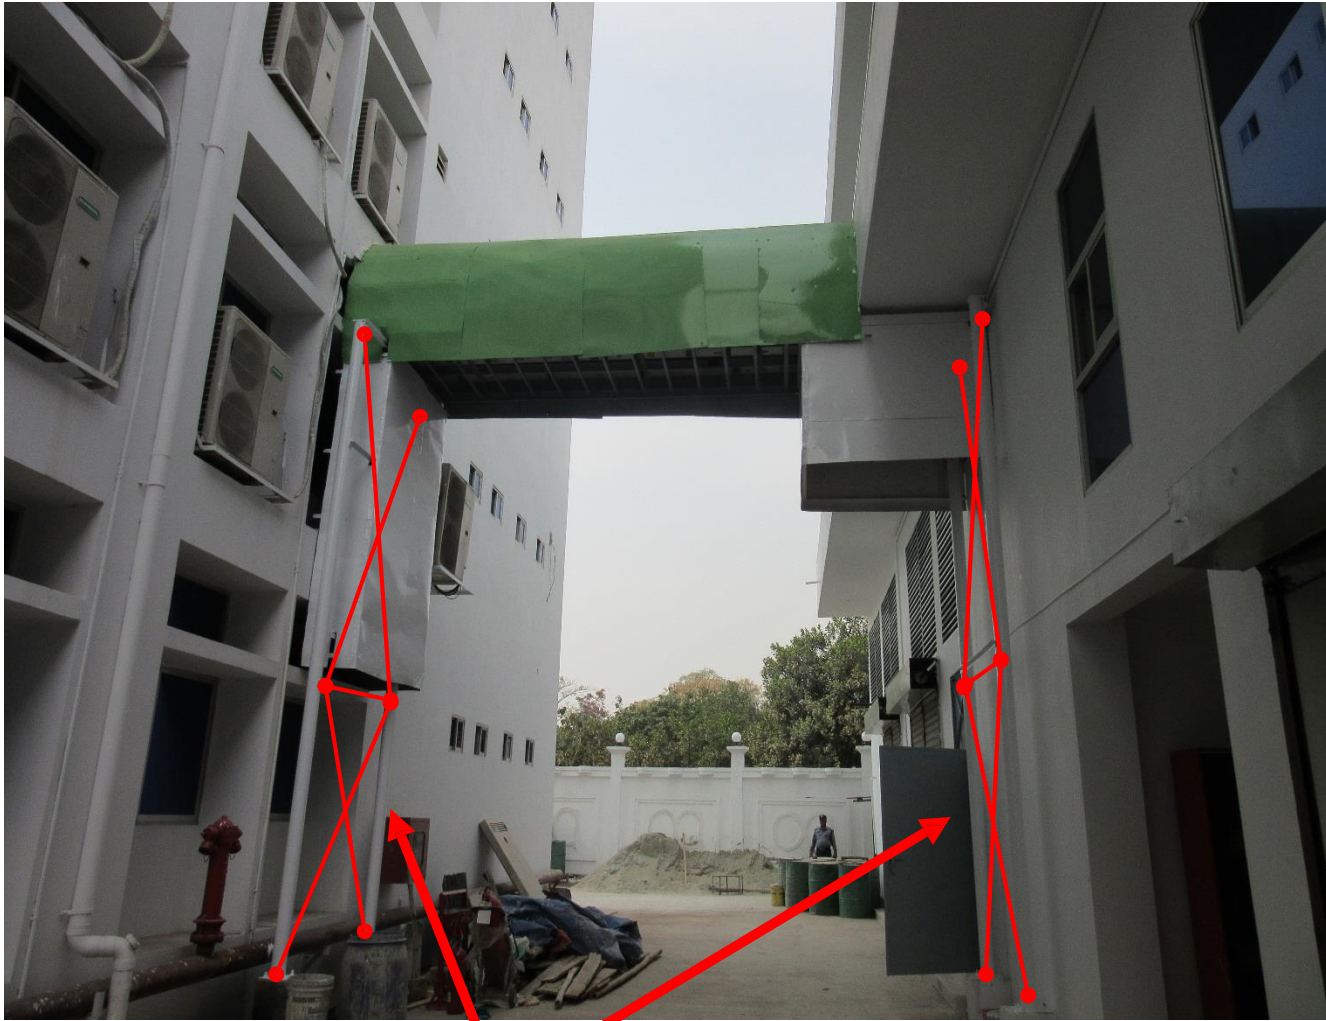
**Building 2:
Lack of Stability bracing of the cable
holder structure**

Lack of stability bracing

- Steel support frame - design to be reviewed by the Building Engineer
- Stability bracings to be implemented to ensure an appropriate lateral stability system
