Kimberly Design(New)

214/3, Technopara, Joydebpur, Gazipur.

7th June 2017

3 **Observations: Child Care & Training Center**

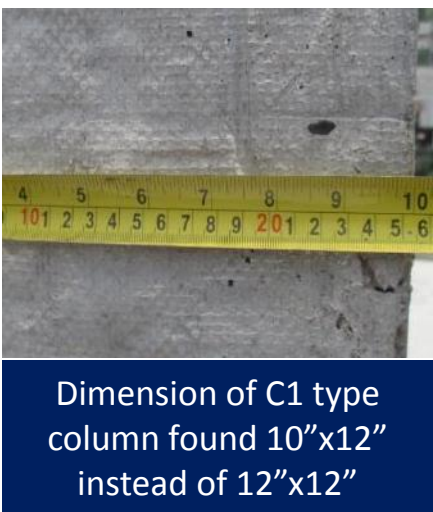
Dimension of C1 type column found 10"x12" instead of 12"x12"

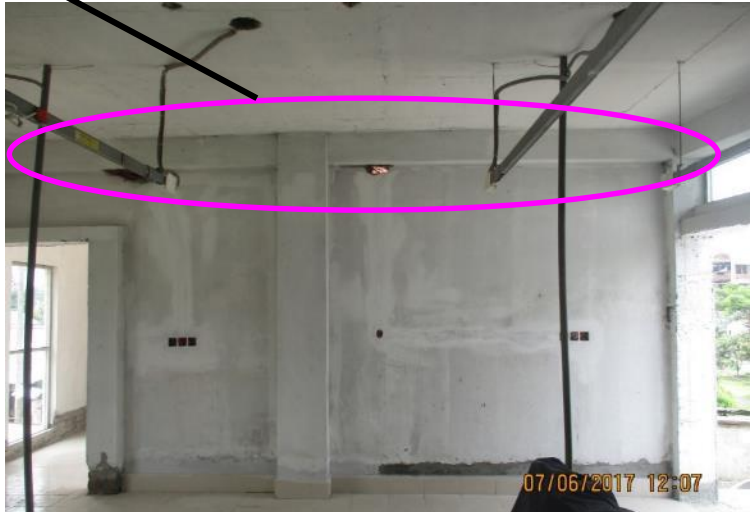
Depth of stair case beam was found 1 inch less then provided drawing

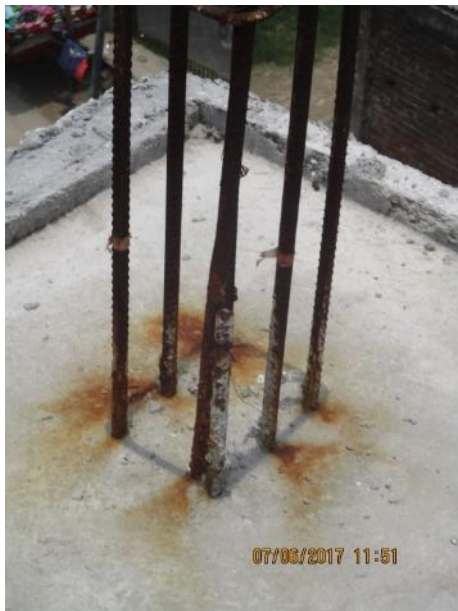
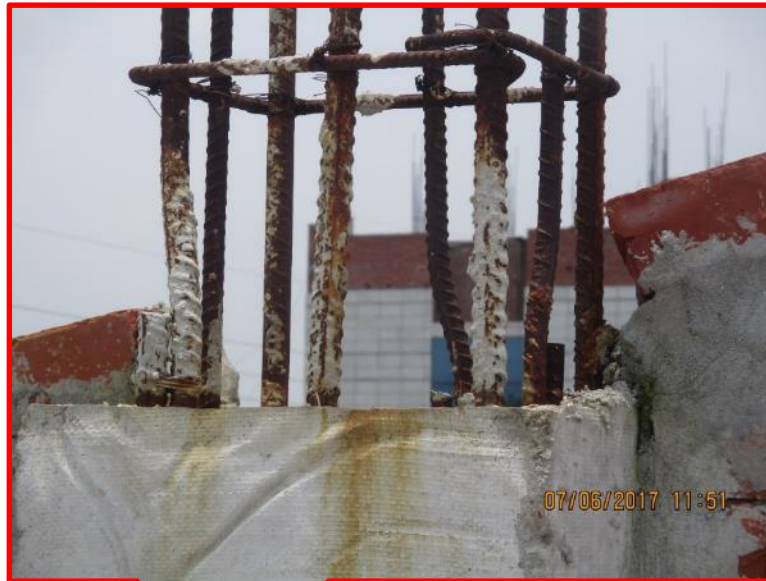
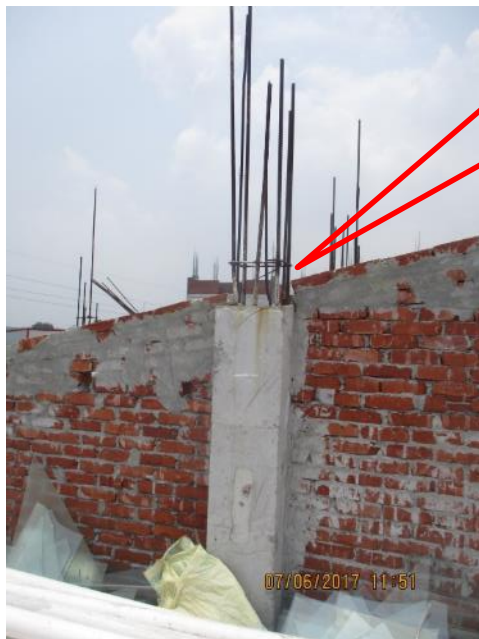
Corrosion observed on the exposed reinforcement of roof

Corrosion was observed at exposed rebar on roof. Building Engineer is required to investigate the extent of corrosion and suggest proper remedial action accordingly.

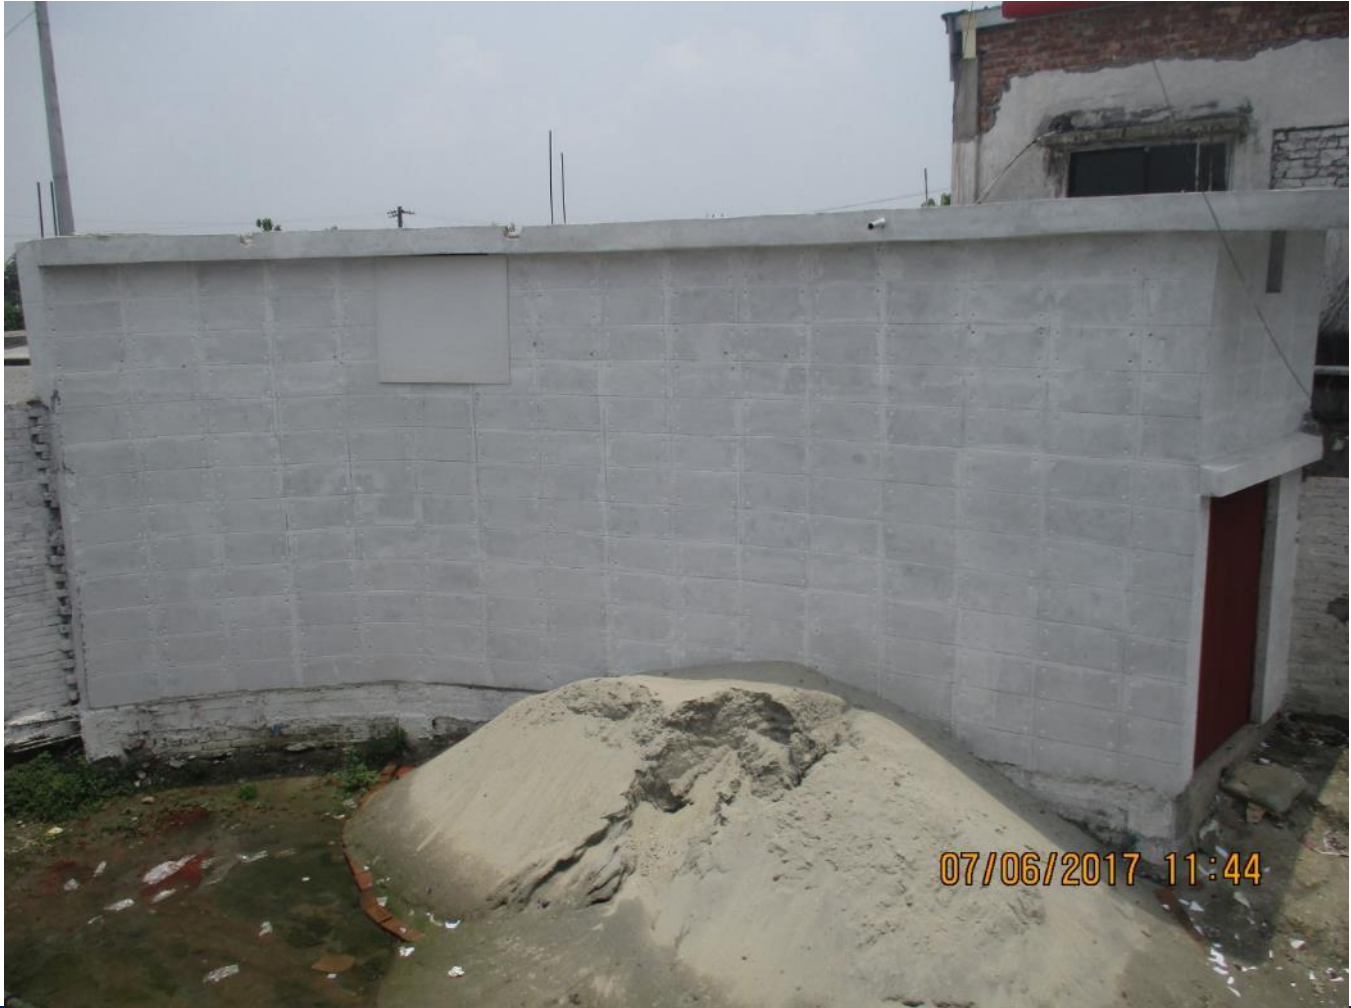
Missing information in provided drawing

No as built structural drawing was provided during inspection. Factory is required to produce as built drawing for the building.
