Texeurop (BD) Ltd. (10029)

Vogra, Joydebpur, Gazipur
(+ 23.983317N, 90.382354E)

11.MAY.2014

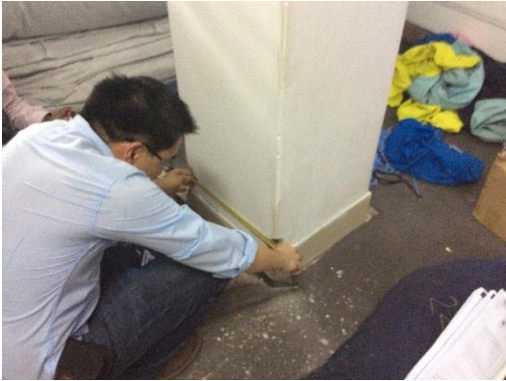
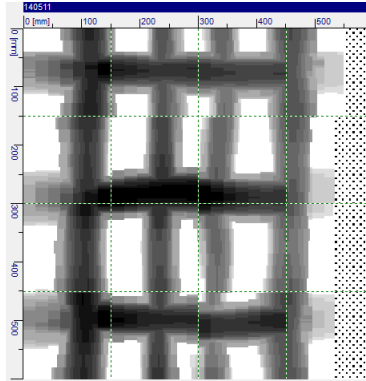
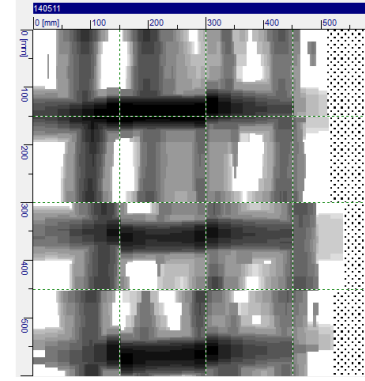
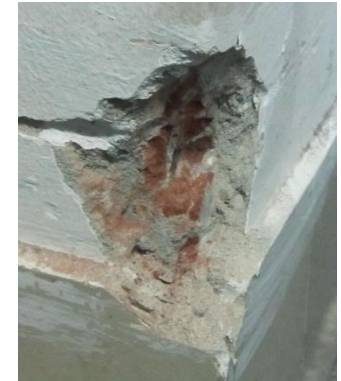
The interior columns, C4 and C5, between grid line E'-I'/2'-6' of Garments Building are supporting the tributary area of 6.30 m x 6.00 m of 8 storeys. The actual condition of column details does not match the details specified in the drawing.

Drawing	On-Site
Size	19"x 19"	18" x 18"
Vertical rebar	12 - φ 25 mm	12 - φ 25 mm
Aggregate	Stone	Brick

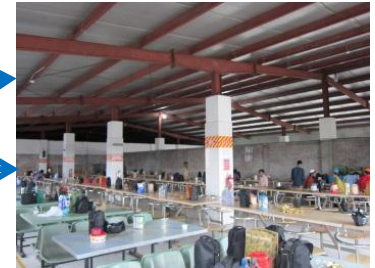
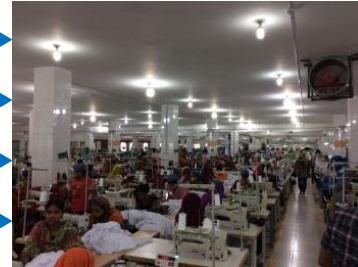
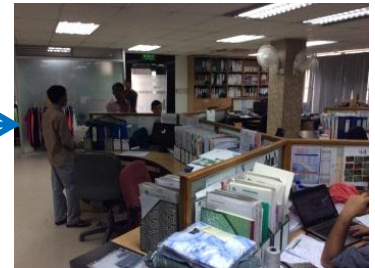
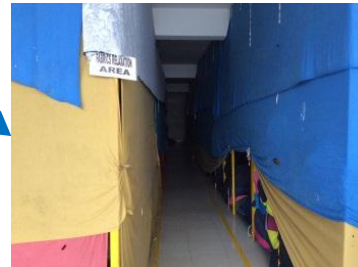
From the result obtained, calculation check of columns between grid line E'-I'/2'-6' appears to be overstressed. Column C4 is indicated that the FoS is **1.14**. And Column C5 is indicated that the FoS is **1.21**.

Remark: Check at ground floor

Item No.	Observation	Recommended Action Plan	Recommended Timeline
1	Columns between grid line E'-P'/2'-6' of Garments Building appear to be overstressed.	Remove roof shed immediately. Load in this area does not exceed 2.0kPa on every floor. Verify in-situ concrete stresses either by cores or existing cylinder strength data for [the identified columns / cores from 4 columns]. Core sizes to be a minimum of 100 mm diameter Factory Engineer to review design, loads and columns stresses in area identified above. A Detail Engineering Assessment of Factory to be commenced immediately.	Immediate – Now
2	Columns between grid line E'-P'/2'-6' of Garments Building appear to be overstressed.	Produce and actively manage a loading plan for all floor plates within the factory giving consideration to floor capacity and column capacity. A Detailed Engineering Assessment to be completed.	6-weeks
3	Columns between grid line E'-P'/2'-6' of Garments Building appear to be overstressed.	Continue to implement load plan.	6-months

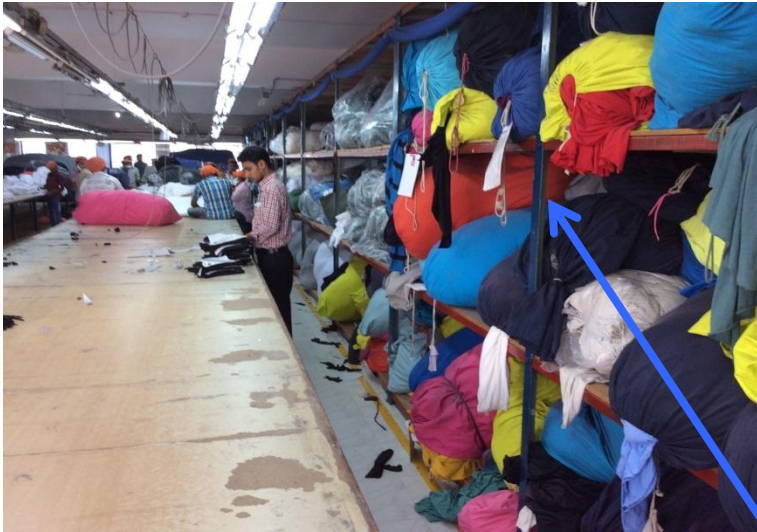
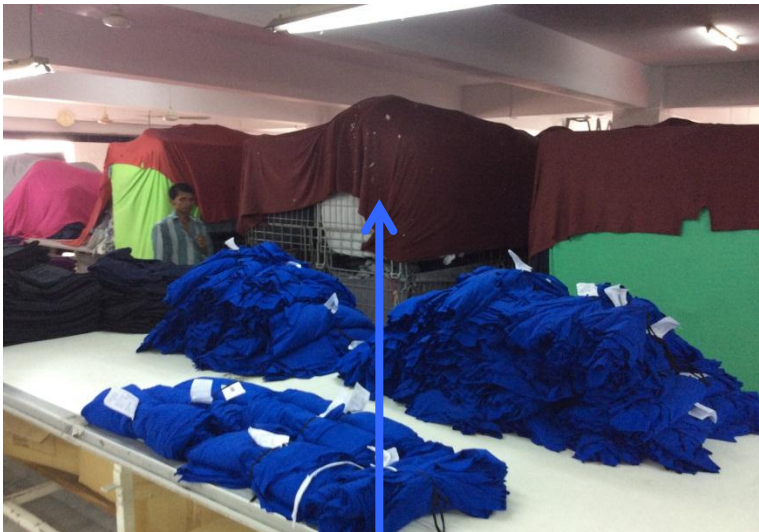
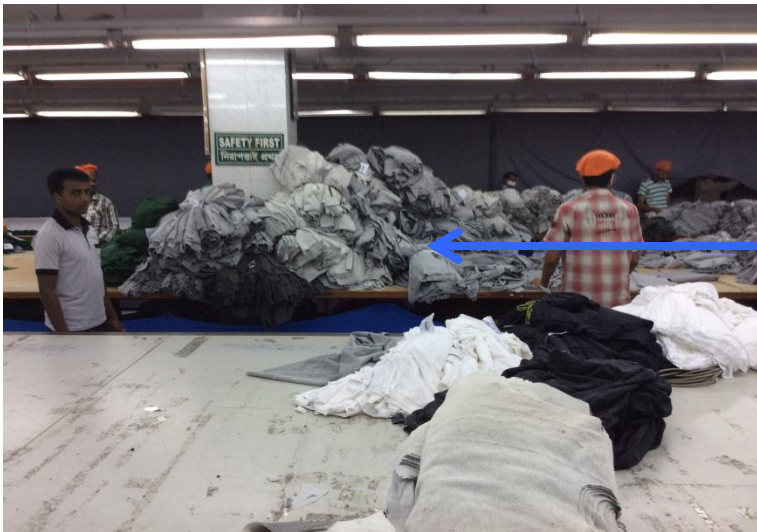
Uncontrolled heavy storage loading was found on the 6th floor supporting by 7.5” thick flat slab without drop panel or column cap. The loading must be reduced to 2.0 kPa to avoid overstress in punching shear, until a DEA is completed for this item.

4	Uncontrolled heavy storage loading on the 6th floor of Garments Building.	Reduce stacking height to ensure total load does not exceed 2 kPa. Factory Engineer to review design, loads, columns stresses and shear stresses in area identified above. Factory Engineer to state the maximum weight that is allowed per square meter. Suggest that state the value on notice boards in this area.	Immediate – Now
5	Uncontrolled heavy storage loading on the 6th floor of Garments Building.	Adopt some sort of signage/staff guidance to ensure that the maximum weight of storage is not exceeded. (Loading Plans).	6-weeks
6	Uncontrolled heavy storage loading on the 6th floor of Garments Building.	Maintain standards of quality control to ensure that storage procedures are correctly followed so that overloading problems do not arise in the future. Implement Loading Plan.	6-months

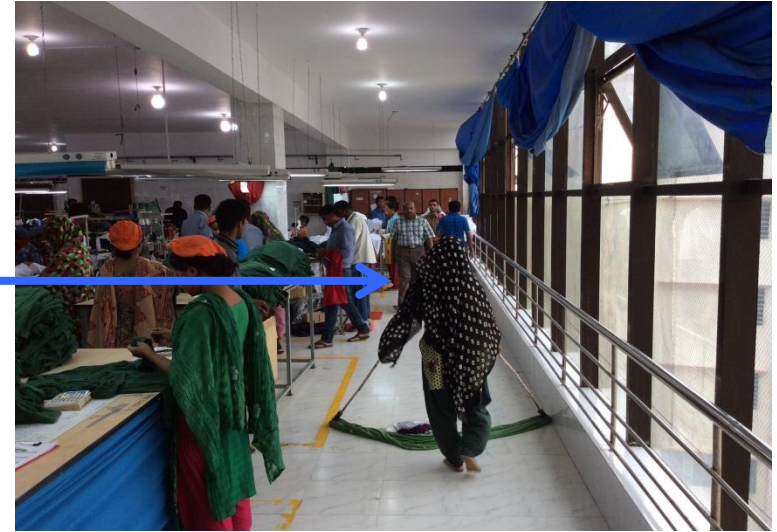
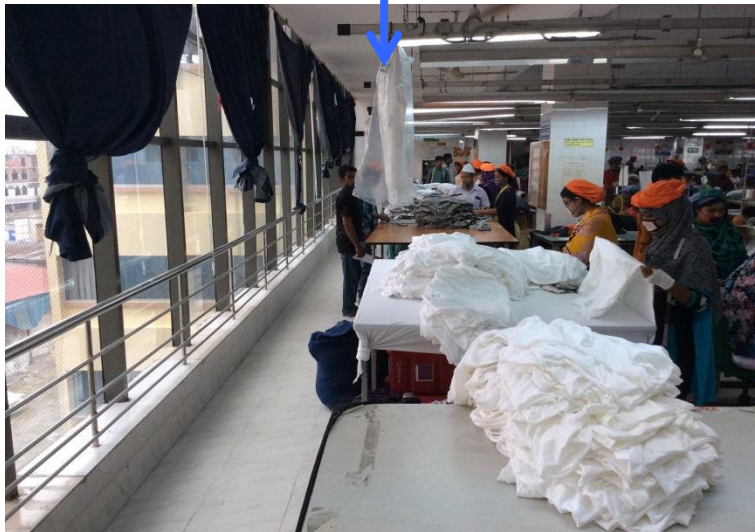
The loading plans on cantilevered slabs (approx. 3 m long without beam) and related elements of Garments Building should be investigated due to the reduction of capacity, in term of compressive strength, supporting column.

Item No.	Observation	Recommended Action Plan	Recommended Timeline
7	Loading plans for cantilevered slabs of Garments Building to be investigated	Factory Engineer to review design, loads and slab in area identified above to confirm suitability for loads applied. Adopt some sort of signage/ staff guidance to ensure that the maximum weight of storage is not exceeded. (Loading Plans).	6-weeks
8	Loading plans for cantilevered slabs of Garments Building to be investigated	Maintain standards of quality control to ensure that loading procedures are correctly followed so that overloading problems do not arise in the future. Implement Loading Plan.	6-months
9	Inconsistencies between the drawings of Garments Building and the actual as-built conditions.	Factory Engineer to survey the actual conditions and revise the drawings. Factory Engineer to review design, loads and columns stresses to confirm suitability for loads applied. Produce and actively manage a loading plan for all floor plates within this area giving consideration to floor capacity and column capacity.	6-weeks

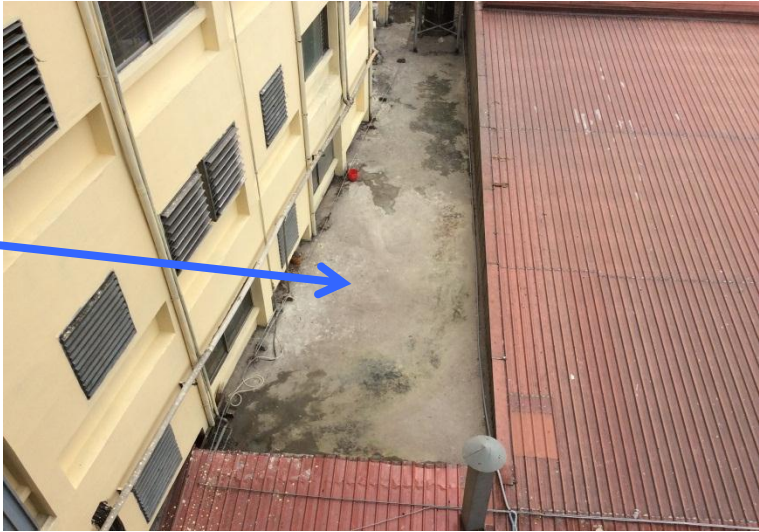
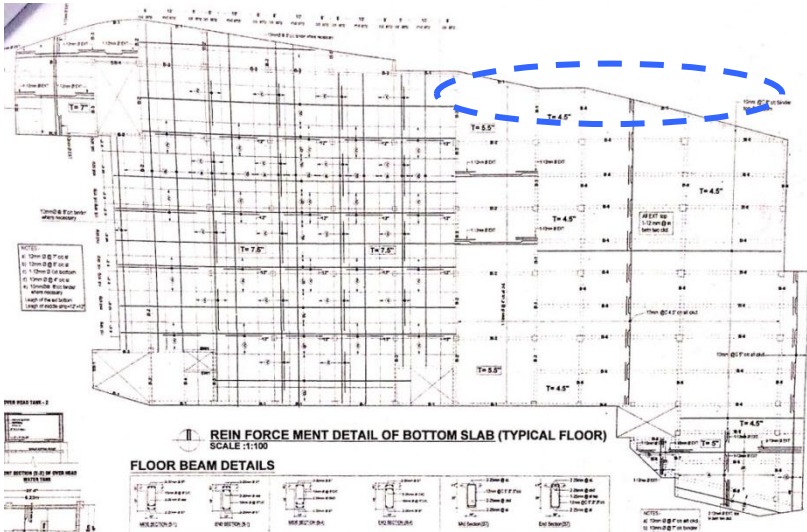
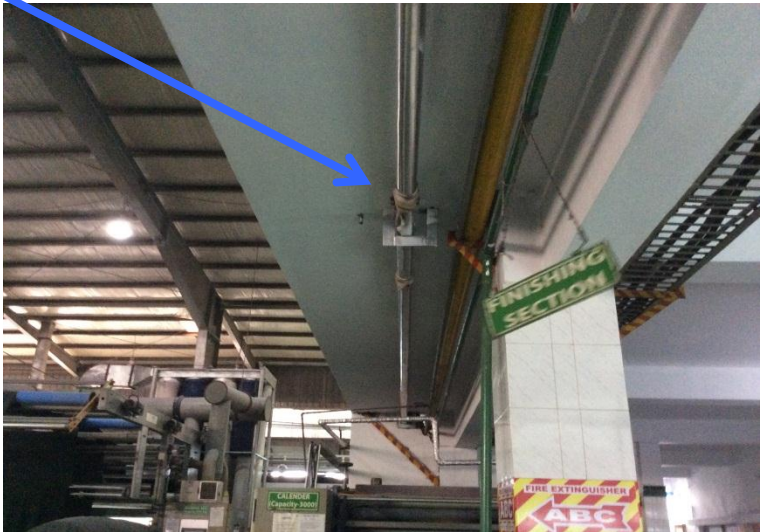
A roof slab not shown on the drawings is present between the Garments Building and Dyeing Shed.

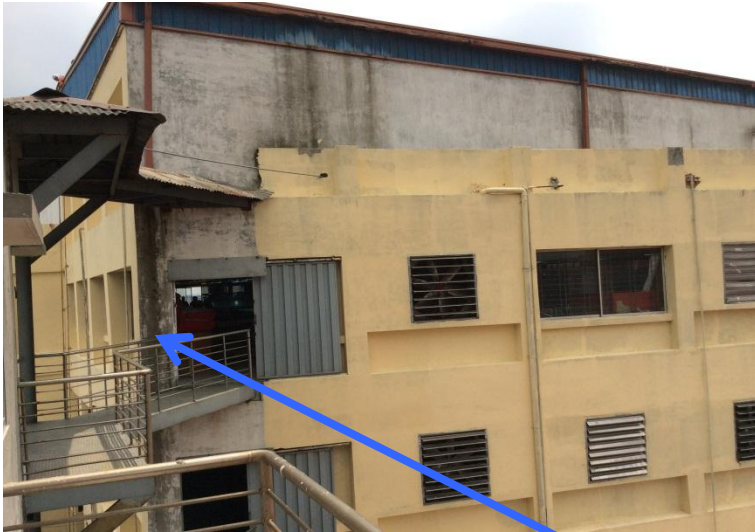
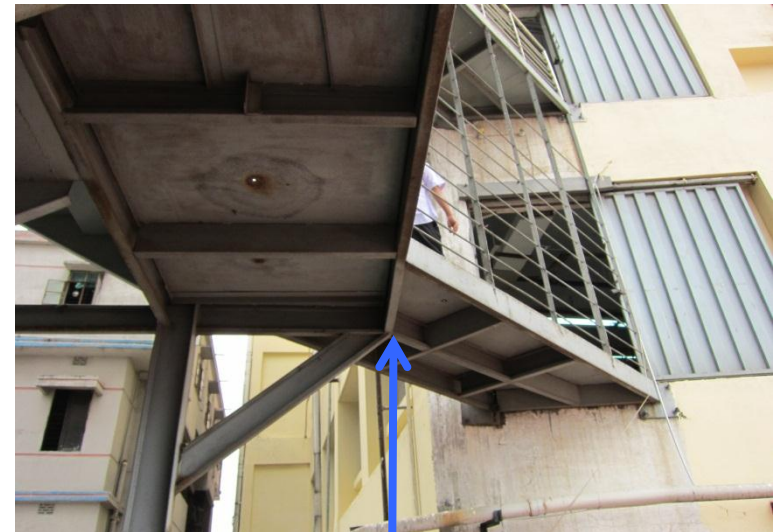
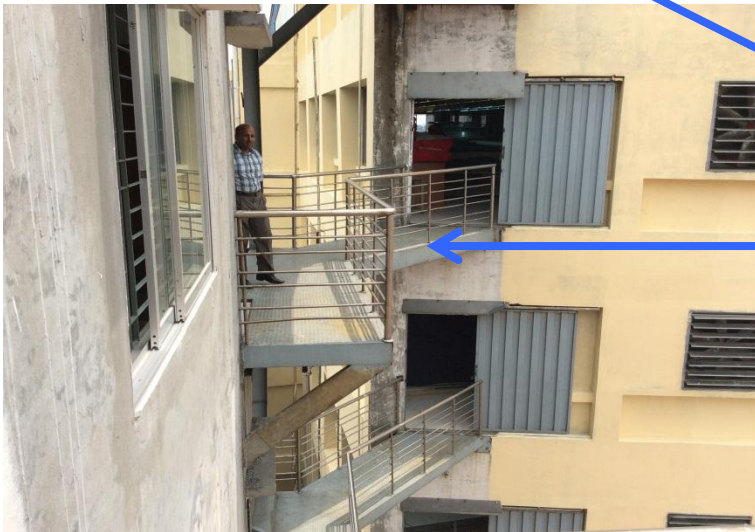
There are connecting bridges between Garments Building and Generator Building on 2nd – 6th floor. The stability and capacity of these elements and the related structure should be investigated.

10	Inconsistencies between the drawings of Garments Building and the actual as-built conditions.	Continue to implement load plan	6-months
11	Stability and capacity check of connecting bridge between Garments Building and Generator Building.	Detail Engineering Assessment to be carried out in particular the stability and capacity of connecting bridge.	6-weeks
12	Stability and capacity check of connecting bridge between Garments Building and Generator Building.	Continue to implement loading plan. A Detailed Engineering Assessment is to be completed.	6-months

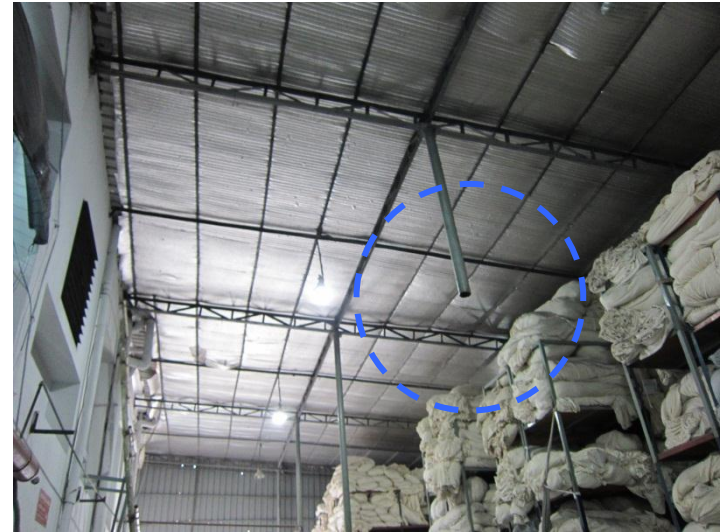
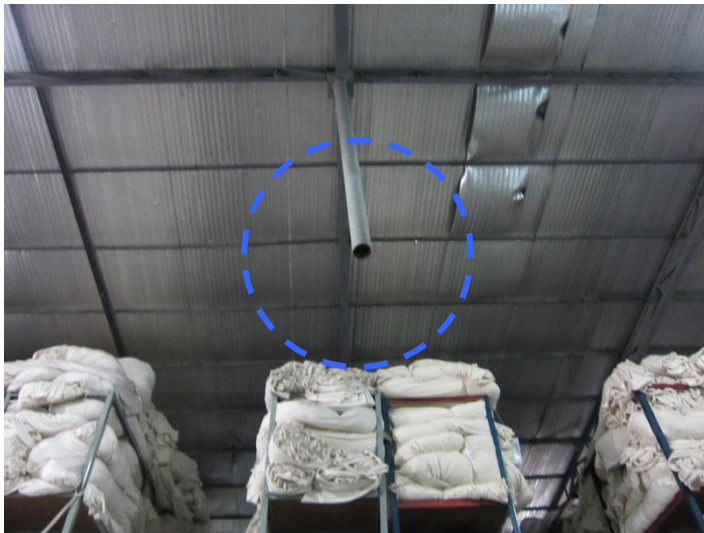
Steel column supporting roof in Dyeing Shed was chopped off. The stability and capacity of steel truss above should be investigated.

Item No.	Observation	Recommended Action Plan	Recommended Timeline
13	Steel column supporting roof in Dyeing Shed has been chopped off	Detail Engineering Assessment to be carried out in particular the stability and capacity of connecting bridge.	6-weeks
14	Steel column supporting roof in Dyeing Shed has been chopped off	Perform any repair work designed in the DEA.	6-months
15	Overall stability system	Request that the Detail Engineering Assessment of the overall building to be carried out and in particular, stability and foundation aspects should be investigated in detail.	6-weeks
16	No fireproofing for steel structure elements (if required).	Fireproofing material for structural steel element is recommended as suggested in BNBC Codes. Maintain standard of quality control.	6-months
17	No waterproofing material at roof level.	Engineer to inspect water damaged structure including the exterior and propose a suitable repair. For both durability and serviceability, waterproofing on the roof slab is recommended. Moreover the roof slab drainage system should be investigated.	6-months

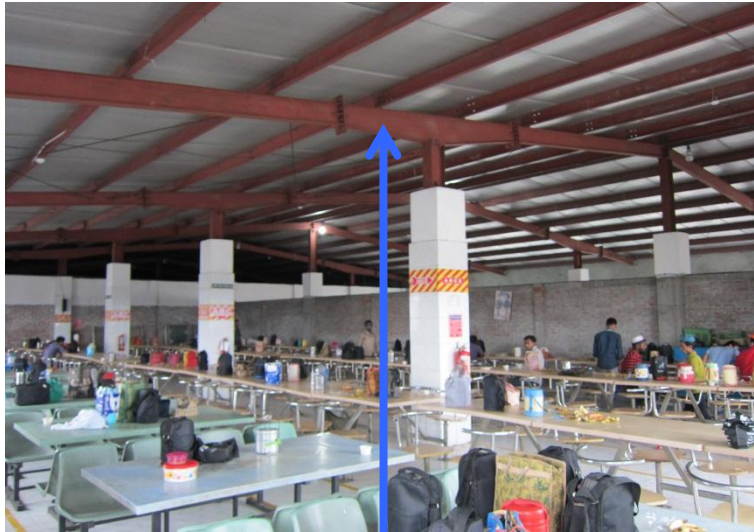
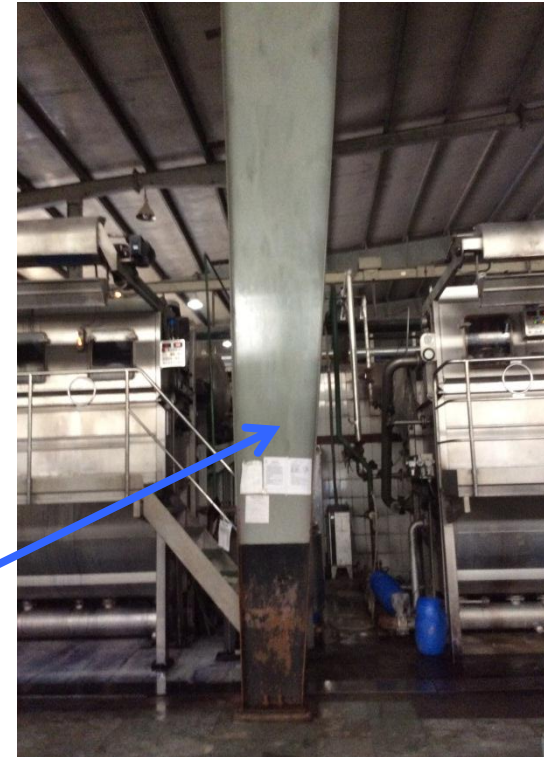
Structural steel elements of Garments Building and Sheds are unclear whether fire proofing material is applied (if required).

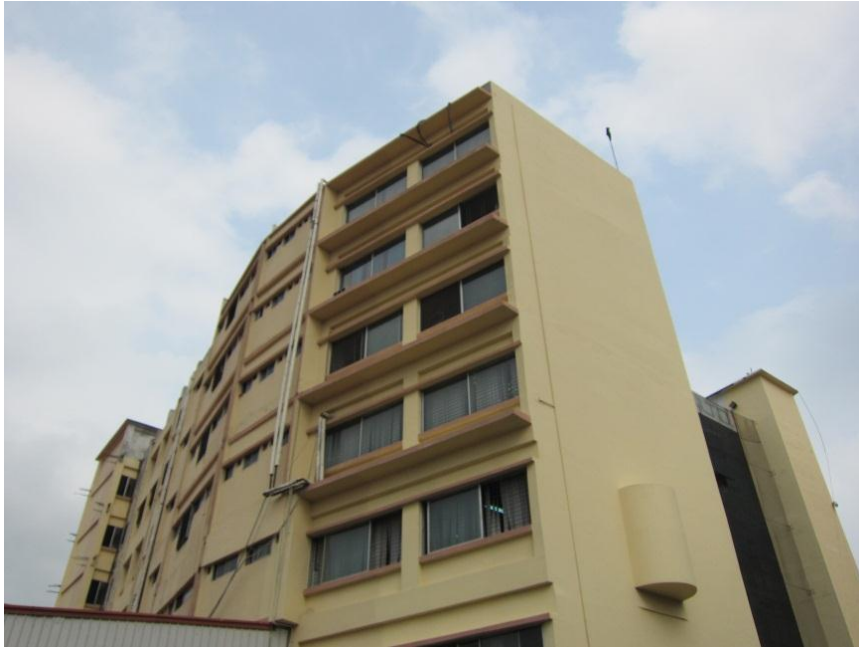
Concerns on the stability system for lateral loading and seismic loading. Façade brickwork walls lack of moment capacity in the connections between columns and beams especially in flat slab areas of Garments Building, as well as the ground floor of the Generator Building and Utility Building.

We require that these items be investigated in a Detail Engineering Assessment.

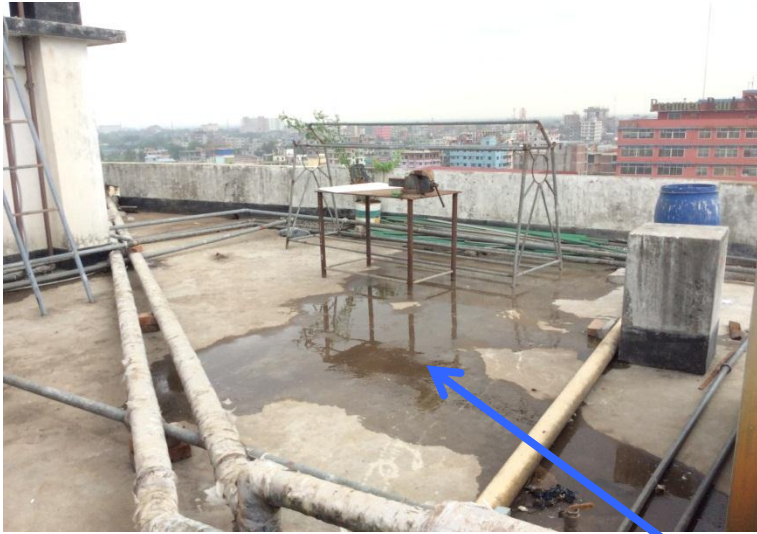
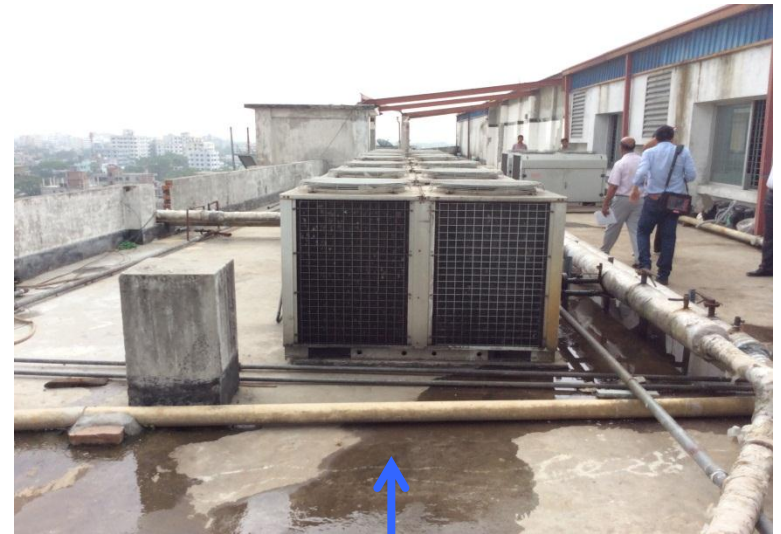
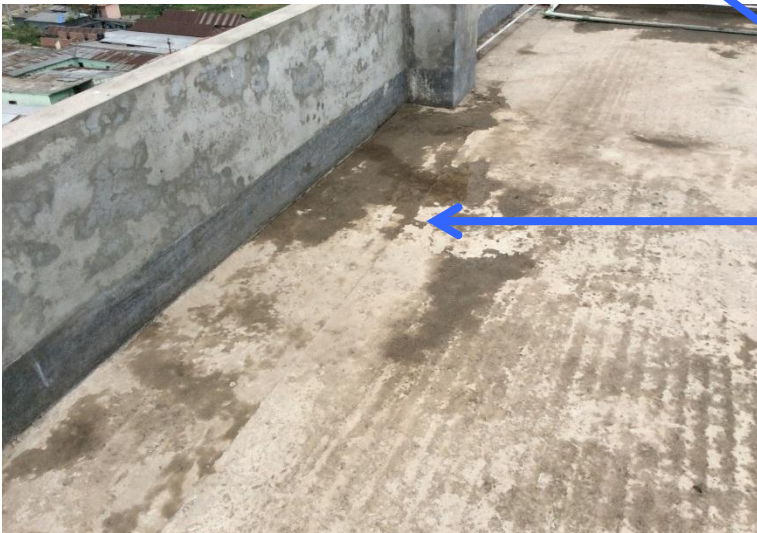
There is no water ingress found at roof level. However water ponding has been found on the roof slab after the rain. It is also unclear whether waterproofing material is applied.
