# Posmi Sweaters Ltd (10170)

Dhaka Road, Chandona Chowrasta, Gazipur

11.May.2014

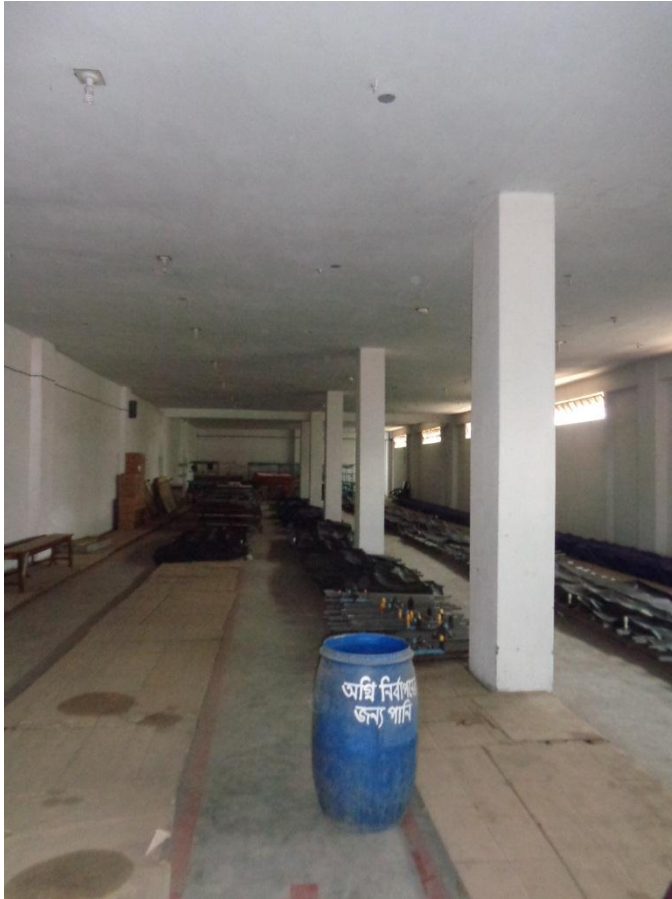
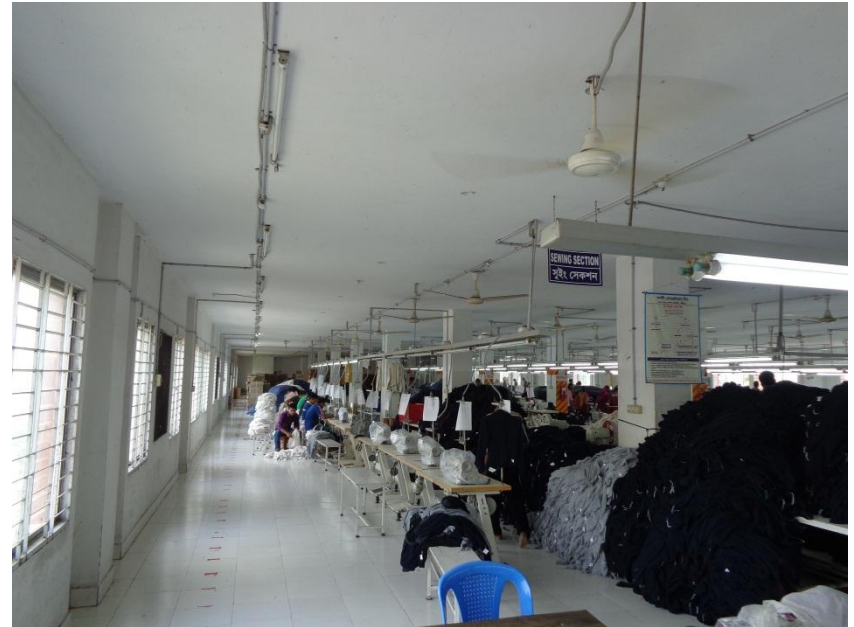
During our survey, we noted very heavy loading at certain levels, (roughly calculated at typically 5.4kPa), this included the flat slab floor. Considering that the Structural drawings originally specified down-stand beams and a slab of 165mm thickness, we are concerned with potential punching shear failure of the flat slab. The loading should be reduced immediately to a maximum load of 3.0kPa.

Item No.	Observation	Recommended Action Plan	Recommended Timeline
1	High concrete stress levels due to current loading – Column Design and Punching Shear concerns.	Reduce all floor loading down to 3.0kPa.	Immediate – Now
2	High concrete stress levels due to current loading – Column Design and Punching Shear concerns	Verify in situ concrete stresses either by existing cylinder strength data or 100mm dia. cores from 4 columns and slabs. Carry out a Detailed Engineering Assessment of the entire structure.	6-weeks
3	High concrete stress levels due to current loading – Column Design and Punching Shear concerns	Create and actively manage loading plans for all floors.	6-months
4	Missing beams and varying positions between different floors – Stability Concerns.	Perform a the previously mentioned Detailed Engineering Assessment and investigate the overall stability.	Immediate – Now
5	Missing beams and varying positions between different floors – Stability Concerns.	If deemed necessary by the DEA strengthen or carry out any remedial or new building works as recommended.	6-weeks

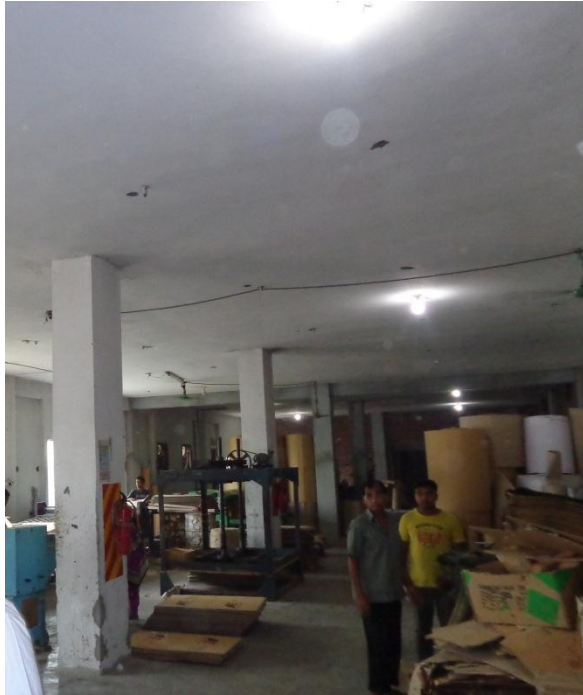
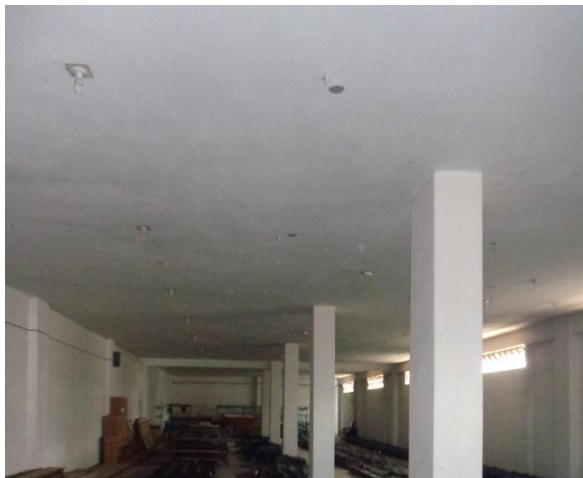
During our survey, we found that the structural floor system varied from floor to floor.

A typical floor had transverse and longitudinal beam on main gridlines. Most floors had beams also around their perimeter.

At 3<sup>rd</sup> floor level there were no down-stand beams and other floors had different arrangements of beams.

When asked, the original Design Engineer confirmed that this should not be the case.

We require a full Detailed Engineering Assessment of the building to investigate these discrepancies.

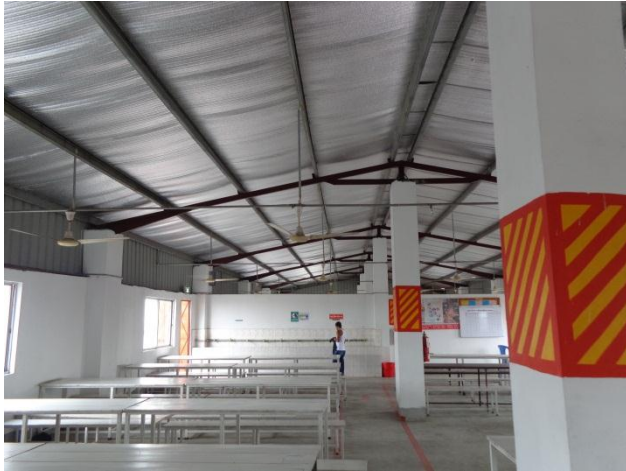
No construction documents were available for any of the structural steel sheds. A design check of all of the structural steel must be included in the Detailed Engineering Assessment. Furthermore, the original technical documents should be located or new As-Built drawings produced.

Item No.	Observation	Recommended Action Plan	Recommended Timeline
7	Documentation not available for the structural steel sheds located on the roof and utility building at ground floor.	The Factory Engineer is to carry out an assessment of the walls and steel roofs of the sheds and evaluate their capacities to resist uplift and lateral forces due to high winds.	6-weeks
8	Documentation not available for the structural steel sheds located on the roof and utility building at ground floor.	If deemed necessary by Factory Engineer, carry out any remedial works recommended.	6-months
9	Exposed slab reinforcement at roof level.	Factory Engineer to provide details to repair the slab and provide adequate cover and waterproof the bars.	6-weeks
10	Exposed slab reinforcement at roof level.	Carry out and complete the remedial works to protect slab.	6-months
11	'Accent' parapet at roof level.	The Factory Engineer must carry out an assessment of the design of the parapet.	6-weeks

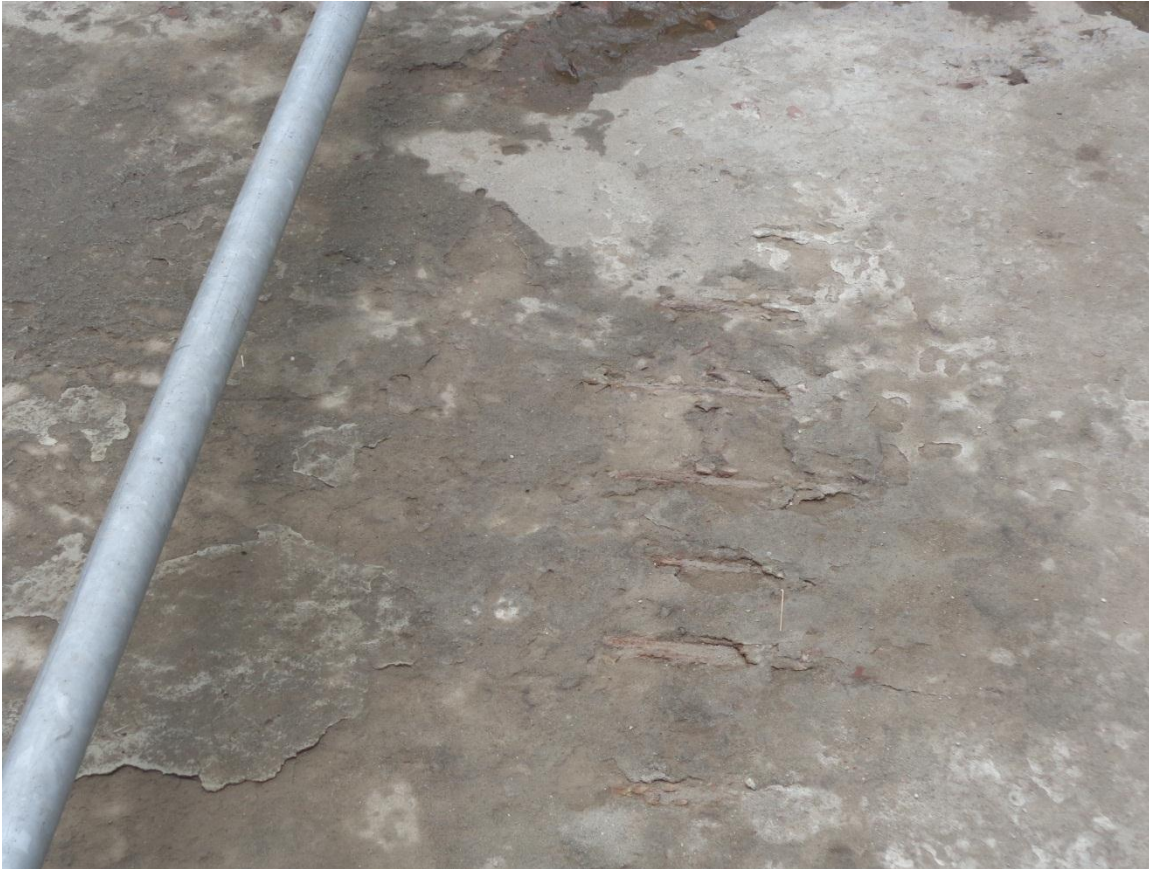
At roof level, reinforcement steel is exposed on the surface of the roof slab. The concern must be corrected immediately in order to protect the reinforcement from corrosion and insure that the slab's strength is maintained.

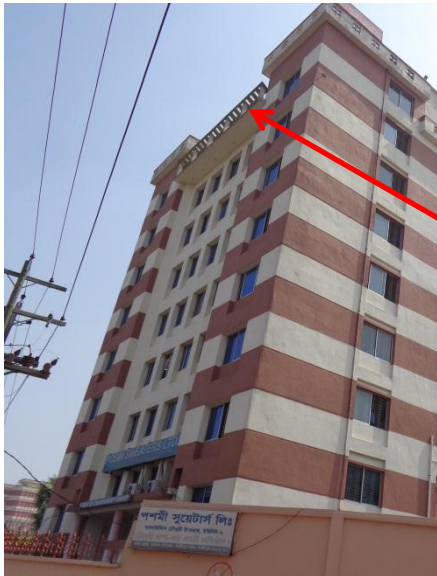
At roof level, the 'Accent' terracotta parapet is very poorly constructed. In a high wind or seismic situation the parapet would be at risk of collapse. It should be reinforced, strengthened or removed to prevent it from being a danger.

Terracotta 'accent' parapet

12	'Accent' parapet at roof level.	The Factory Engineer must carry out an assessment of the design of the parapet.	6-months

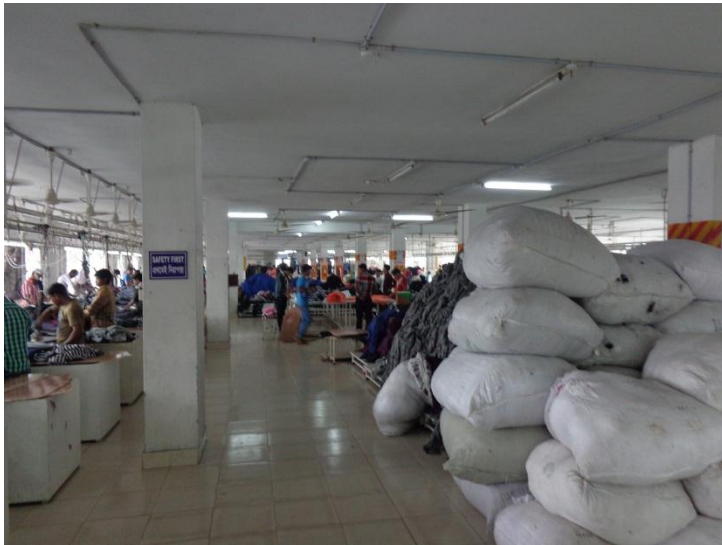
We believe that the intent of the original structural design was to use the main grid line beams to provide some form of lateral stability via moment frame action.

However, as some of the beams are missing and there is one floor built as a flat plate with no beams, then the lateral stability strategy is greatly affected. Under lateral loads the additional loads attracted to columns may cause a risk of local punching shear failure.

We require that the lateral support system is investigated as part of a Detailed Engineering Assessment.

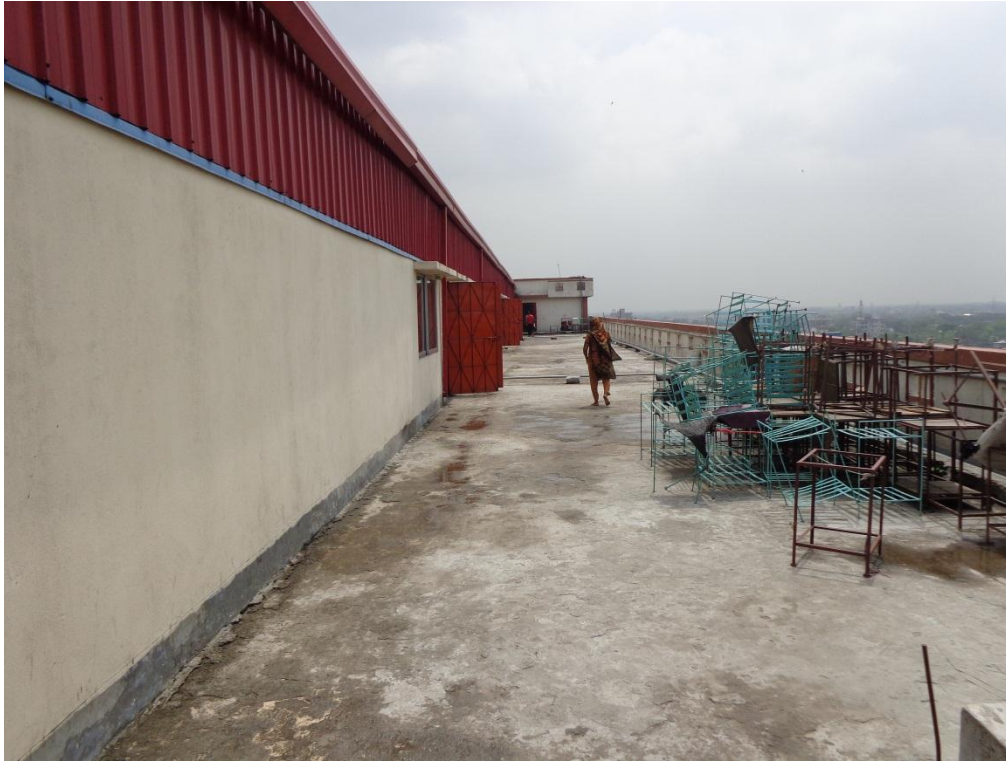
No waterproofing membrane was visible on the roofs. This means that any cracks in the surface will allow water to seep into the concrete slab and cause long-term soaking of the slab.
