# Zaheen Knitwears Limited (11497)

Keodala, Madanpur, Bondar, Narayanganj, Dhaka, Bangladesh

12.May.2014

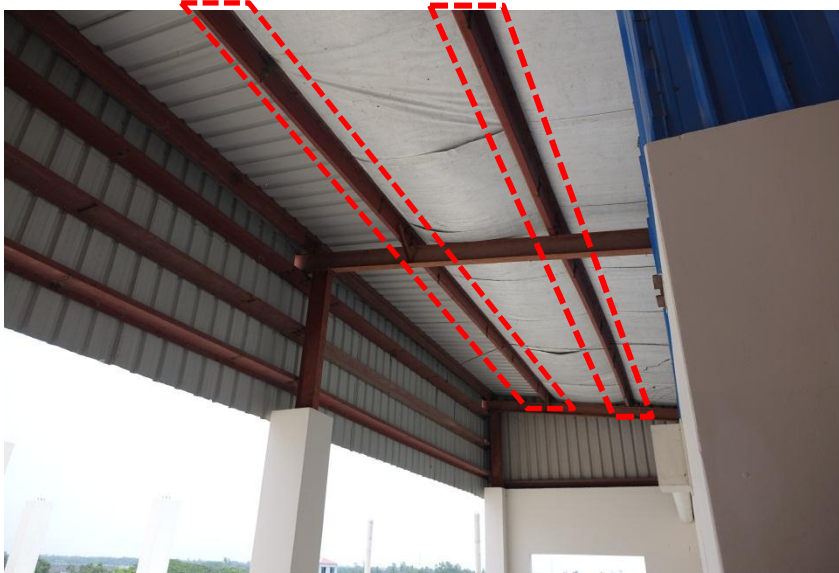
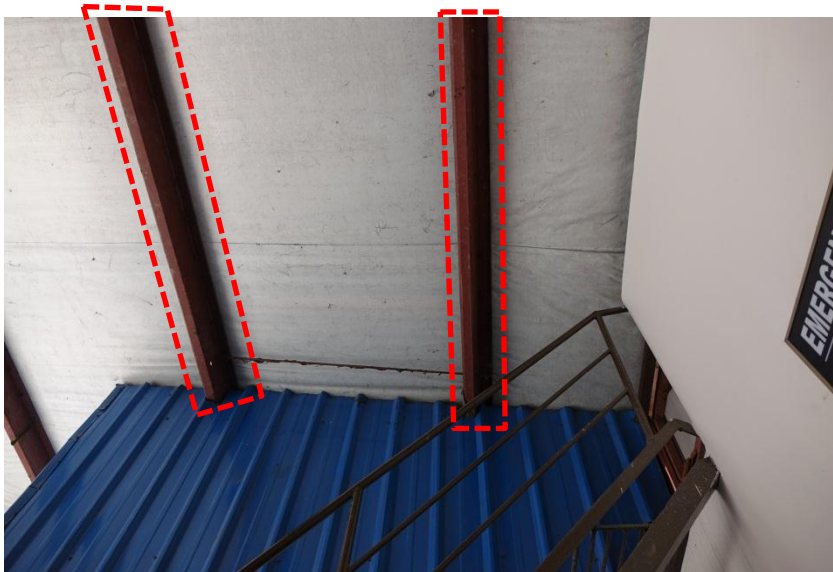
## 1<sup>st</sup> Priority 3 Concern

The roof of the Building 1 is currently a steel roof instead of a concrete roof. We noticed that some of the purlins (Z-shaped) have buckled. This is due to the lack of bracing of the purlin.

**Some of the purlins at roof of Building 1 have buckled**

| Item No. | Observation | Recommended Action Plan | Recommended Timeline |
|---|---|---|---|
| 1 | (1st Priority 3) Some of the purlins at R/F of Building 1 have buckled | Carry out the strengthening work to provide lateral buckling restraint system | 6-months |

Suitable lateral bracing should be provided to prevent buckling of these purlin members.

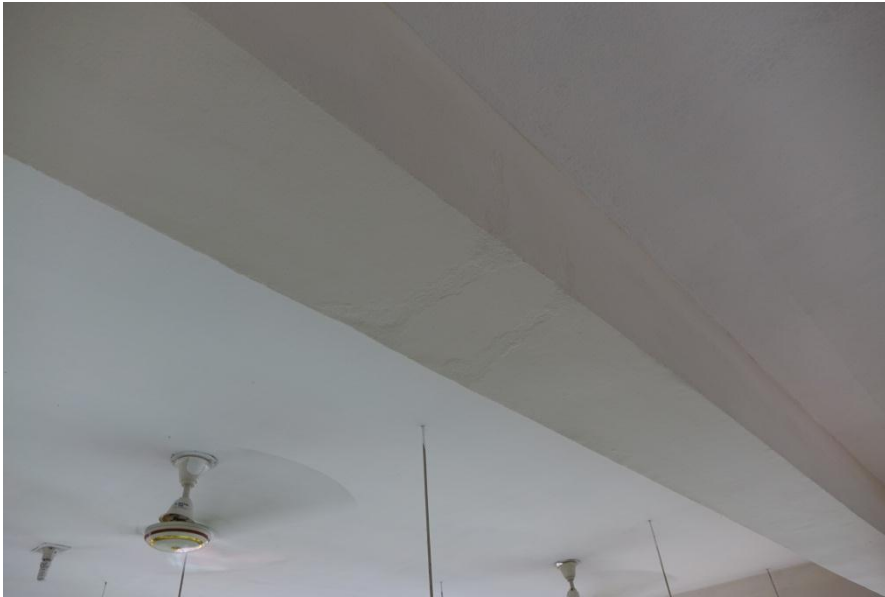
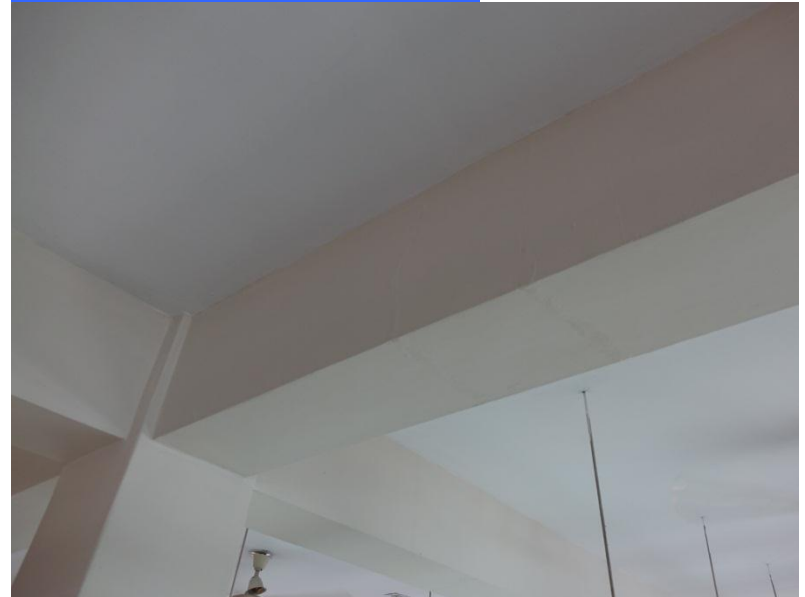
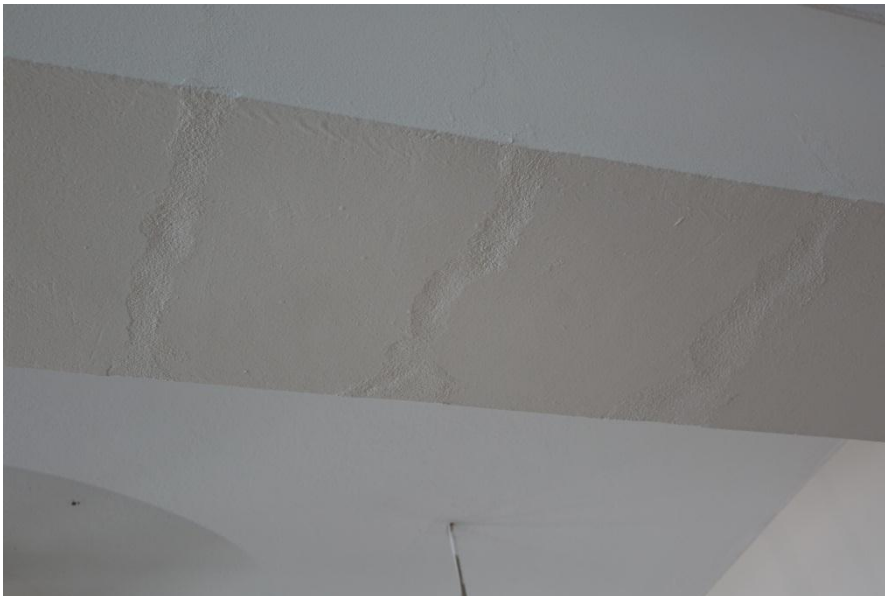
## 2<sup>nd</sup> Priority 3 Concern

On 2nd floor of the factory building 1, a number of cracks were noticed in some beams. The cracks have since been repaired, but it is unknown the reason for the appearance of these cracks. Investigation of the reason for the cracks should be carried out.

**Cracks were noticed in some beams**

| Item No. | Observation | Recommended Action Plan | Recommended Timeline |
|---|---|---|---|
| 2 | (2nd Priority 3) Previous cracks were noticed in some beams on 2/F ceiling | Carry out full survey of all structural elements to check for cracking and remove surface finishes to expose concrete<br>Ensure that there are no design deficiencies associated with the observed defects, and carry out suitable repairs to the structural elements.<br>Regularly inspect repaired structural elements for re-occurring damage | 6-months |

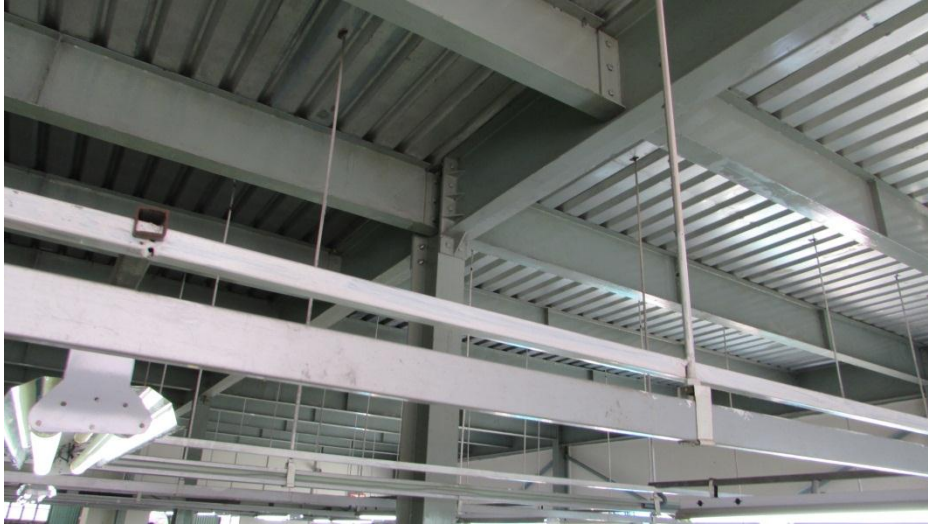
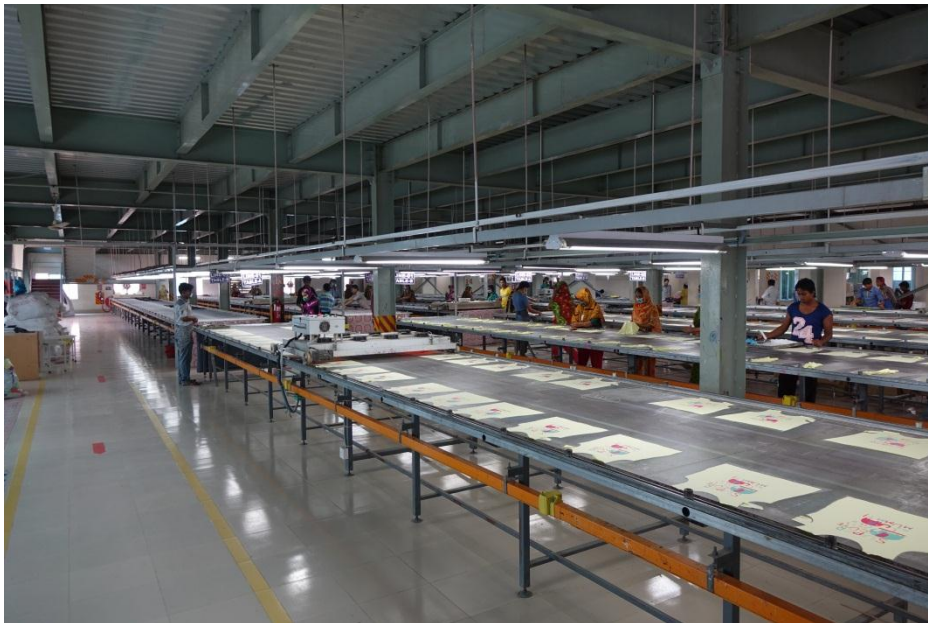
### 3<sup>rd</sup> Priority 3 Concern

In the garment building 2 (printing), the building mezzanine is a concrete slab with permanent steel formwork, and supported by steel beams and columns. However, it is noticed that the steel beams are not fireproofed in any way.

**No fireproofing of steel support members for M/F slab at Building 2**

It is recommended that the floor support system should be fireproofed to at least 1 hour fire resistance period for both flame and heat insulation.

| Item No. | Observation | Recommended Action Plan | Recommended Timeline |
|---|---|---|---|
| 3 | (3rd Priority 3) No fireproofing was observed for the mezzanine floor supporting structure of Building 2 | Carry out the necessary measures for fire protection system of steel beams to ensure minimum fire protection of at least 1 hour | 6-months |

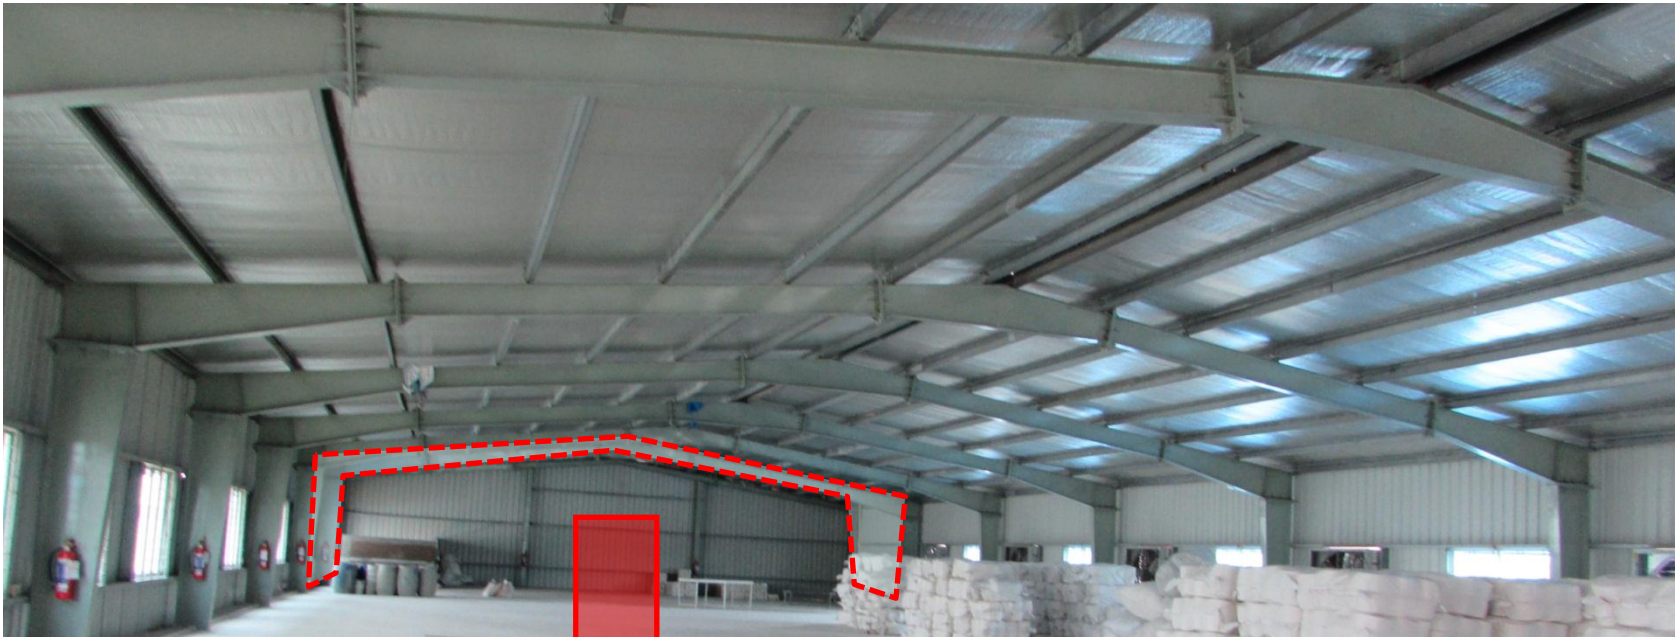
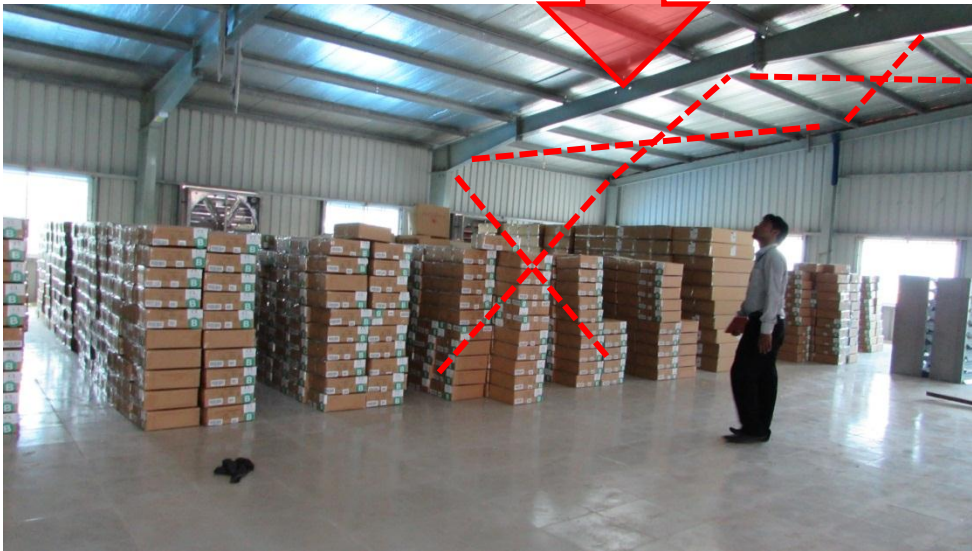
## 4<sup>th</sup> Priority 3 Concern

In Building 2, lateral bracing has been provided beneath the mezzanine floor slab only. Bracing should also be added on the roof, as well as the upper vertical portion of the frame, as shown in the photos.

**Bracing has been omitted above the mezzanine, and from the roof.**

| Item No. | Observation | Recommended Action Plan | Recommended Timeline |
|---|---|---|---|
| 4 | (4th Priority 3) Lateral bracing has been omitted above the mezzanine, and from the roof of Building 2 | Factory to retain a structural engineer to design a lateral load resisting system in compliance with BNBC 2006. | 6-weeks |
| 5 | (4th Priority 3) Lateral bracing has been omitted above the mezzanine, and from the roof of Building 2 | Carry out the strengthening work to provide the bracing system | 6-months |
