# M.I.T Apparels Ltd. (9687)

Pathantuly, Godnail, Shiddirgonj, Narayanganj, Bangladesh

12.MAY.2014

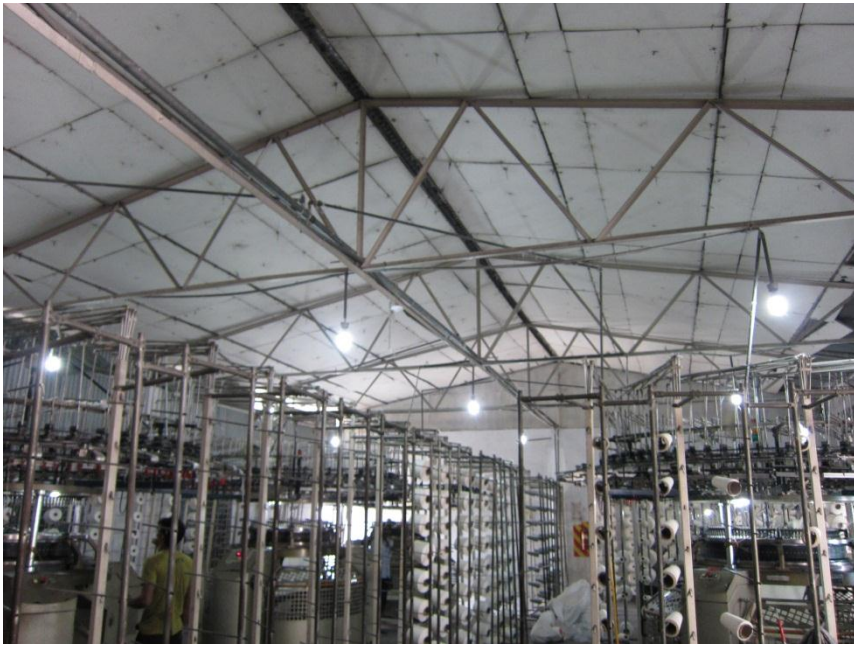
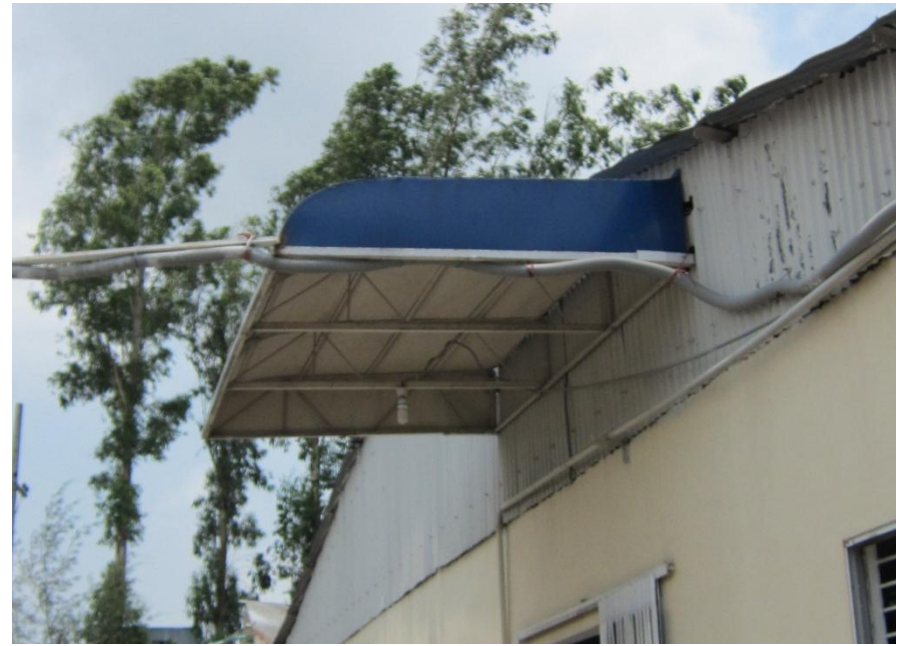
- No roof plan and details specified in the drawings

Steel roof truss and canopy have been built without any plan or details specified on the drawings.

| Item No. | Observation | Recommended Action Plan | Recommended Timeline |
|---|---|---|---|
| 1 | No roof plan and details specified in the drawings. | Factory Engineer to survey the actual conditions and produce the drawings.<br>Factory Engineer to review design, loads of steel roof truss to confirm suitability for loads applied. | 6-weeks |
| 2 | No roof plan and details specified in the drawings. | Implement any remedial works found necessary by the abovementioned review. | 6-months |

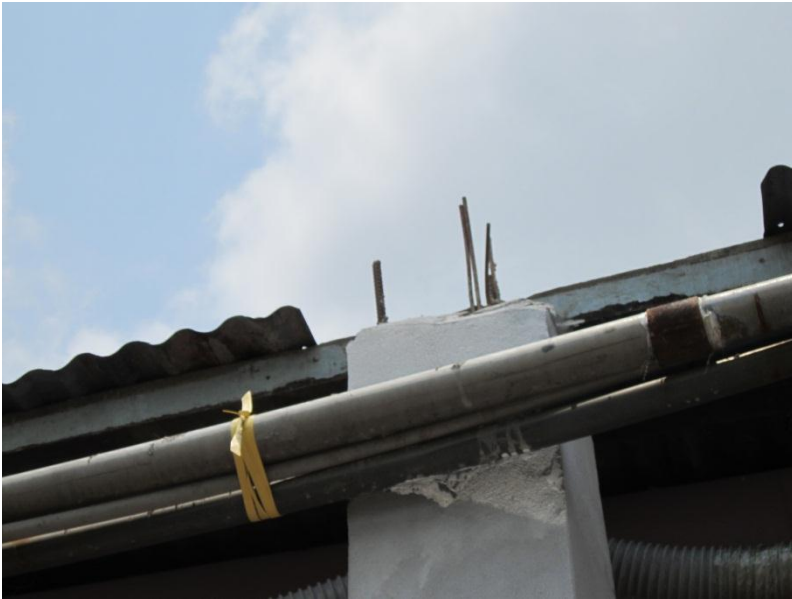
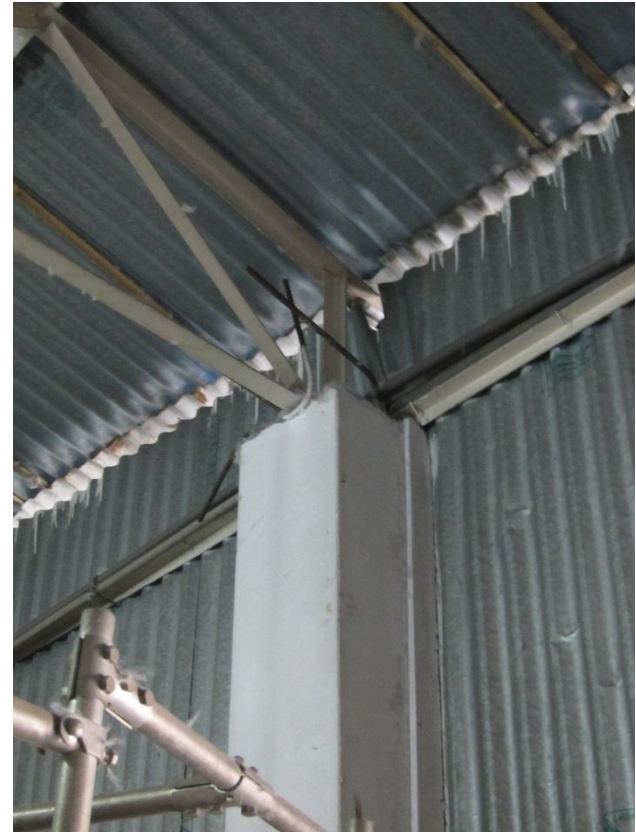
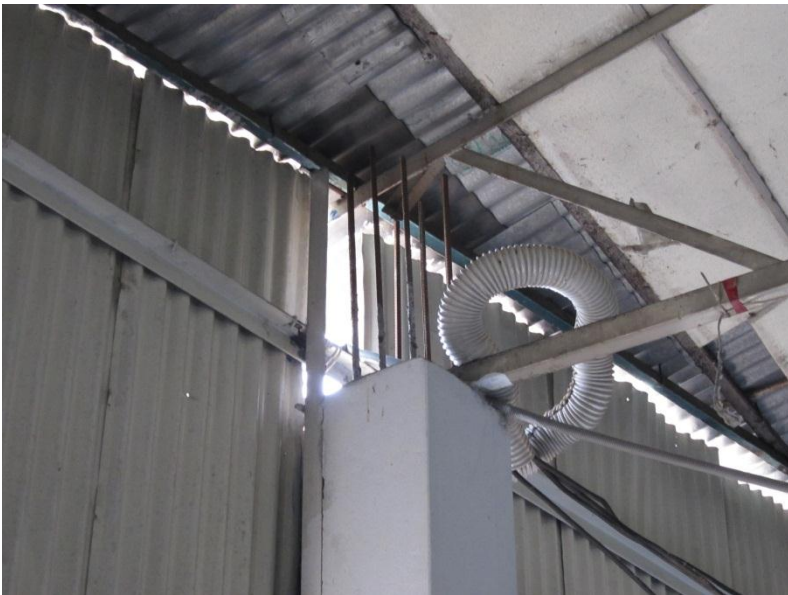
Steel reinforcement are left exposed on the top of reinforced concrete column. It is unclear whether rust-proof paint is applied.

| Item No. | Observation | Recommended Action Plan | Recommended Timeline |
|---|---|---|---|
| 5 | Steel reinforcement left exposed. | Rust-proof paint to be applied for the exposed steel reinforcement. | 6-months |

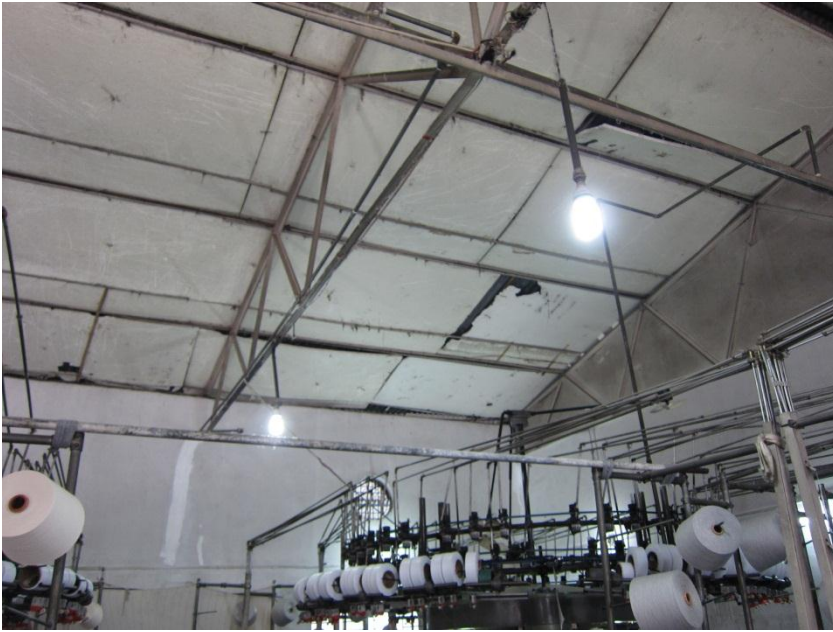
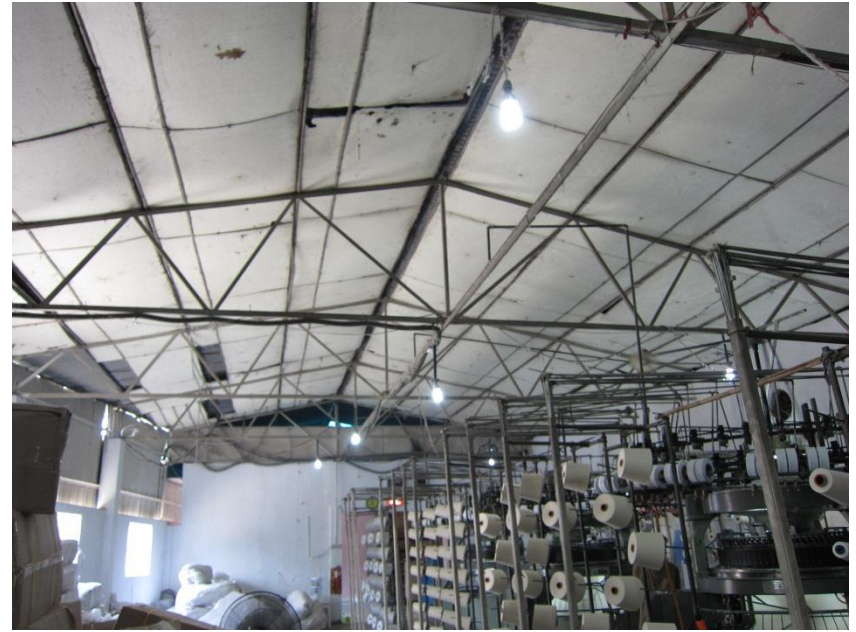
It is unclear whether fire-proof paint (if required by regulations) is applied for the steel roof truss.

| Item No. | Observation | Recommended Action Plan | Recommended Timeline |
|---|---|---|---|
| 6 | Fireproof paint for steel roof truss (if required) | Fireproofing material for structural steel element needs to be applied (if required based on the provision of BNBC Codes).<br>Maintain standard of quality control. | 6-months |

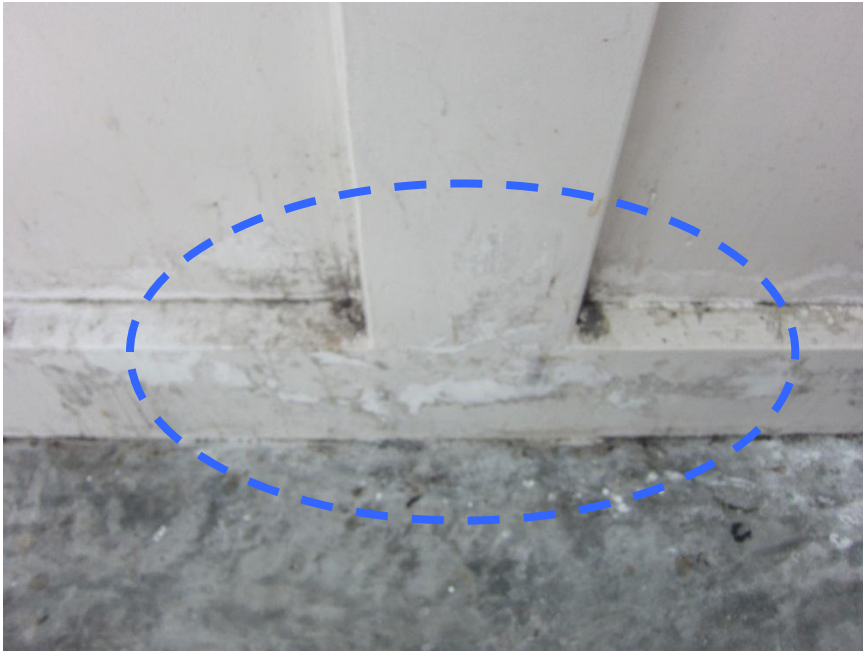
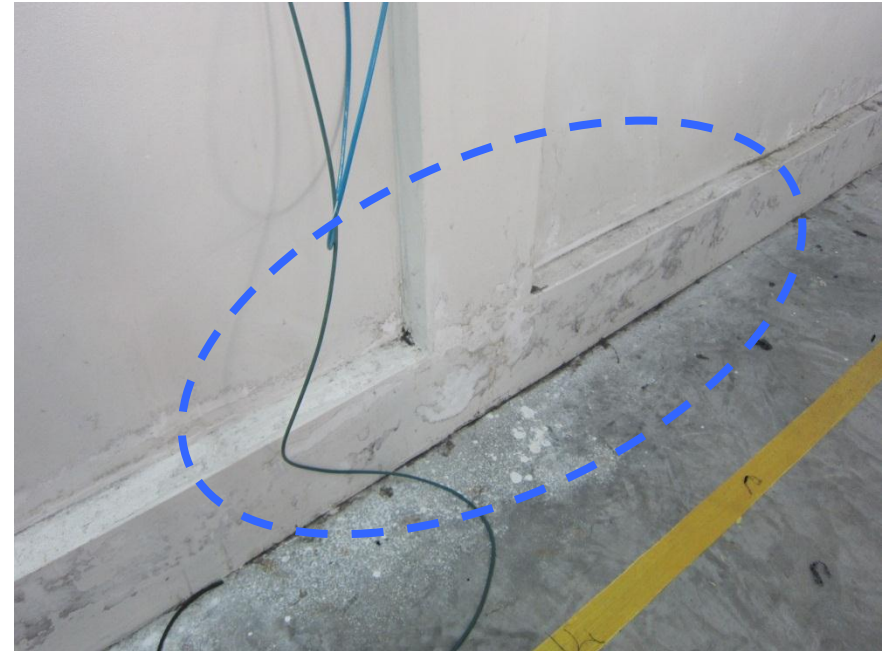
It seems that there are signs of water ingress noted at ground beam level. Maintenance/repair should be carried out.

| Item No. | Observation | Recommended Action Plan | Recommended Timeline |
|---|---|---|---|
| 7 | Water ingress at the ground beam level. | Engineer to inspect water damaged structure and propose a suitable repair. | 6-months |

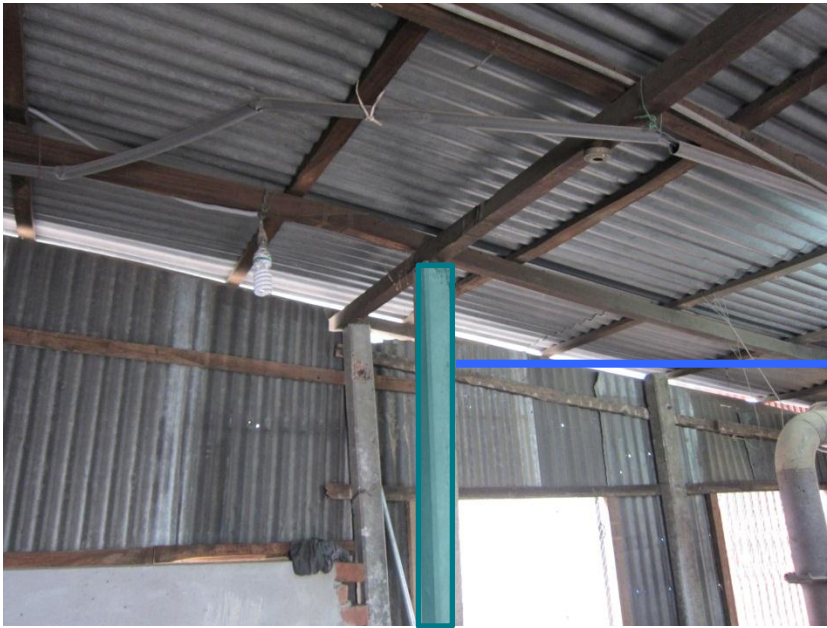
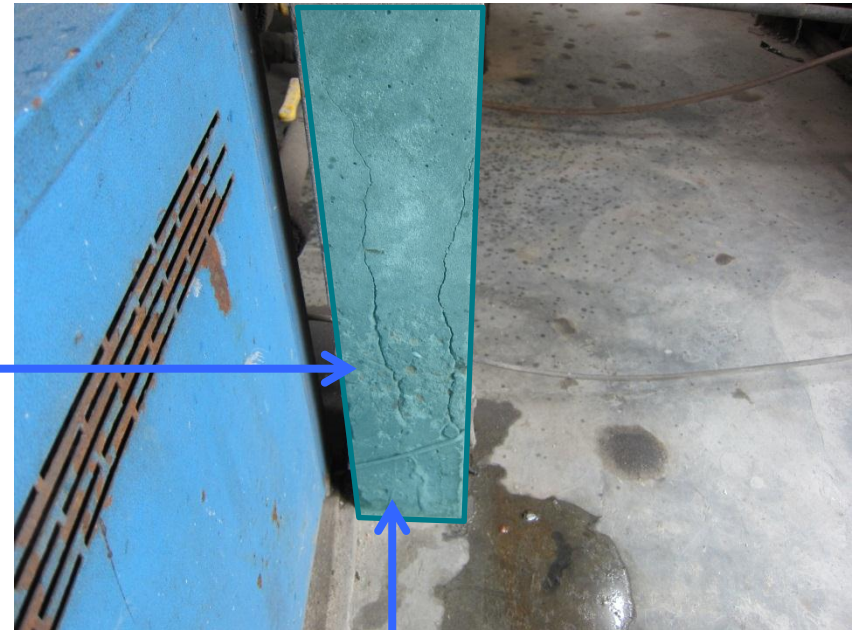
Cracks appeared at the bottom of brick column with no reinforcement which is used to support the wooden rafter above. This column should be replaced by a RC or steel column.

| Item No. | Observation | Recommended Action Plan | Recommended Timeline |
|---|---|---|---|
| 8 | Maintenance/Repair of supporting steel column to water tank including brick column supporting wooden rafter at generator shed | Factory engineer to inspect the damaged structure and propose a suitable maintenance/repair. | 6-months |

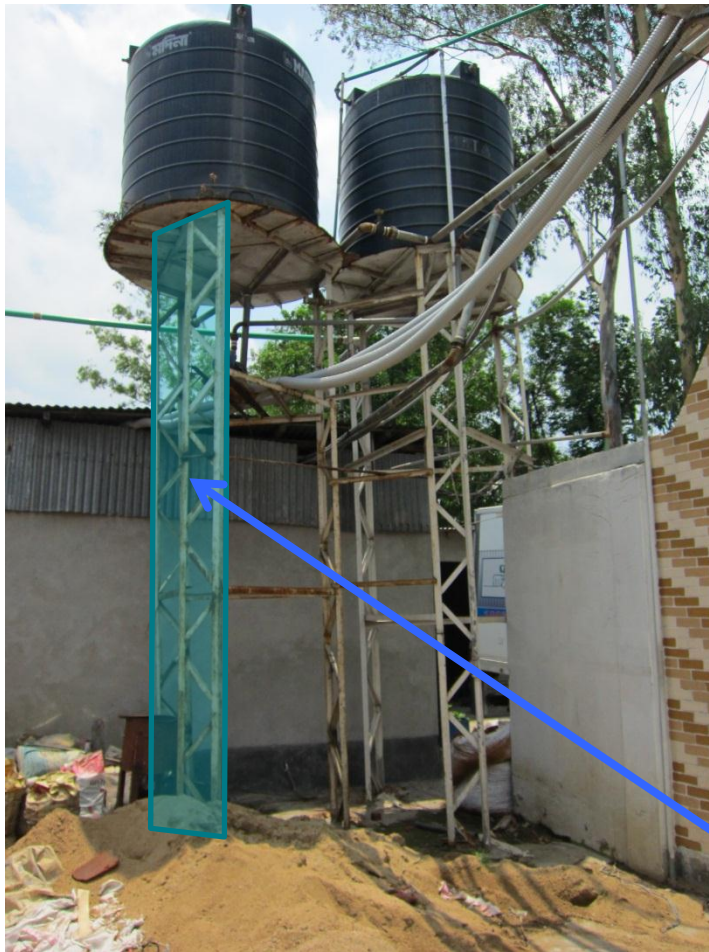
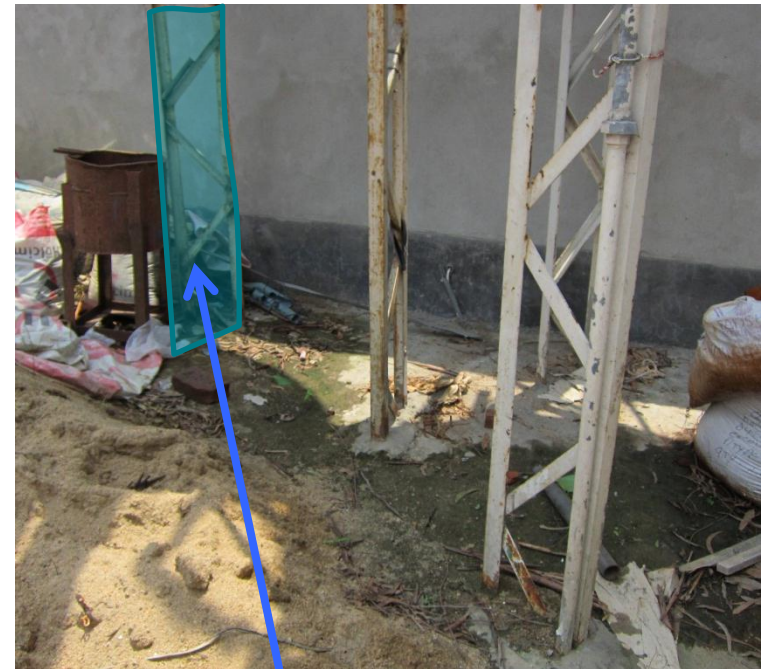
Steel laced column supporting the water tank appeared to be tilted. The capacity of this structure should be checked.

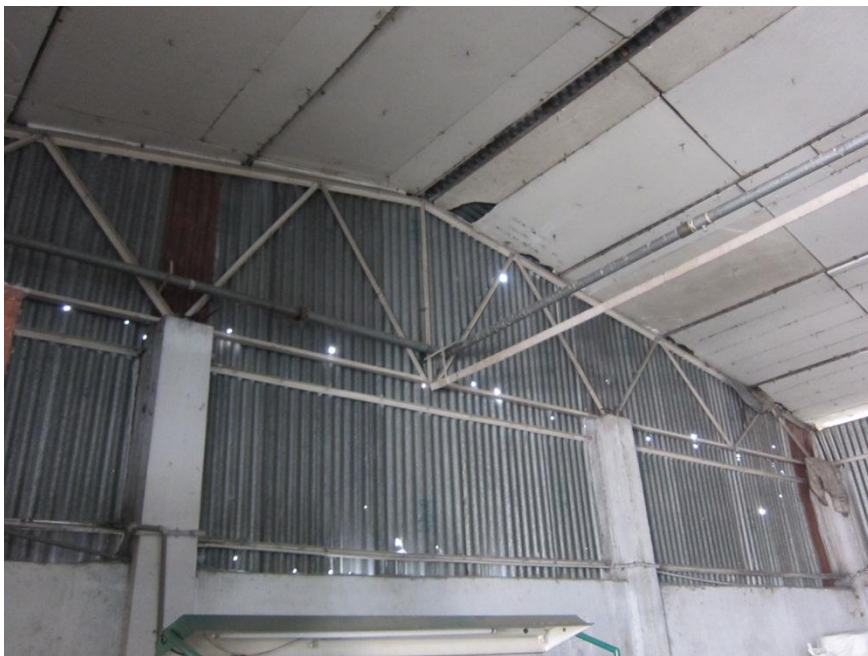
Concerns on the stability system for lateral loading, especially at the joint connection of steel roof truss and reinforced concrete column.

We require that these items be investigated in a Detail Engineering Assessment.

| Item No. | Observation | Recommended Action Plan | Recommended Timeline |
|---|---|---|---|
| 3 | Overall stability system. | Request that the Detail Engineering Assessment of the overall building to be carried out and in particular, stability and foundation aspects should be investigated in detail. | 6-weeks |
| 4 | Overall stability system. | Implement any remedial works found necessary by the DEA. | 6-months |

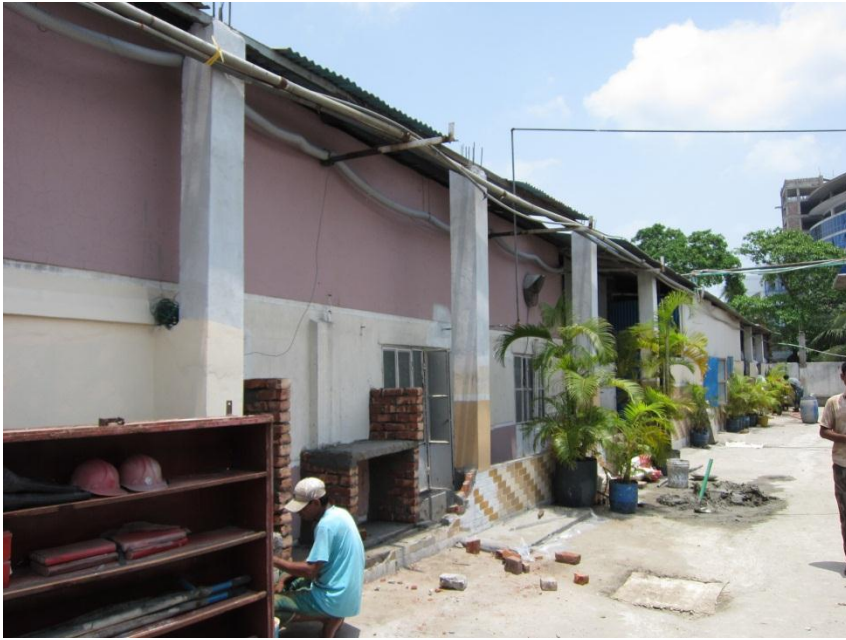
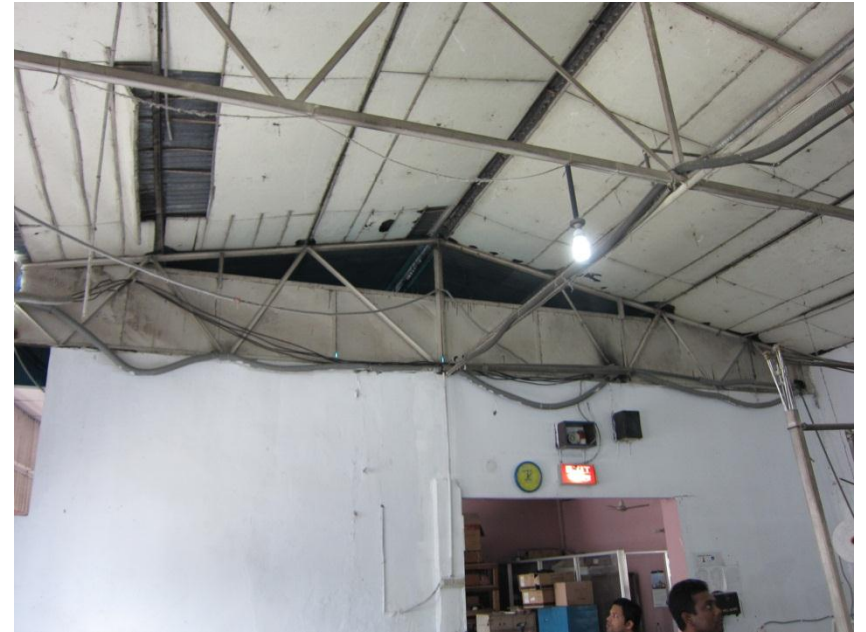
There is no distress due water ingress noted at roof sheet.
