# Weldone Apparels Ltd. #10249

Baraidrchalae, Sreepur, Gazipur

12.May.2014

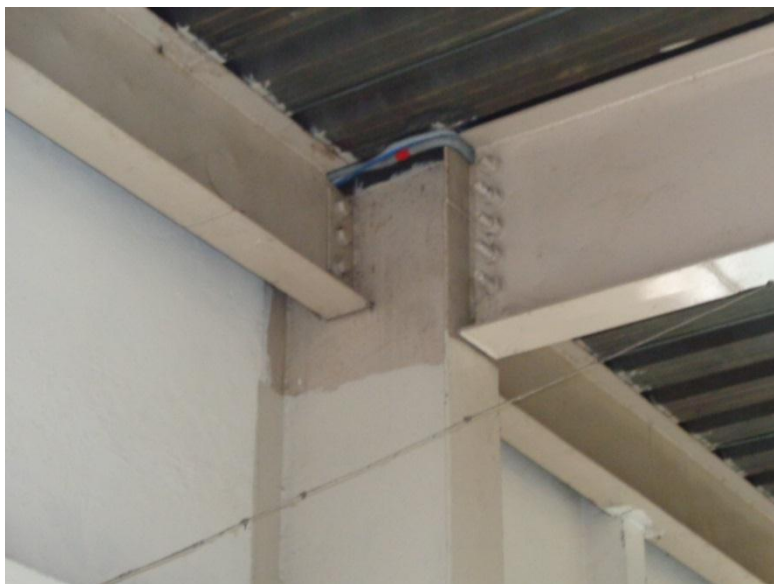
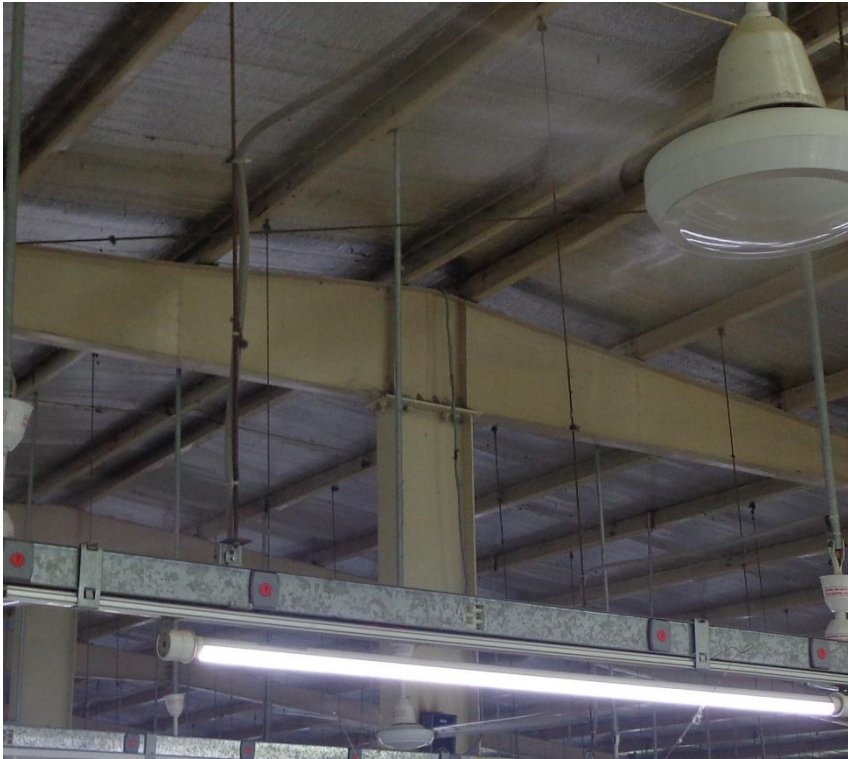
During our survey, we have only found shear tab connections (perimeter and interior columns) which provide no moment resistance. All the masonry is in front of the steel structure

Base plates are not designed for moment resisting either.

We consider this building to have no lateral resisting system and could present signs of instability in case of high winds or earthquakes.

We require a full Detail Engineering Assessment of this building

| Item No. | Observation | Recommended Action Plan | Recommended Timeline |
|---|---|---|---|
| 1 | Main Building has no lateral load resisting system | Carry out an immediate full Detail Engineering Assessment of the steel structure including lateral stability | Immediate – Now |
| 2 | Main Building has no lateral load resisting system | Prepare engineering plans of required remedial works. | 6-weeks |
| 3 | Main Building has no lateral load resisting system | Carry out all remedial works deemed necessary by DEA. | 6-months |

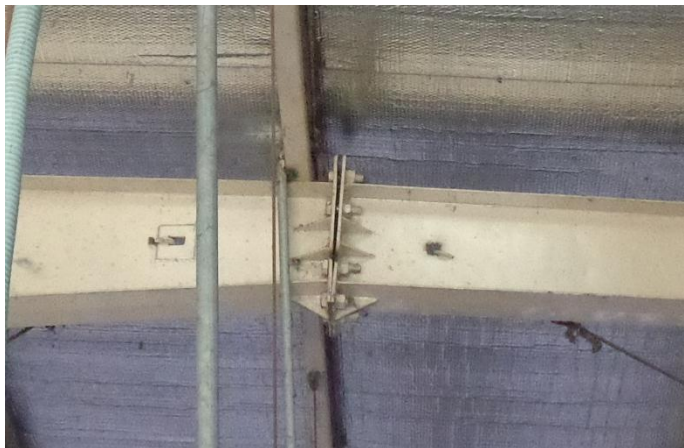
We have certain concerns with the roof structure as there are some missing bolts and main beam elements that are not restrained.

Include in Detail Engineering Assessment of the building

| Item No. | Observation | Recommended Action Plan | Recommended Timeline |
|---|---|---|---|
| 4 | Poor steel detailing at the roof | Complete the connections with missing bolts<br>Include roof structure in full Detailed Engineering Assessment. | Immediate – Now |
| 5 | Poor steel detailing at the roof | Make sure ALL the bolts are well tightened | 6-weeks |
| 6 | Poor steel detailing at the roof | Carry out any remedial works deemed necessary by assessment. | 6-months |

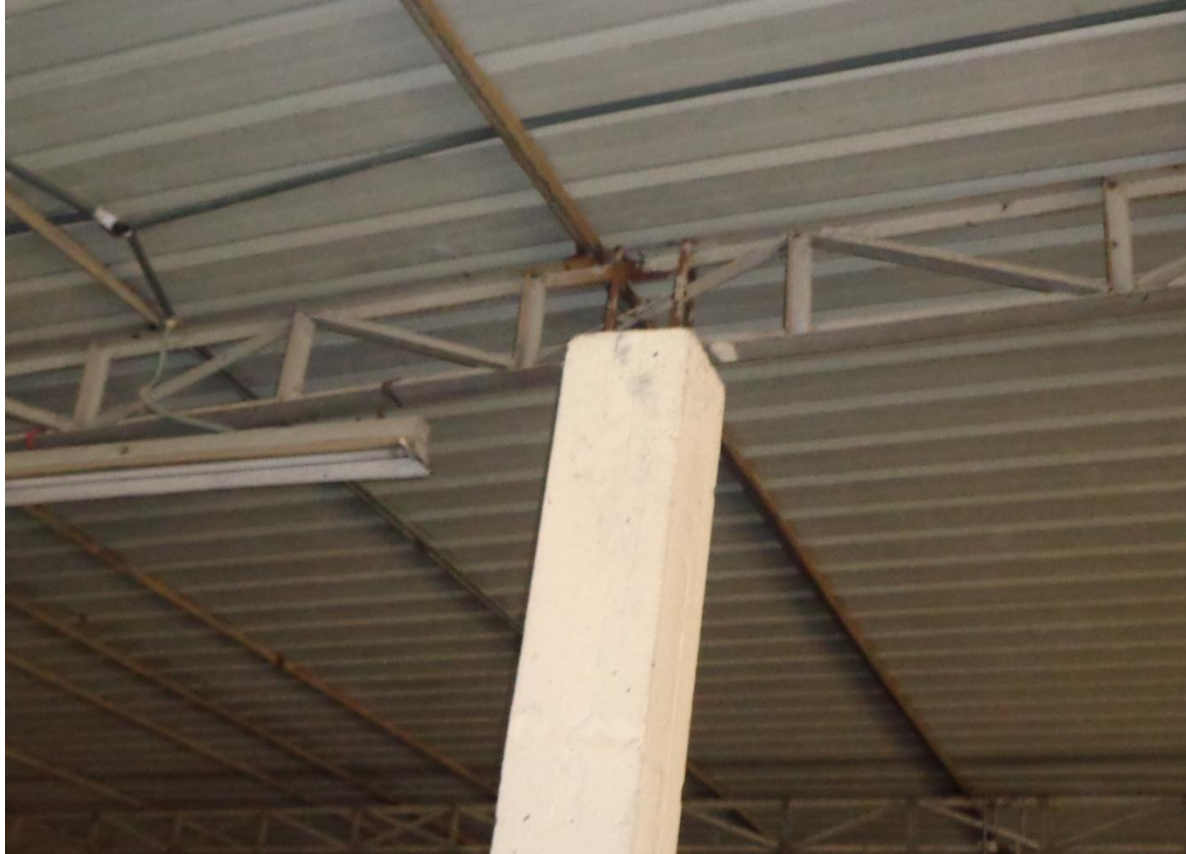
The single storey sheds are flimsy and show poor detailing.

We recommend a Detailed Engineering Assessment of the sheds in the courtyard.

| Item No. | Observation | Recommended Action Plan | Recommended Timeline |
|---|---|---|---|
| 7 | Sheds are flimsy | We recommend a Detailed Engineering Assessment of the sheds in the courtyard. | 6-months |
